NATIONAL TRANSPORTATION SAFETY BOARD

REPORT

**AIR CANADA FLIGHT 797
McDONNELL DOUGLAS DC-9-32, C-FTLL
GREATER CINCINNATI
INTERNATIONAL AIRPORT
COVINGTON, KENTUCKY
JUNE 2, 1983**

NTSB/AAR-86/02

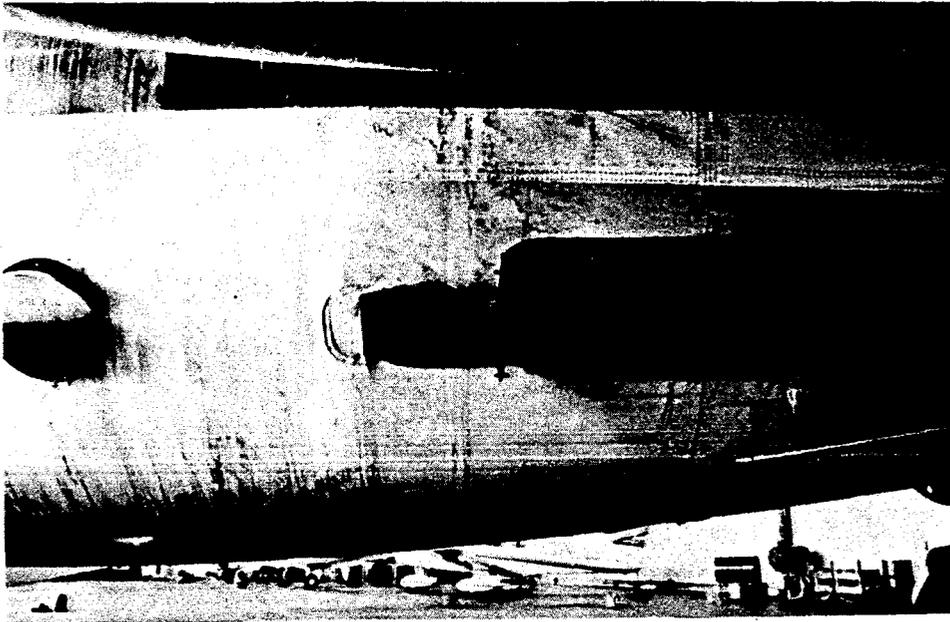
There were thick soot deposits along the lower side of the fuselage beginning at the cabin air outflow valve at FS 945 and from around the access **door** in the lavatory service panel at FS 965. The soot pattern trailed rearward along the airplane's side,

including the tailcone. The cabin air dump valve, at FS 920, was open, and light soot deposits trailed aft from around the edges of the valve. (See figure 5.)

Figure S.-Soot trail deposits on left side of fuselage at lavatory, service panel and outflow valve.

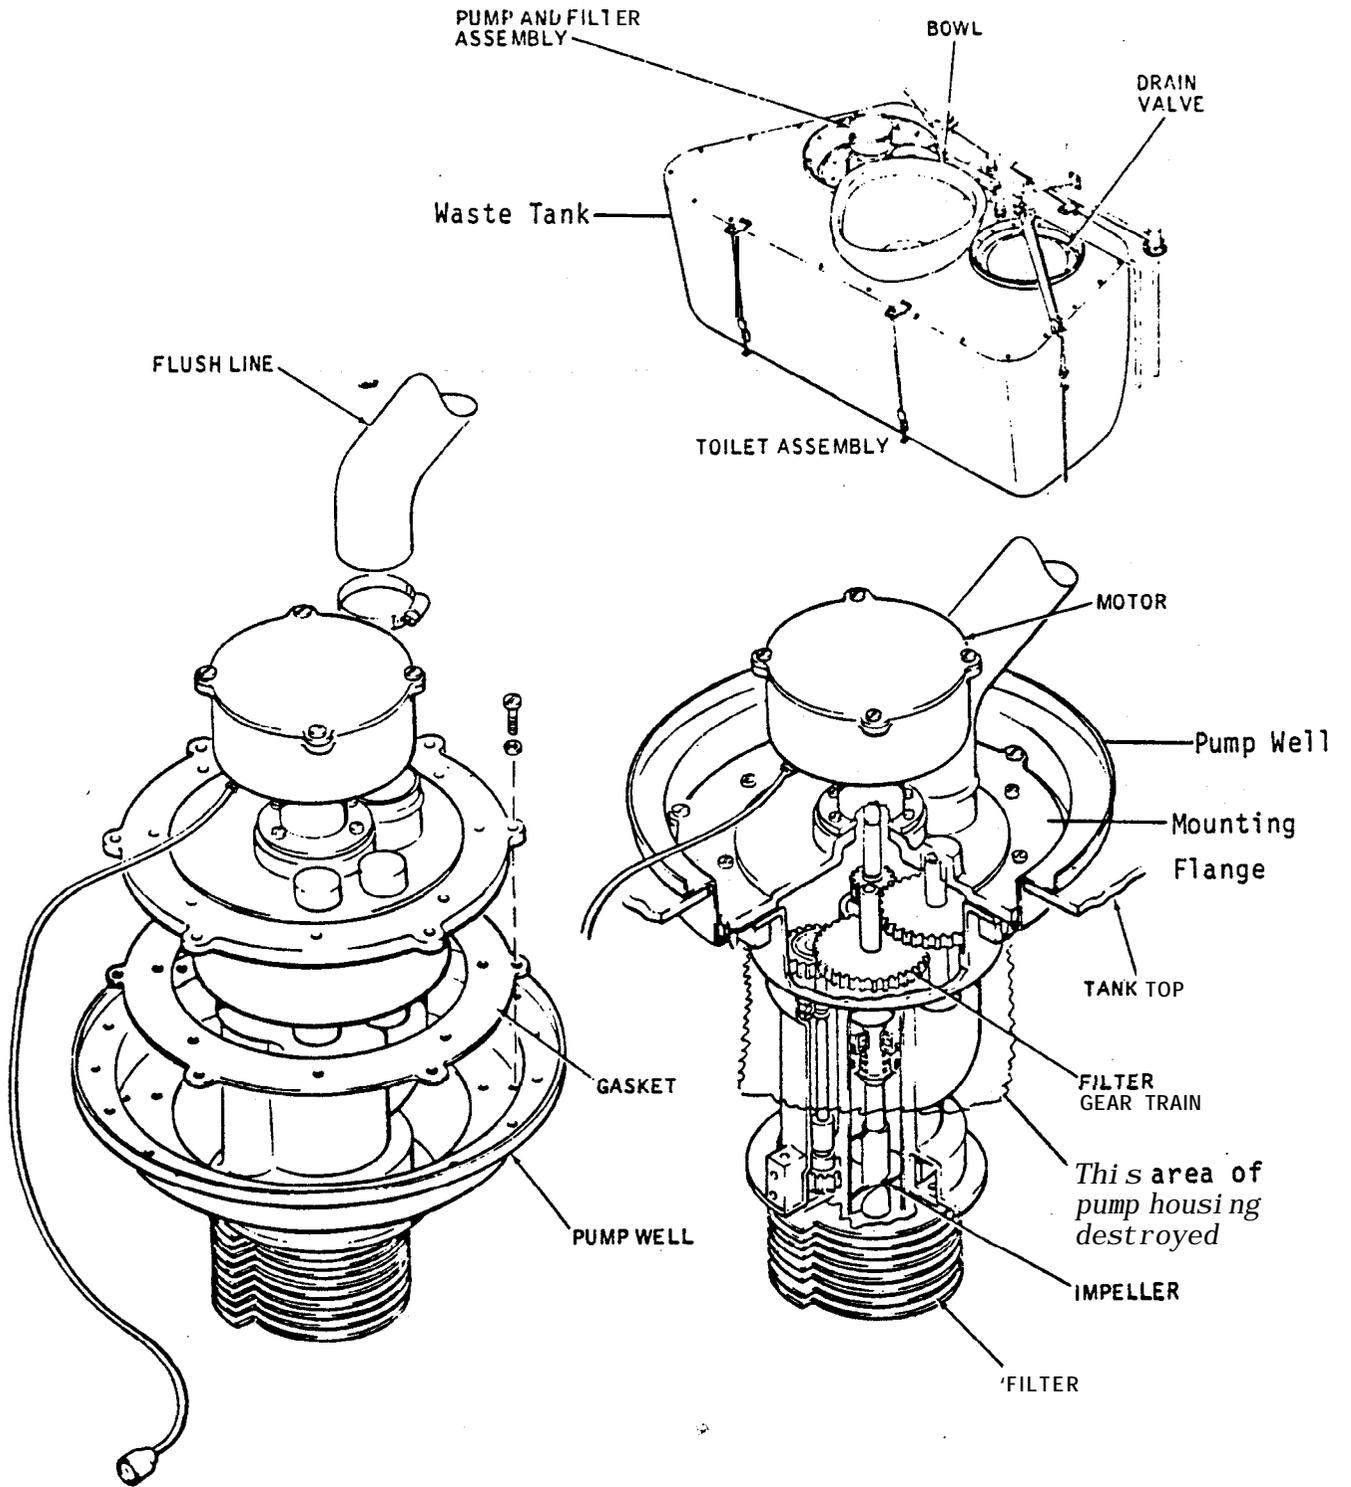
The flush motor was found attached to its mounting flange which was attached to the pump well. The flush motor assembly was found in approximately its normal position in the waste tank next to, but detached from, the flush pump and filter assembly. The motor housing was completely melted. Large concentrations of molten metal were found on the forward side of the mounting flange facing the toilet bowl, and on the aft side where the **3-phase** electrical leads enter the motor housing. A portion of the wiring harness which supplies **a.c.** power to the flush timer, flush motor, and flush button was encased in the molten metal on the aft side of the motor. The rotor section of the flush motor was encased in molten metal above the field windings; however, the rotor did not appear to have been damaged extensively by heat. (See figure 11.)

The flush pump and filter assembly found in the waste tank was partially intact. The filter and pump mechanisms, which apparently had been located below the water line in the waste tank, were in good condition. Above the water line, the plastic housing for the pump and filter was melted away. This housing also encloses the filter gear train and is part of the assembly used to mount the pump and filter to the pump well. The exposed shaft and gears showed heat damage. The gears, which make up the filter gear train that connects the motor to the pump and filter, were found lying in the waste tank. The plastic mounting ring, which mates the pump and filter housing to the pump well, was found intact among the debris in the waste tank. There was some slight melting of the top surface of the mounting ring. All of the components of the flush motor and pump assembly were removed for further examination.

Figure 11.—Lavatory pump and filter system.
