EQUIPMENT/FURNISHINGS - Lavatories - Seal Openings in Lavatory Washstand.

Bulletin 25-264

Revision 1 June 9/87

DC-9

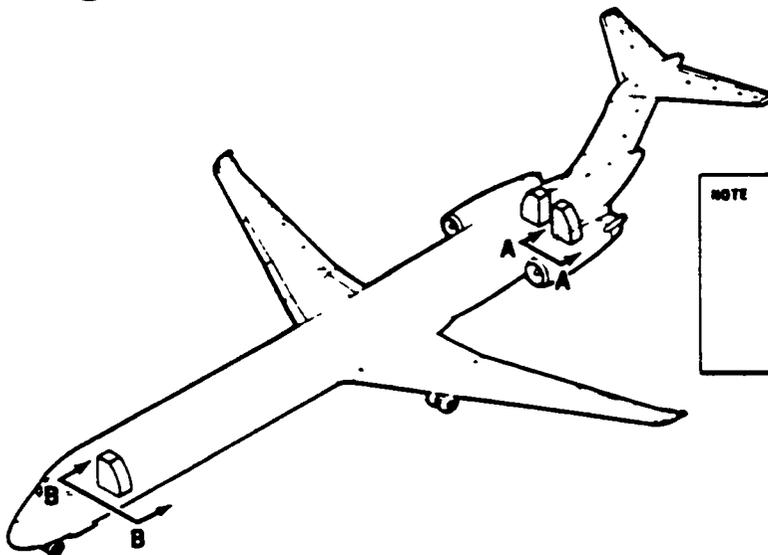
FORWARD AND/OR AFT LAVATORY WASHSTAND - MODIFICATION

NOTE: INSTRUCTIONS ARE TYPICAL FOR AFT LEFT, AFT RIGHT AND FORWARD LAVATORY CABINETS, EXCEPT AS NOTED.

NOTE: TAPE ALL OPEN SEAMS, HOLES, AND GAPS 3/16-INCH OR GREATER. IF AN OPENING BEING TAPED IS TOO CLOSE TO EDGE TO MAINTAIN .75 (19.1)-INCH, APPLY TAPE TO ADJACENT SURFACE. ALL ENDS OF TAPE TO BE CUT TO PROVIDE FOR NEAT INSTALLATION. SEAL ALL SEAMS, HOLES OR GAPS LESS THAN 3/16-INCH USING PR1422,B-2 SEALANT.

- ① REMOVE AND RETAIN 5920937 AND/OR 5956509-(ANY CONFIGURATION) CONTAINER ASSEMBLY.
- ② REMOVE AND RETAIN 5930671-11 LEFT SIDE (-12 RIGHT SIDE) AND 5930670-11 COVERS.
- ③ REMOVE 5930670-5, -7, 5930671-5, -7 TAPE FROM COVERS AND 5919078-17 LEFT SIDE (-18 RIGHT SIDE) AND 5923853-11 LEFT SIDE BOTTOMS. REMOVE ADHESIVE RESIDUAL USING 1,1,1 TRICHLOROETHANE SOLVENT.
- ④ PRIME AREA USING 1200 SILICONE PRIMER, AND APPLY 90-006 SEALANT WITH 90-006-2 CATALYST TO FAYING SURFACE AND POSITION COVERS ON BOTTOMS.
- ⑤ INSTALL SR09250001-5 TAPE.

- ⑥ INSTALL TWO SR09250001-9 SEALS.

NOTE: SEAL MAY BE CUT IN MORE THAN ONE PIECE, COMPRESS BETWEEN CUTS TO INSTALL.

- ⑦ APPLY A BEAD OF 732 RTV SILICONE SEALANT.
- ⑦A INSTALL THREE NAS1836-06-08 INSERTS IN FILLER. (SEE MAINTENANCE MANUAL CHAPTER 20-19-0, PARAGRAPH ENTITLED, "SINGLE STEP INSTALLATION OF BLIND INSERTS WITH POTTING HOLES.")
- ⑧ APPLY EC2216 B/A ADHESIVE TO SR09250001-7 FILLER AND INSTALL ON DOOR JAMB.
- ⑨ INSTALL SR09250001-3 AND -4 ANGLE ON FILLER.
- ⑩ APPLY TWO COATS OF TIP-6041 MOLD RELEASE TO DOOR JAMB AND ANGLES. (ALLOW 15 MINUTES DRYING TIME AFTER EACH COAT.)
- ⑪ MASK AREA TO BE SEALED TO ENSURE STRAIGHT EDGES AND APPLY SEAL AROUND PERIPHERY OF DOOR USING 90-006 SEALANT WITH 90-006-2 CATALYST. ALLOW SEALANT TO CURE FOR 24 HOURS WITH THE DOORS IN THE CLOSED AND LATCHED POSITION. REMOVE TAPE AND EXCESS SEALANT.
- ⑫ REINSTALL RETAINED 5920937 AND/OR 5956509-(ANY CONFIGURATION) CONTAINER ASSEMBLY.
