Crash to Boost FAA Scrutiny

Accident, subsequent findings, expected to spur agency to review transport maintenance inspection procedures

By David M. North

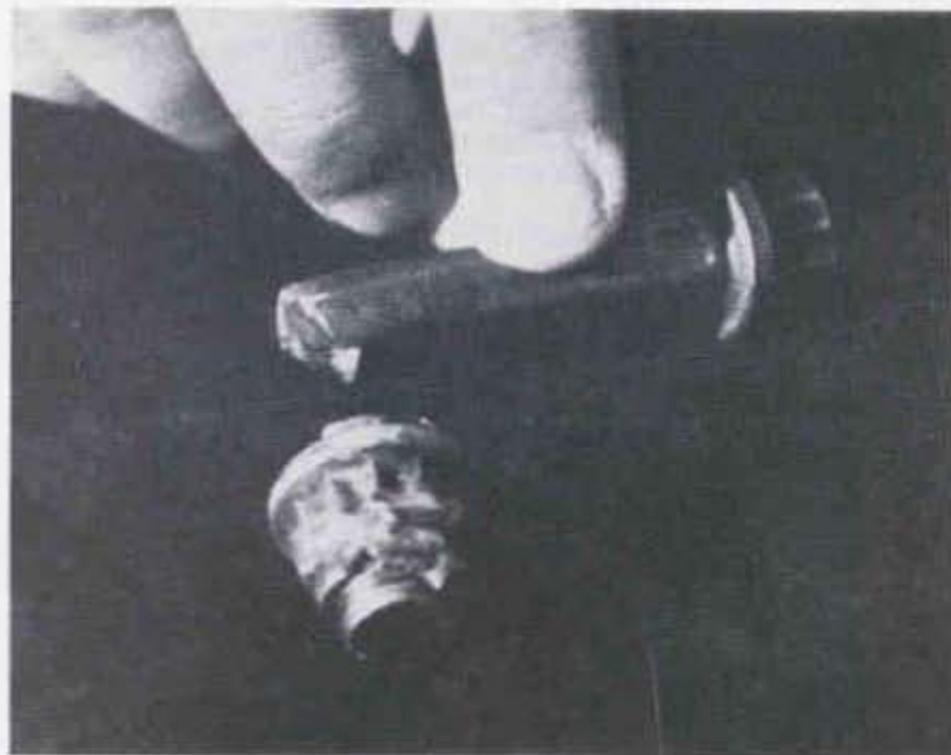
Thrust link bolt from left engine pylon on American Airlines DC-10 that crashed at Chicago was found along the runway. Bolt had been sheared in two, allowing the thrust bushing to break away. Cause of the bolt's breaking is under investigation.

fatigue fracture in the thrust link attach bolt, started to pick up contradictory reports from investigators and from further inspections of the DC-10s' engine pylons. As one NTSB accident investigator said: "The link attach bolt does not carry the load of the forward thrust; the bushing does, and the bolt holds the bushing in place. It would appear that the fracture of the bolt is a symptom of the disease, rather than the problem itself."

Late last week, the safety board's laboratory here was conducting tests on the pylon link attach bolts to determine whether the fracture in the bolt was due to fatigue or some other stress.

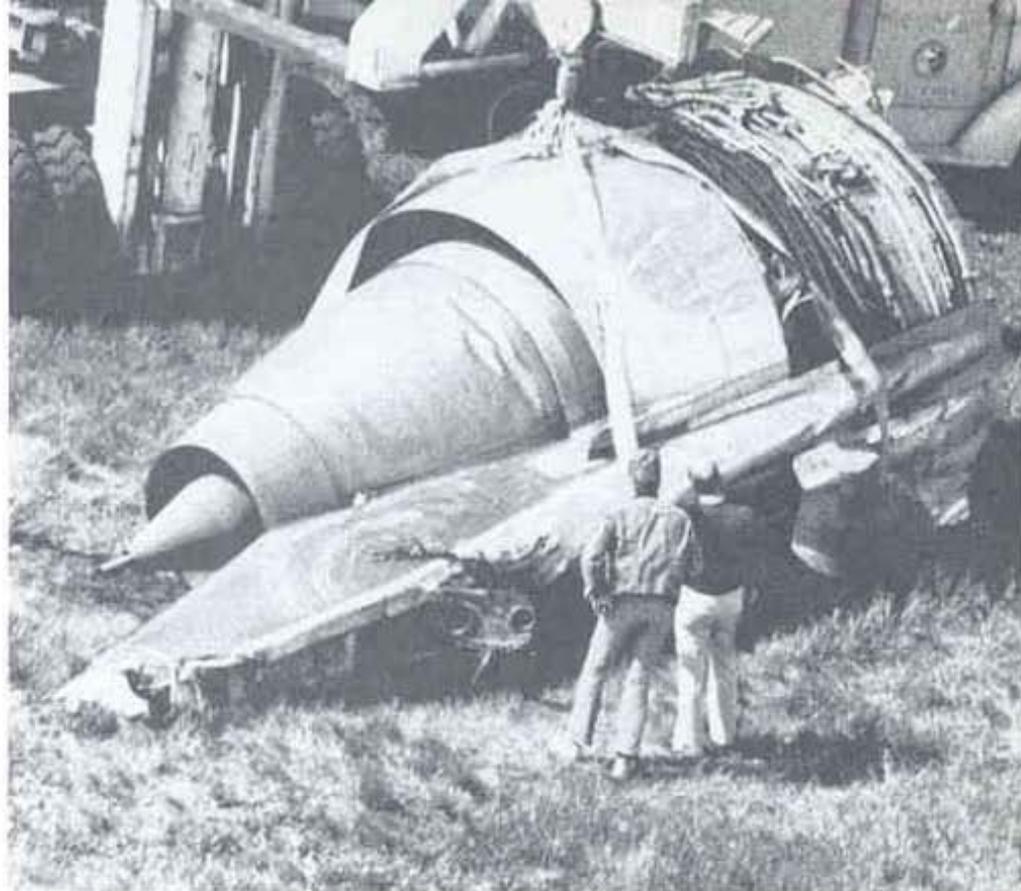
Left engine and pylon assembly from American's DC-10 is recovered at Chicago's O'Hare International Airport. Note pylon attachment fitting to left of men.

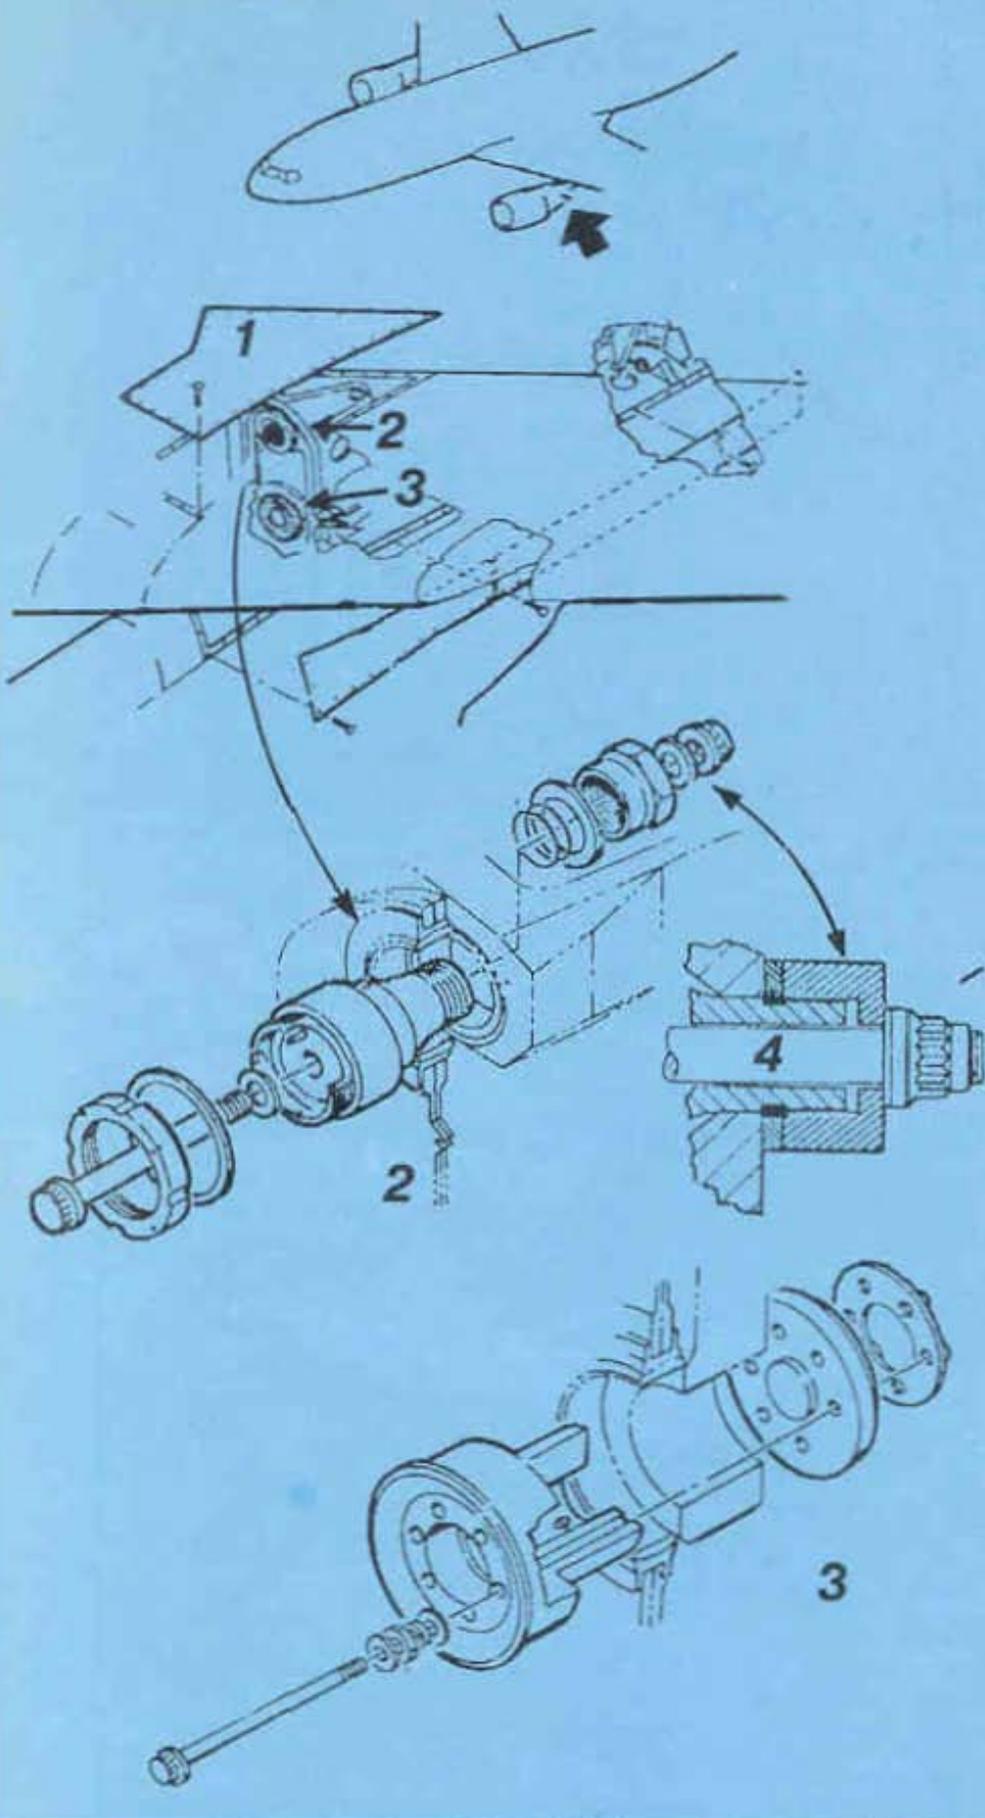
Tombstone fitting on the McDonnell Douglas DC-10 connects the engine pylon's forward bulkhead (1) to the aircraft's front wing spar and is designed to carry vertical and lateral loads from the engine to the spar. The fitting is held by an upper plug (2) and a lower plug (3). Fig. (4) shows the cutaway of the upper plug and retaining nut. The thrust link assembly is located to the rear of the tombstone fitting's lower plug.

The new supplement directed operators to conduct a detailed visual inspection of the upper and lower plug areas of the pylon-to-front-spar attach fittings, the aft monoball joint attachment and the pylon upper spar web.

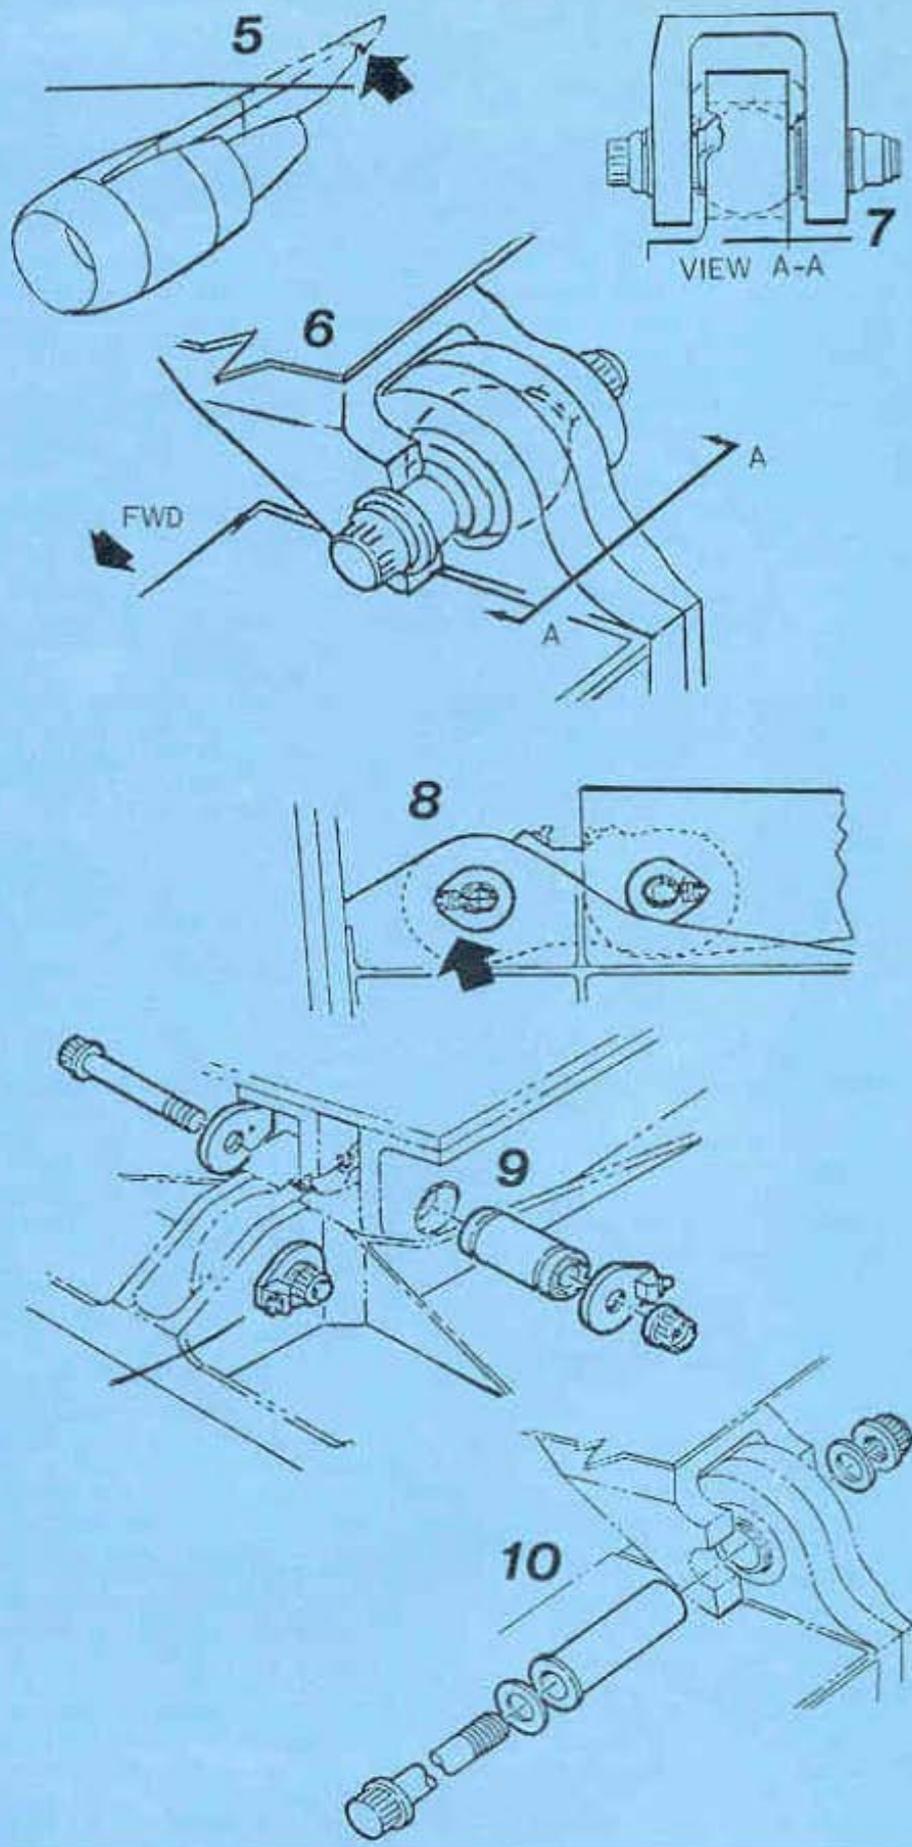
The FAA official also detailed what he believed was the sequence of events in the accident of the seven-year-old DC-10 that had accumulated 19,871 hr. of flight: "When the thrust link bolt fractured and the bushing taking the load left the aircraft, the thrust load was taken by the pylon aft monoball attach bearing which is designed for vertical and side loads, and not thrust loads. This bearing let go taking the tombstone fitting with it."

Pylon-to-wing thrust link assembly (8) on the DC-10 is designed to carry the full thrust load of the engine. Following the finding of the fractured thrust link assembly bolt (9) at the crash site, bolts at the forward and aft ends (10) of the assembly had to be inspected or replaced. Pylon aft monoball attach bearing (6 and 7), also designed to carry lateral and vertical loads, attaches the rear of the engine pylon to the aircraft wing (5).

The NTSB recommendation was followed by an emergency airworthiness directive issued by the FAA on May 28 directing all U. S. operators of all models of McDonnell Douglas DC-10s to complete an inspection or replacement of the bolts at both the forward and aft ends of the thrust link assemblies.

The amended directive further directed operators to conduct a visual inspection of the entire remaining pylon-to-wing attach area paying particular attention to the thrust link support fittings, the pylon-to-front-spar attach fittings, and the aft pylon support bulkhead and associated wing support fittings for evidence of cracks, condition and security of fasteners and other signs of structural distress. The thrust link bushings and bolts also are to be inspected on a regular basis.

The inspections of this area are to be done at intervals not to exceed 100 hr. time in service since the last inspection, or 10 days since the last inspection, whichever occurs earlier.
