DC-10

SERVICE BULLETIN

BULLETIN 54-48

NACELLES/PYLONS - Attach Fittings - Replace Engines 1 And 3 Wing Pylon Aft Attach Spherical Bearings.

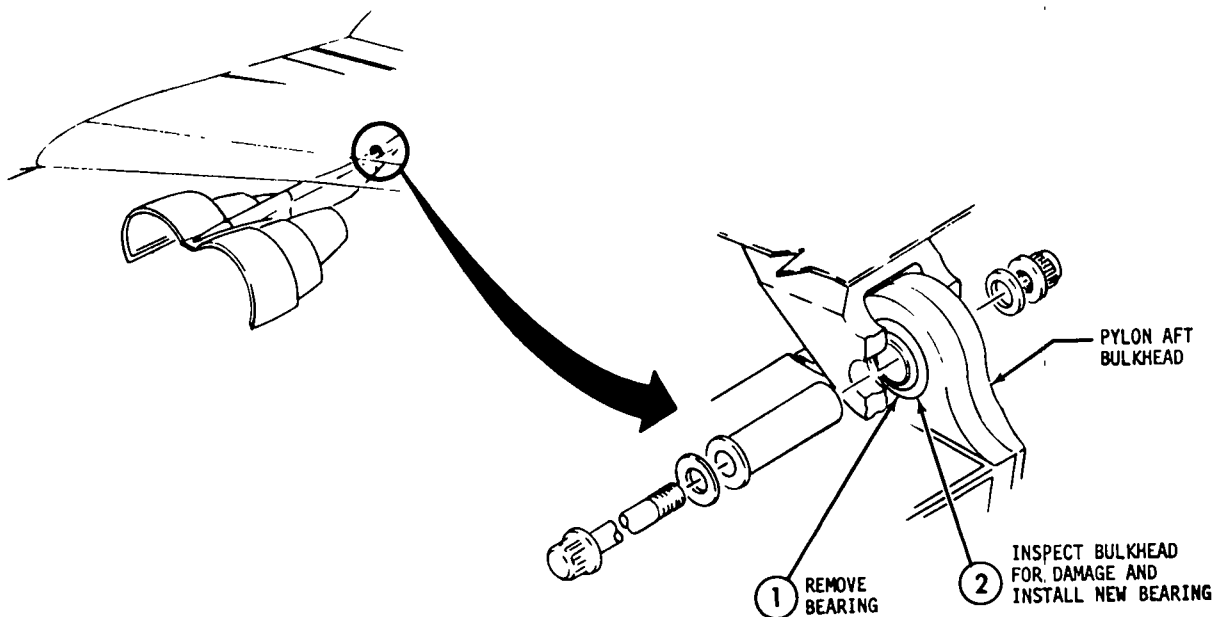
ENGINES 1 AND 3 WING PYLON AFT ATTACH BEARINGS - REPLACEMENT

- 1 REMOVE KSBY22N1, ATBY22V4, BLFR22-034, YTA301, 76689, LHSS22-77, LHSSR22-77, OR KSBY22-2 BEARING USING DZZ7237-1 WING PYLON AFT BEARING REMOVAL SET TOOLS AND HP-60G ENERPAC PUMP AND CYLINDER SET. (SEE MAINTENANCE MANUAL CHAPTER 54-00-00, PARAGRAPH ENTITLED "REMOVE PYLON", STEP 43b.)
- 2 VISUALLY INSPECT BULKHEAD FOR EVIDENCE OF DAMAGE DUE TO GOUGING OF BEARING INTO BULKHEAD AND ACCOMPLISH THE FOLLOWING:
 - a. IF DAMAGE IS NOT EVIDENT, MEASURE HOLE IN BULKHEAD. IF HOLE SIZE IS 2.9985/2.9990(76.1619/76.1746)-INCH DIAMETER INSTALL NEW KSBY22-5, BSSR-22220, NSS220, OR 79583 BEARING USING DZZ7237-1 WING PYLON AFT BEARING TOOLS AND HP-60G ENERPAC PUMP AND CYLINDER SET. (SEE MAINTENANCE MANUAL CHAPTER 54-00-00, PARAGRAPH ENTITLED "REMOVE PYLON", STEP 43c.)

NOTE: IF HOLE SIZE IS GREATER THAN 2.9990(76.1746)-INCH DIAMETER, OVERSIZE BEARING MUST BE INSTALLED PER STEP 2b.

- b. IF DAMAGE IS EVIDENT OR HOLE SIZE EXCEEDS 2.9990(76.1746)-INCH DIAMETER, ENLARGE HOLE IN BULKHEAD IN INCREMENTS NOTED AS REQUIRED TO CLEANUP DAMAGE, CHAMFER BOTH HOLE EDGES .045+.010(1.143+.254) X 45° USING APPLICABLE REAMER AND CUTTER FROM DZZ7244-1 "C" TOOL SET. SEE TABLE 1. (SEE MAINTENANCE MANUAL CHAPTER 54-00-00, PARAGRAPH ENTITLED "REMOVE PYLON.")

NOTE: OVERSIZE BEARING TO BE USED ONLY WHEN DAMAGE IS EVIDENT OR HOLE IN BULKHEAD EXCEEDS 2.9990(76.1746)-INCH DIAMETER.
