**SERVICE BULLETIN**  
**REVISION TRANSMITTAL SHEET**

NACELLES/PYLONS - Attach Fittings - Lubricate/Replace Engines 1 and 3 Forward Attach Spherical Bearings.

Bulletin 54-59

Revision 3 July 11/90

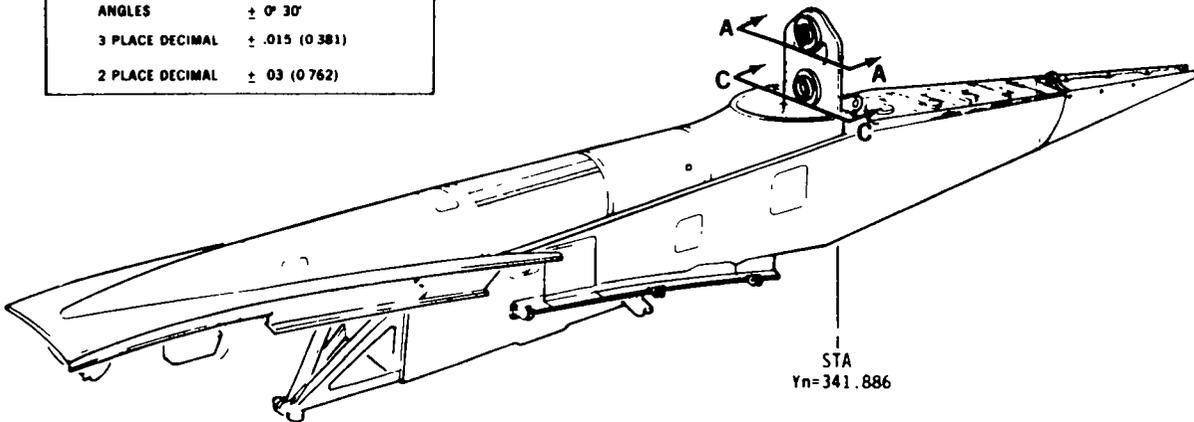
FIGURE 1 (SHEET 1 OF 3)

Eight operators have reported unsatisfactory performance of the dry film lubricant used on the forward upper and lower wing-to-pylon attach spherical bearings. This condition is due to wear of the dry lube finish on the surface of the bearing and the presence of corrosion pits on the surfaces which lose the dry lube finish. Corrosion pits have developed on bearings having logged 2000 flight-hours. If not corrected, the corrosion would continue to be a maintenance problem, and the bearings could possibly seize. Replacing the spherical bearings with bearings that can be lubricated will significantly increase the service life of the bearings.

- B. Remove upper spherical bearing, retain attaching parts.
- C. Modify upper wing-to-pylon attach plug as shown on Figure 1.
- D. Install new 79748, HSPF-64-MD, KSB64-3, AMB64-100, or ASSB64 spherical bearing using retained attaching parts.

- G. Remove lower spherical bearing. Retain attaching parts.
- H. Modify lower wing-to-pylon attach plug as shown on Figure 1.
- I. Install new 79749, HSPF-100-MD, KSB100-3, AMB100-100, or ASSB100 spherical bearing using retained attaching parts.

- ① DRILL TWO HOLES IN UPPER WING-TO-PYLON ATTACH PLUG.
- ② THREAD COUNTERBORED HOLES 1/4-28UNF-3B, PERFECT THREAD .19 (4.82)-INCH MINIMUM DEPTH.
- ③ INSTALL TWO MS15001-1 LUBRICATION FITTINGS.

- ④ DRILL TWO HOLES TO INTERSECT HOLES DRILLED IN STEP 1.
- ⑤ AUB7065-503 PLUG ONLY - MODIFY PLUG ASSEMBLY AS OUTLINED IN DC-10 STRUCTURAL REPAIR MANUAL, CHAPTER 54-20-00, PARAGRAPH ENTITLED, "REWORK PROCEDURES FOR AUB7065-503 PLUG."

- ⑥ REIDENTIFY MODIFIED AUB7065-503 UPPER PYLON-TO-WING ATTACH PLUG AS AUB7065-505 PER OPERATOR'S SHOP PRACTICE. REIDENTIFICATION OF MODIFIED AUB7065-1 OR -501 PLUG IS AT OPERATOR'S OPTION.

- ⑦ DRILL THREE HOLES IN LOWER WING-TO-PYLON ATTACH PLUG.
- ⑧ THREAD COUNTERBORED HOLES 1/4-28UNF-3B, PERFECT THREAD .19 (4.82)-INCH MINIMUM DEPTH.
- ⑨ INSTALL THREE MS15001-1 LUBRICATION FITTINGS.

- ⑩ DRILL THREE HOLES TO INTERSECT HOLES DRILLED IN STEP 7.
- ⑪ DRILL ONE .125 (3.18)-INCH DIAMETER HOLE THROUGH NEAR SIDE (SIDE OPPOSITE EXISTING LUBRICATION FITTING) WALL OF LOWER WING-TO-PYLON ATTACH PLUG.

- ⑫ REIDENTIFY AUB7066-1 LOWER WING-TO-PYLON ATTACH PLUG AS AUB7066-501 PER OPERATOR'S SHOP PRACTICE.

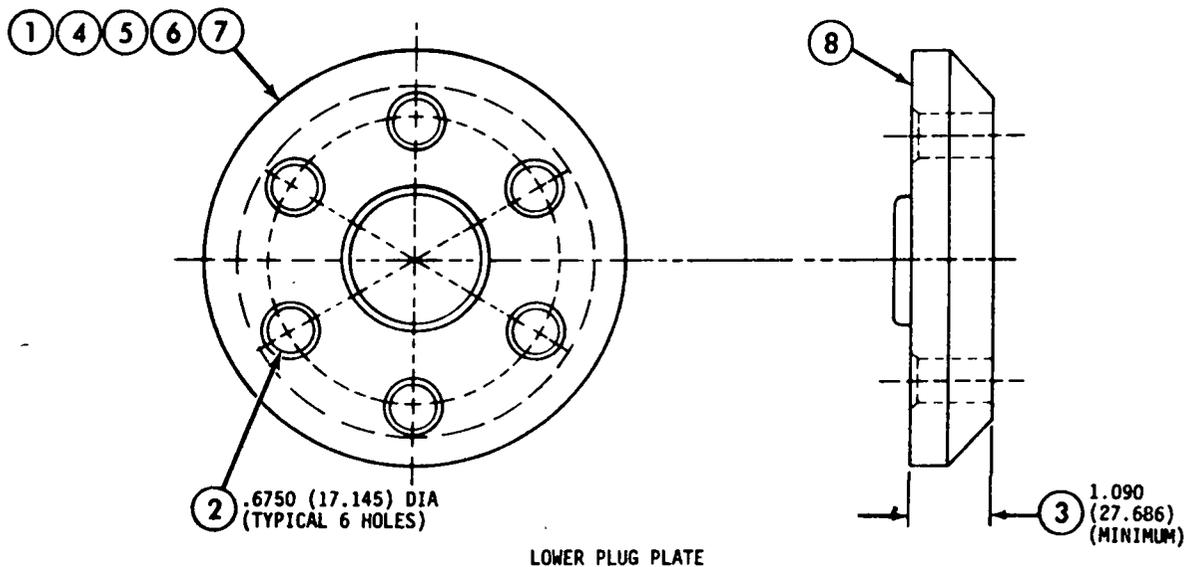
FIGURE 2

- ① CHECK LOWER PLUG PLATE FOR CORROSION. IF CORROSION IS EVIDENT, REMOVE CORROSION PER DC-10 STRUCTURAL REPAIR MANUAL, CHAPTER 51-21-01, VOLUME II, AND PROCEED TO STEP 2. IF NO CORROSION EXISTS, PROCEED TO STEP 7.

- ② MAXIMUM HOLE DIAMETER AFTER REMOVAL OF CORROSION IS .6750(17.145) INCH DIAMETER.
- ③ MINIMUM THICKNESS AFTER REMOVAL OF CORROSION IS 1.090(27.686) INCH.

- M. Check lower plug plate for corrosion. See Figure 2.
- N. Install lower spherical bearing, attach plug, and lower plug plate using retained attaching parts. Coat retained bolts using 90-006 sealant with 90-006-2 catalyst. Prime using DC1200 silicone primer. Use six new 62524-9-24.9 PLI washers on installation.

- J. Check lower plug plate for corrosion. See Figure 2.
- K. Install lower wing-to-pylon attach plug and lower plug plate using retained attaching parts. Coat retained bolts using 90-006 sealant with 90-006-2 catalyst. Prime using DC1200 primer. Use six new 62524-9-24.9 PLI washers on installation.

- ④ IF THE CORROSION HAS BEEN REMOVED BY LOCAL BLENDING OR MACHINING, RETURN REWORKED AREA TO A PLANE SURFACE BY SULFAMATE NICKEL PLATING PER DC-10 COMPONENT MAINTENANCE MANUAL, CHAPTER 20-10-02.

- ⑤ IF LOWER PLUG PLATE HAS BEEN MACHINED TO A FLAT BEARING SURFACE, SULFAMATE NICKEL PLATING IS NOT REQUIRED.
- ⑥ RESTORE CADMIUM PLATE FINISH PER DC-10 COMPONENT MAINTENANCE MANUAL, CHAPTER 20-10-01, AFTER ANY CORROSION REWORK.

- ⑦ APPLY A COAT OF FR EPOXY PRIMER TO SURFACE OF LOWER PLUG PLATE.
- ⑧ APPLY A COAT OF CORROSION PREVENTATIVE COMPOUND, MIL-C-16173 GRADE 4 (BRAYCOTE 194) OR EQUIVALENT, TO FACE OF LOWER PLUG PLATE.
