1. Report No. NTSB-AAR-76-24		2. Government Accession No.		3. Recipient's Catalog No.	
4. Title and Subtitle Aircraft Accident Report Alaska Airlines, Inc., Boeing 727-81, N124AS Ketchikan, Alaska, April 5, 1976		5. Report Date December 22, 1976		6. Performing Organization Code

AIRCRAFT ACCIDENT REPORT

Adopted: December 22, 1976

ALASKA AIRLINES, INC.
B-727-81, N124AS
KETCHIKAN INTERNATIONAL AIRPORT
KETCHIKAN, ALASKA
APRIL 5, 1976

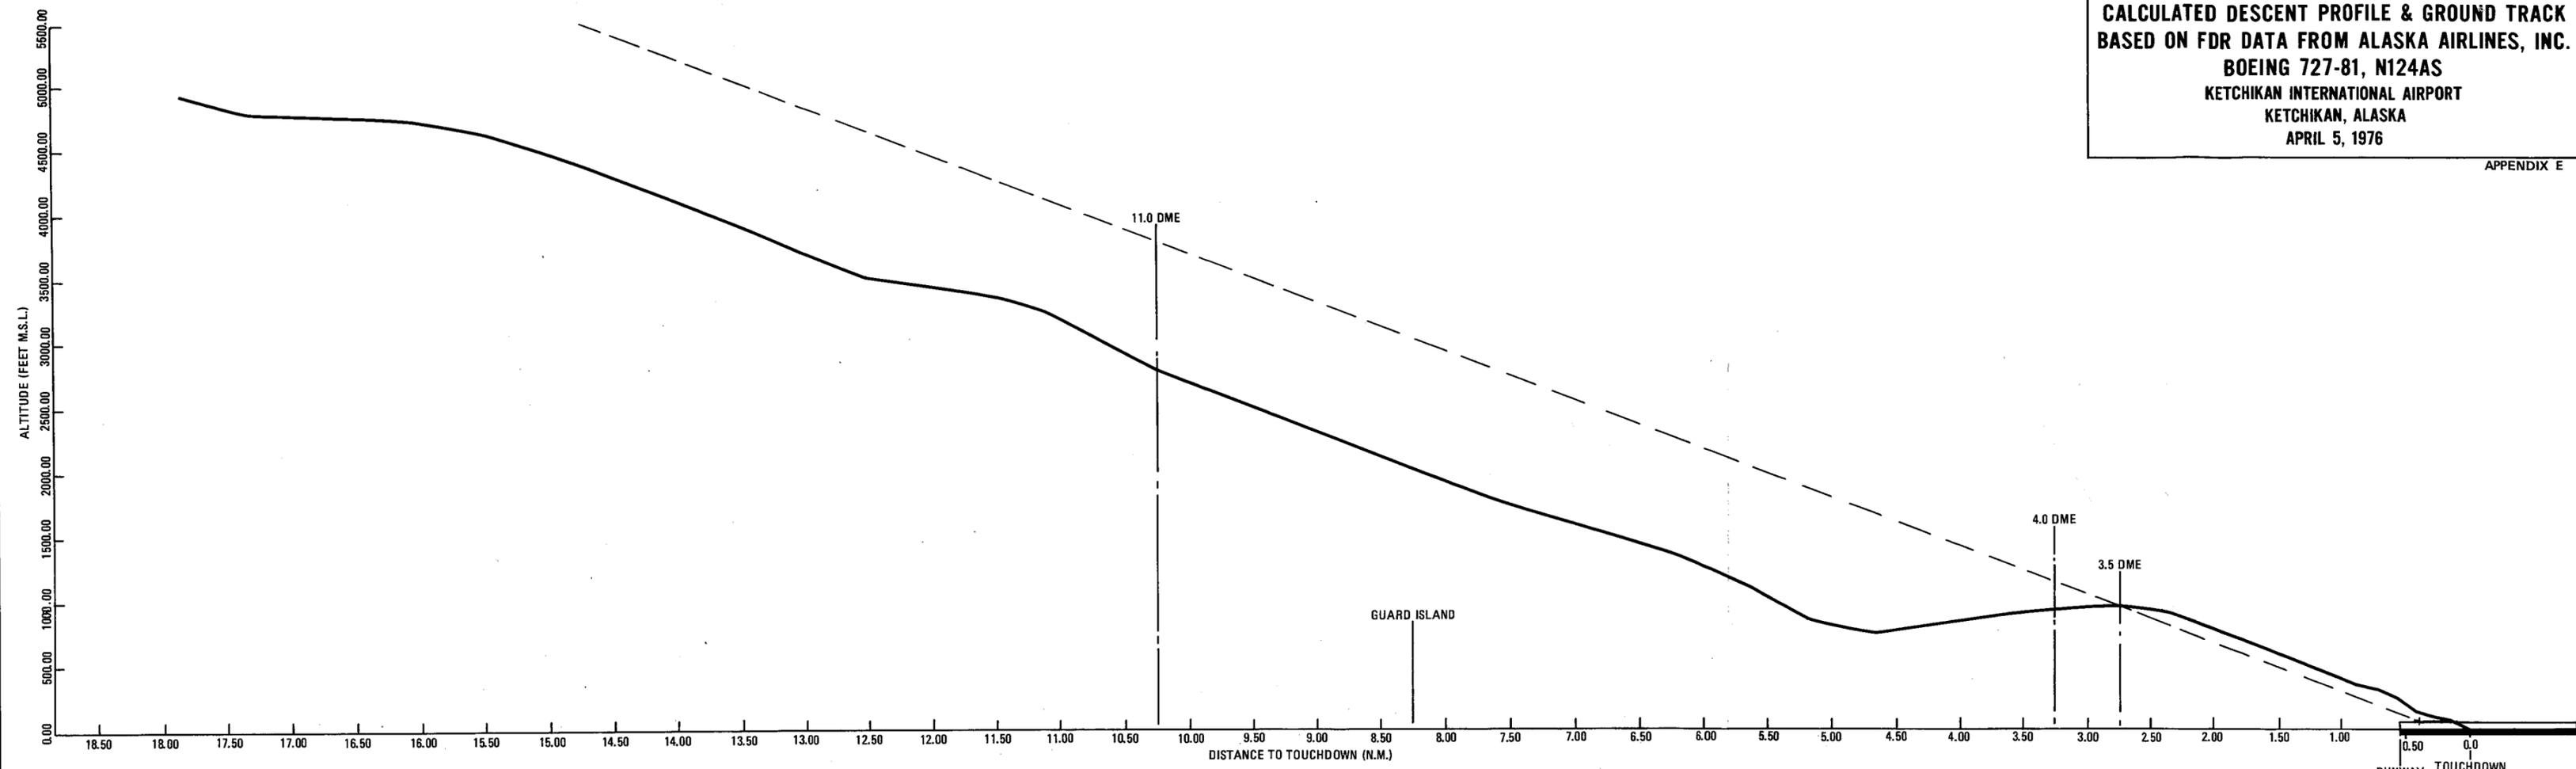
CALCULATED DESCENT PROFILE & GROUND TRACK
BASED ON FDR DATA FROM ALASKA AIRLINES, INC.
BOEING 727-81, N124AS
KETCHIKAN INTERNATIONAL AIRPORT
KETCHIKAN, ALASKA
APRIL 5, 1976

The accuracy of the computed flight track and distance calculations depends on (1) the accuracy of the FDR measurements for this particular recorder, (2) the accuracy of the readout, (3) the accuracy of the wind information and its relationship to actual conditions, and (4) the accuracy of the assumed times of touchdown and leaving the overrun. Because of the unknown errors, the flight track distance computations must be considered approximations and are presented for comparison with other evidence.

The indicated airspeed was consistently higher than normal throughout the approach. It varied from 240 kns at 5,000 ft to 145 kns at touchdown. The captain apparently intended to land with 30° flap extension. The reference airspeed based upon the aircraft's weight and the 30° flap configuration was 121 kns. Alaska Airlines, Inc., operating procedures allows an additive correction not to exceed 20 kns to provide a maneuverability margin when headwind and gusty conditions prevail. Although such conditions were not indicated by the reported weather, the captain explained that he added the full 20 kns on the expectation that turbulence would be encountered. Sometime before landing, the first officer extended the flaps to 40°. The reference speed for that configuration was 117 kns.
