No. 12

British European Airways Corporation, Vickers Viscount 802, G-AOHP,
made a forced landing at Ballerup, Denmark, on 17 November 1957.
Report released by the Director of Civil Aviation, Denmark.

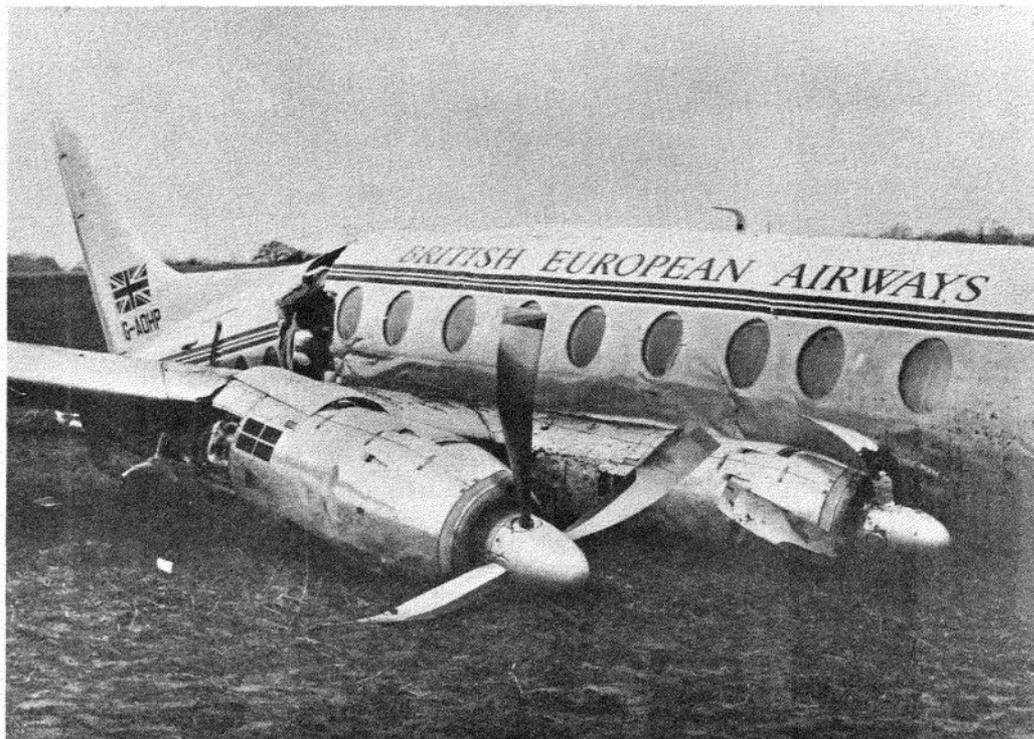
FIGURE 4

VISCOUNT G-AOHP WHICH MADE
A FORCED LANDING AT
BALLERUP, DENMARK
ON 17 NOVEMBER 1957
