EMERGENCY AIRWORTHINESS DIRECTIVE

AD 2007-18-51; Docket No. FAA-2007-29089; Directorate Identifier 2007-NM-214-AD

Emergency airworthiness directive (AD) 2007-18-51 is sent to all owners and operators of Boeing Model 737-600, -700, -700C, -800, -900, and -900ER series airplanes.

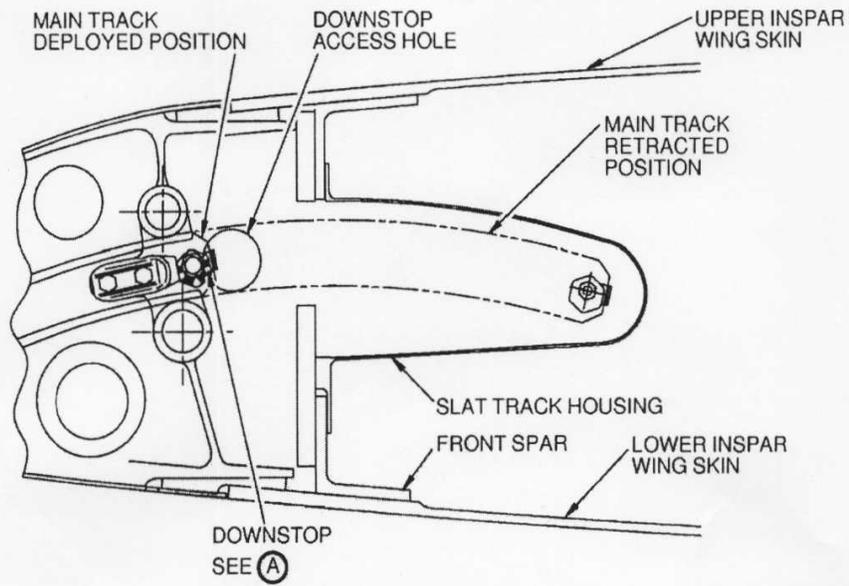
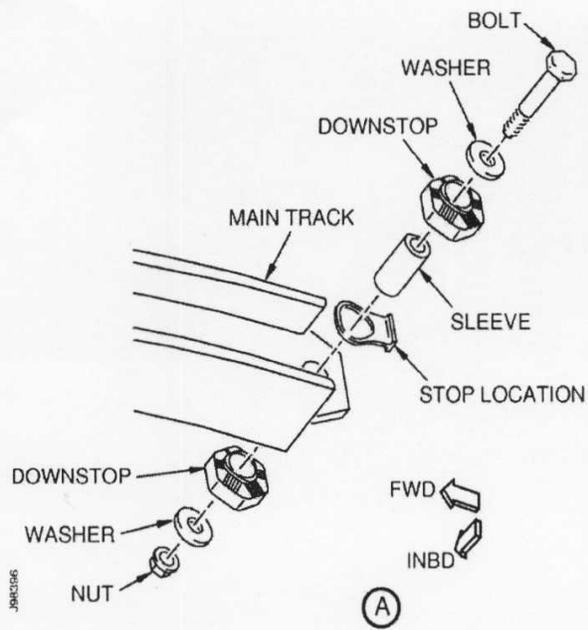
(d) This AD results from reports of the main slat track downstop hardware coming off the retaining bolts for the main slat track downstops. The Federal Aviation Administration is issuing this AD to detect and correct loose or missing parts from the main slat track downstop assemblies, which could result in a fuel leak and consequent fire.

Slat Track Downstop Assembly

(1) Do a detailed inspection of each main slat track downstop assembly to verify proper installation of the slat track hardware (the bolt, washers, downstops, sleeve, stop location, and nut shown in Figure 1 of Boeing Service Letter 737-SL-57-084-B, dated July 10, 2007, and in this AD). If any part is missing or is installed improperly, before further flight, install a new or serviceable part using a method approved in accordance with the procedures specified in paragraph (g) of this AD; and do a detailed inspection of the inside of the slat can for foreign object debris (FOD) and damage. Before further flight, remove any FOD found and repair any damage found using a method approved in accordance with the procedures specified in paragraph (g) of this AD. Using Boeing Correspondence (Multi-Operator Message) Service Request ID 1-523812011, issued August 25, 2007, is one approved method for verifying proper installation; installing a new or serviceable part; and inspecting for damage and FOD, and removing FOD and repairing damage. Repeat the actions required by paragraph (f)(1) of this AD thereafter at intervals not to exceed 3,000 flight cycles:

(2) Apply a torque between 50 to 80 inch-pounds to the nut. The bolt head must be held with the torque applied to the nut.
