AIRCRAFT ACCIDENT INVESTIGATION REPORT

China Airlines
Airbus Industrie A300B4-622R, B1816
Nagoya Airport
April 26, 1994

July 19, 1996

Aircraft Accident Investigation Commission
Ministry of Transport

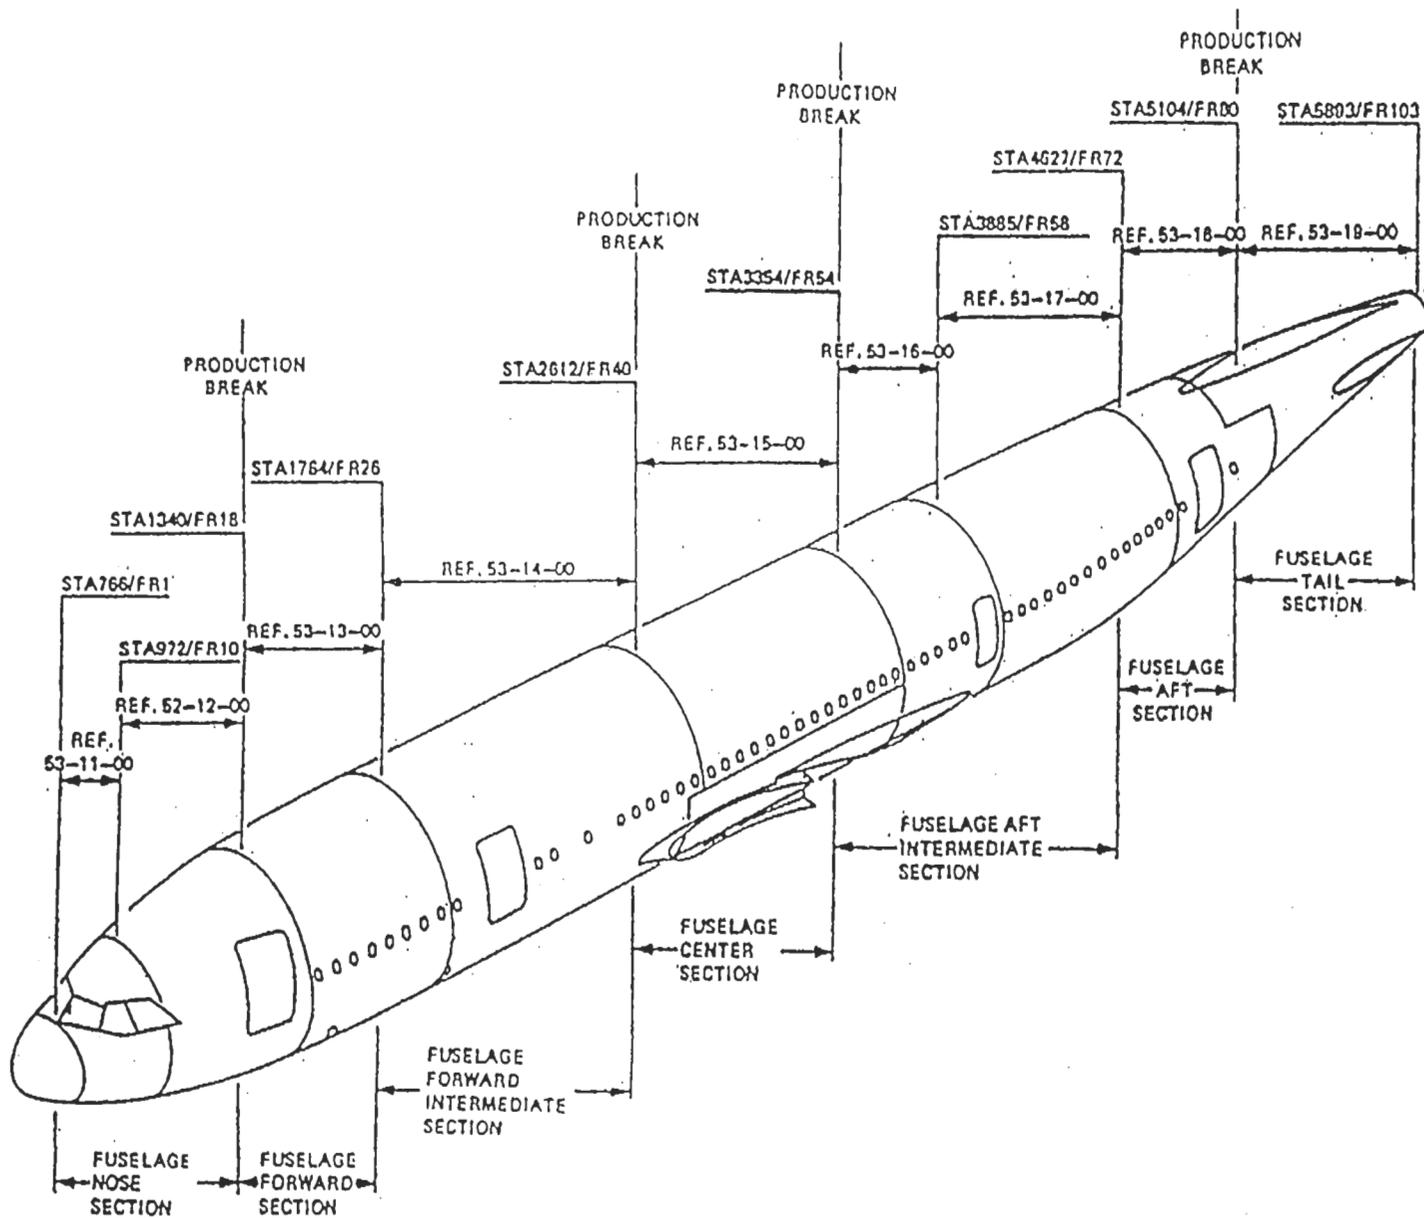
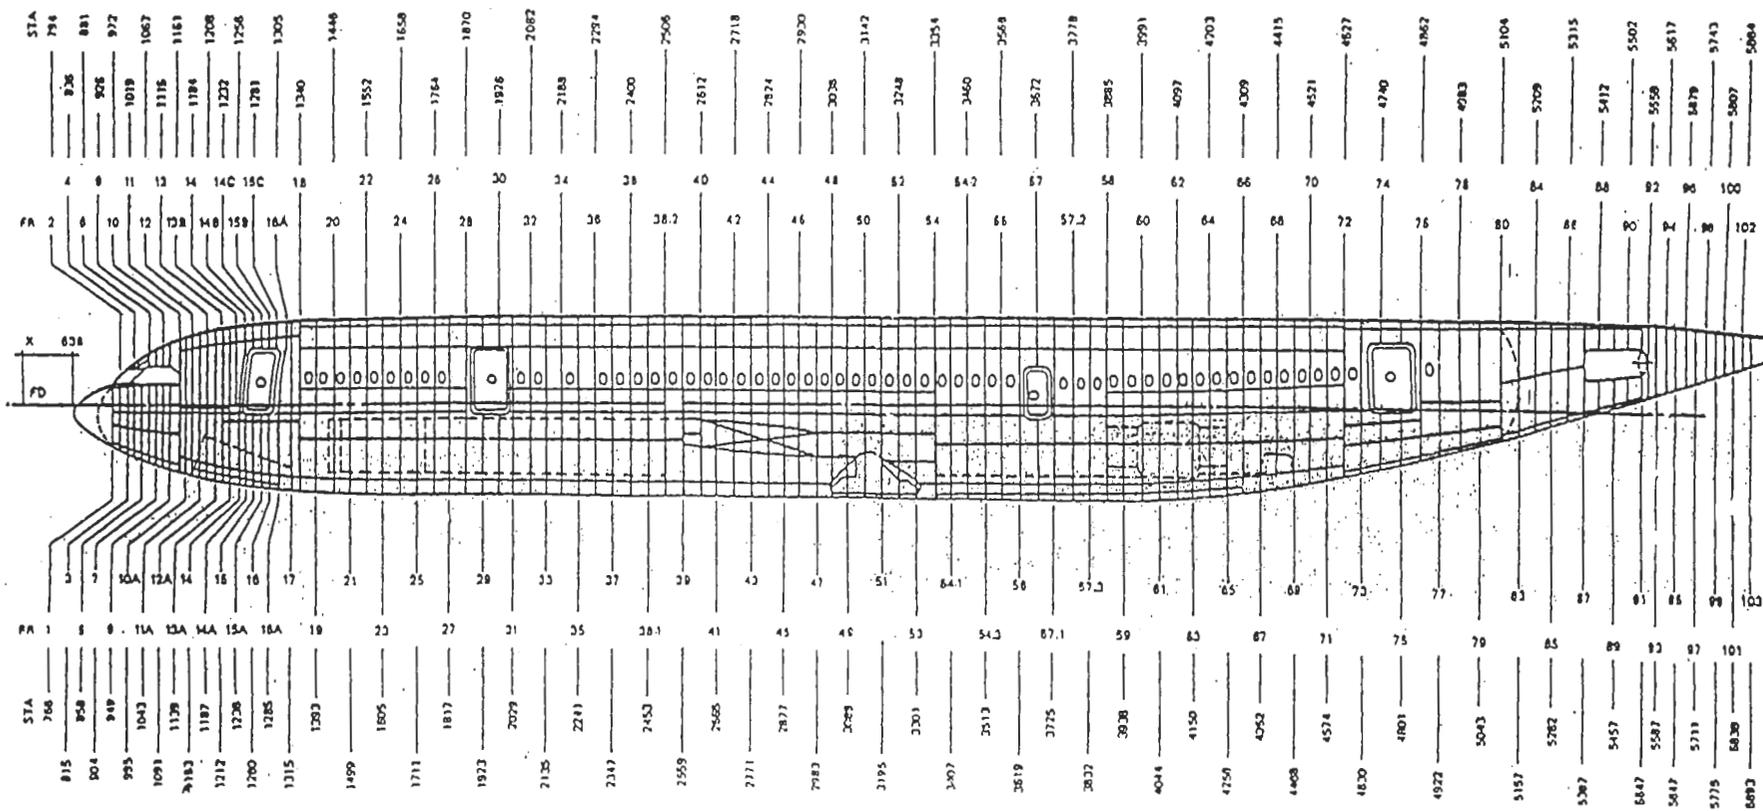
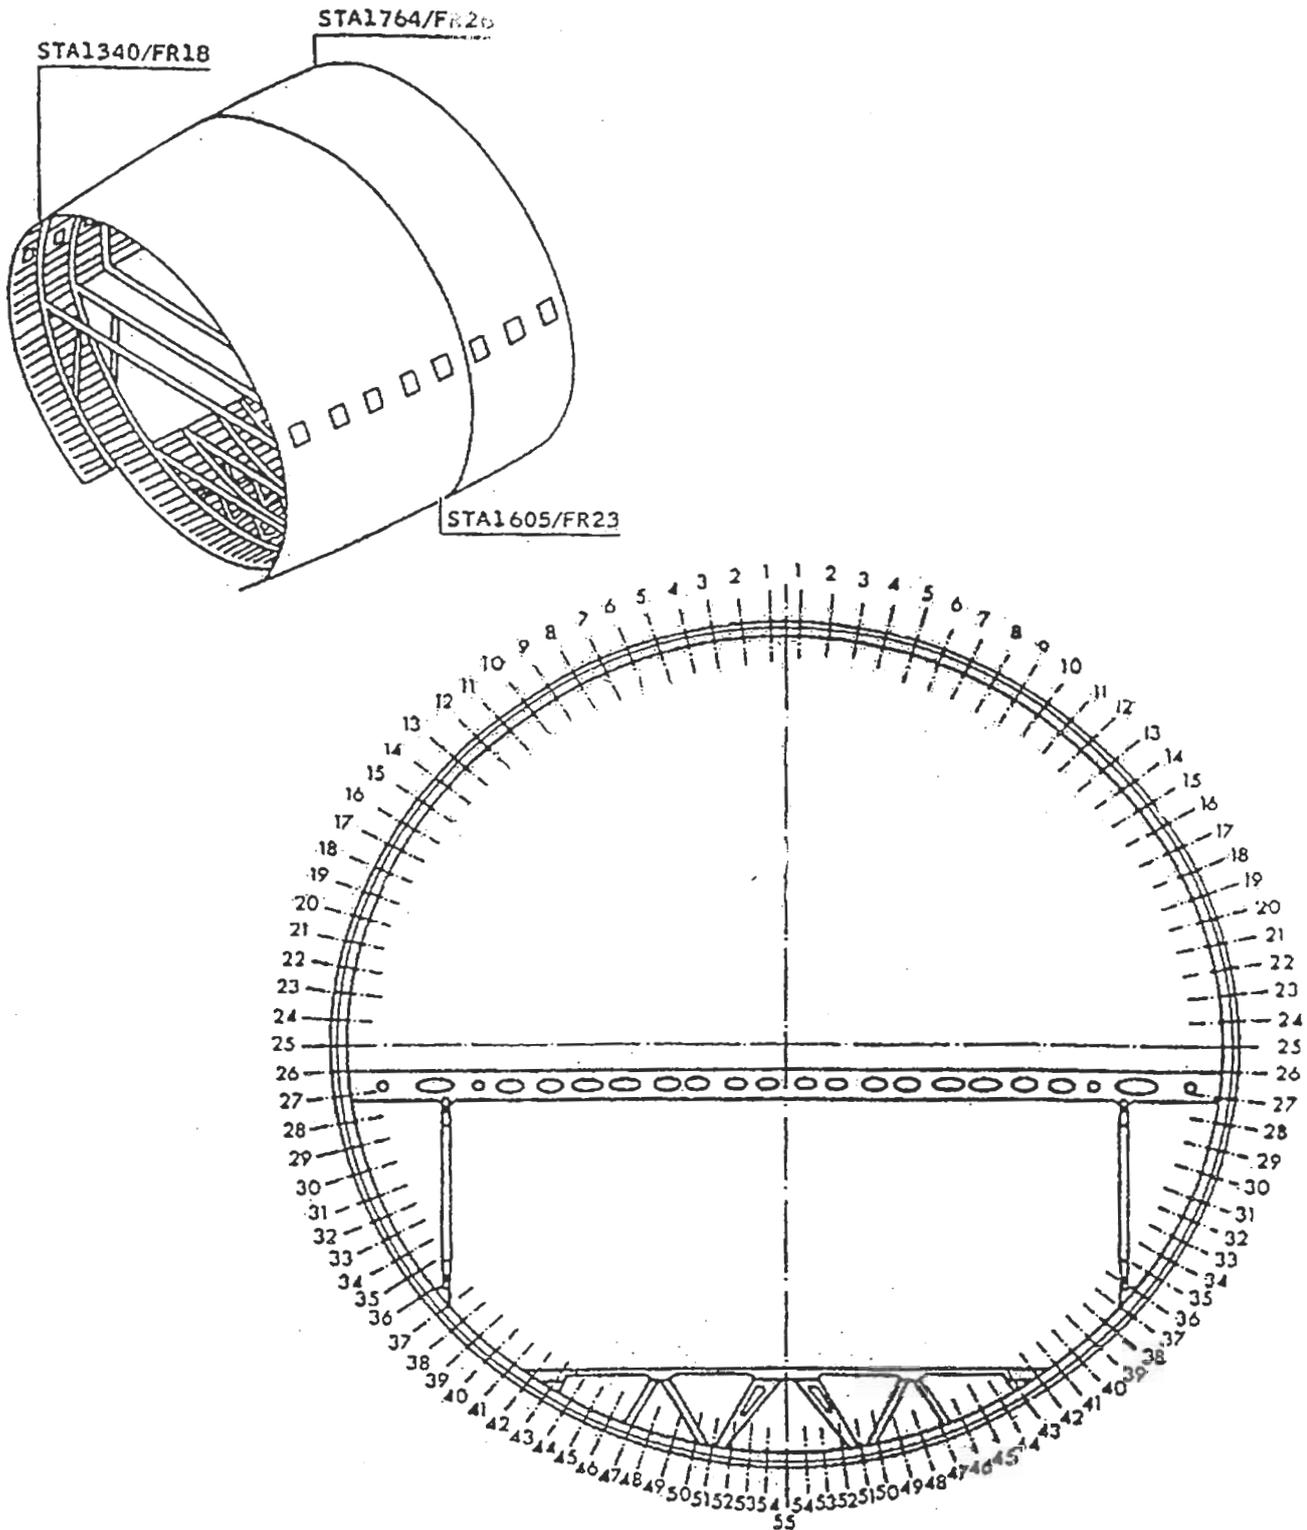
- The tail was fractured at locations corresponding to Frames 72 and 92 with the vertical stabilizer attached to it. It was partly burnt and was found in the irrigation water channel.
- The upper joints of the tail section had separated. The APU compartment was damaged at its bottom with the APU still inside, and was found partly overlapping the THS.
- The bottom skin was fractured at a location corresponding to Frame 78, and was found together with fragments of the other bottom skin near where the aircraft had hit the ground. (See attached Figures 16, 17, 18 and Photographs 27, 28, 29 and 30.)

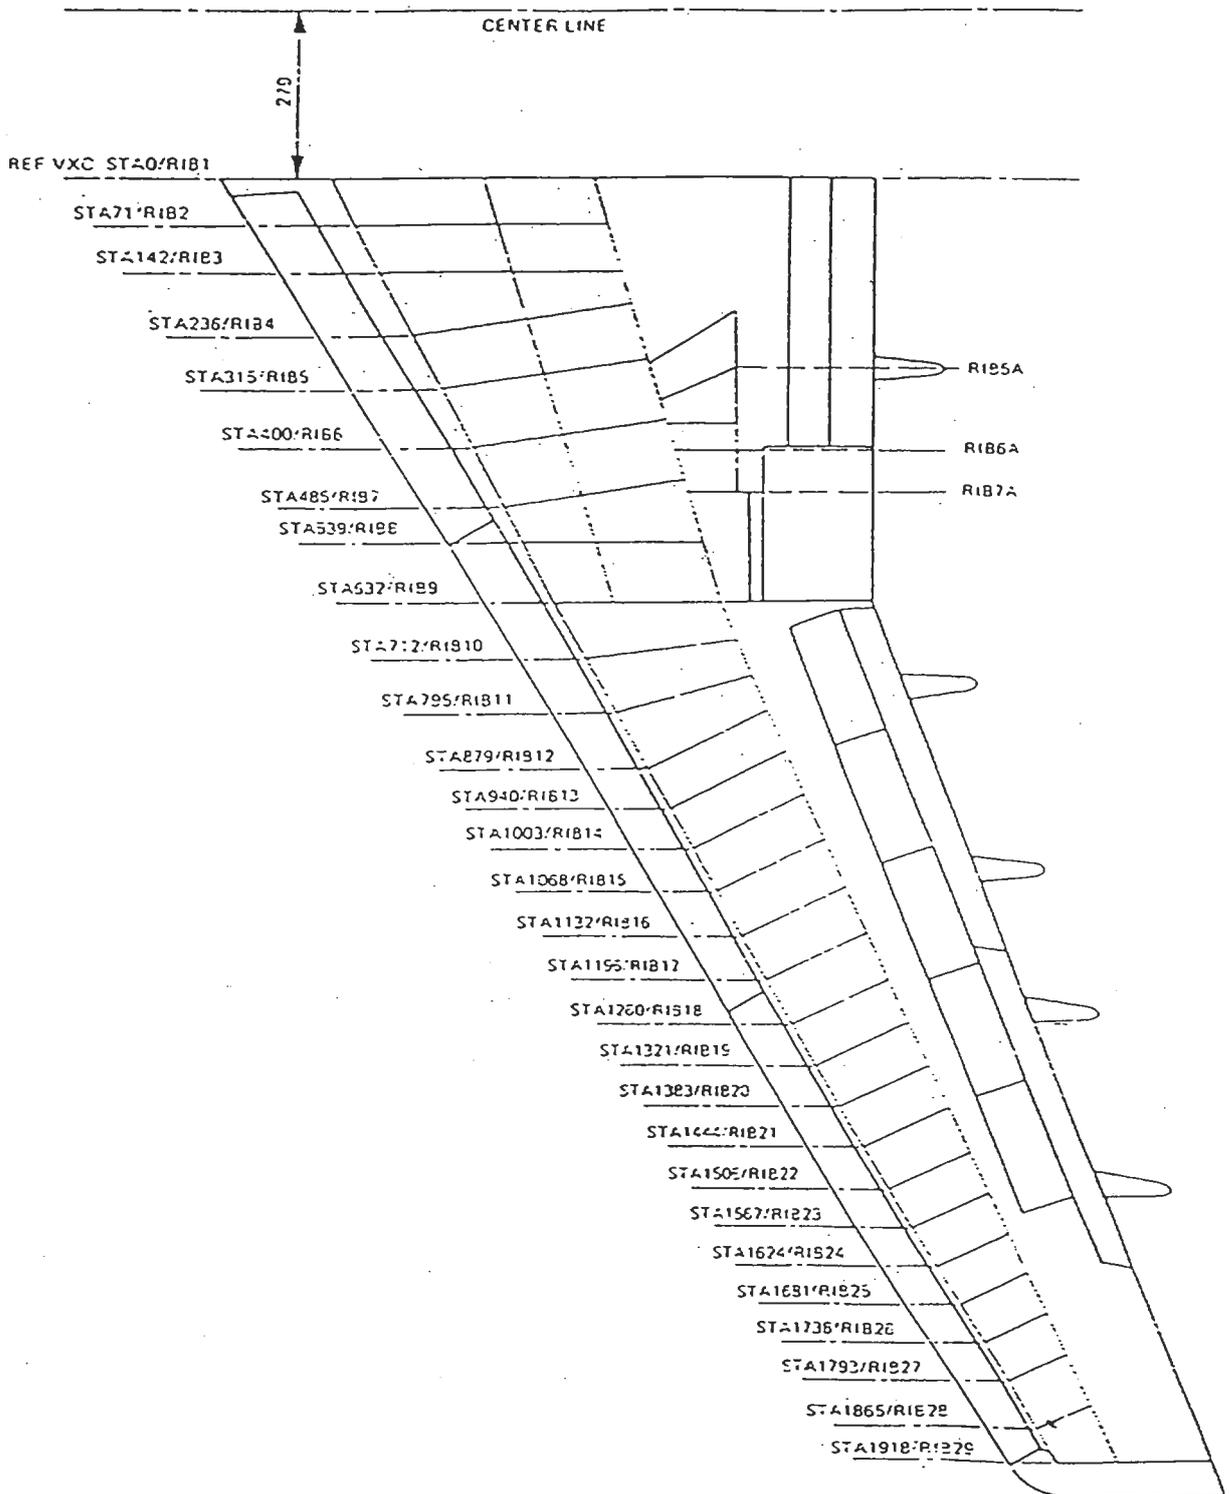
Attached Figure 19 Wing Stations

- ③ Center box section
 - The center box section was burnt.
 - Almost all thrust work ribs of the center-box lower structure had buckled and fractured by an upward force (see attached Figure 19).

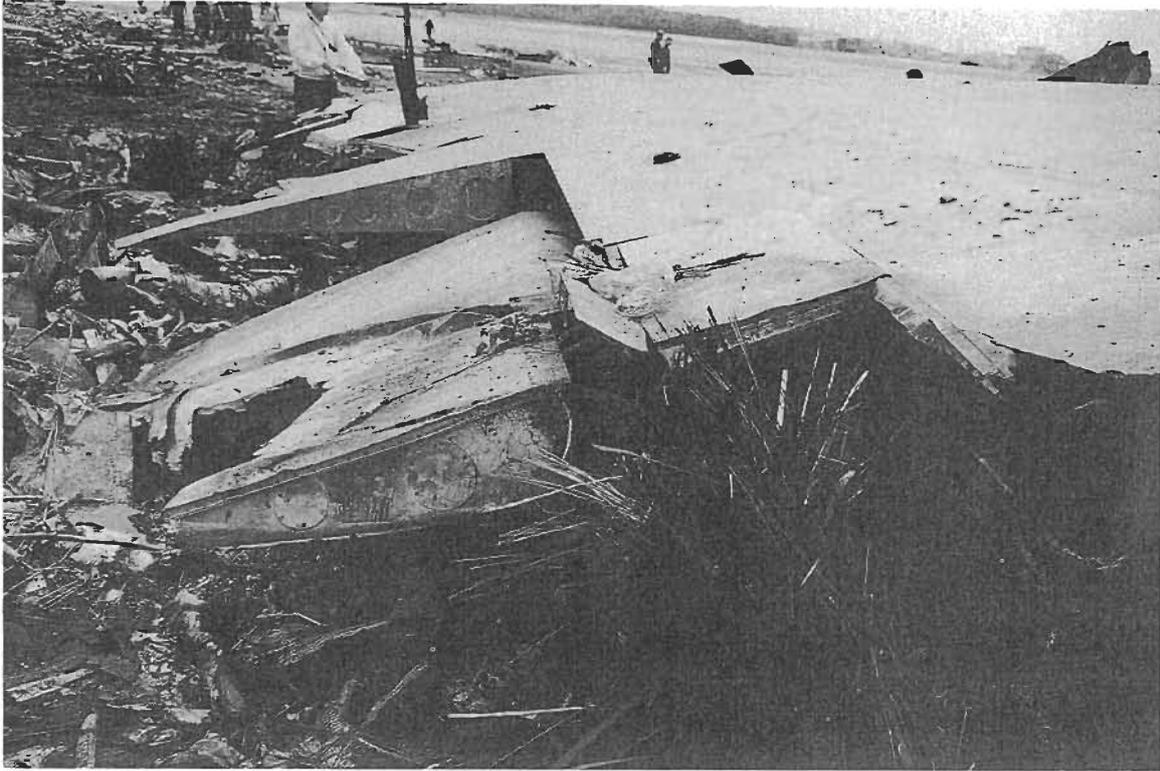
Photo.5 Left Aileron

Both the RH and LH ailerons were in their down positions and were burnt.
(See attached Photographs 5 and 6)

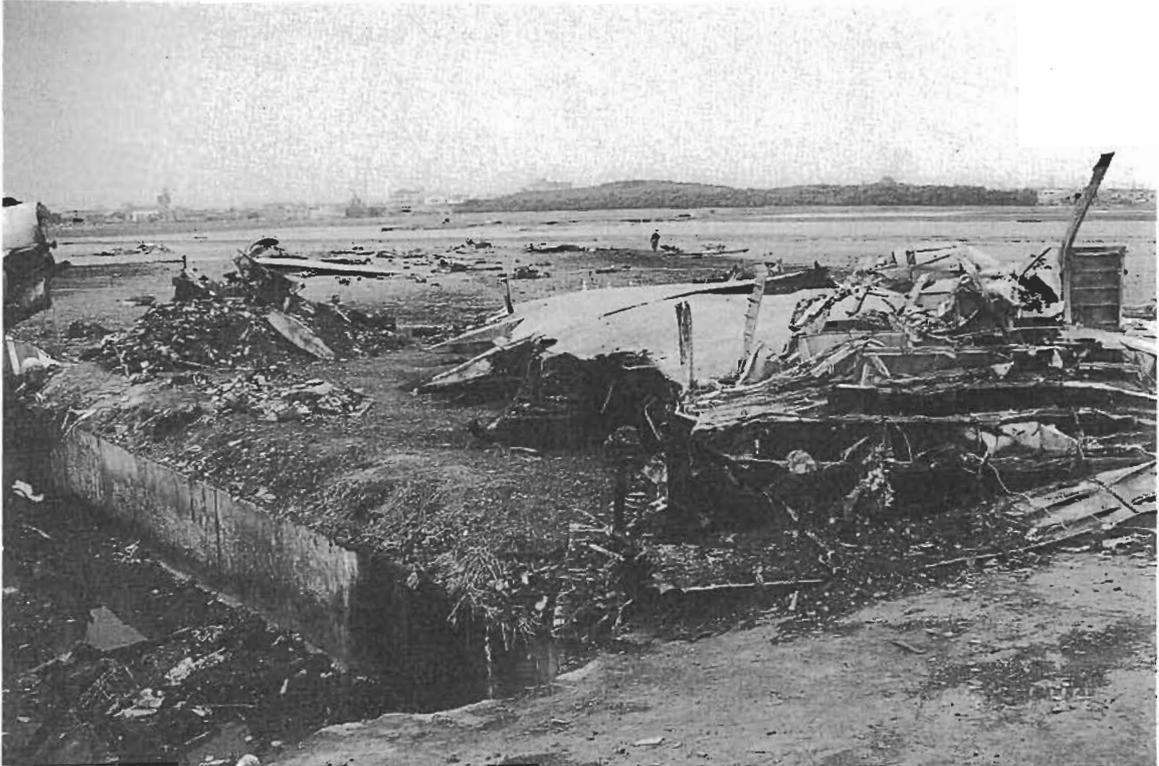
Photo.19 Left Wing

- ① LH wing
 - The main spar and upper skin in the upper section of the pylon (between W.STA 400 and 485) were fractured.
 - The skin in the rear part of the aft main spar, on the inboard side of the aileron, was destroyed by fire.
 - The lower skin had been exposed to flames and was burnt.
 - The upper skin between W.STA 940/RIB 13 and W.STA 1567/ RIB 23 had melted.
 - The wing tip was fractured near W.STA 1567/RIB 23, and had separated from the main wing and burnt.
 - The tip fence was fractured and burnt, and had separated with its lower part deformed. (See attached Photograph 19)

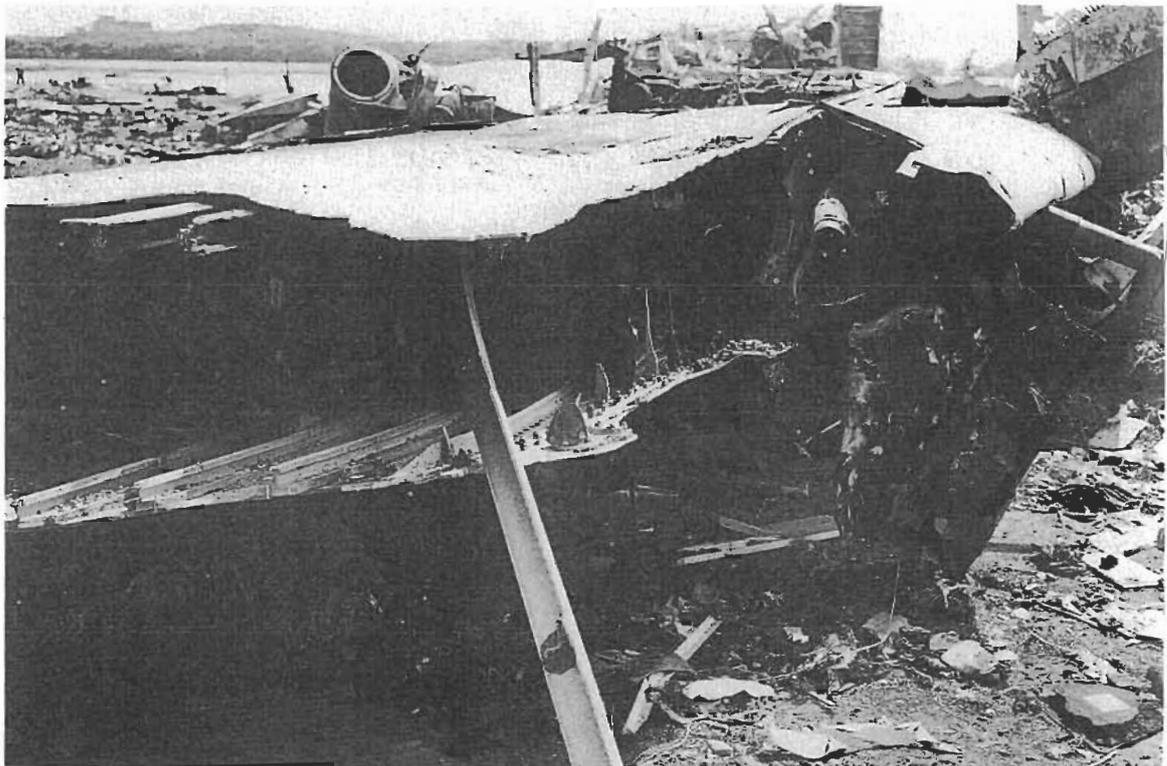
Photo.20 Fractures of the Right Wing

- ② RH wing
 - Almost all portions of the leading edge located on the inboard side of the No. 2 engine pylon were destroyed by fire.
 - The skin in the rear part of the aft main spar, inboard the aileron, was partly destroyed by fire.
 - The upper skin and the aft main spar near W.STA 879/RIB 12 were cracked.
 - The RH wing was fractured and had torn off near W.STA 1132/ RIB 16; the detached wing outboard structure had fragmented into small pieces, some of which were burnt.
 - The wing tip was fractured, had torn off near W.STA 1624/RIB 24, and was burnt.
 - Tip fence was fractured and had torn off with its top deformed. (See attached Photograph 20)

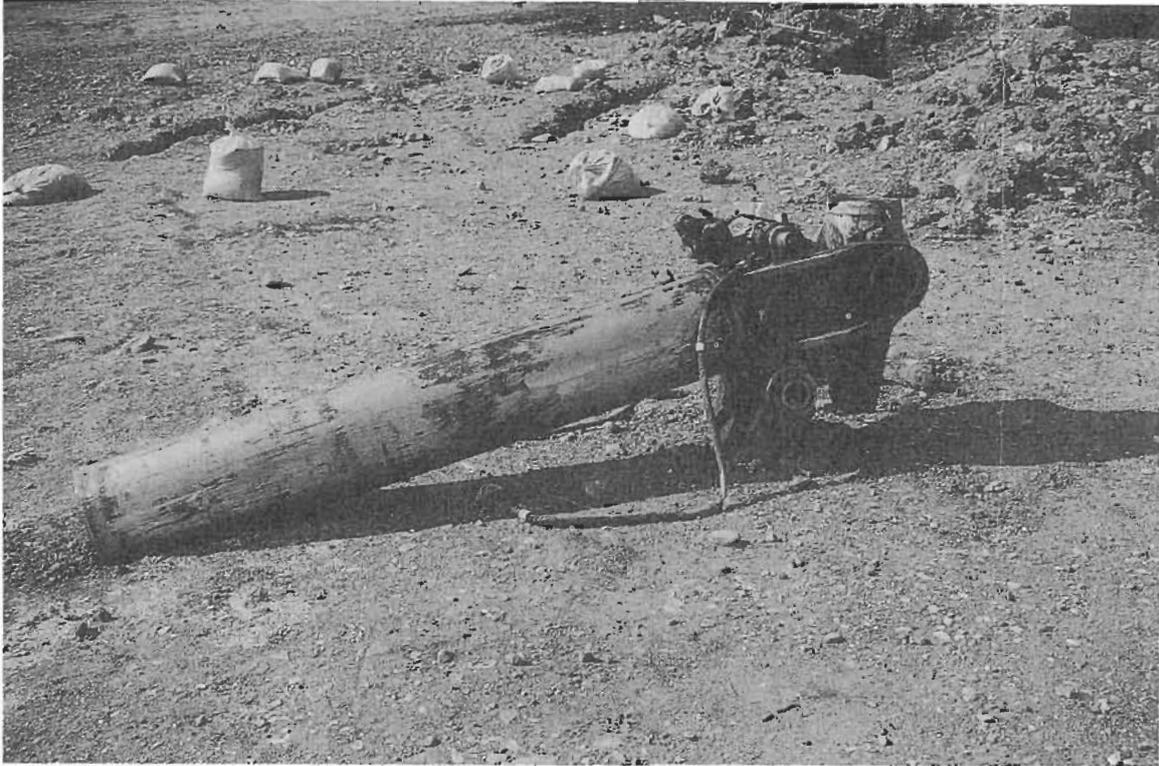
Photo.21 Shock Absorber of the Left Main Landing Gear

- The upper section of the shock strut was fractured, and had broken off and burnt.
- Fractured drag strut and torque link remained attached to the lower section of the shock strut.
- The shock strut was fractured; its upper section was partly burnt and had been detached with the actuating cylinder, fractured drag strut and other parts still attached to it.

- The wing side rear mount was fractured and remained attached to the aft hinge point in the upper section of the shock strut.
- The shock absorber had been displaced from the shock strut and was detached.

- The shock absorber contained pieces of the fractured bogey beam and torque link still attached to it.
- The shock absorber's piston was detached from the cylinder.

- The lower strut of the folding brace was fractured and detached.
- The lock link assembly was fractured and detached, with the cylinder and the strut of the folding brace (fractured) still attached to it.

- Both of the two cross braces had separated and burnt.
- The bogey beam was fractured at both its front and rear sections, with the outer brake assemblies (No. 1 and No. 5 assemblies) of both sections detached from their axles. Tires and wheels were also detached.

- No. 1 and No. 5 tires were burnt.
(See attached Photographs 21 and 22)

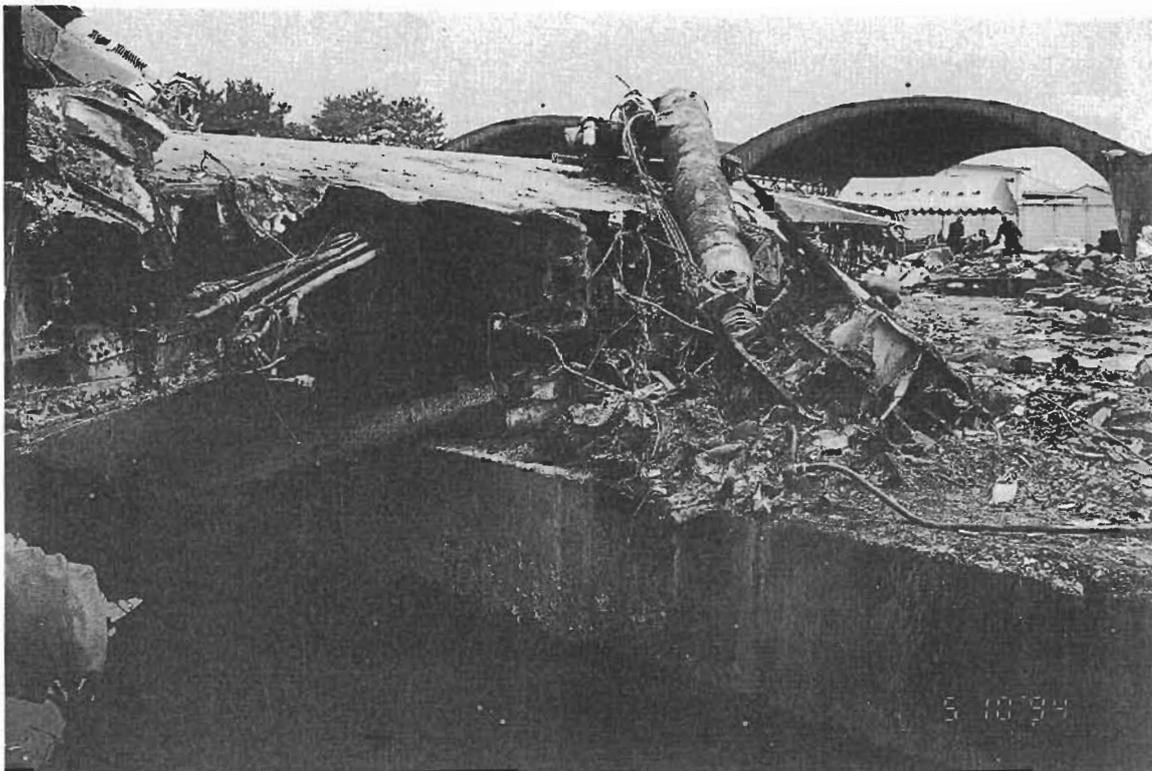
Photo.23 Shock Strut of the Right Main Landing Gear

- The shock strut was partly burnt and detached, with parts including the actuating cylinder and fractured drag strut, etc, still attached to its upper section.

- The drag strut, torque link, and part of the folding brace strut, all fractured, remained attached to the lower section of the shock strut.
- The shock strut rear mount, fractured and detached from the wing, remained attached to the aft hinge point in the upper section of the shock strut.

- The shock absorber had been displaced from the shock strut and was detached.
- The shock absorber had the fractured bogey beam and pieces of torque link still attached to it.

- The shock absorber's piston had torn off.
- The folding brace had a fractured lower strut, and was burnt and detached with a part of airframe structural element still attached to it.

- Both cross braces had separated and were burnt.
- The lock link was fractured and found at a point about 170 meters away from where the RH main landing gear had hit the ground.

- The bogey beam was fractured at both its front and rear sections. The No. 3 and No. 4 brake assemblies of the front section had come off their axles, and the tires and wheels were detached and destroyed.

- The No. 7 and No. 8 brakes, as well as the corresponding tires and wheels (two each) were burnt in an assembled state.
- The No. 3 and No. 4 tires had burst, and the No. 4 tires were burnt.
(See attached Photographs 23 and 24)

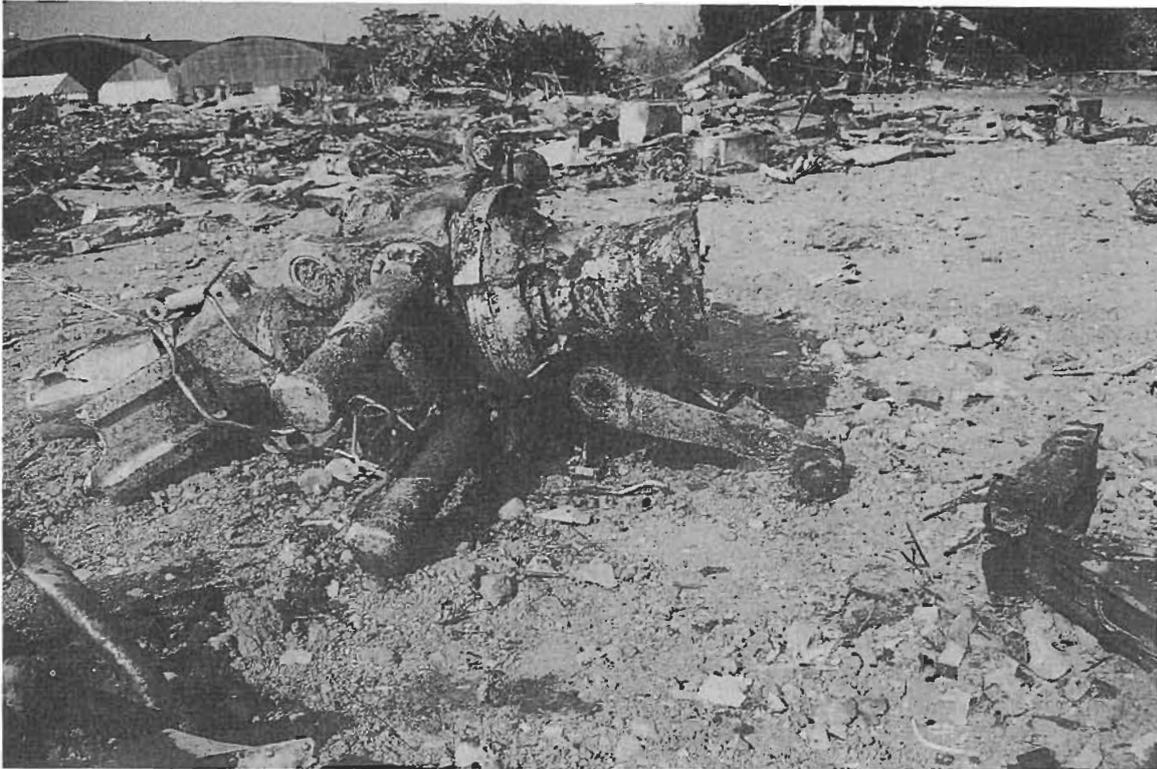
Photo.25 Leg Assembly of the Nose Landing Gear

- The shock strut was fractured at its upper and lower sections.
- The upper section of the barrel had fragmented into small pieces.
- The telescopic drag strut was found bent in the down-lock state and was burnt.
- The lower part of the torque link was fractured.
- Both tires and wheels were in place on the axle and were found in the irrigation water channel. The axle was bent and the LH tire had burst. (See attached Photographs 25 and 26)
