Aviation Occurrence Report Volume I

IN-FLIGHT BREAKUP OVER THE TAIWAN STRAIT

CHINA AIRLINES FLIGHT CI611

BOEING 747-200, B-18255

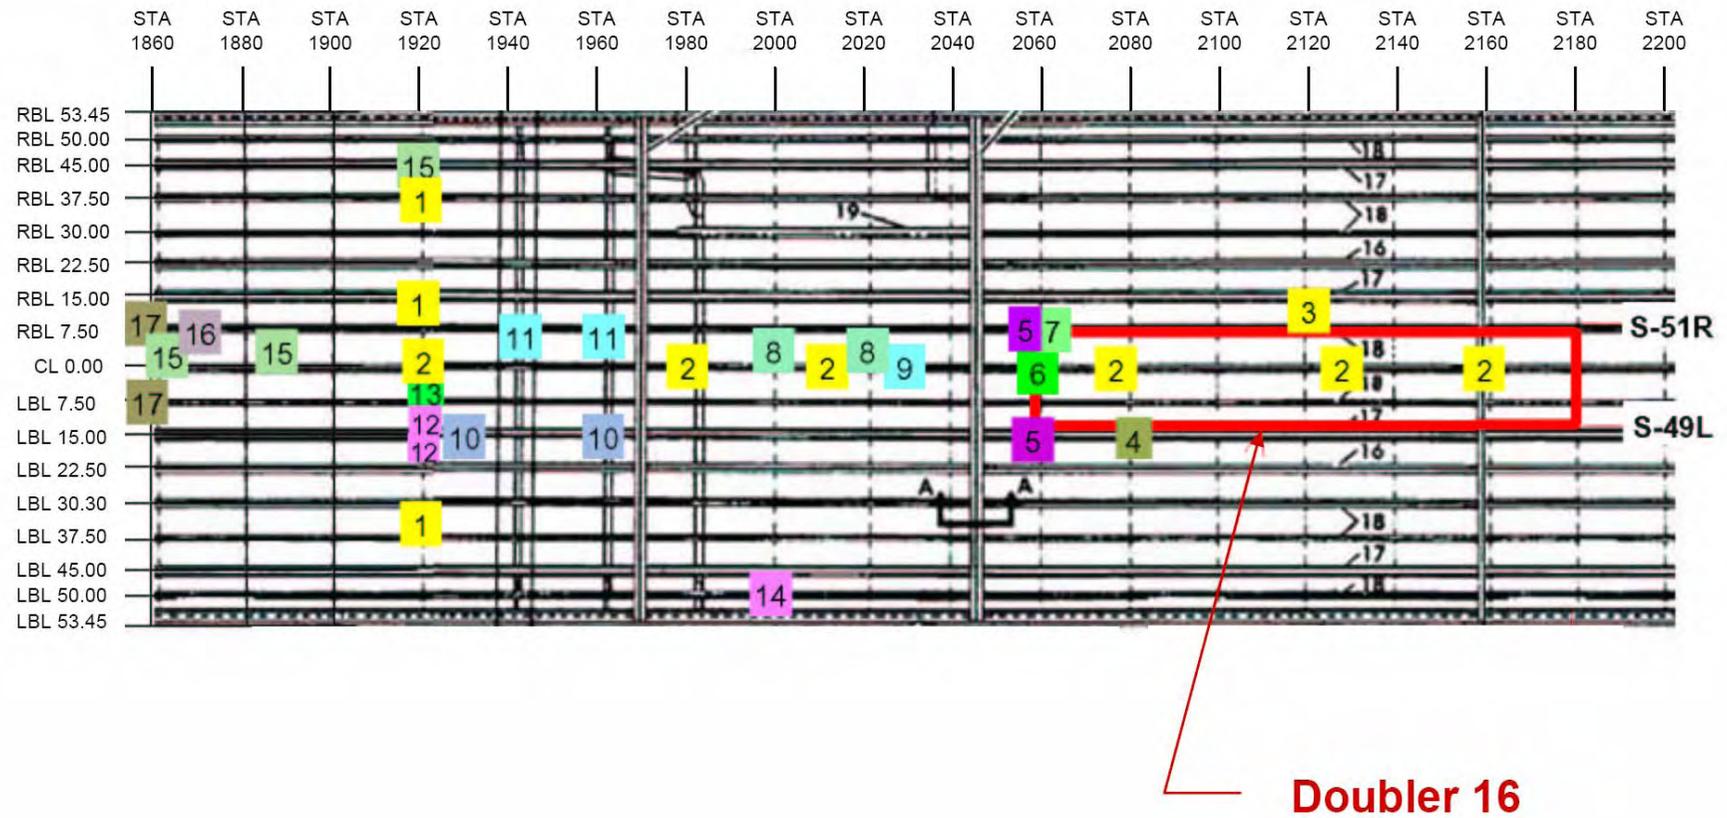
The above defects were corrected by the approved methods.

Figure 1.6-5 Locations of discrepancies adjacent to the STA 2060 doubler

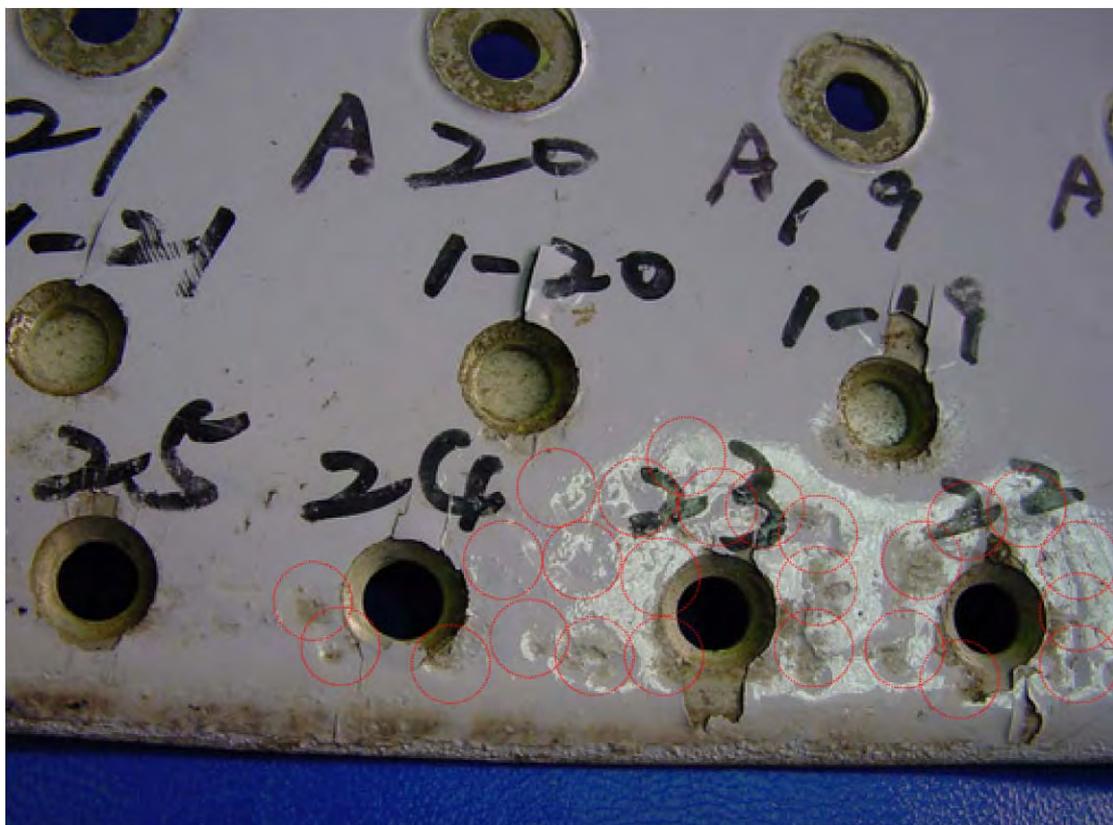
The exterior skin of number-16 doubler with various types of cavities around the rivets and along the edge of doubler can be observed as shown in Figure 1.6-10. Paint (topcoat) was present up to the edge of the doubler without sealant. In the same doubler paint (topcoat) was removed from the edge of the doubler during the doubler disassembly process, the sealant was still present, as shown in Figure 1.16-11.

Figure 1.6-10 Various types of cavities along the doubler edge

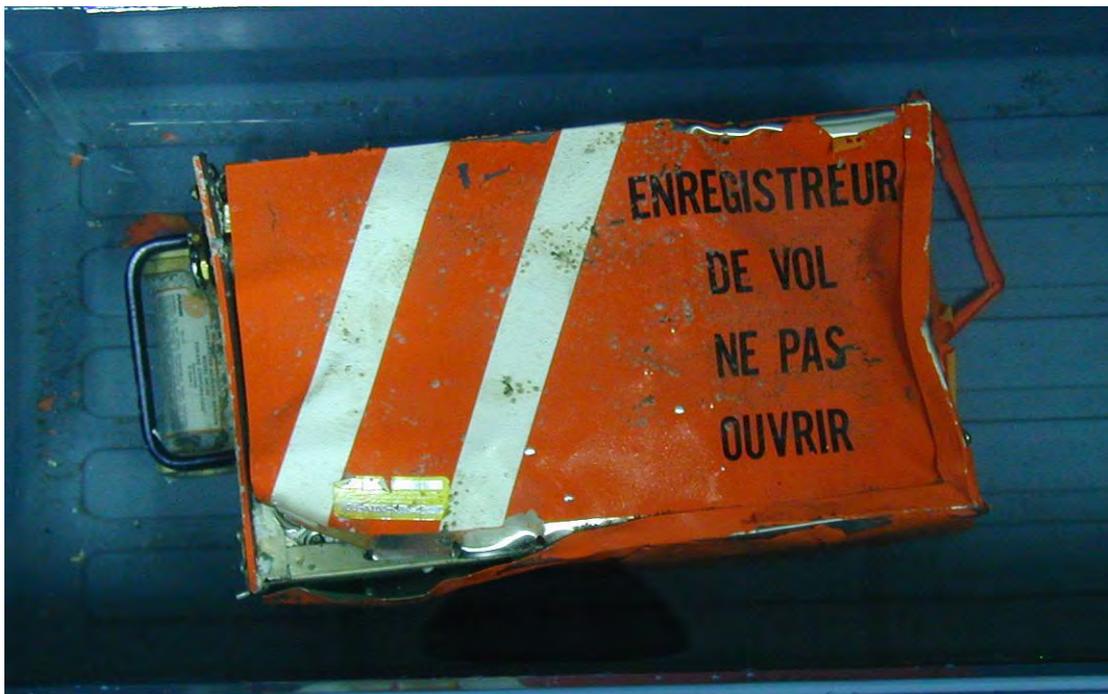
Figure 1.11-1 Damaged CVR in the water cooler

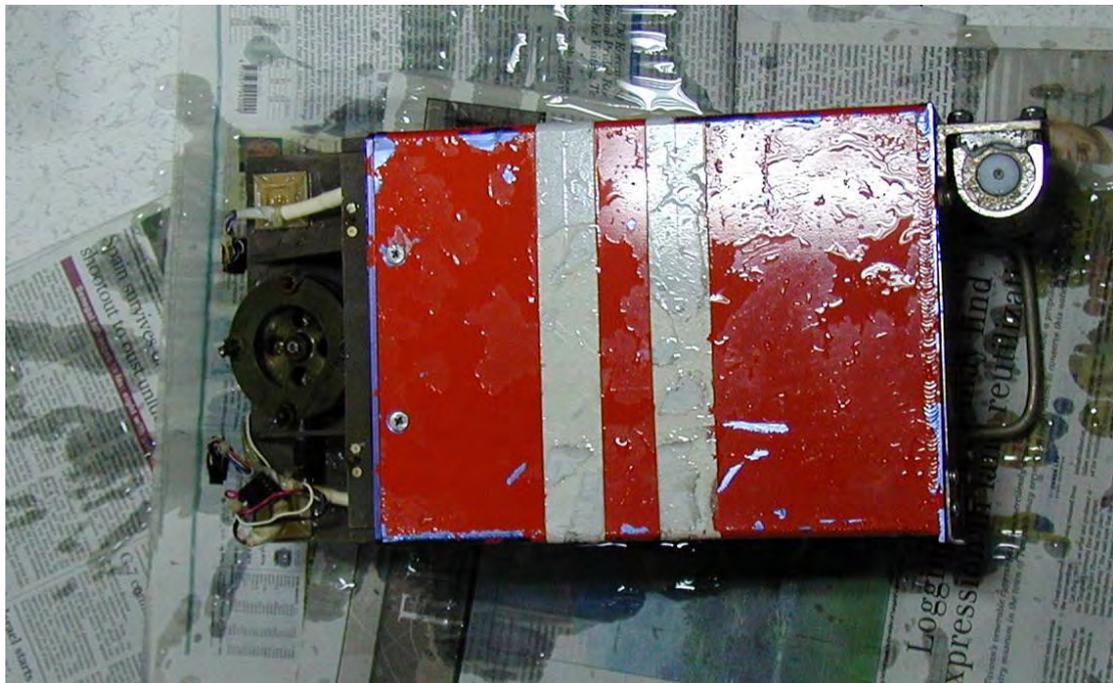
Figure 1.11-2 Damaged FDR in the water cooler

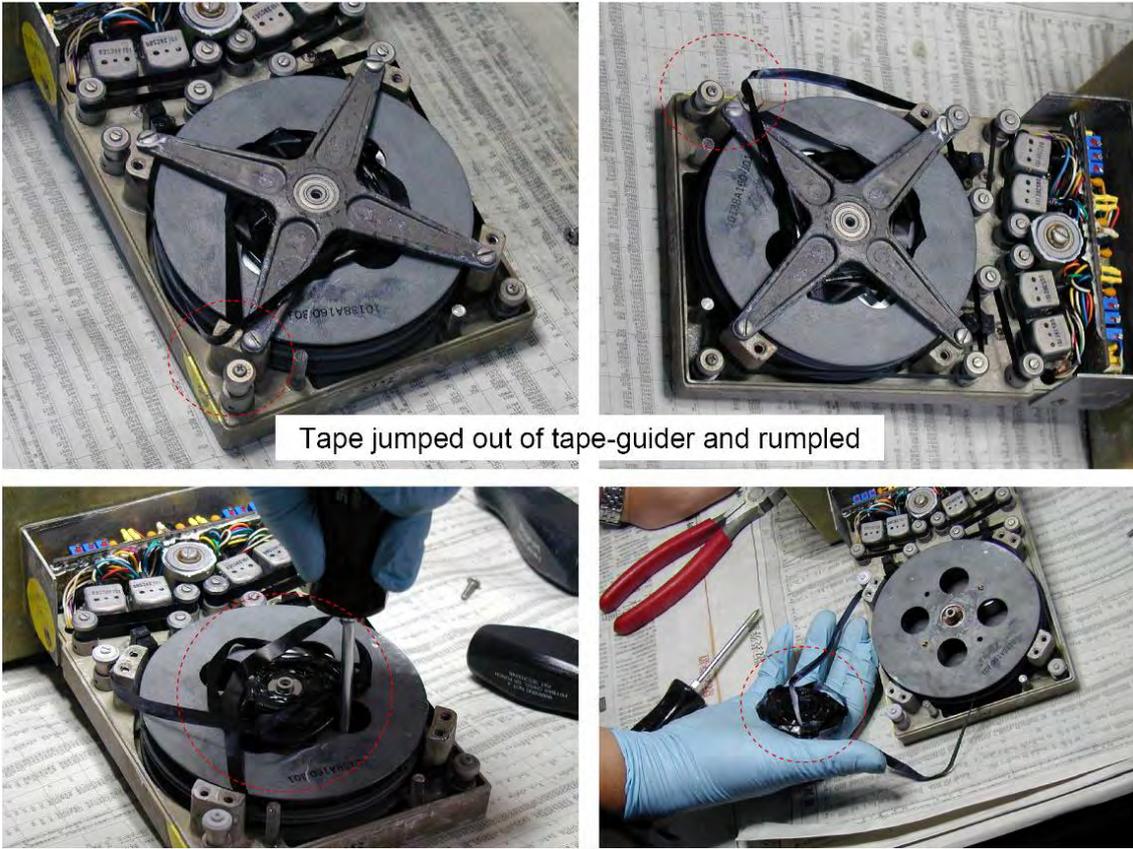
Figure 1.11-3 Photographs of damaged magnetic tape

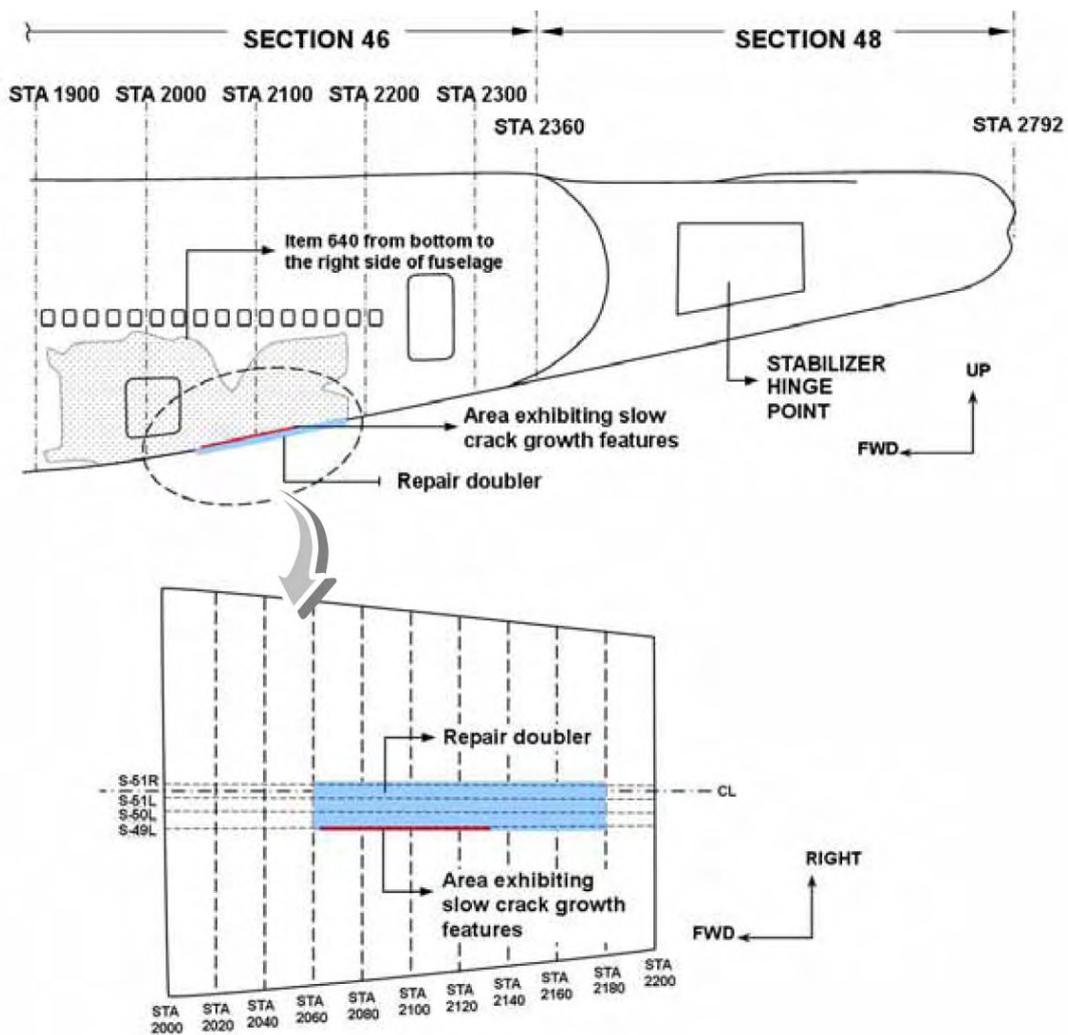
5. Examination of photographs of the item 640 repair doubler on the accident aircraft, which was taken in November 2001 during CAL's structural patch survey for the Repair Assessment Program, revealed traces of staining on the aft lower lobe fuselage around STA 2100 were an indication of a possible hidden structural damage beneath the doubler. (1.6, 2.2)

Figure 1.12-7 Item 640 and the repair doubler

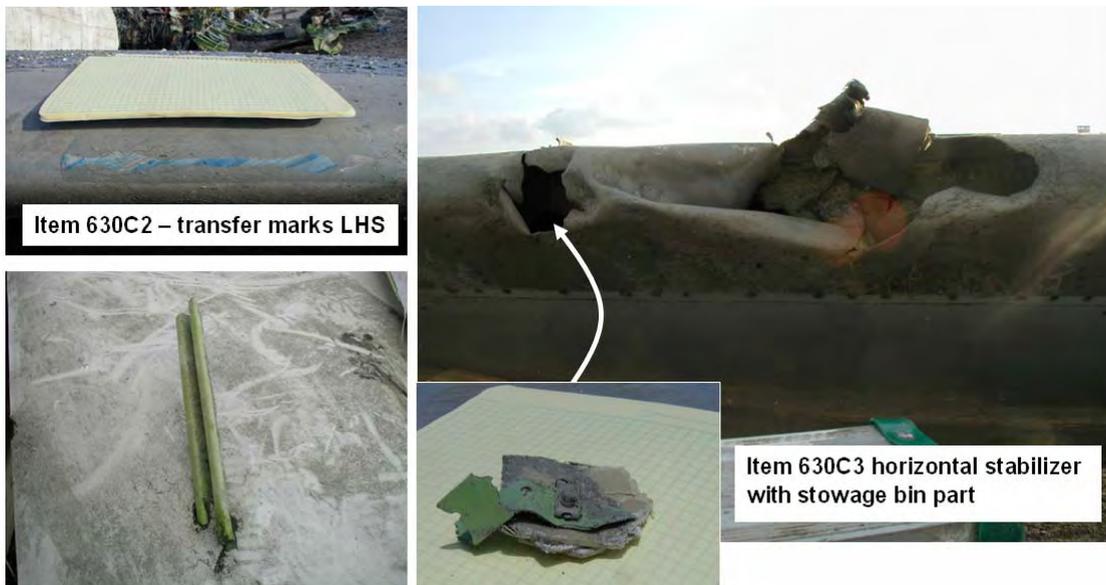
The right horizontal stabilizer (RHS) is considerably more damaged than the left horizontal stabilizer (LHS). The inboard portion of the RHS leading edge is deformed upwards. At the root of the RHS, the inboard 10 feet showed considerable impact damage along with upwards deformation of the compromised structure. A portion of seat support was found inside a puncture common to the lower surface of the LHS. A small segment of fuselage stringer was also found imbedded in the RHS elevator (Figure 1.12-10 left-down). A small fastener and shim from a stowage bin assembly were found inside a puncture common to the RHS leading edge (Figure 1.12-10 right).

Figure 1.12-10 A small segment of fuselage stringer imbedded in the RHS elevator (left-down). A small fastener and shim were found inside the RHS leading edge (right).

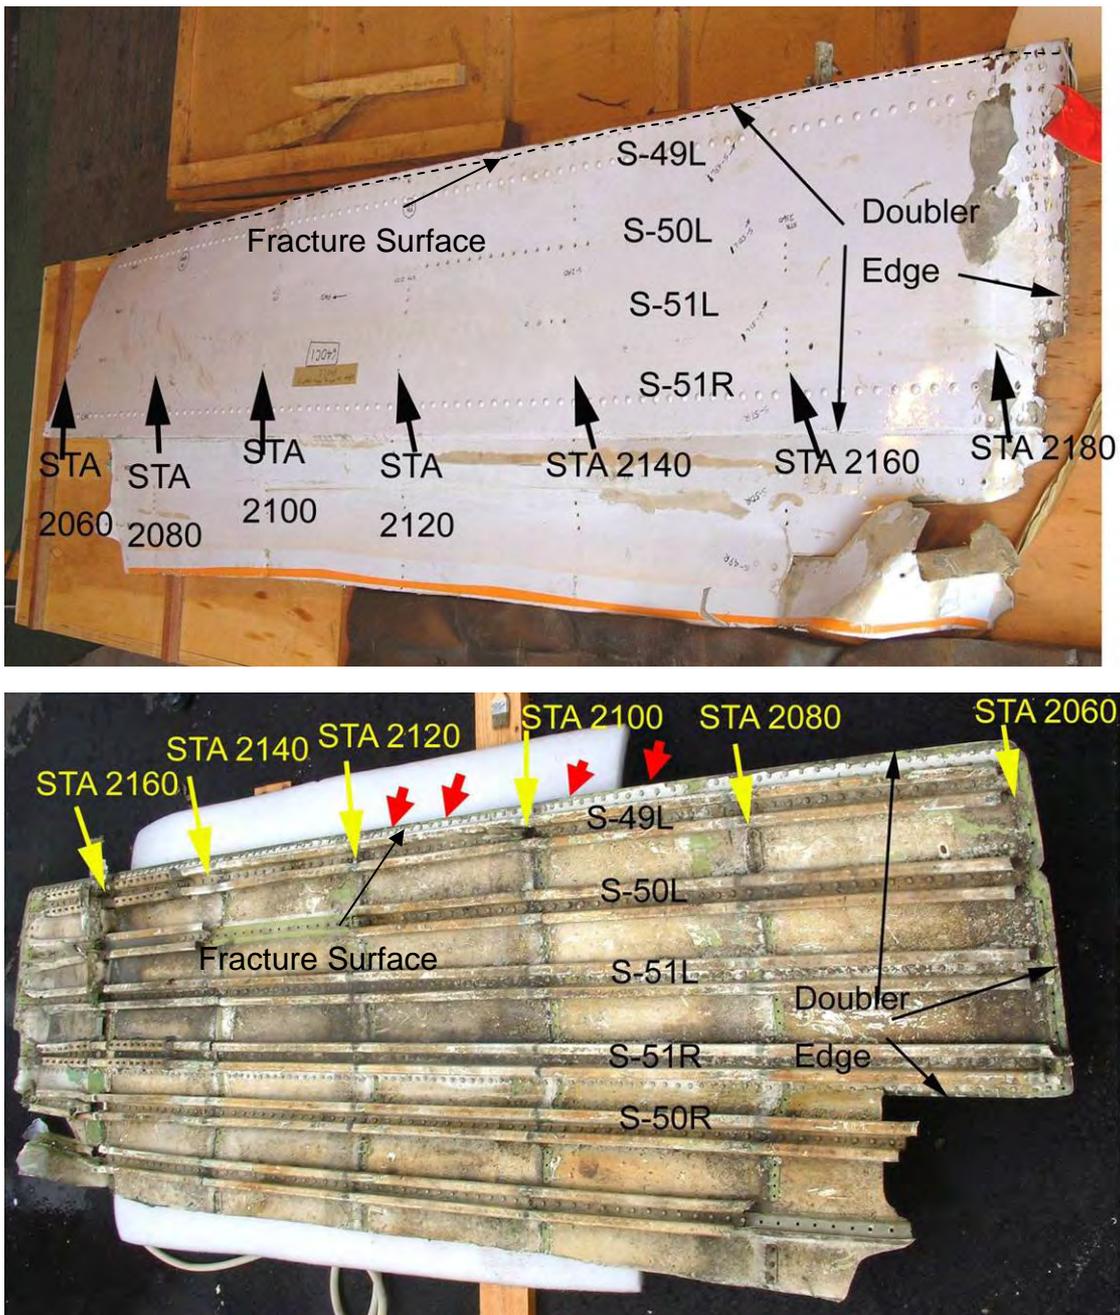
Figure 1.16-1 Exterior (up) and interior (down) of Item 640C1

Item 640C1 was a segment of Item 640 approximately from STA 2060 to 2180 and from S-49L to S-49R (Figure 1.16-1). A 23-inch wide, 125-inch long external repair doubler was attached to the skin by two rows of countersunk rivets around its periphery as well as by fasteners common to the stringer and shear tie locations. Universal head rivets were used at S-51R and S-49L while countersunk rivets were used at S-50L and S-51L.

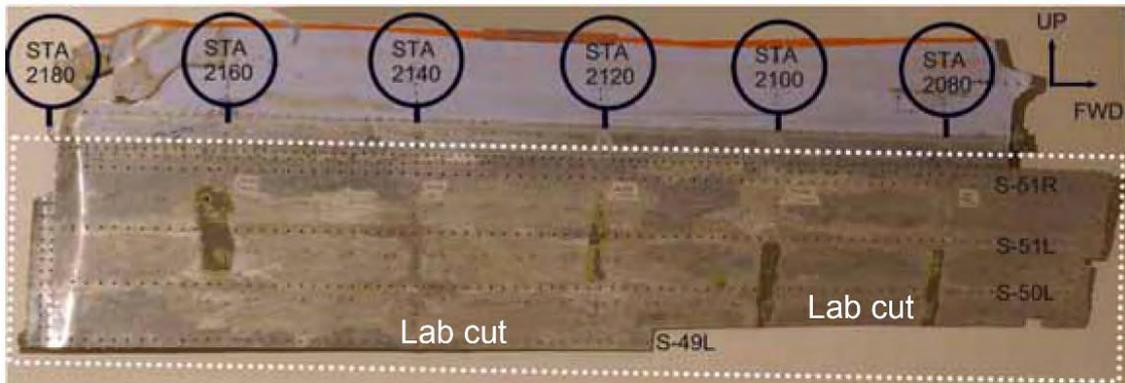
Figure 1.16-2 Faying surface with the repair doubler and protective finishes removed

After disassembling the doubler from the skin and removal of the protective finishes, scratching damage was noticed on the faying surface of the skin (Figure 1.16-2). This damage consists of primarily longitudinal scratching distributed in an area of 120 inches by 20 inches. The most severe scratching typically occurred at the skin stiffening members such as skin stringers and body frame shear ties. Evidence of an attempt to blend out these skin scratches, in the form of rework sanding marks, was noted over much of the repair surface. A close view of the skin area near STA 2080 is shown in Figure 1.16-3.

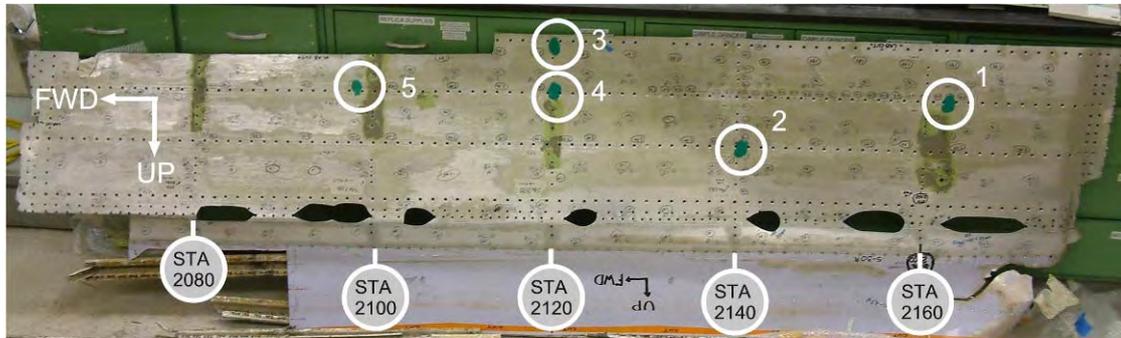
Figure 1.16-4 Locations chosen for scratch depth measurement

Five locations exhibiting major scratches on the repair faying surface of the skin as shown in Figure 1.16-4, were chosen for the examination of the scratch geometry and depth. The maximum scratch depth measured in each location is shown in Table 1.16-1.

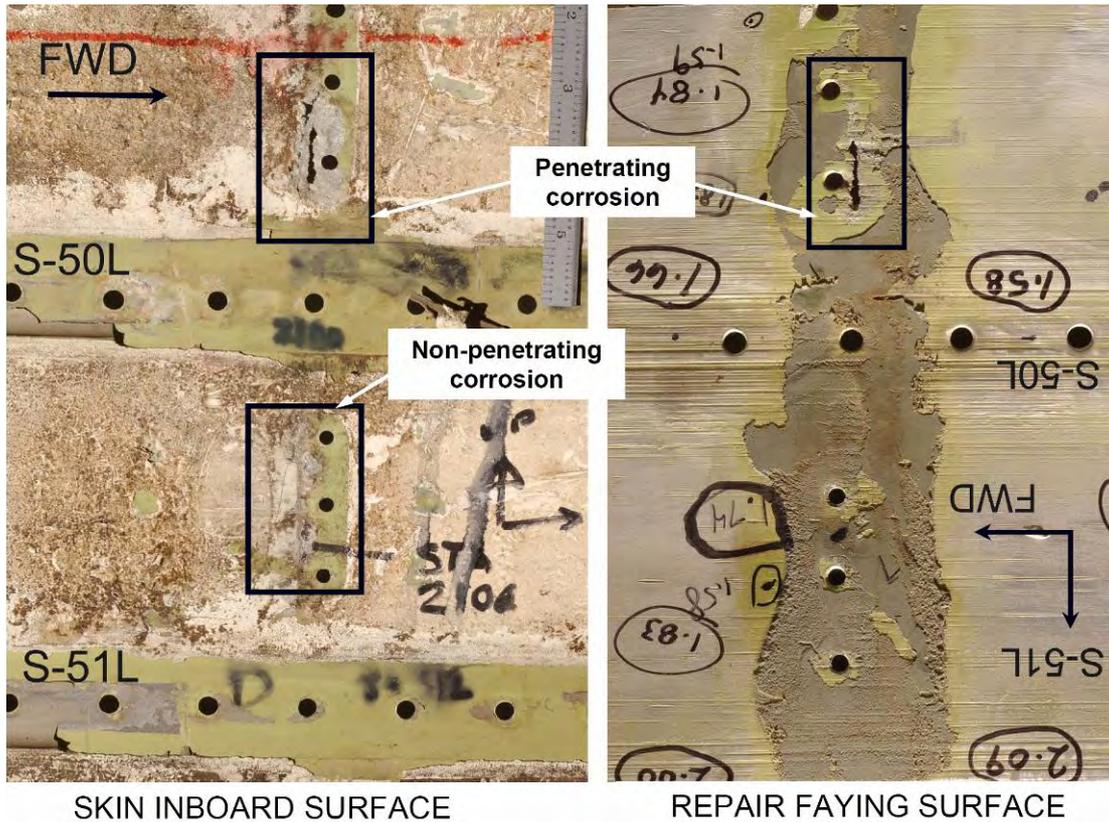
Figure 1.16-5 Skin corrosion features at STA 2100

Corrosion was noted at several shear tie locations on the skin inboard surface sometimes penetrating completely through the skin thickness. Figure 1.16-5 shows the corrosion features near STA 2100. General features of this damage and condition of the skin indicate that the corrosion was not the result of salt-water immersion after the event. Table 1.16-2 displays all the corrosion features found on item 640C1.

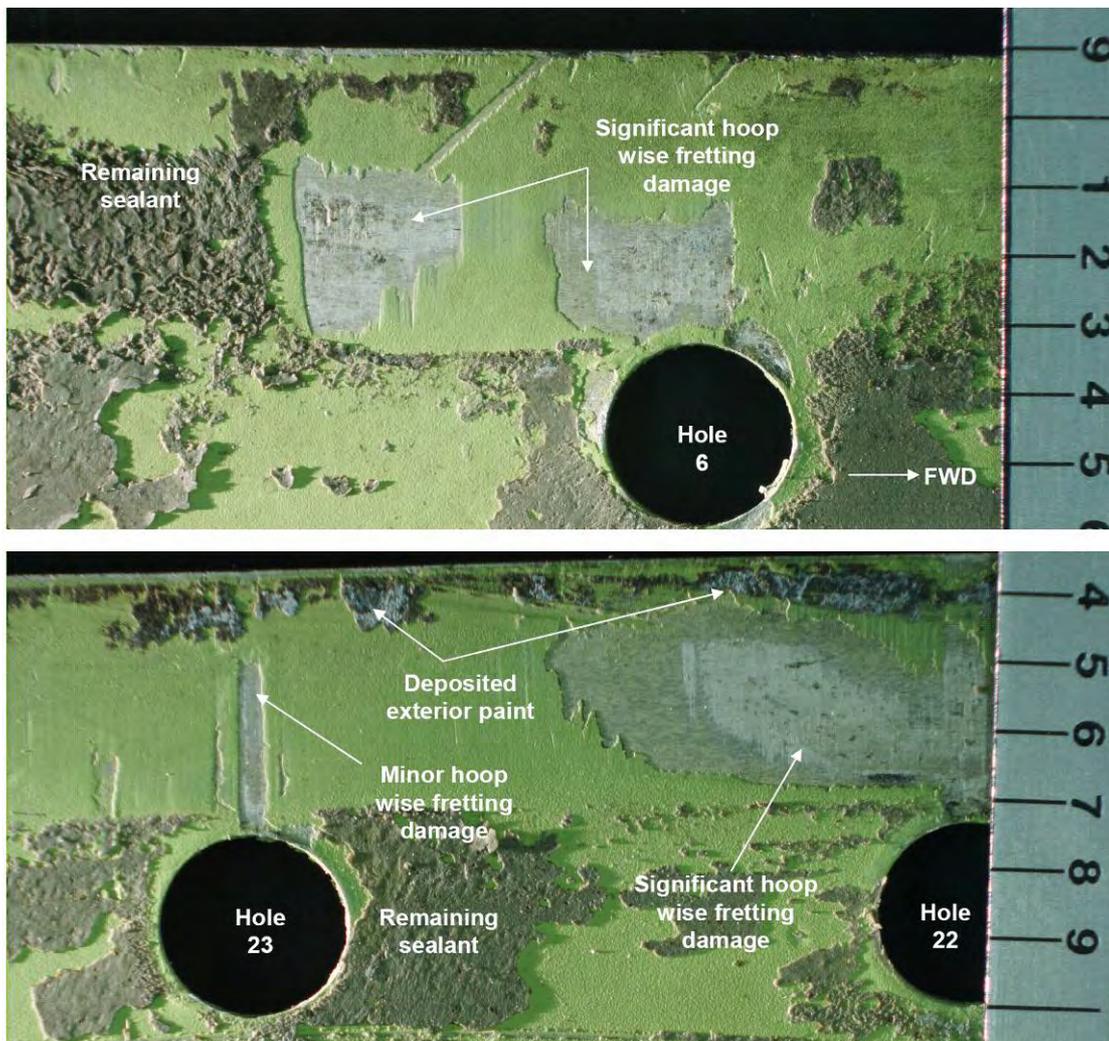
- The fretting marks observed from STA 2061 (hole +16) to STA 2132 (hole 49) are associated with most of the rivet locations. The most significant fretting damage was present between holes 8 and 43.
- The fretting marks near hole 32 and an optically magnified photograph of the area of contact is shown in Figure 1.16-9. It shows that the area of contact exhibits many colors and some hoop-wise scratches (marked by arrows).
- Two cross-section locations were chosen to characterize the area of contact. Figures 1.16-10 and Figure 1.16-11 show the metallographic photographs through the area marked by data sampling cut #1 and data sampling cut #2 respectively. It is observed that there was some material superimposed over the grooves of the scratches.

Figure 1.16-8 Fretting damage observed on faying surface of the repair doubler

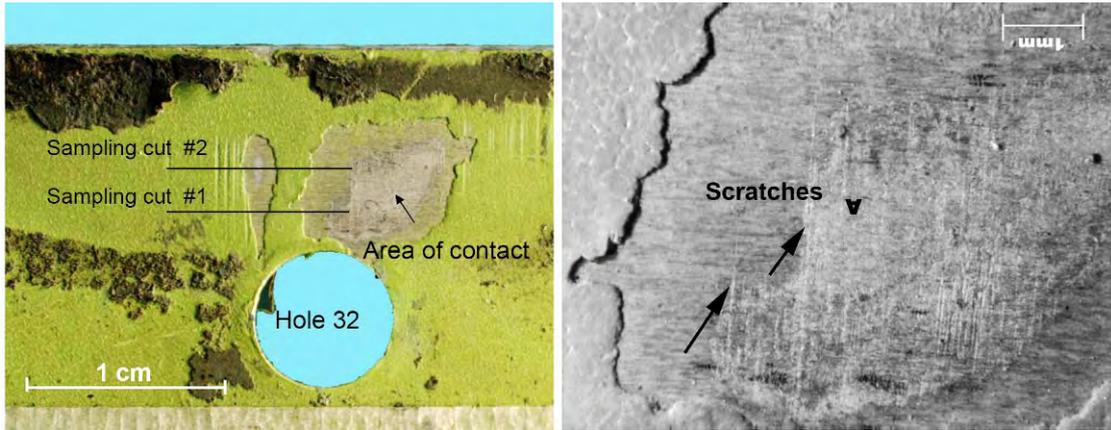
Figure 1.16-9 Area of contact near hole 32 showing the different colors (left) and scratches present (right)

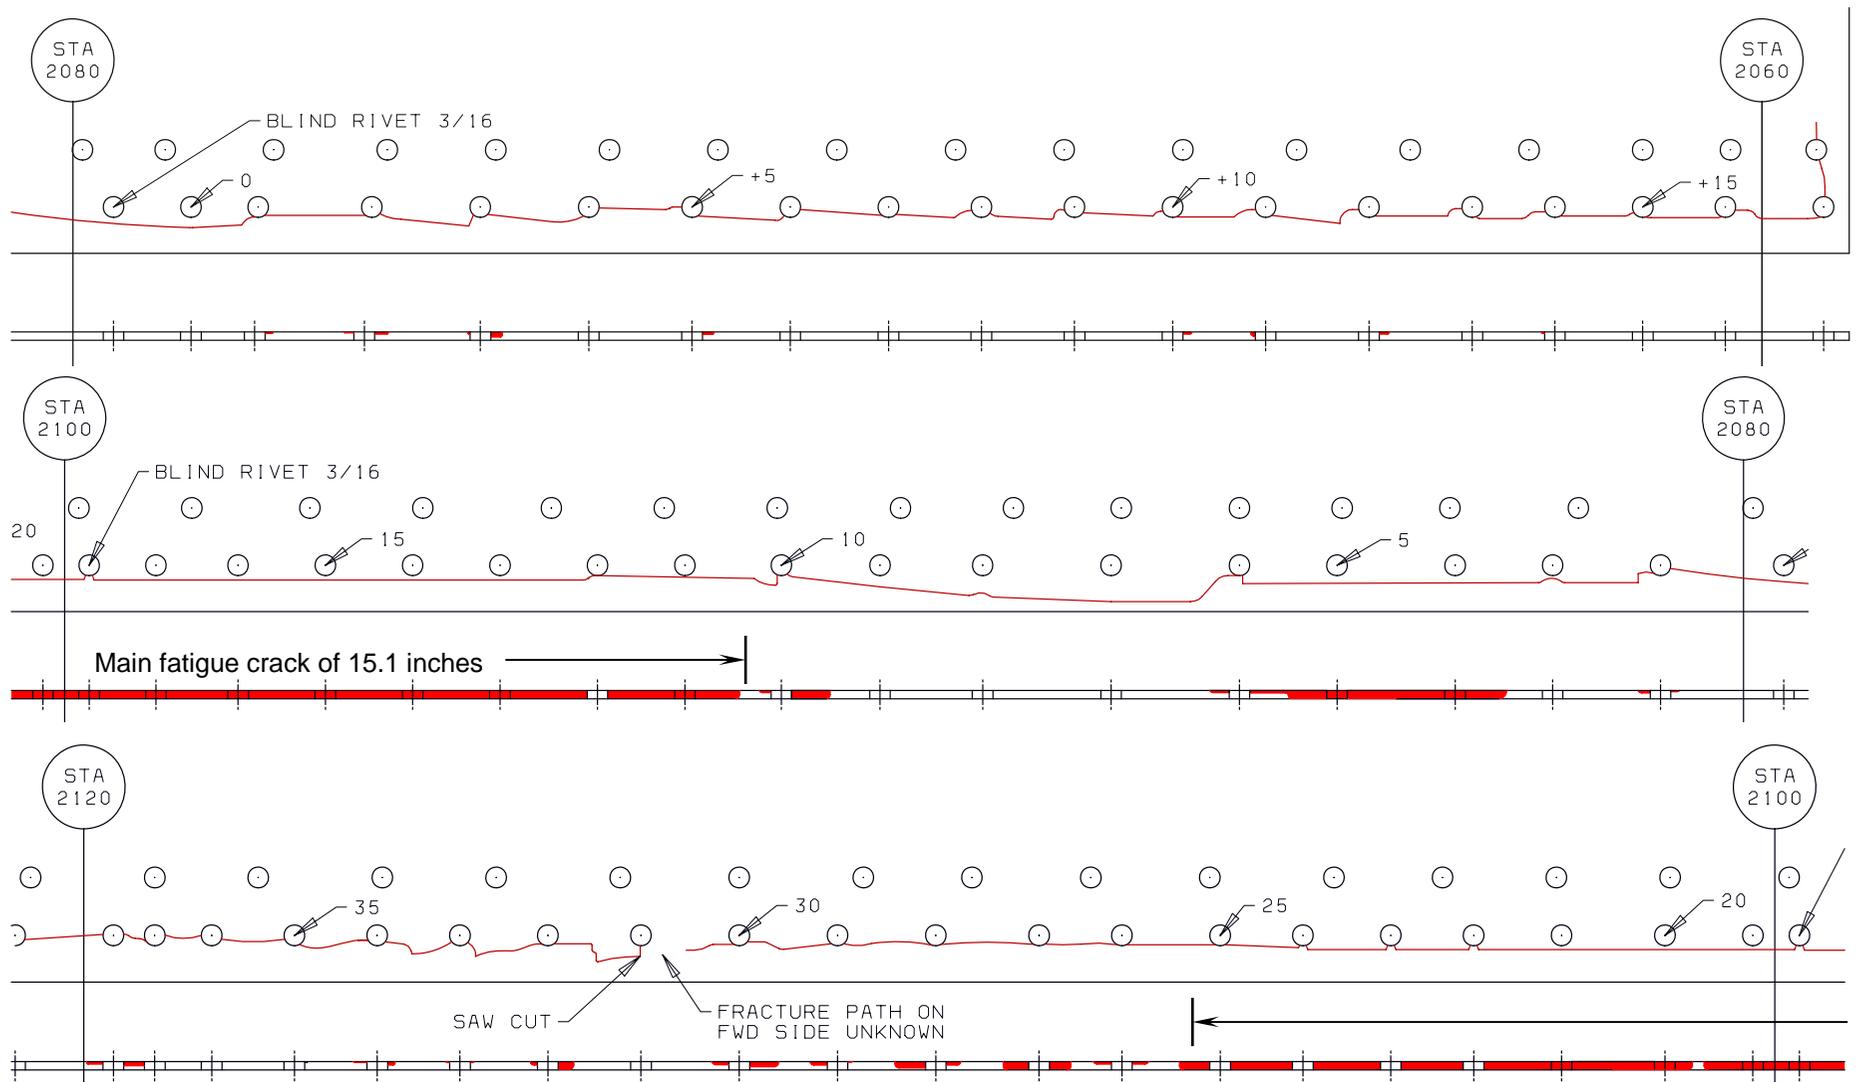
4. Evidence of fatigue damage was found in the lower aft fuselage centered about STA 2100, between stringers S-48L and S-49L, under the repair doubler near its edge and outside the outer row of securing rivets. Multiple Site Damage (MSD), including a 15.1-inch through thickness main fatigue crack and some small fatigue cracks were confirmed. The 15.1-inch crack and most of the MSD cracks initiated from the scratching damage associated with the 1980 tail strike incident. (1.16, 2.2)

Figure 1.16-12 Distribution of the fatigue cracks (from STA 2060 to STA 2120)

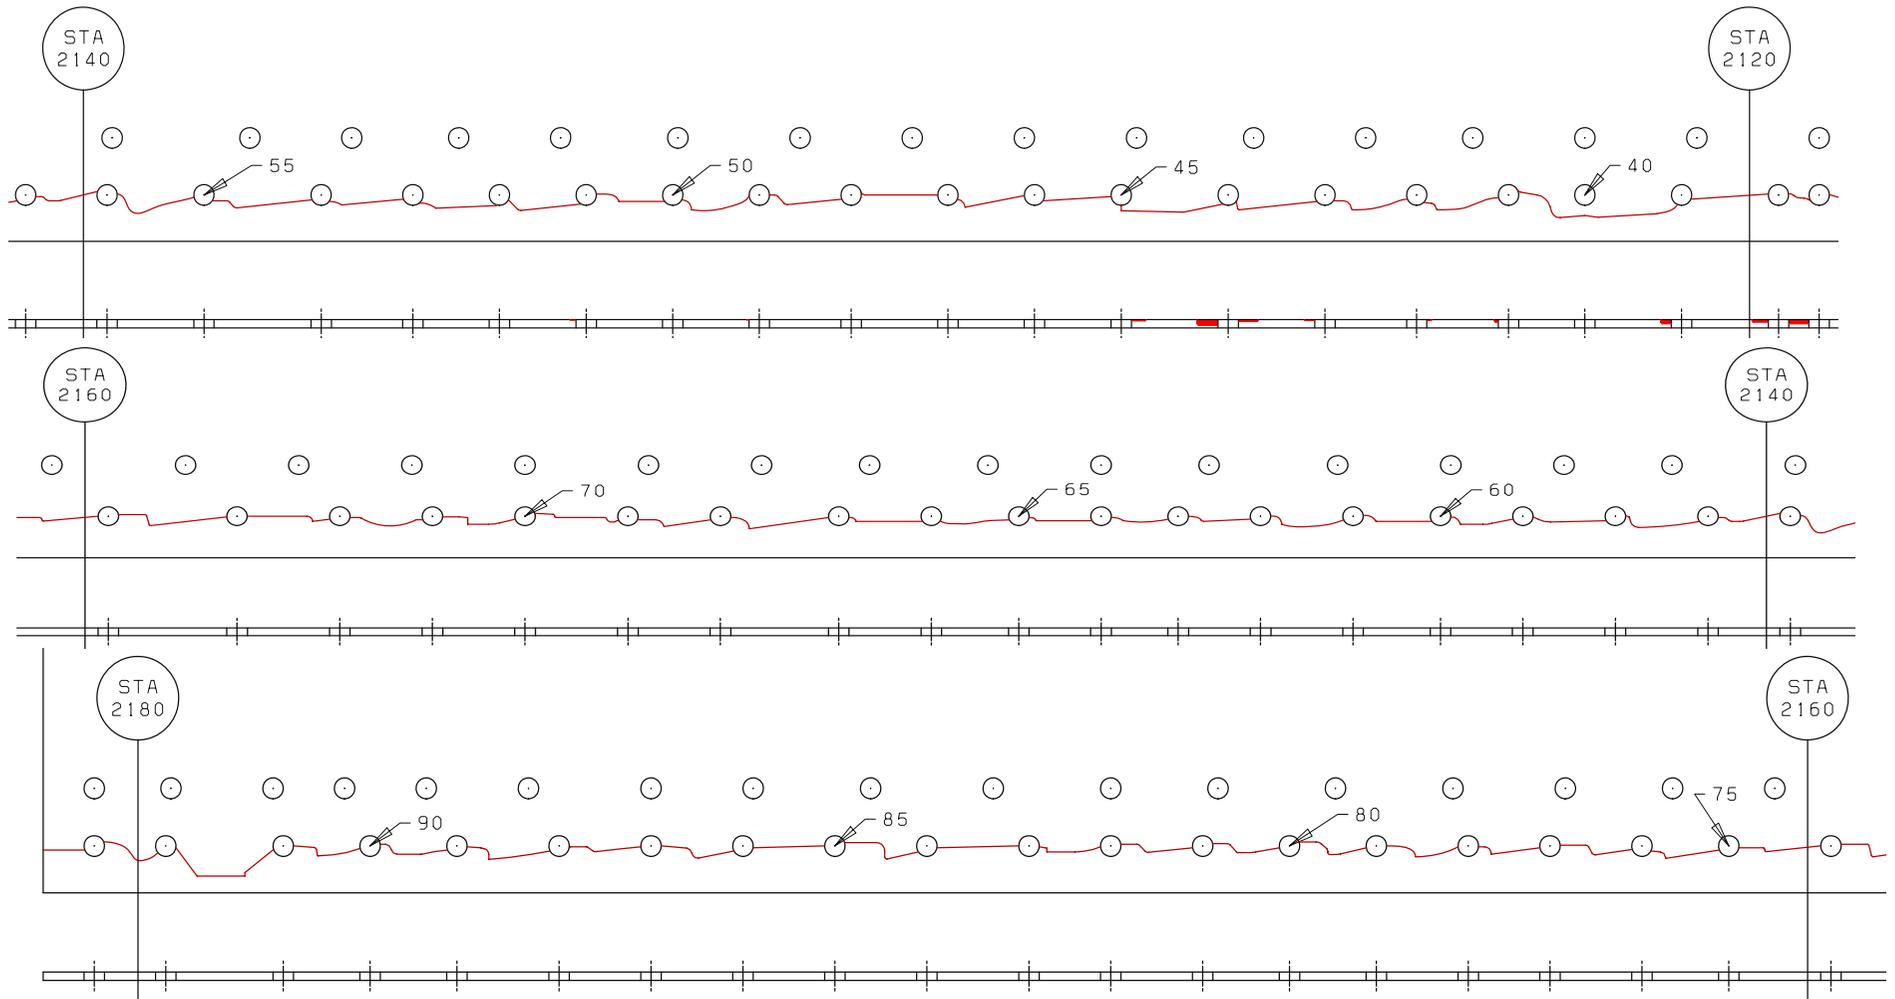
Figure 1.16-13 Distribution of the fatigue cracks (from STA 2120 to STA 2180)

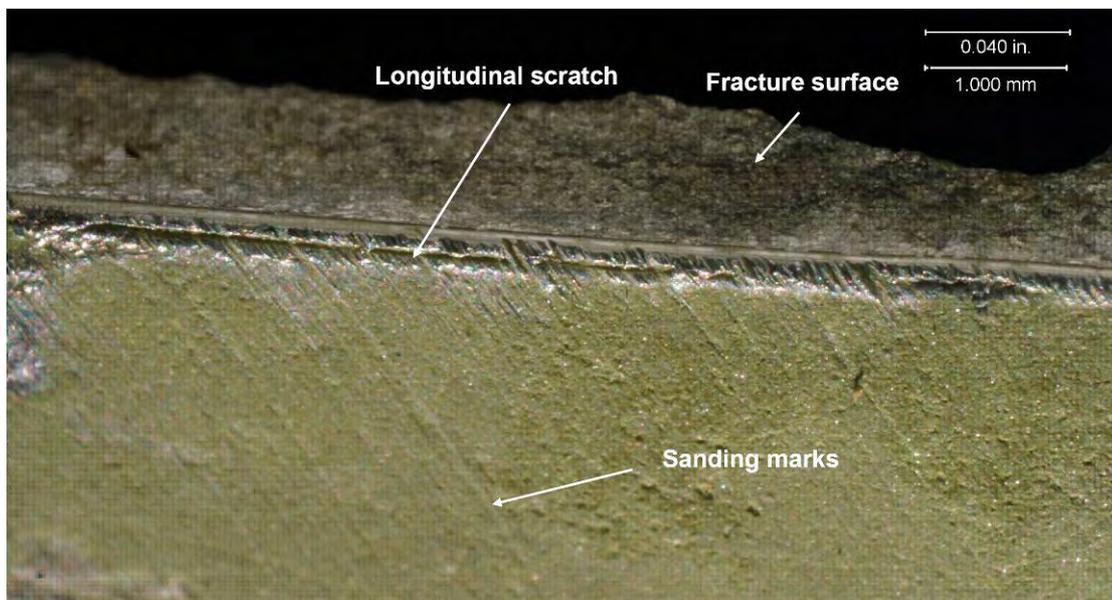
Figure 2.2-6 Fatigue crack originated from the scratch near hole 20

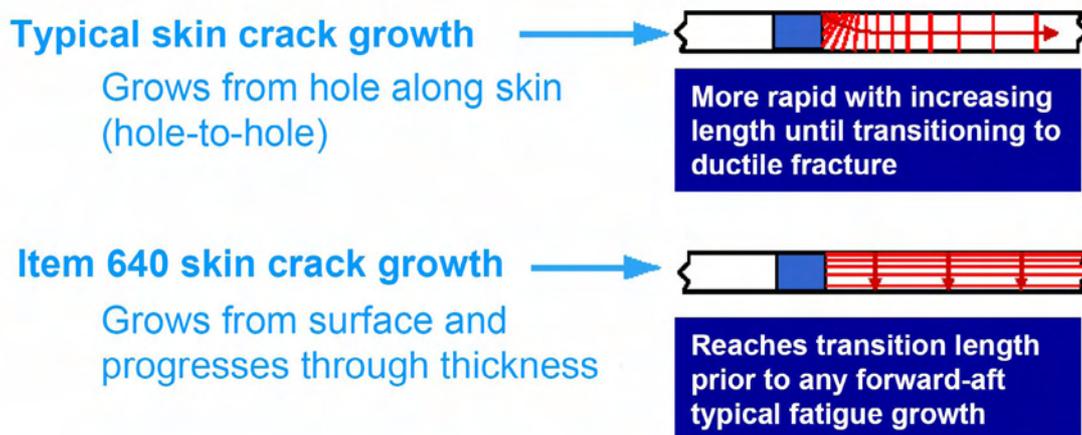
Figure 2.2-7 Cracking on Item 640 differs from typical fatigue crack

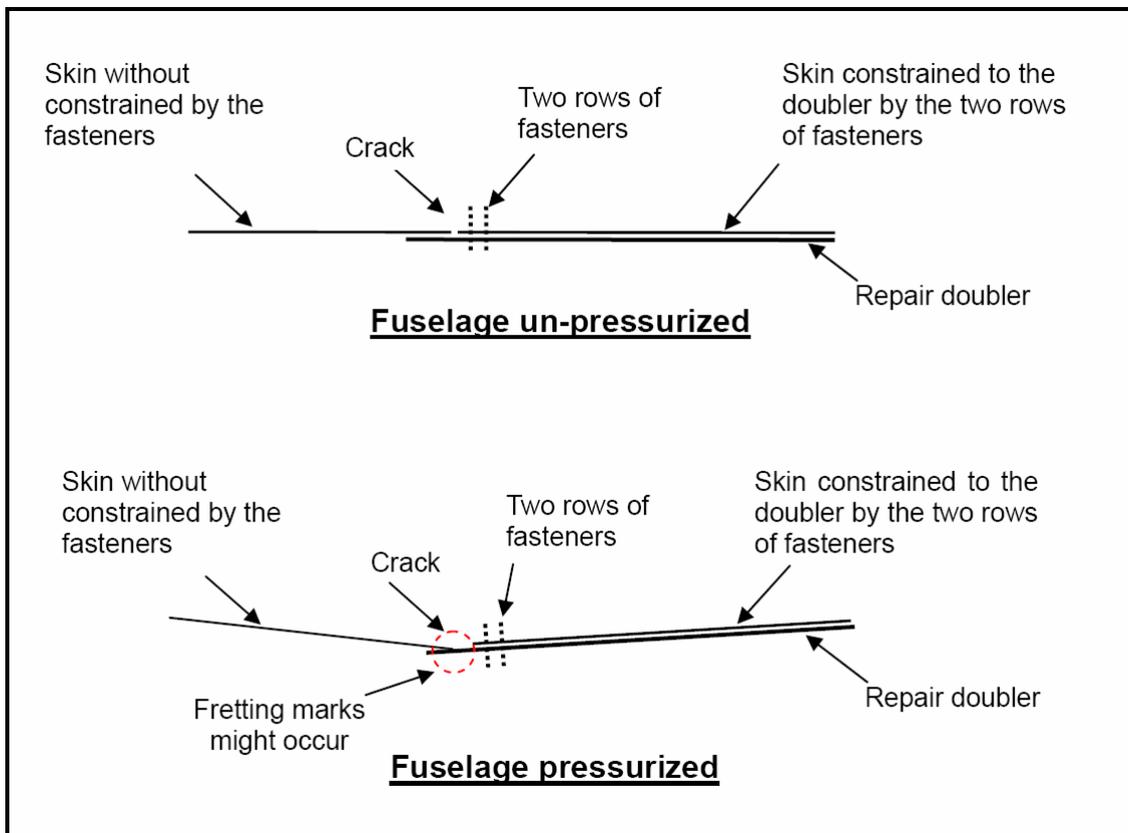
portion of the repair doubler was consistent with this phenomenon (Figure 1.16-8).

Figure 2.2-8 The fretting marks caused by the pressurization cycles

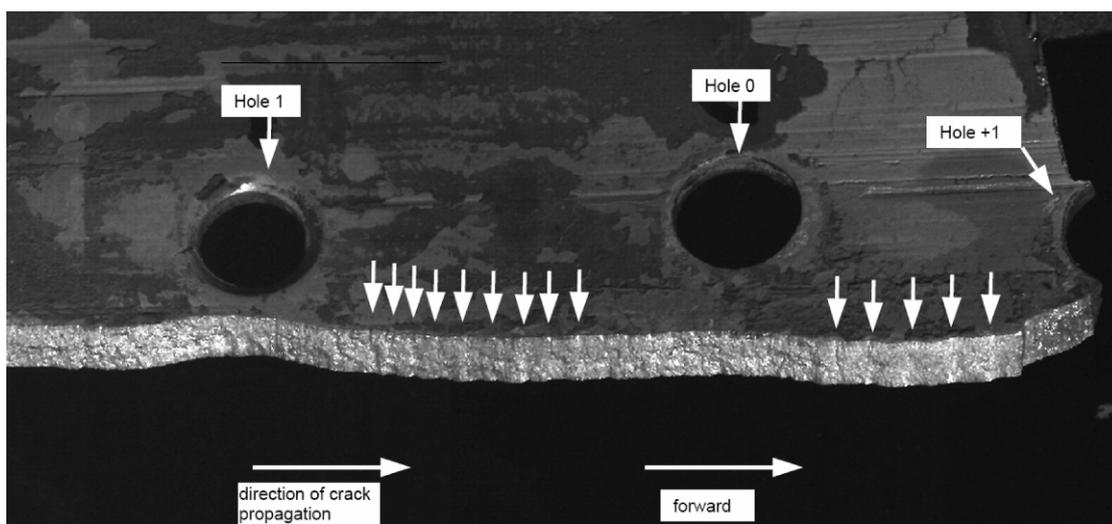
Figure 2.2-9 The regular spacing of cracking increments found on Item 640

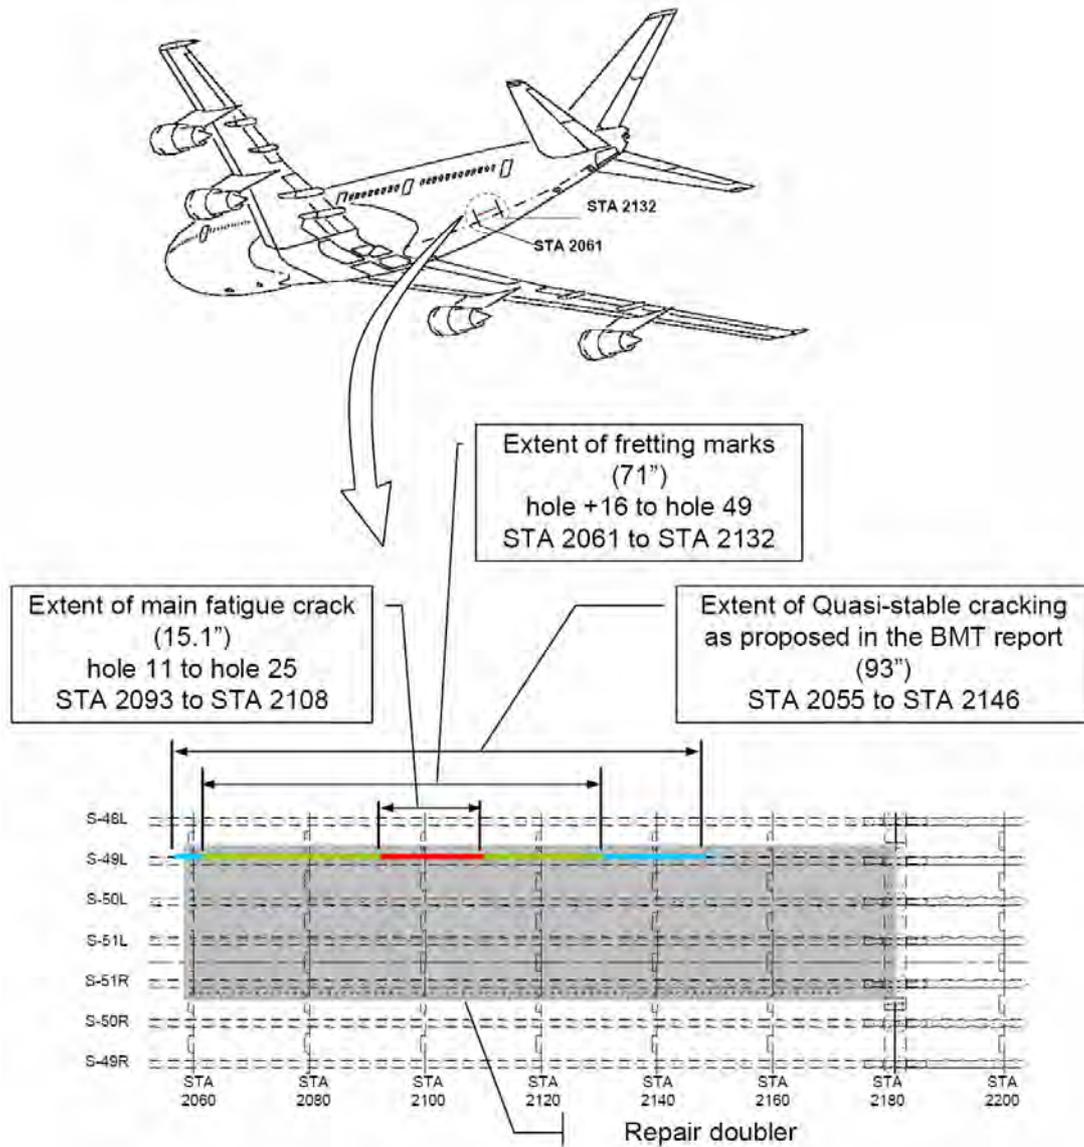
Figure 2.2-12 Different signs of cracks
