MINISTRY OF CIVIL AVIATION

Report of the Court Investigation
on the Accident to
COMET G-ALYV
on 2nd May, 1953

OF COURT INVESTIGATION OF THE ACCIDENT TO B.O.A.C. COMET AIRCRAFT G-ALYV ON 2nd MAY, 1953

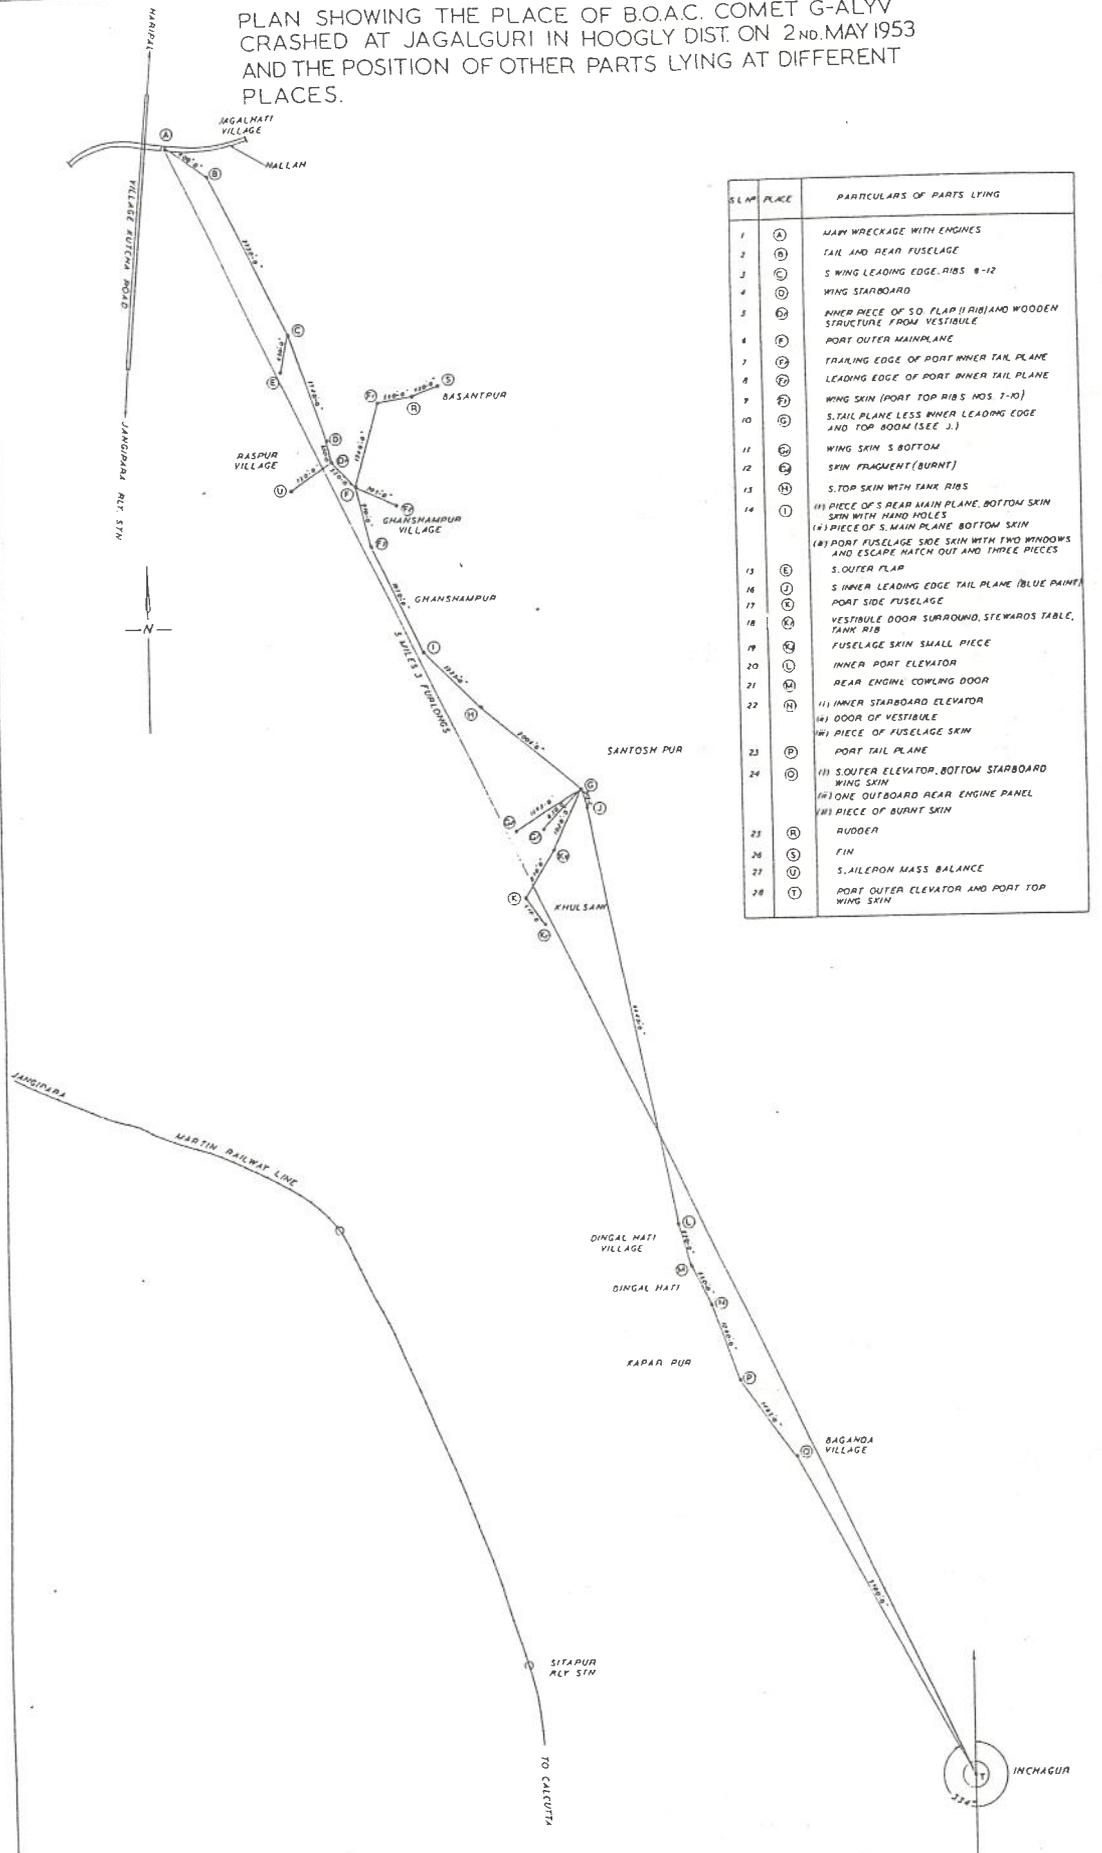
PLAN SHOWING THE PLACE OF B.O.A.C. COMET G-ALYV
 CRASHED AT JAGALGURI IN HOOGLY DIST. ON 2ND MAY 1953
 AND THE POSITION OF OTHER PARTS LYING AT DIFFERENT
 PLACES.

A sketch showing the distribution of the different components of the aircraft along the wreckage trail is appended to the Report. Normally, it may be possible to plot the trajectories of the falling bodies and predict with a certain amount of accuracy the primary failure of the aircraft. Since the aircraft disintegrated into several pieces up in the air with several successive failures and collision loads between parts and due to the fact that definite data on the wing velocities at the time of wreckage are not possible, no attempt was made to draw the trajectories and predict the primary failure.

S. NO.	PLACE	PARTICULARS OF PARTS LYING
1	(A)	MAIN WRECKAGE WITH ENGINES
2	(B)	TAIL AND REAR FUSELAGE
3	(C)	S WING LEADING EDGE, RIBS 8-12
4	(D)	WING STARBOARD
5	(E)	INNER PIECE OF S.D. FLAP (RIB) AND WOODEN STRUCTURE FROM VESTIBULE
6	(F)	PORT OUTER MAINPLANE
7	(G)	TRAILING EDGE OF PORT INNER TAIL PLANE
8	(H)	LEADING EDGE OF PORT INNER TAIL PLANE
9	(I)	WING SKIN (PORT TOP RIBS NOS 7-10)
10	(J)	S. TAIL PLANE LESS INNER LEADING EDGE AND TOP BOOM (SEE J.)
11	(K)	WING SKIN S BOTTOM
12	(L)	SKIN FRAGMENT (BURNT)
13	(M)	S. TOP SKIN WITH TANK RIBS
14	(N)	(N) PIECE OF S. REAR MAIN PLANE, BOTTOM SKIN SKIN WITH HANG HOLES
15	(O)	(O) PIECE OF S. MAIN PLANE, BOTTOM SKIN
16	(P)	(P) PORT FUSELAGE SIDE SKIN WITH TWO WINDOWS AND ESCAPE HATCH OUT AND THREE PIECES
17	(Q)	S. OUTER FLAP
18	(R)	S. INNER LEADING EDGE TAIL PLANE (BLUE PAINT)
19	(S)	PORT SIDE FUSELAGE
20	(T)	VESTIBULE DOOR SURROUND, STEWARDS TABLE, TANK RIB
21	(U)	FUSELAGE SKIN SMALL PIECE

22	(V)	INNER PORT ELEVATOR
23	(W)	REAR ENGINE COWLING DOOR
24	(X)	(X) INNER STARBOARD ELEVATOR
25	(Y)	(Y) DOOR OF VESTIBULE
26	(Z)	(Z) PIECE OF FUSELAGE SKIN
27	(AA)	PORT TAIL PLANE
28	(AB)	(AB) S. OUTER ELEVATOR, BOTTOM STARBOARD WING SKIN
	(AC)	(AC) ONE OUTBOARD REAR ENGINE PANEL
	(AD)	(AD) PIECE OF BURNT SKIN
	(AE)	RUDDER
	(AF)	FIN
	(AG)	S. AILERON MASS BALANCE
	(AH)	PORT OUTER ELEVATOR AND PORT TOP WING SKIN
