COMMISSION OF
INQUIRY INTO THE
AIR ONTARIO CRASH
AT DRYDEN, ONTARIO

Final Report

Volume II

Part Five

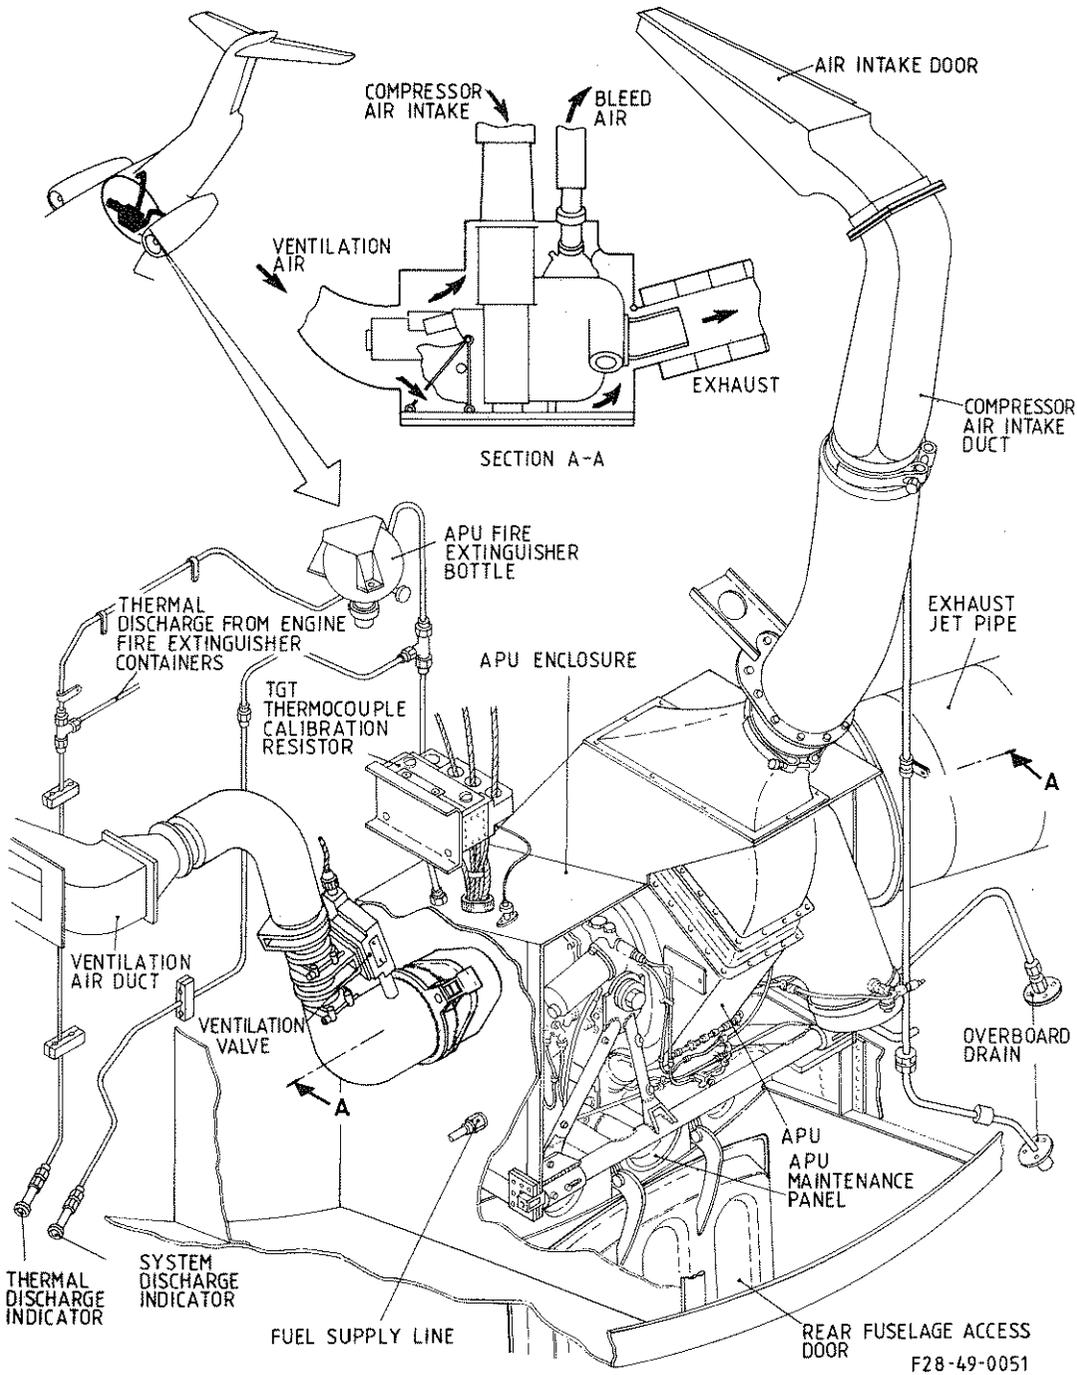
Figure 16-1 APU Installation

power.² Shutting both engines down will result in a loss of electrical power from generators 1 and 2. In this critical situation, the electrical power from generator 3, which is powered by the APU, is necessary to operate the aircraft anti-skid system.

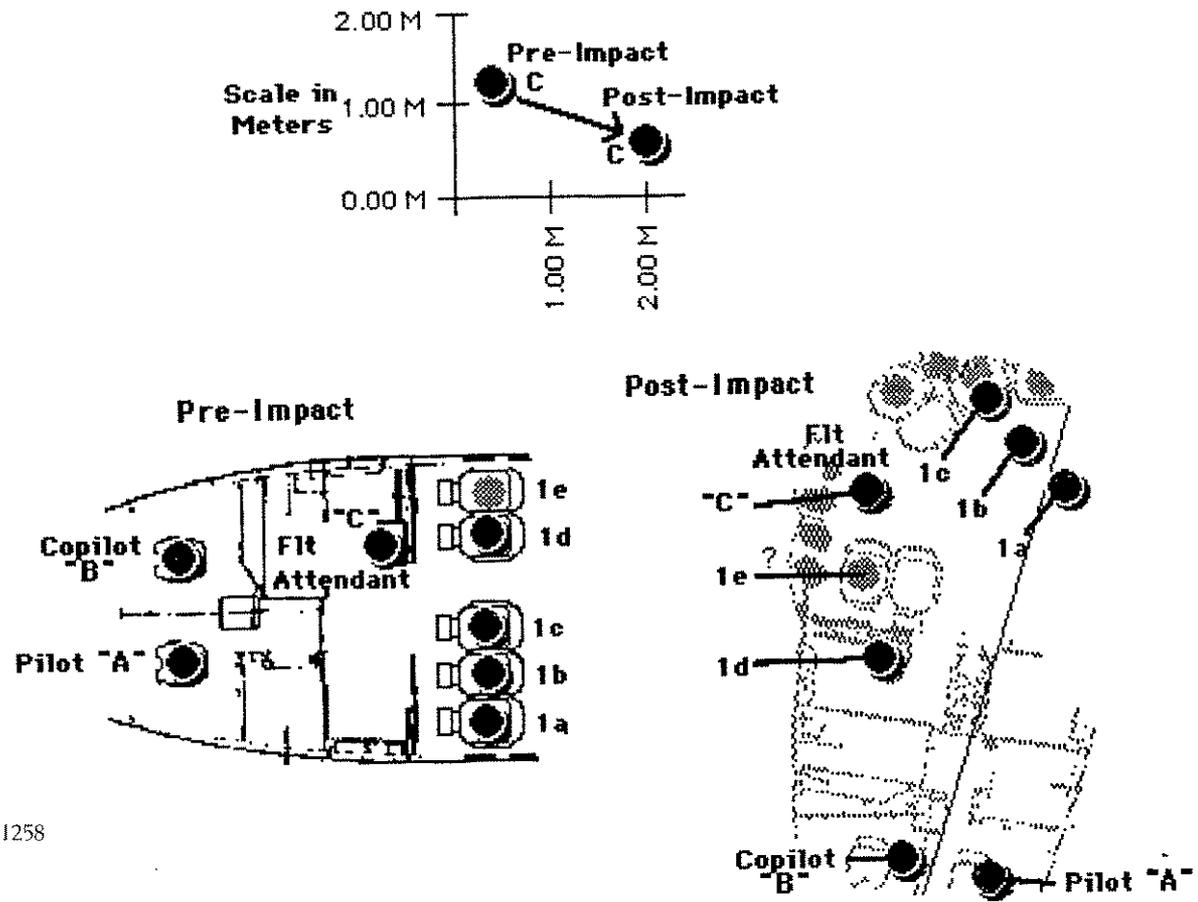
Figure 22-1 Pre- and Post-Accident Locations of Individuals Seated in Forward Positions on Flight 1363

Although other factors may have intervened to cause her head injury during the breakup sequence, it is beyond dispute that, had she been secured by a shoulder harness, her upper body would have been markedly better restrained and protected from injury caused by forward motion on impact. This, after all, is the function of a shoulder harness.
