Airbus Industrie Flight Safety

A320 Accident - Bangalore

14 February 1990

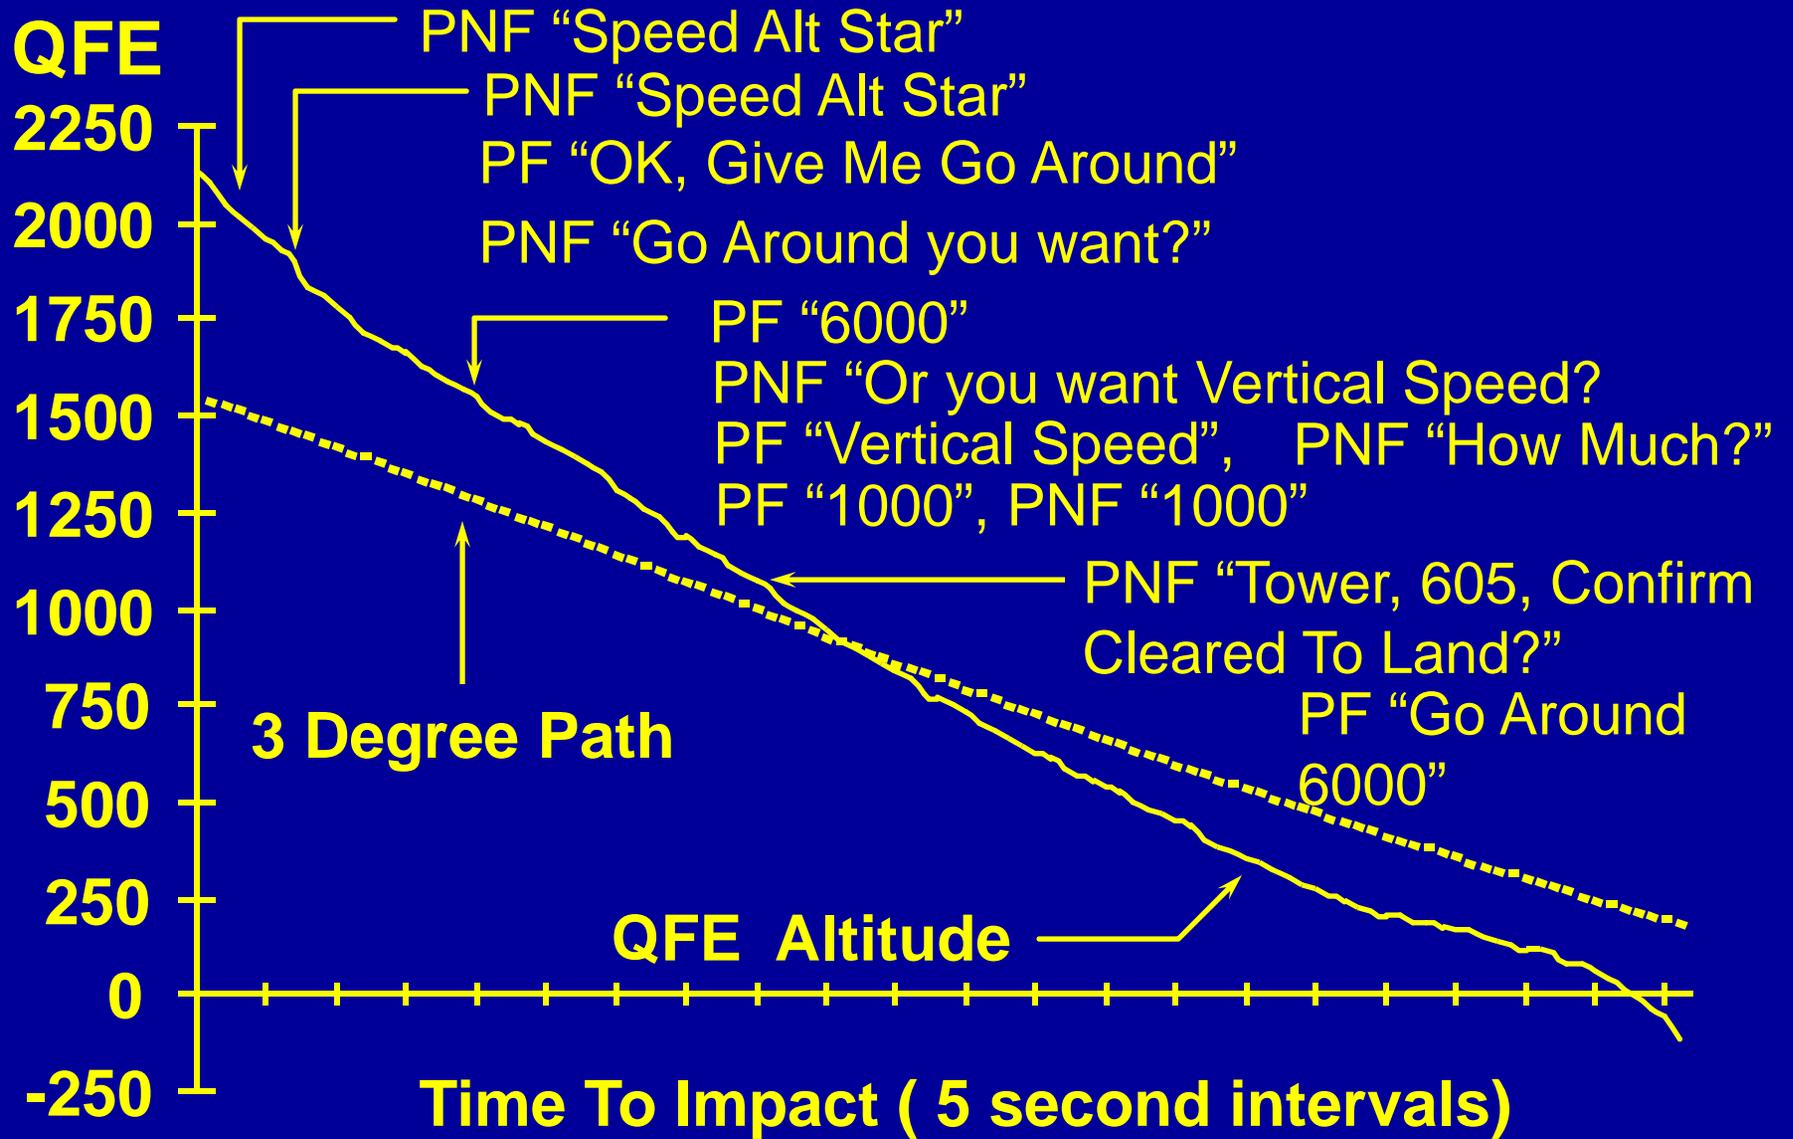
Final Approach Profile

- **At about 600 feet QFE (3500 QNH):**
 - The aircraft was about 130 feet below the desired flight path.
 - The Auto Thrust system was in Speed mode.
 - The Flight Director was in Vertical Speed mode.
 - The CAS was 136 knots ($V_{APP} = 132$).
 - The Rate of Descent was about minus 1000 fpm.
- **At this point, several things happened very close together.**
- **First, the Flight Director engaged in ALT* mode because the Check Airman had apparently set 3300 feet in the FCU Altitude Select window.**

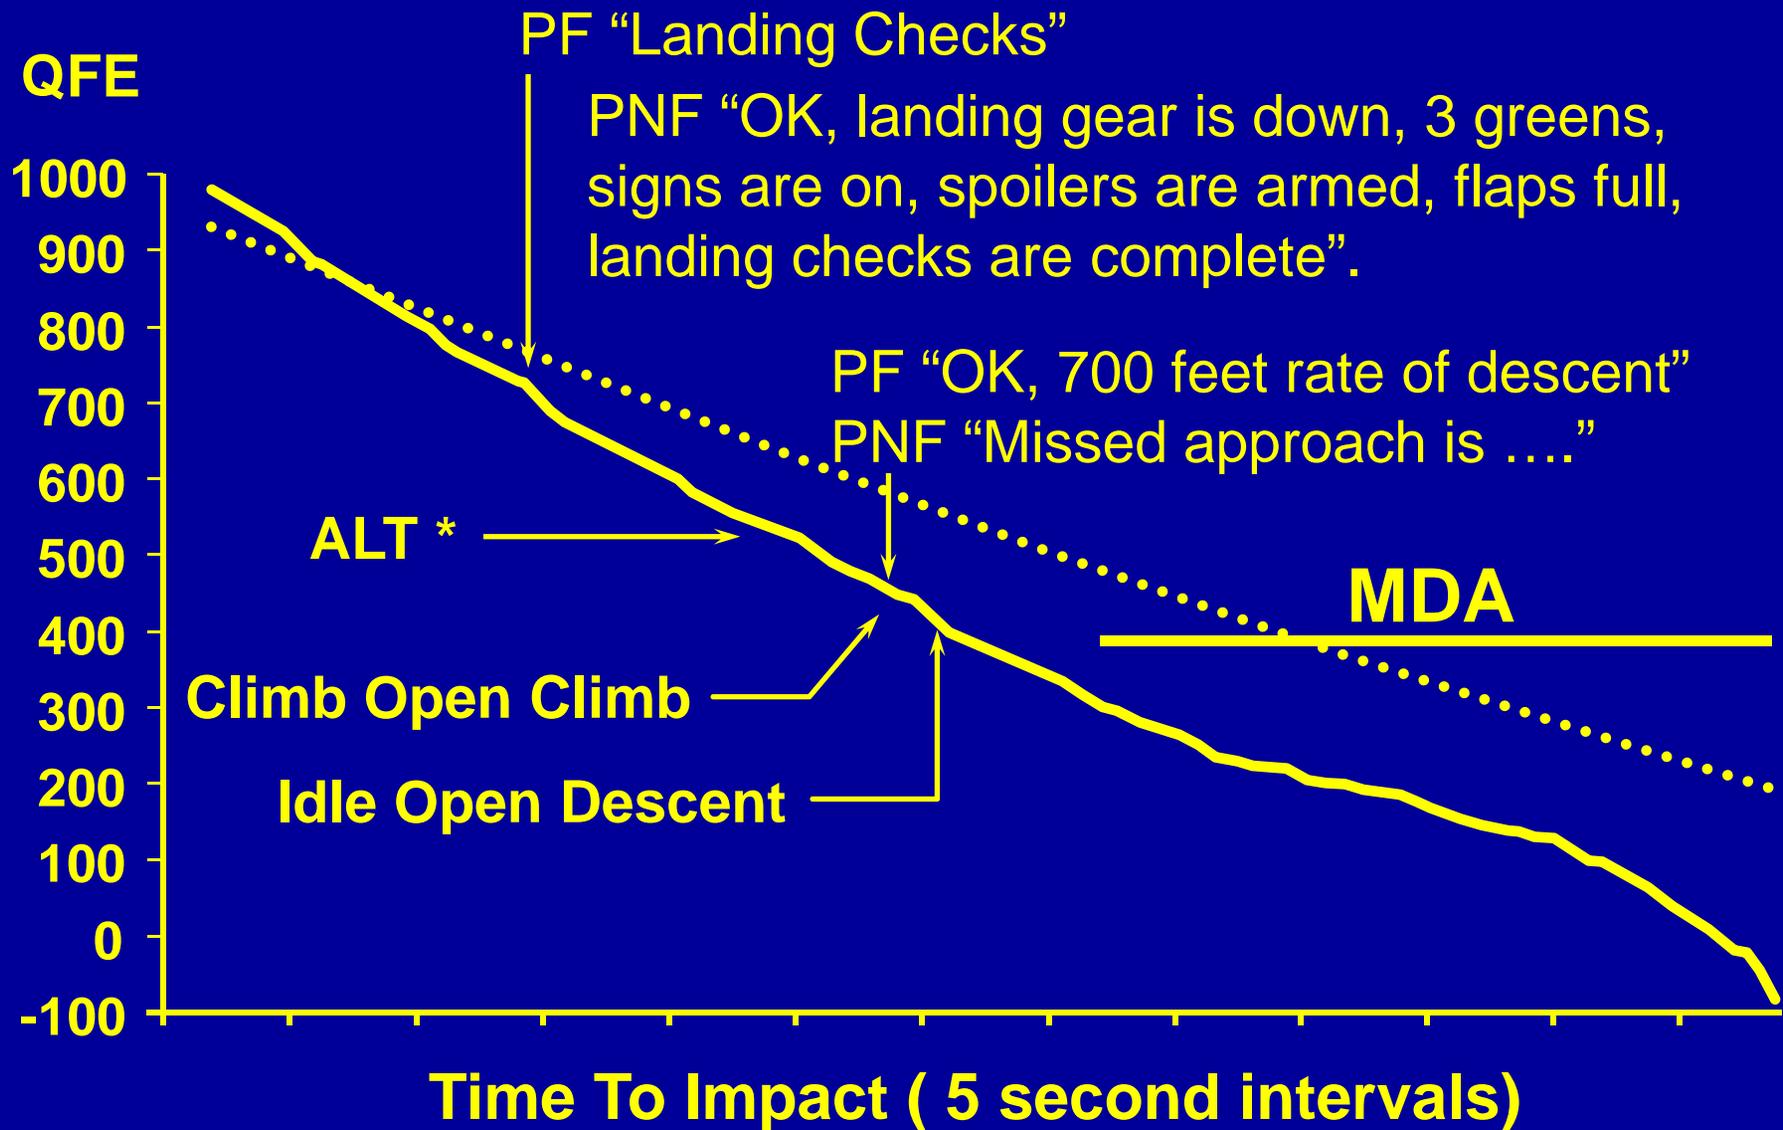
Flight Profile Below 1000 QFE

- The Pilot Flying then asked for “Vertical Speed 700 ft/min”.
- The Check Airman said “Missed Approach is”, but did not acknowledge the PF request or comply with it.
- At this point, it appears that the FD / ATHR system momentarily engaged in “Climb - Open Climb” mode. This caused the thrust to increase slightly for a brief period.
- The most likely reason for this is that the Check Airman started to set 6000 feet in the FCU while the system was in ALT* mode.

- **This would cause the system to automatically revert to “Climb - Open Climb” mode.**
- **Evidently this error was quickly detected by the Check Airman.**
- **The Check Airman then selected an FCU altitude that was below Field Elevation.**
 - This caused the FD and ATHR to engage in “Idle - Open Descent” mode.
 - This mode change was identified a short time later.
 - However, the crew did not change the mode.
 - The use of “Idle - Open Descent” mode was prohibited below 1000 feet AGL.

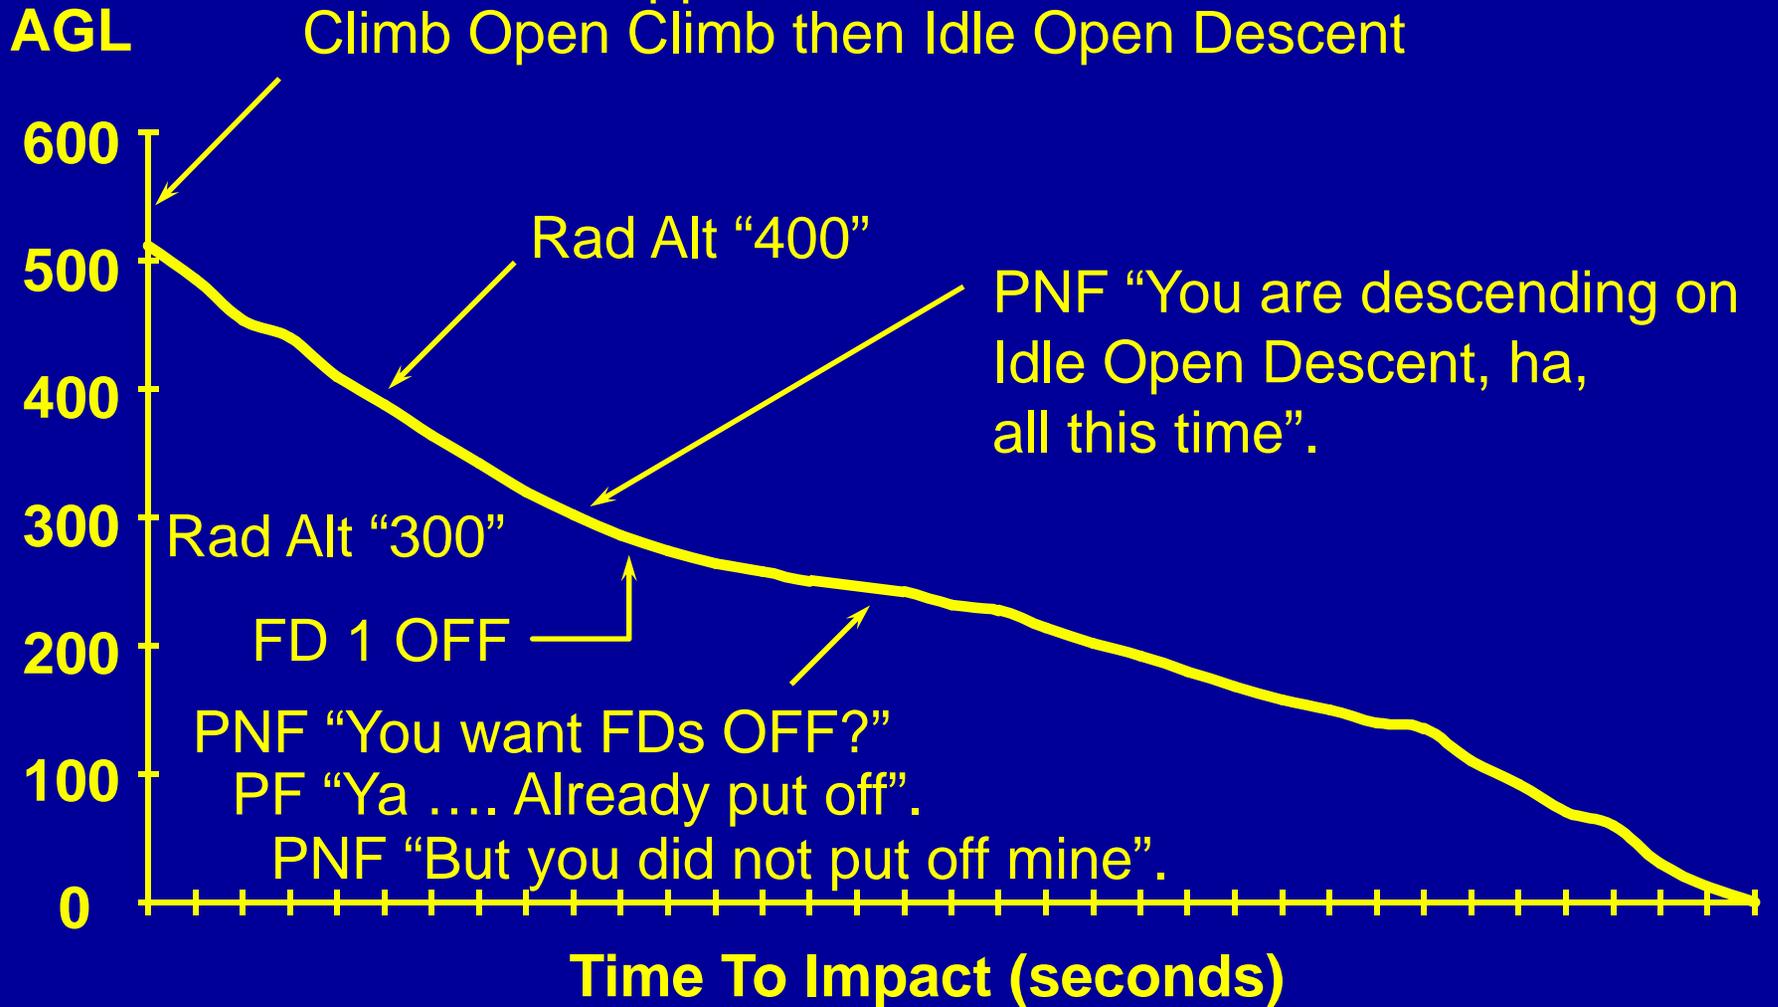
Last 500 Feet

PF "700 feet rate of descent"

PNF "Missed approach is"

Climb Open Climb then Idle Open Descent

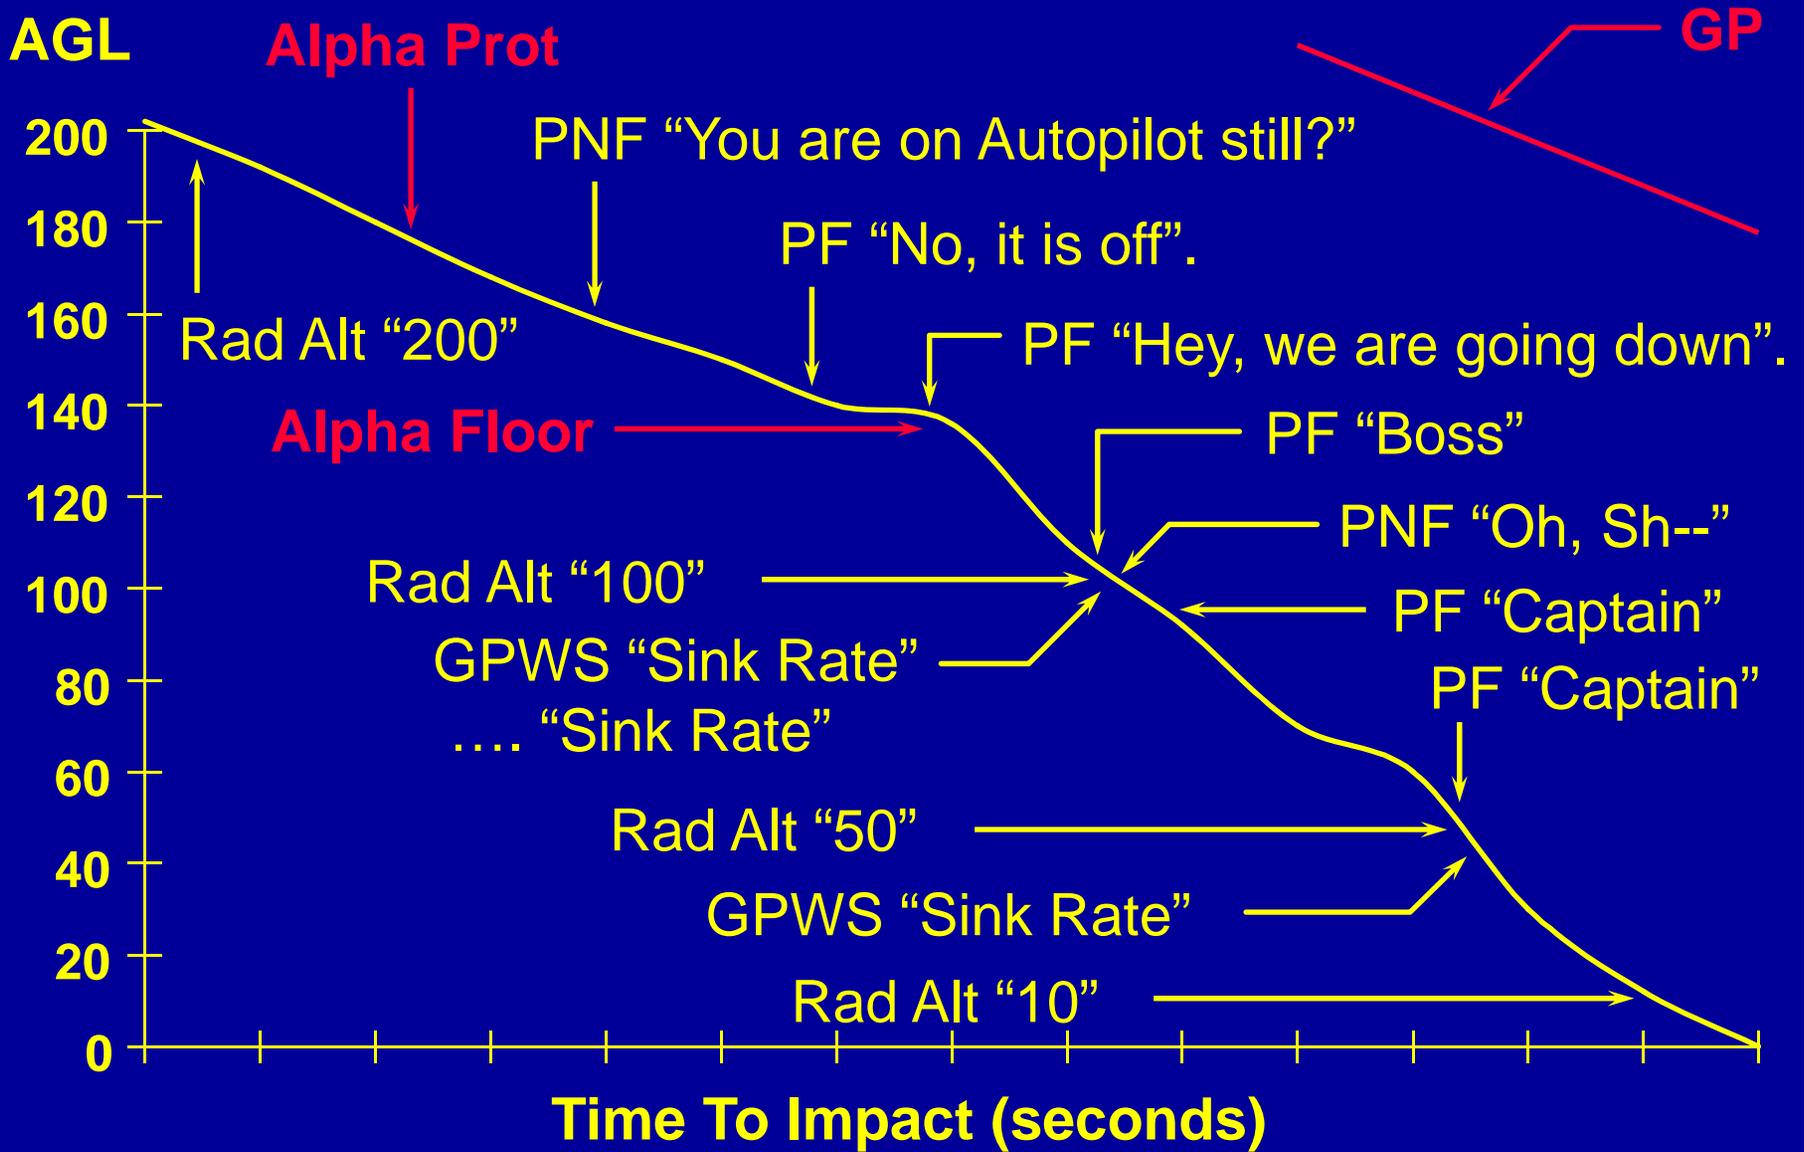
Flight Profile - Last 200' AGL

- **Almost immediately thereafter, the Pilot Flying reached full aft stick input and said: “Hey, we are going down”.**
 - The descent rate increased to about 1300 fpm.
- **At the 100 feet radio altimeter callout, the Check Airman said: “Oh S...” and the GPWS “Sink Rate” warning was activated.**
- **The Thrust Levers were also rapidly moved to TOGA.**
 - However, this had no practical effect since the Alpha Floor function had already commanded maximum thrust and the engines were responding normally.

- **Simultaneous with TOGA selection, the Check Airman applied full aft stick input.**
 - However, this had no practical effect since the Pilot Flying had been applying full back stick input ever since the aircraft descended below 100 feet.
- **The aircraft touched down firmly on a golf course with a CAS of about 113 knots with the engines spooling up normally.**
- **The aircraft bounced and impacted a dike about 700 meters prior to the runway threshold. Both engines were sheared off and the aircraft caught fire.**
