## REVISED FINAL REPORT

# Accident on 6 November 2002 in Luxembourg to the Luxair Fokker 27 Mk050 registered LX-LGB

REVISED ISSUE: JULY 2009

**Report N° AET-2009/AC-01**

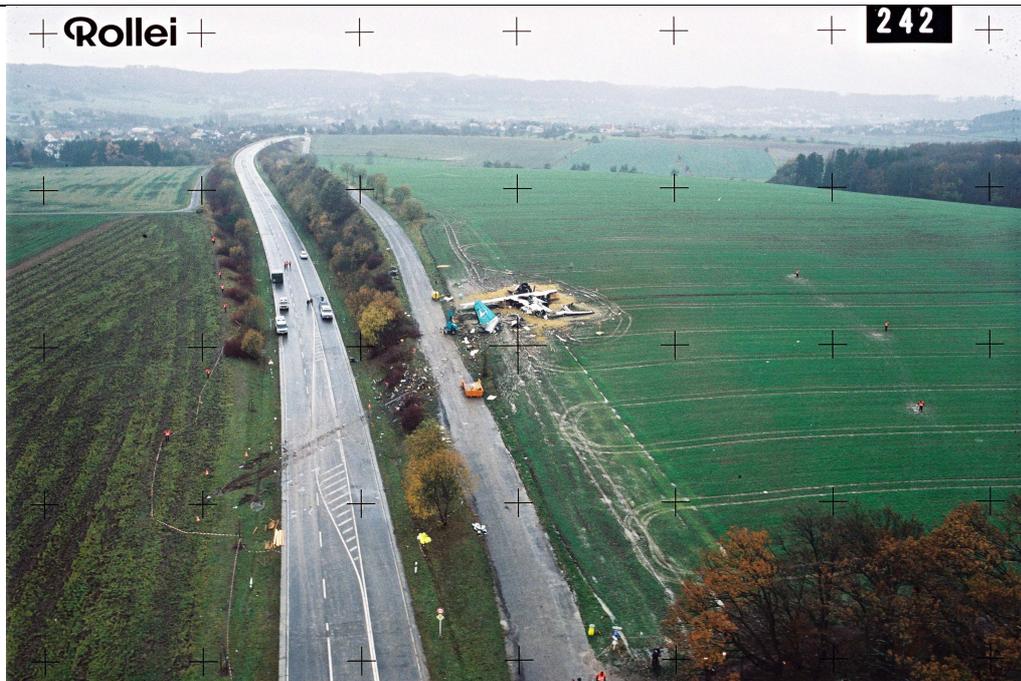
The aircraft touched down approximately on a heading of 295°, as indicated by the general direction of the debris. The first impact marks are found on the south edge of the road RN1. They represent the two main landing gears and the fuselage tail cone.

Scraping marks on the road, notably from the left wing tip show that the aircraft scratched across the road before hitting an embankment at the north side of the road RN1.

*Aerial view of RN1 and the site*

The major part of the damage results from this impact during which the aircraft lost three blades from the right propeller and two from the left propeller, wheels from the left and right landing gear.

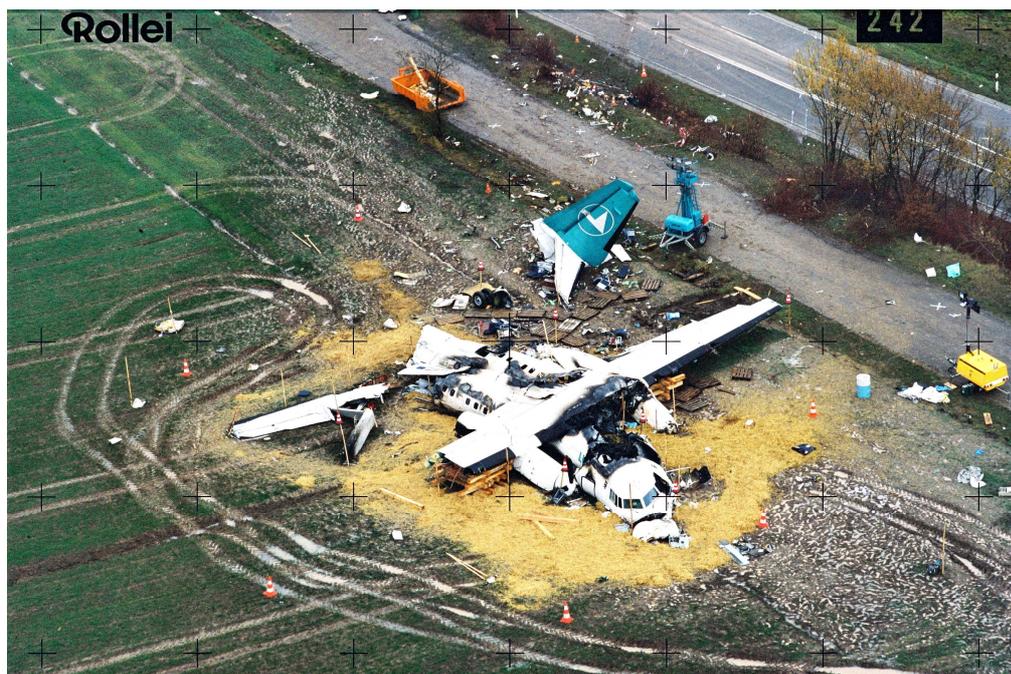
After this bounce, the empennage and part of the right outboard wing broke away, the aft portion of the fuselage turned around to the right and the aircraft came to rest 25 meters further away in a field.

*Aerial view of the right hand side of the aircraft*

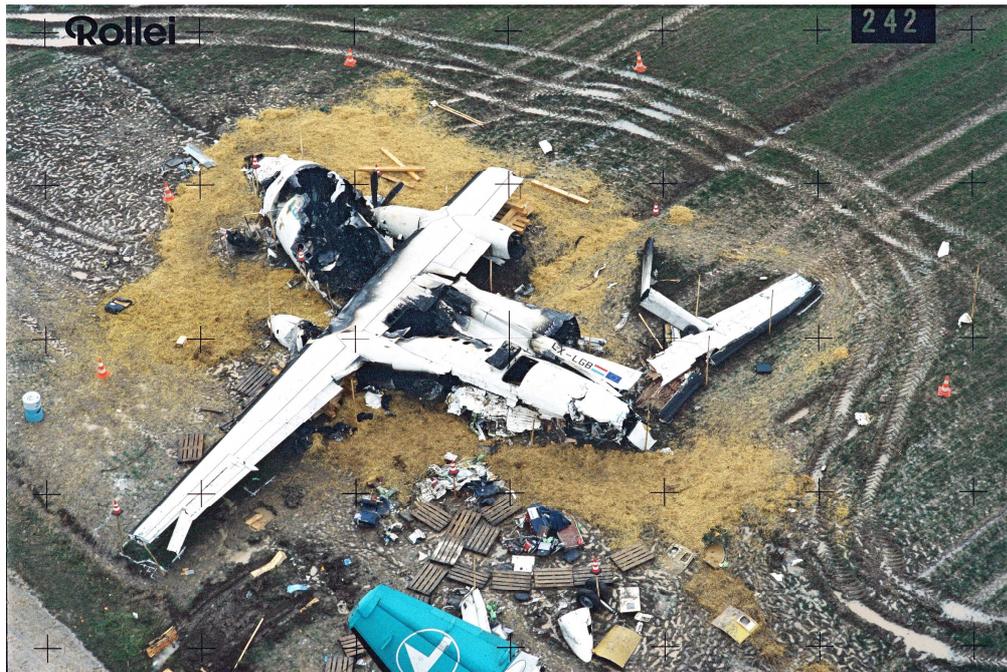
*Aerial view of the left hand side of the aircraft*

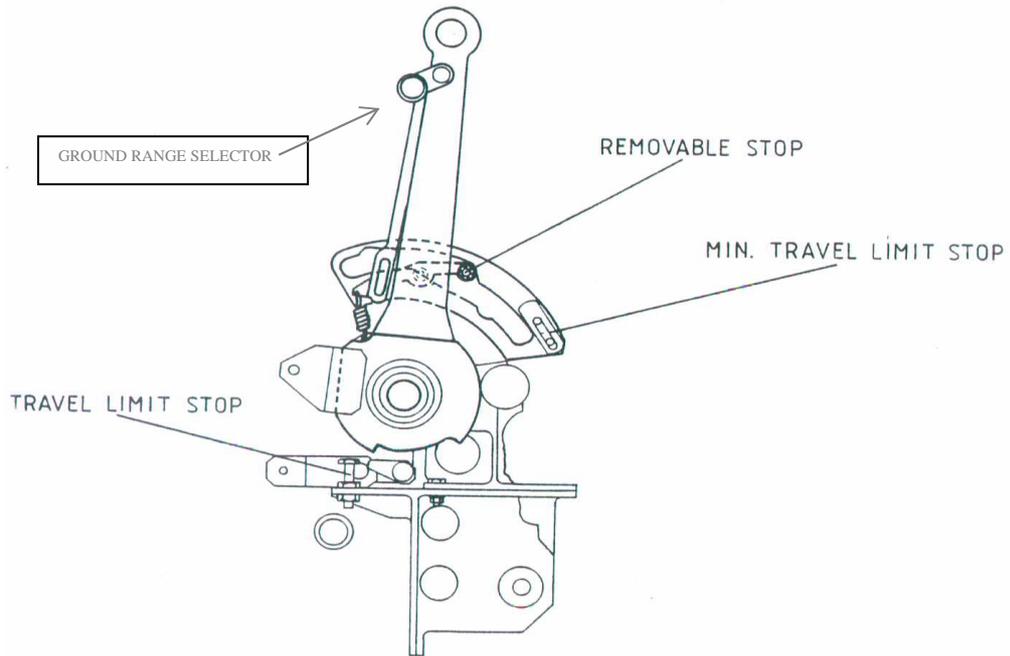
*Power levers and ground range selector*

- a mechanical primary stop (ground range selector) on the power levers. This primary stop requires a positive, distinct and separate pilot action, as required by certification regulations

During the investigation it was found that, with the power levers in flight idle, it is possible to lift the ground range selectors (primary lock) and move the power levers a small distance further aft until blocked by the secondary lock. This is a deliberate action by the pilot.

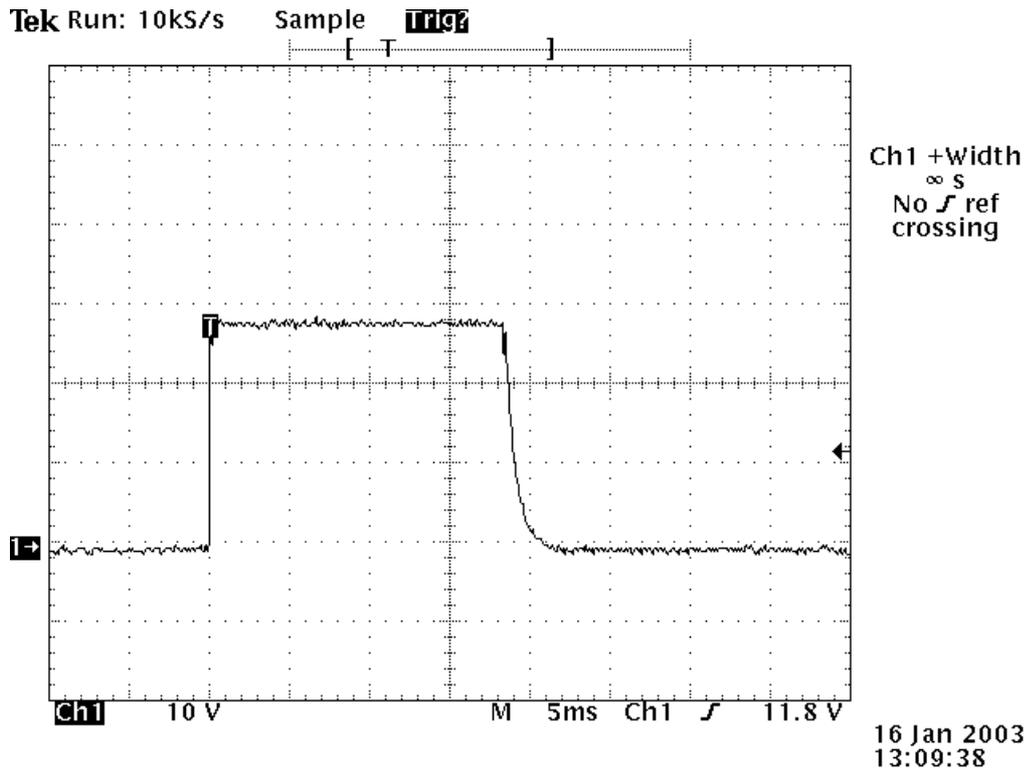
only the duration varied and the same repeated tests produced always the same results. The following illustration shows the signal from the right hand outboard relay.

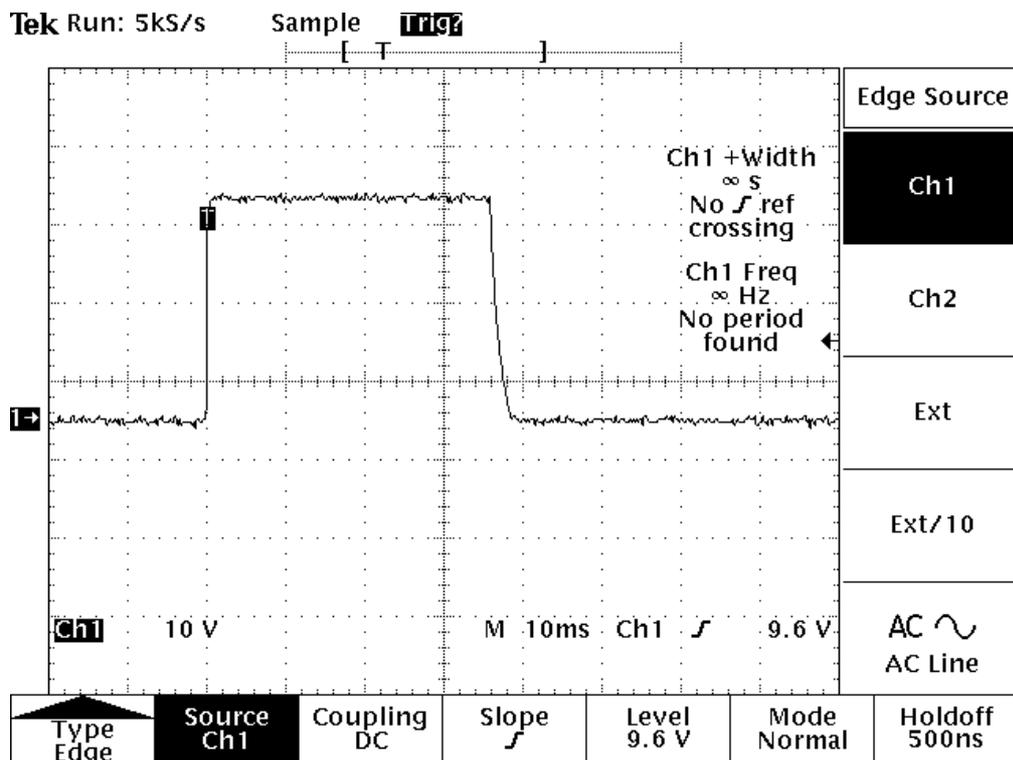
In order to reproduce the aircraft installation, where two relays are connected in series for the left and right hand gear legs, the test set up was reconfigured to observe the power up behaviour, this time only in mode FLT in order to duplicate the aircraft configuration. The duration of the power up signal is found to be 36 ms for both the right and the left hand side. The signal from the RH side is illustrated below.

All signals resemble each other and repetitive tests produce each time the same results.

These tests show the working characteristics of the installation associated with the antiskid control unit, part number 6004125 as installed on the accident aircraft.

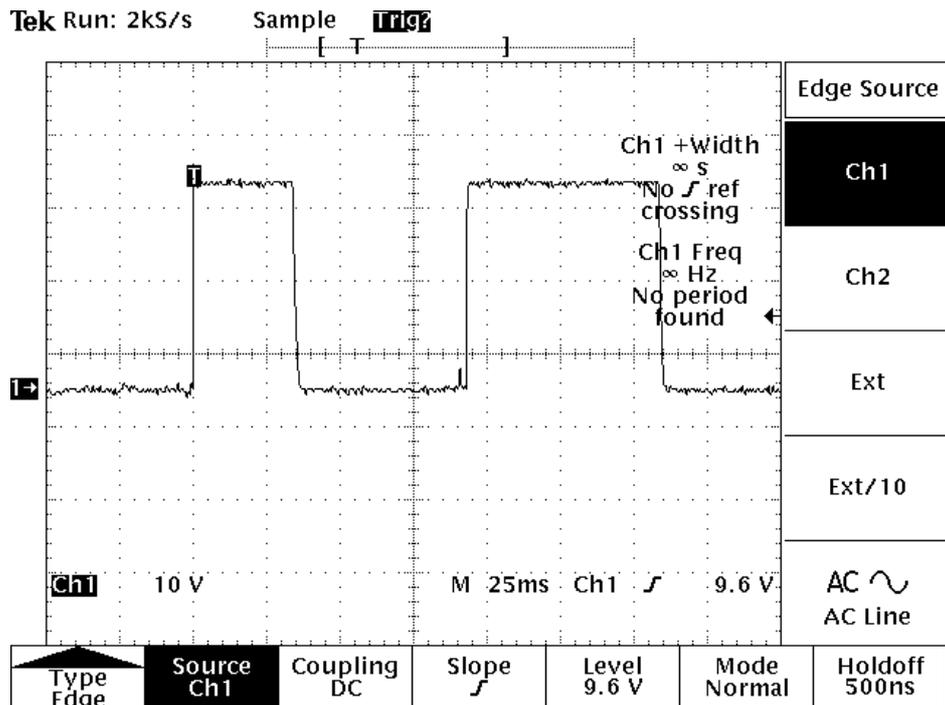
An electrical signal introduced on the TEST button of the antiskid control unit simulated an EMI signal during power up. These tests were executed in mode FLT. It is noted that a new signal is generated repeatedly on power up, showing a duration of around 65 ms. The tests were performed on the unmodified and the modified control unit. The following picture illustrates the signal output of the LH outboard and LH inboard discrete relays for the unmodified control unit.

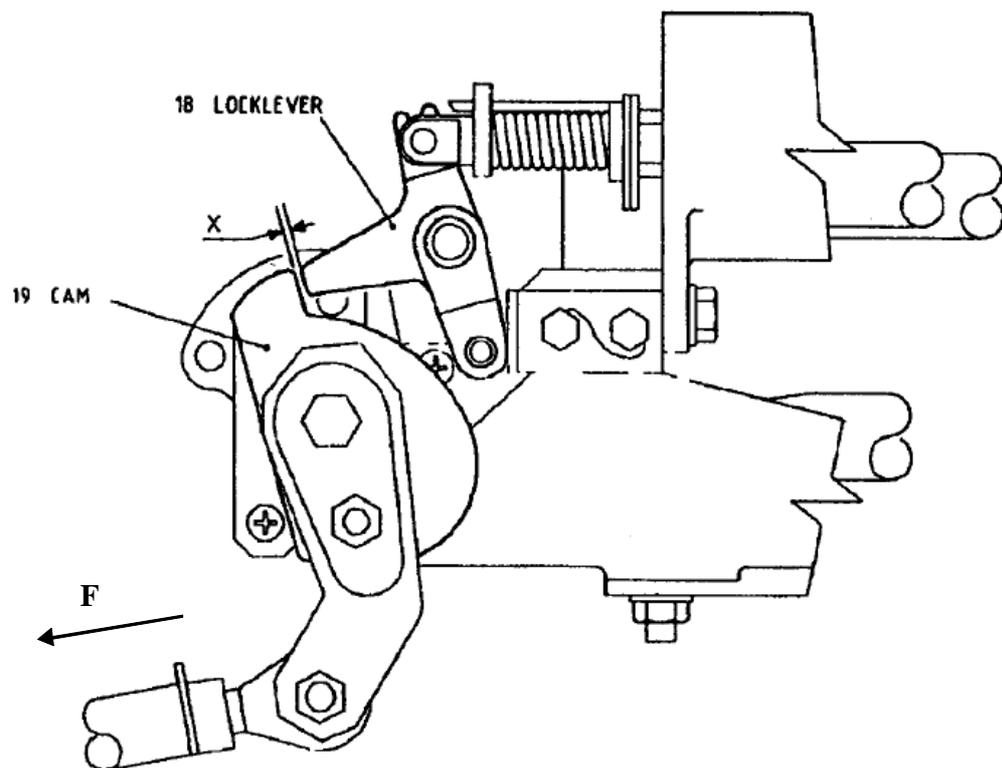
A final test was set up for the determination of the force required to prevent disengagement of the flight idle locklever and cam (see illustration below).

When the flight idle cam is pulled against the flight idle lock lever and the flight idle solenoid is energised, then the amount of force applied, determines whether the flight idle lock can disengage.

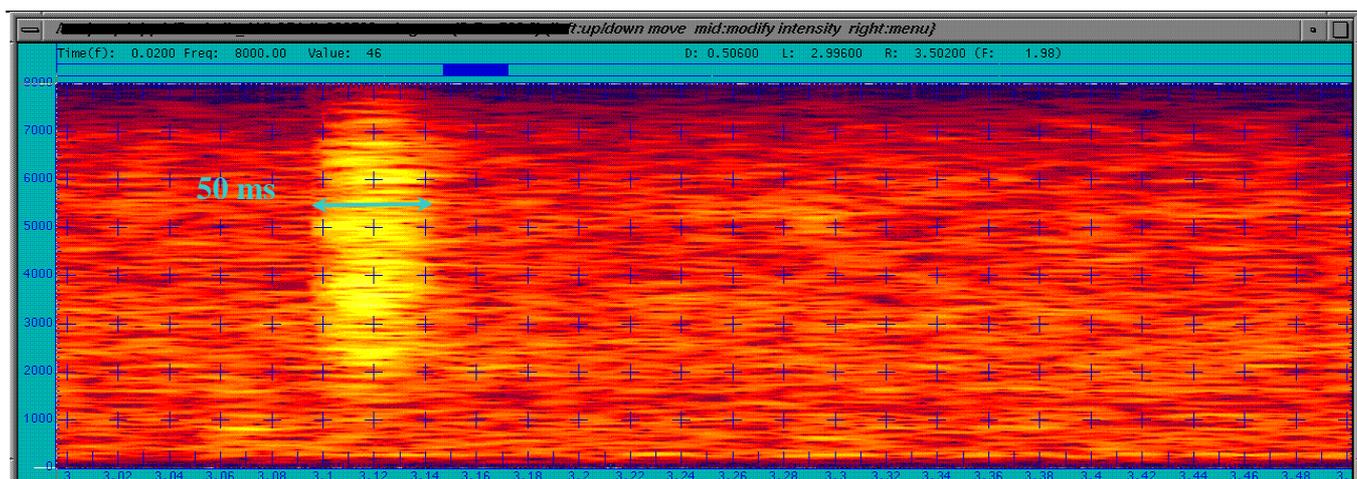
*This noise is generated when, from the Flight Idle position of the throttles the pilot has to lift two levers called Ground Range Selector permitting the movement of the throttles into the Beat range. A noise can be heard for each lever, left and right. However, when the operation is done simultaneously for both sides, the two noises appear to be one.*

**Fig. 10: Représentation Temps – Fréquence du bruit transcrit. Time – Frequency representation of the transcribed noise.**

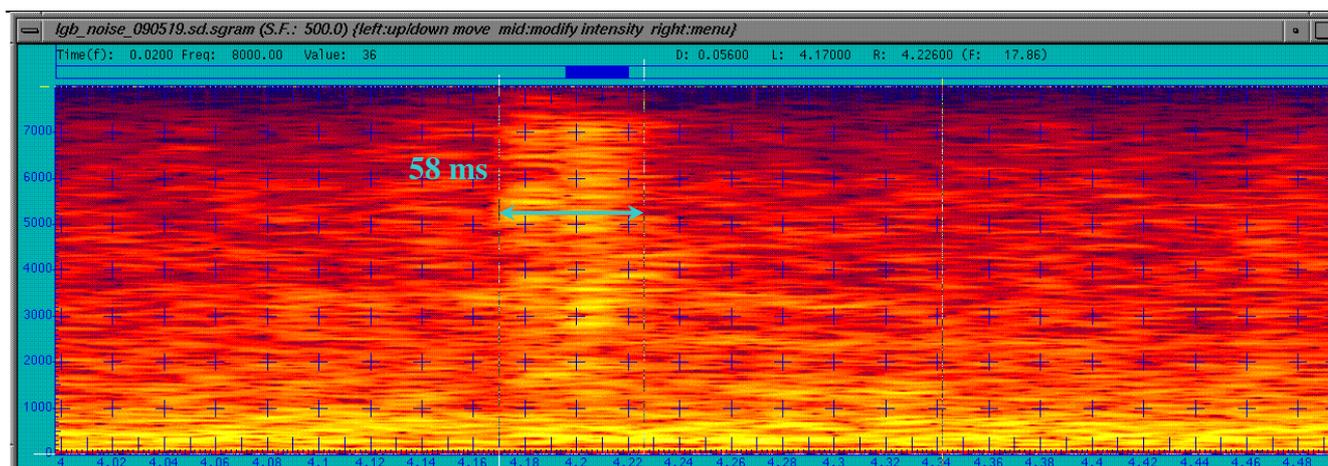
**Fig. 16:** *Représentation Temps - Fréquence du bruit à identifier). Time Frequency representation of the noise to be identified.*

*This noise can be decomposed temporally in two parts corresponding with two separate but adjacent noises. Its total duration is 58 ms.*
