FINAL REPORT

ON THE ACCIDENT OF 6 NOVEMBRE 2002
AT LUXEMBOURG
TO THE LUXAIR FOKKER 27 MK050
REGISTERED LX – LGB

December 2003

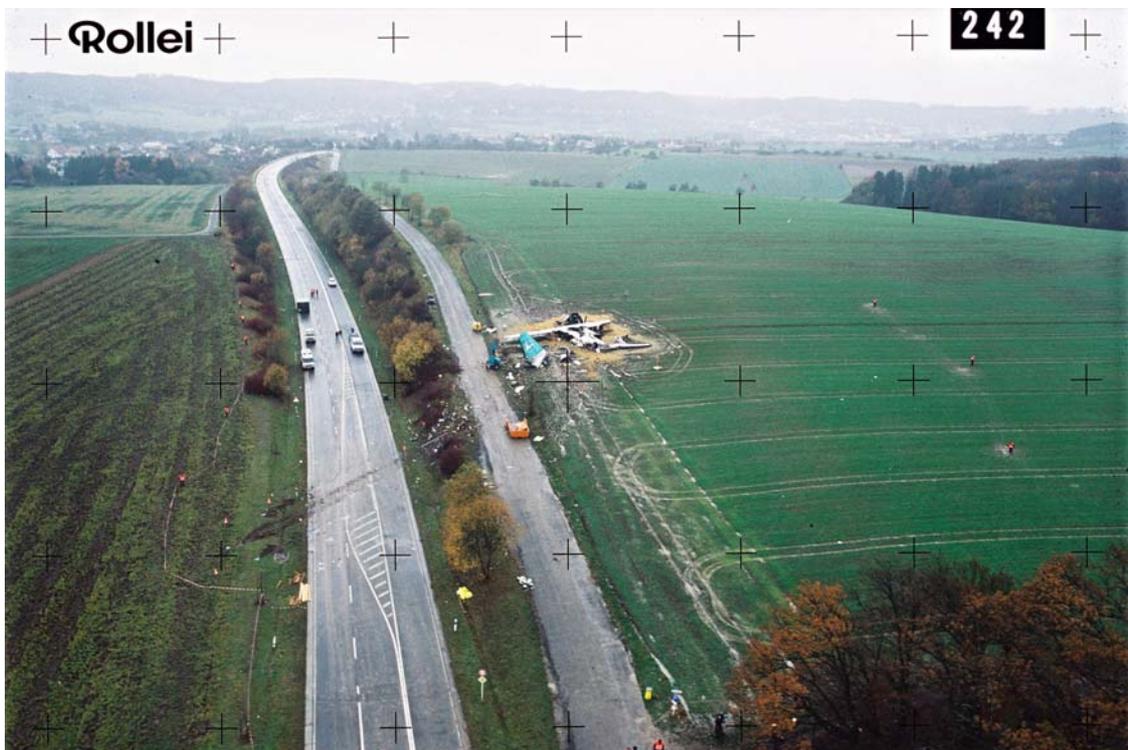
Scraping marks on the road, notably from the left wing tip show that the aircraft scratched across the road before hitting an embankment at the north side of the road RN1.

Aerial view of RN1 and the site

The major part of the damage results from this blow during which the aircraft lost three blades from the right propeller and two from the left propeller, wheels from the left and right landing gear.

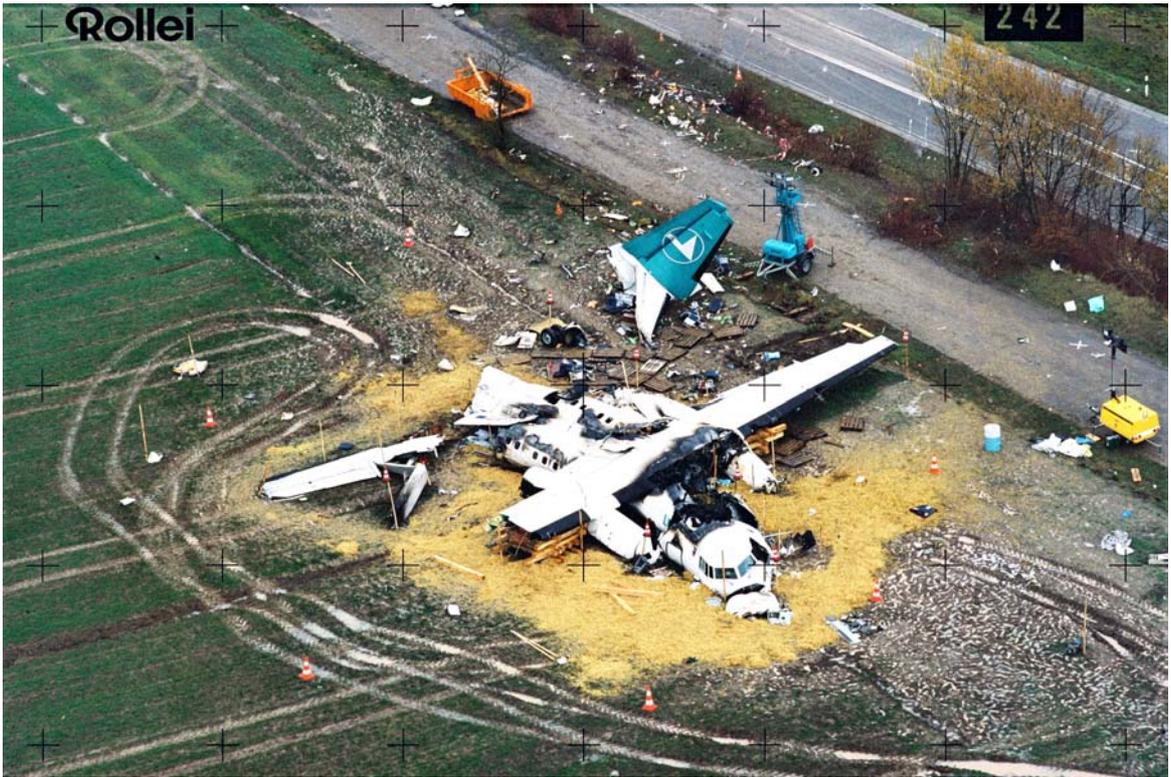
Aerial view of the right hand side of the aircraft

The engines suffered light damage, except the lower parts that were in contact with the ground. On the left hand side, all propeller blades are broken at their root. On the right hand side, three propeller blades out of six remain attached to the hub. All blades, of composite construction, are damaged. Some are delaminated and others are totally destroyed. Blade pitch angle of the LH propeller is close to feather. Blade pitch of the RH propeller is in the beta range.

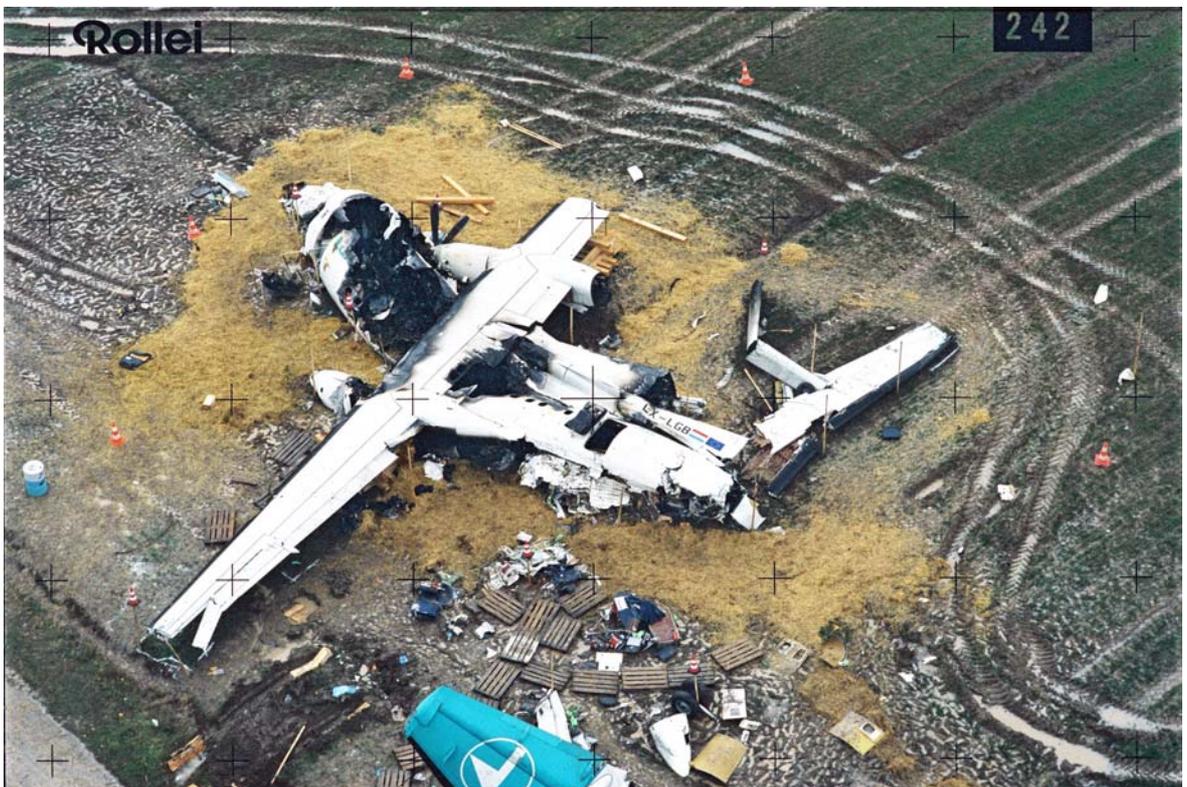
Aerial view of the left hand side of the aircraft

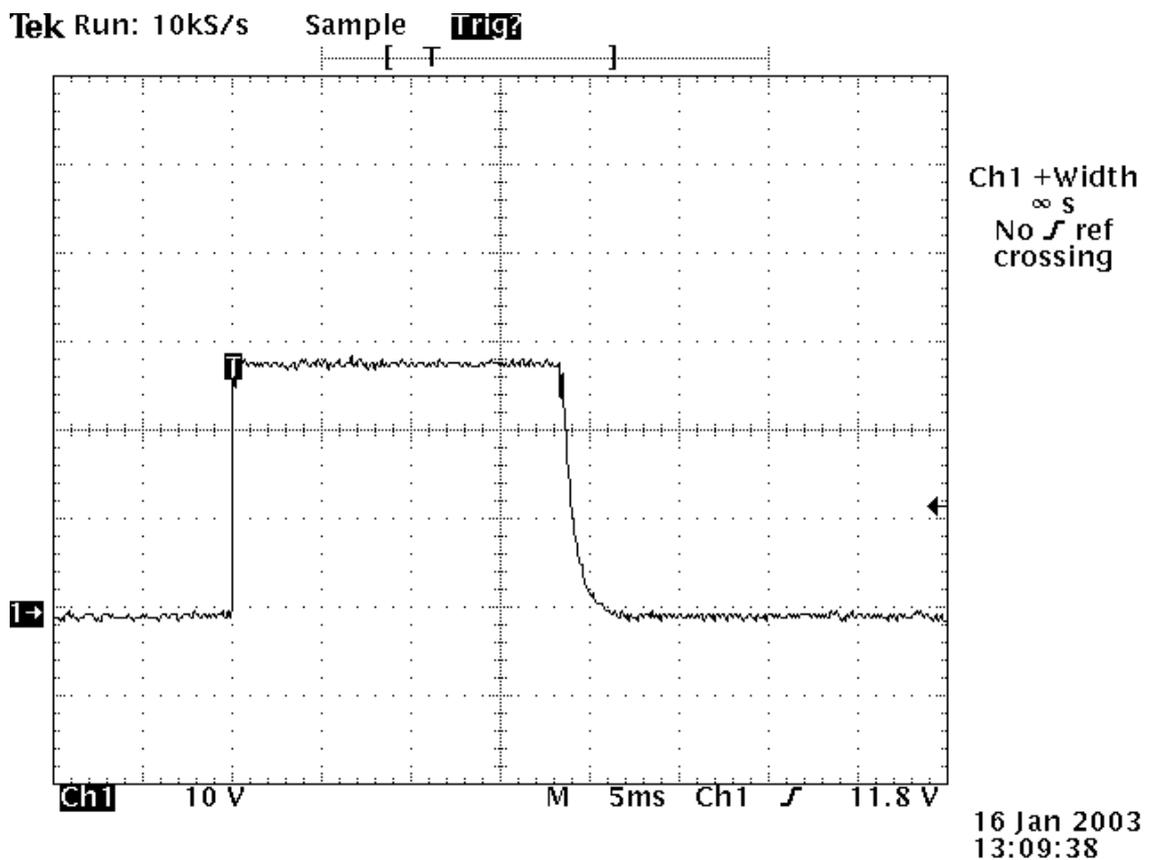
The four wheel speed discrete relays were tested separately in the modes FLT and GND in order to verify their power up behaviour. In mode FLT, the duration of the power up signal was found to be in the range from 13 ms to 20 ms for the four relays. In mode GND, the signal duration was slightly less in the range from 11 ms to 19ms. All signals looked identical, only the duration varied and repeated tests produced always the same results. The following illustration shows the signal from the right hand outboard relay.

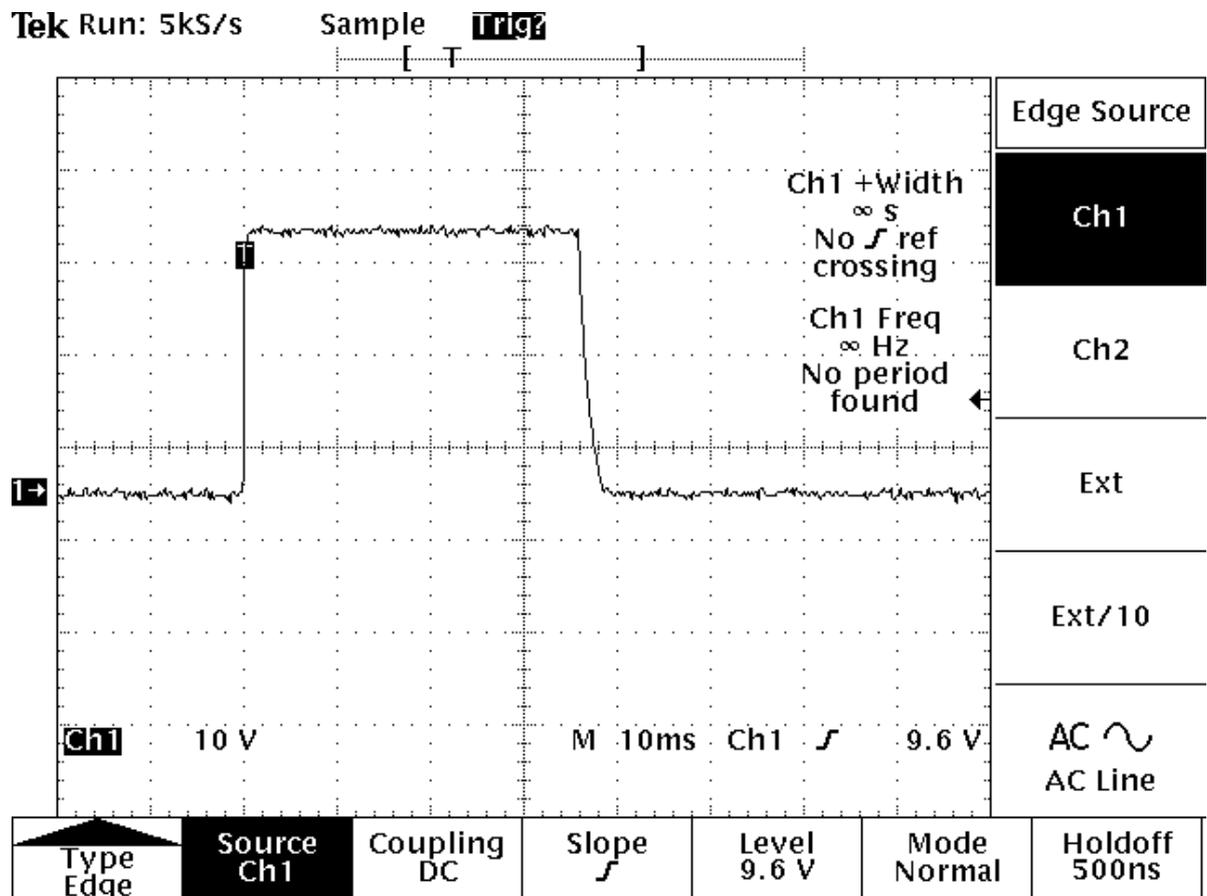
In order to reproduce the aircraft installation, where two relays are connected in series for the left and right hand gear legs, the test set up was reconfigured to demonstrate the power up behaviour, this time only in mode FLT, this being the situation of the aircraft. The duration of

the power up signal was found to be 36 ms for both the right and the left hand side. The signal from the RH side being illustrated below. All signals looked identical and repeated tests produced always the same results.

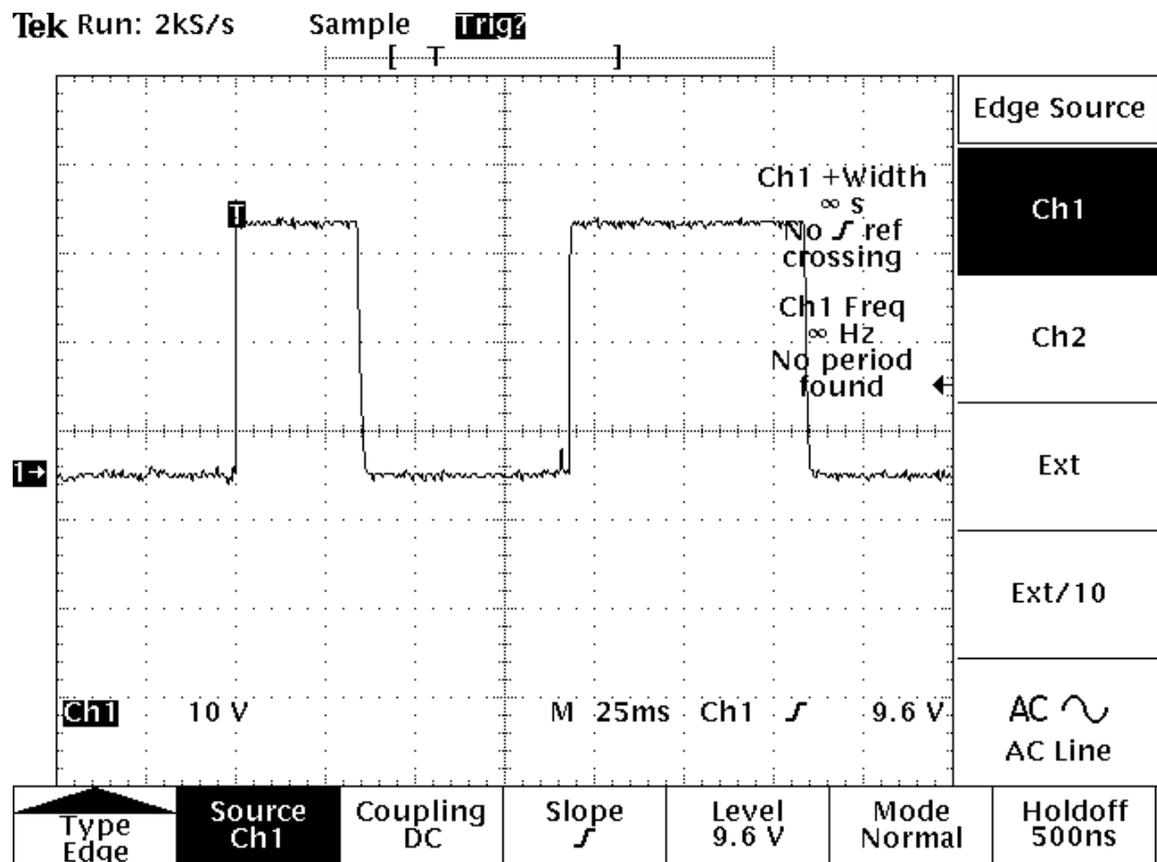
An electrical signal was introduced on the TEST button of the antiskid control unit, thereby inducing an EMI signal on power up. These tests were executed in mode FLT. It became apparent that a new signal was produced repeatedly on power up, showing a duration of around 65 ms. The tests were performed on the unmodified and the modified control unit. The following picture illustrates the signal output of the left hand wheels for the unmodified control unit.

The result was that the first impulse (~35 ms) was due to the power up of the unit through the release of the main gear up-locks and the second impulse (~65 ms) was triggered by the EMI signal.

The same tests were carried out on the modified unit (modified by ABSC SB F50-32-4) and it became apparent that the first impulse due to the power up of the system was suppressed, leaving only the EMI induced impulse.

The duration of the second pulse (EMI) was long enough to energize the flight idle solenoid under all circumstances, thus removing the secondary stop. There was however no reason to suspect that this was a condition of the accident.

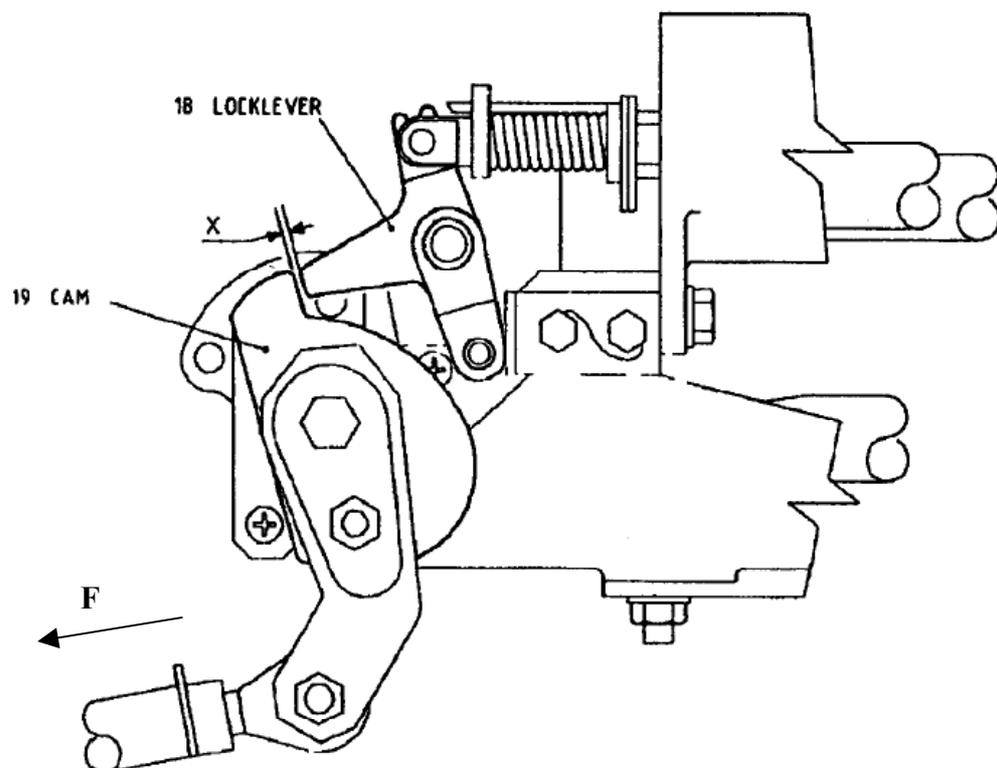
A final test was set up for the determination of the force required to prevent disengagement of the flight idle locklever and cam. (see illustration below)

When the flight idle cam is pulled against the flight idle lock lever and the flight idle solenoid is energised, then the amount of force applied, determines whether the flight idle lock can disengage.

With a force (F) applied to the push-pull rod was lower than 44.5 N, the flight idle stop disengaged when the flight idle solenoid was energised. When higher forces were applied the flight idle stop remained engaged. The same value was found on both flight idle solenoid assemblies. It was thus demonstrated, that by pulling hard enough back on the power levers against the secondary stop and with the solenoids energised, the flight idle lock lever was prevented from disengaging.
