**DC-10**

**SERVICE BULLETIN**

Bulletin 35-16  
DC-10 SC 1981/2134

OXYGEN - Passenger - Modify Oxygen Compartment In Passenger Seat Back And Compartment Partition.

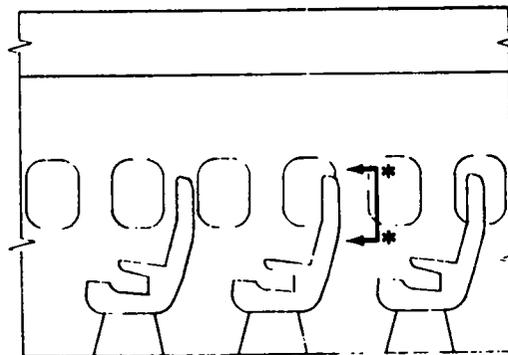
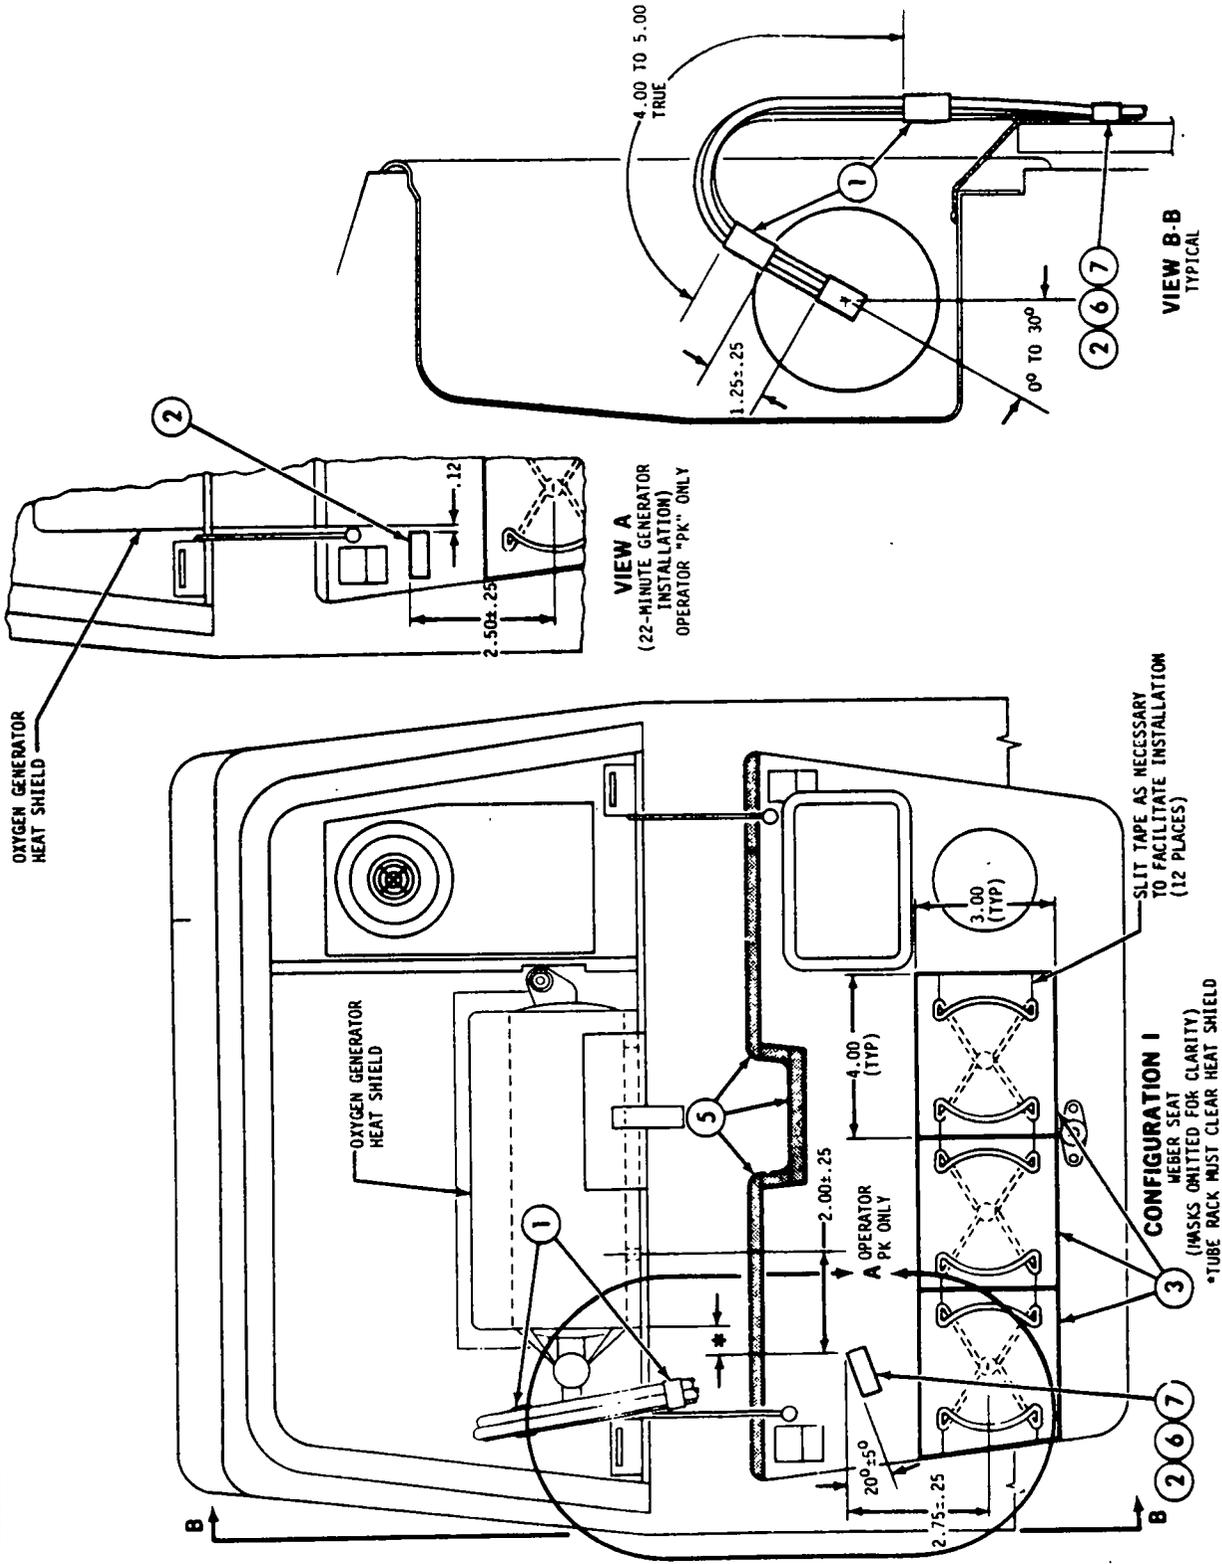
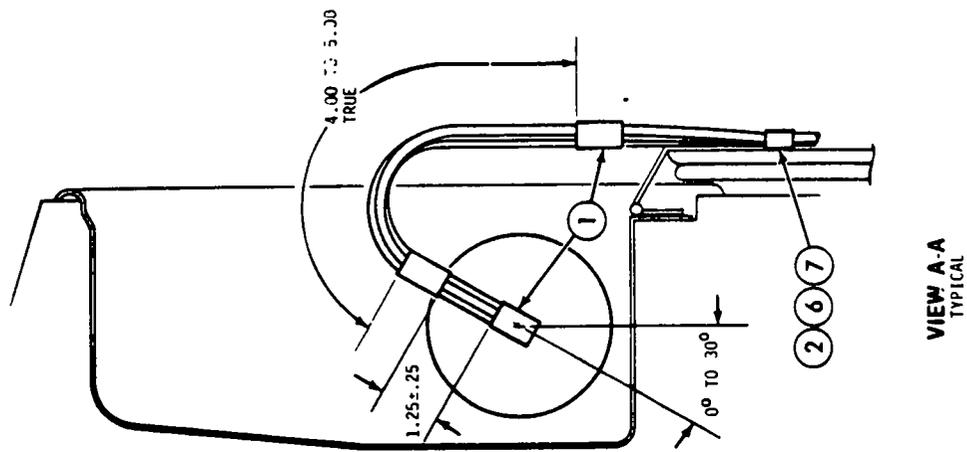
FIGURE 1 (SHEET 1 OF 8)

Several operators have reported instances where passenger oxygen mask hoses were being crimped by the door hinge and the lanyard was protruding through gap at door hinge area. In one instance the mask lanyard became entangled in the mask holder which could have resulted in expending of oxygen and passenger not being able to bring mask to face. Securing the oxygen mask hoses to the door and installing a seal to close the gap will aid in preventing these conditions from recurring.

- ① APPLY TWO OR THREE COMPLETE WRAPS OF P-2650 TAPE AROUND OXYGEN HOSES TO DIMENSIONS SHOWN.

- ② BOND NMC700-3 TUBE RACK TO DOOR, TO DIMENSIONS SHOWN, USING EA9311 A/B ADHESIVE. (SEE DOUGLAS PROCESS STANDARD (DPS) 1.07-66, TYPE 6.)
- ③ INSTALL 425 TAPE ON OXYGEN MASK HOLDER AS SHOWN. (SEE DPS 1.091.)
- ④ CONFIGURATION IV - FILL GAP BETWEEN OXYGEN MASK HOLDER AND RAISED SURFACE OF DOOR WITH SILASTIC 140 SILICONE ADHESIVE. (SEE DPS 1.07-2, TYPE 7.)
- ⑤ INSTALL P133UA TAPE ON DOOR AS SHOWN. CUT TAPE AS REQUIRED FOR PROPER FIT. (SEE DPS 1.091.)

- ⑥ REMOVE 4282 TAPE FROM NMC700-3 TUBE RACK AND COMPARTMENT DOOR.
- ⑦ BOND NMC700-3 TUBE RACK TO COMPARTMENT DOOR, TO DIMENSIONS SHOWN, USING EA9311 A/B ADHESIVE. (SEE DPS 1.07-66, TYPE 6.)

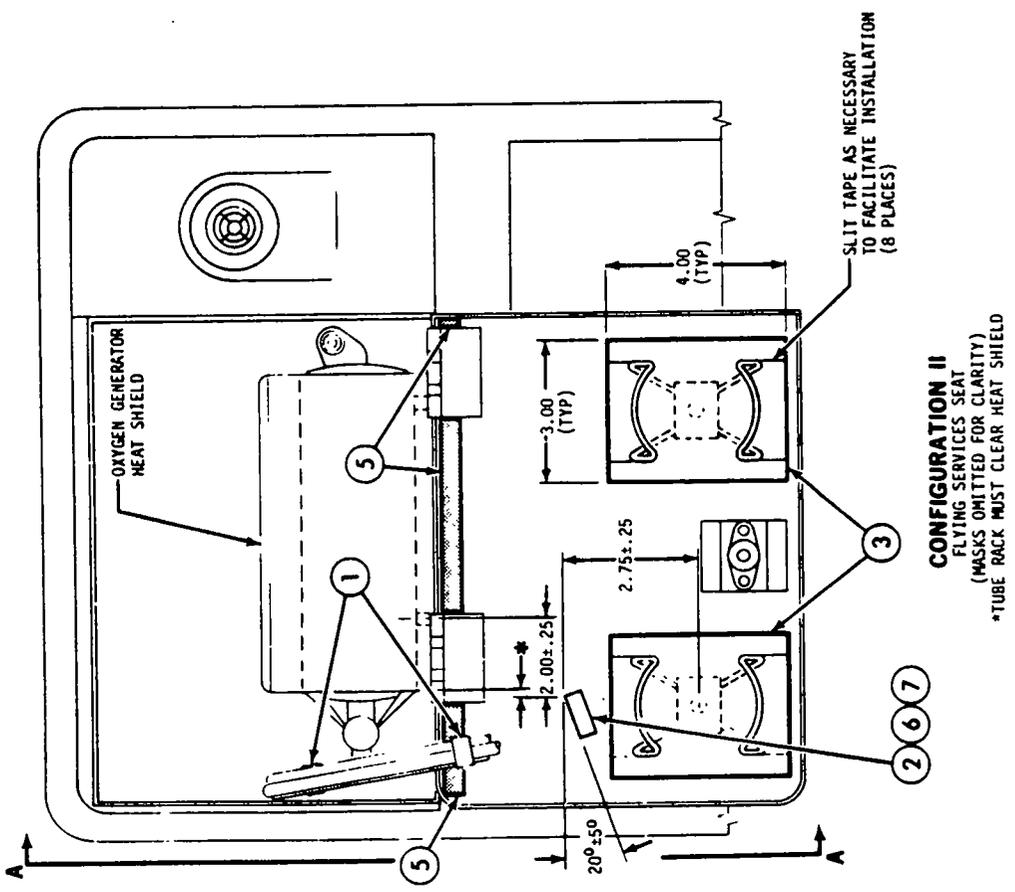
FIGURE 1 (SHEET 3 OF 8)

CONFIGURATION II  
FLYING SERVICES SEAT  
(MASKS OMITTED FOR CLARITY)  
\*TUBE RACK MUST CLEAR HEAT SHIELD

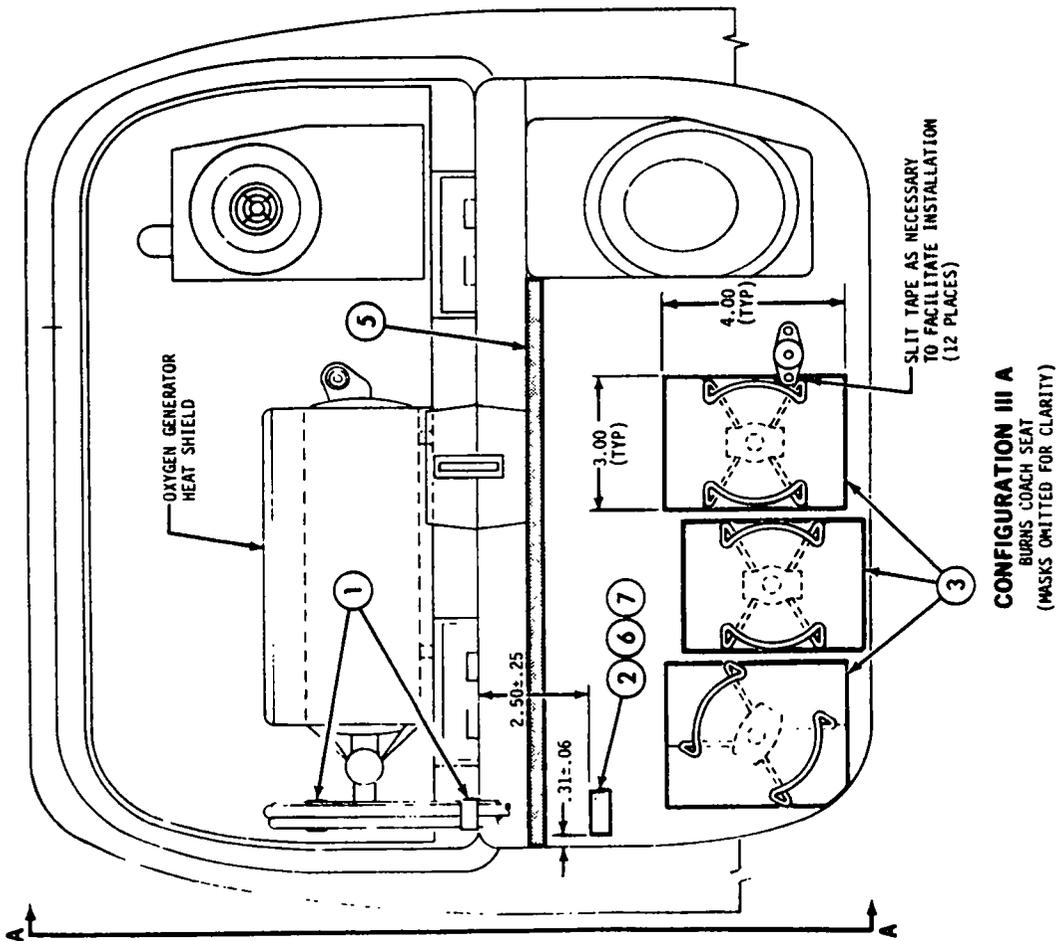
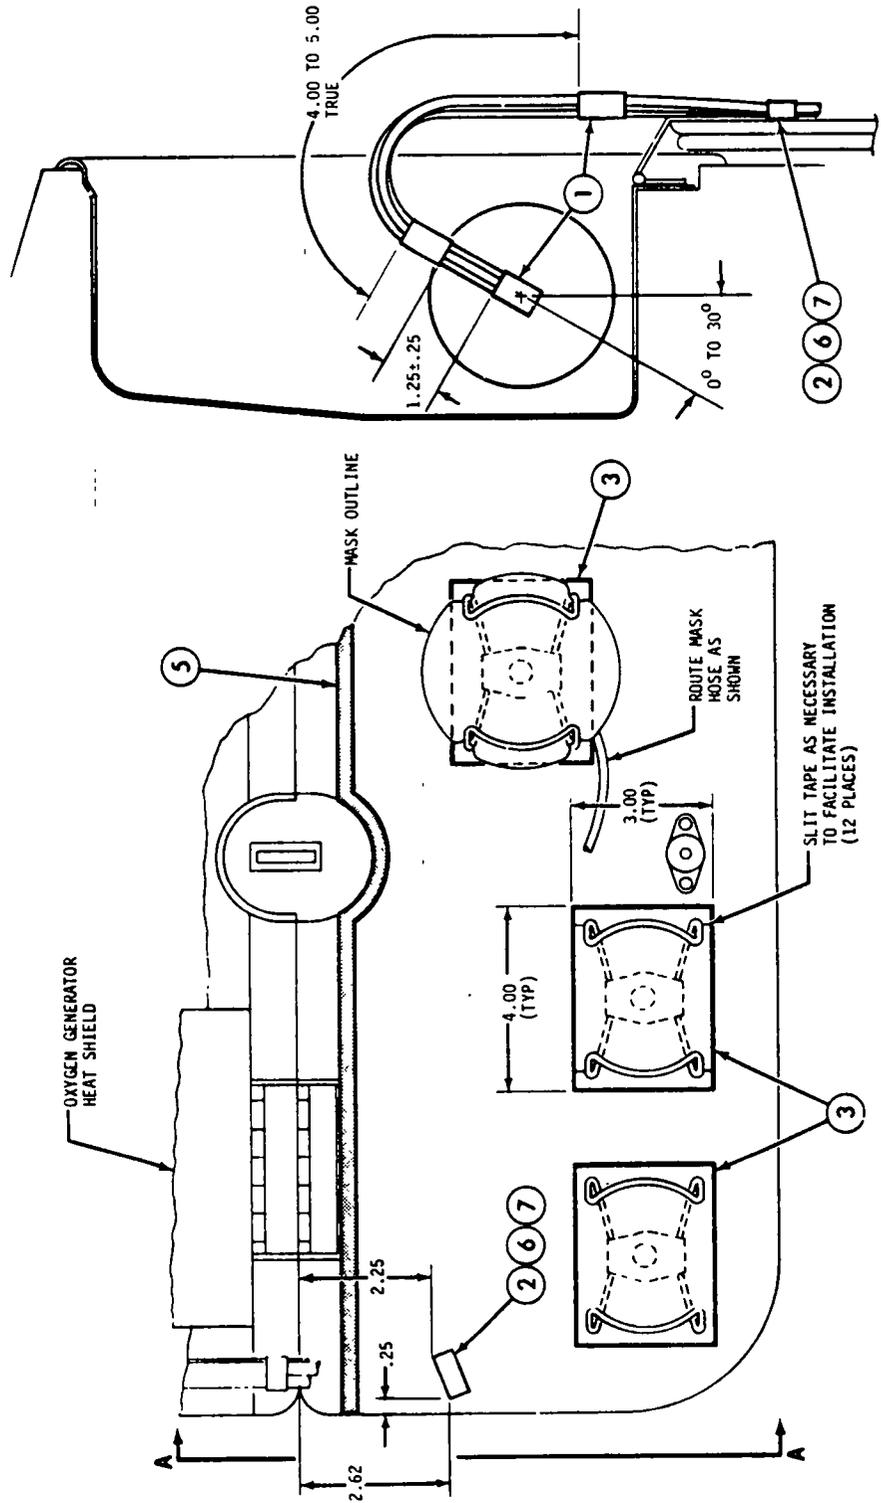
FIGURE 1 (SHEET 5 OF 8)

**CONFIGURATION III B**  
BURNS FIRST CLASS SEAT  
(2 MASKS OMITTED FOR CLARITY)

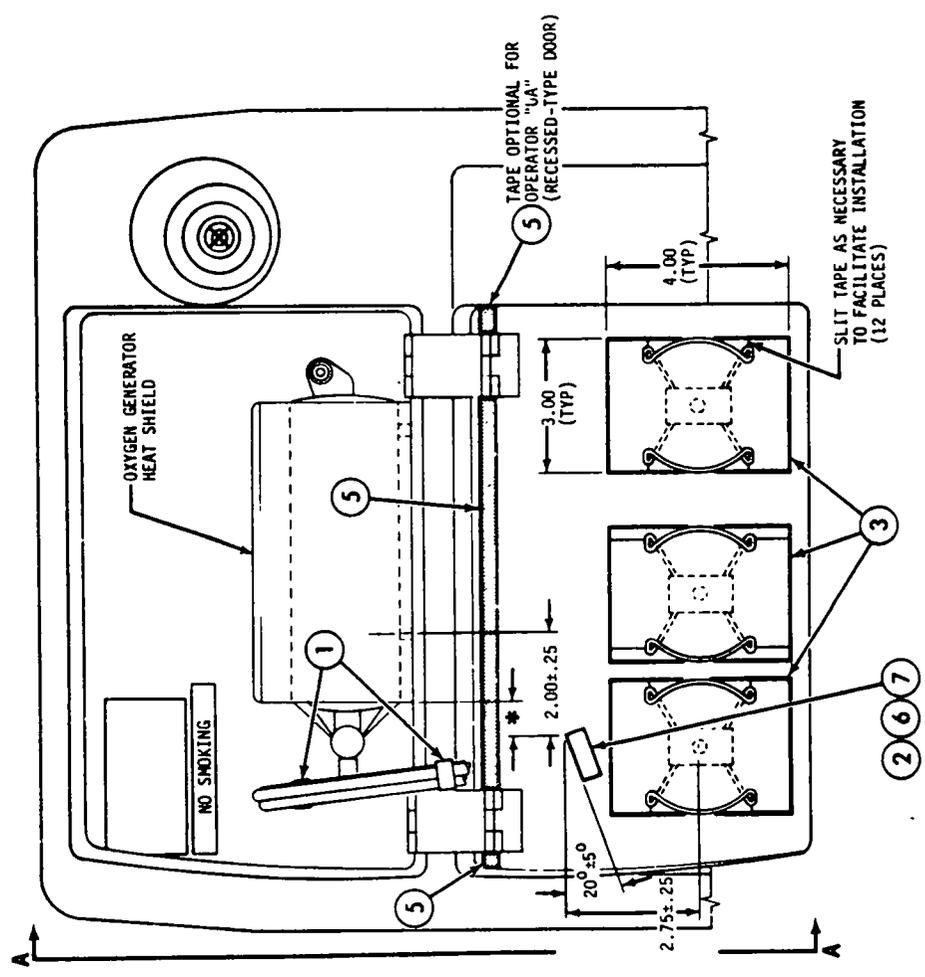
FIGURE 1 (SHEET 7 OF 8)

**CONFIGURATION V**  
UNIVERSAL OIL PRODUCTS SEAT  
(MASKS OMITTED FOR CLARITY)  
\*TUBE RACK MUST CLEAR HEAT SHIELD
