NATIONAL
TRANSPORTATION
SAFETY
BOARD

**STUDY OF
LESSONS TO BE LEARNED
FROM ACCIDENTS
ATTRIBUTED TO TURBULENCE**

**NATIONAL TRANSPORTATION SAFETY BOARD
Washington, D. C. 20591
REPORT NUMBER: NTSB-AAS-71-1**

ADOPTED: DECEMBER 15, 1971

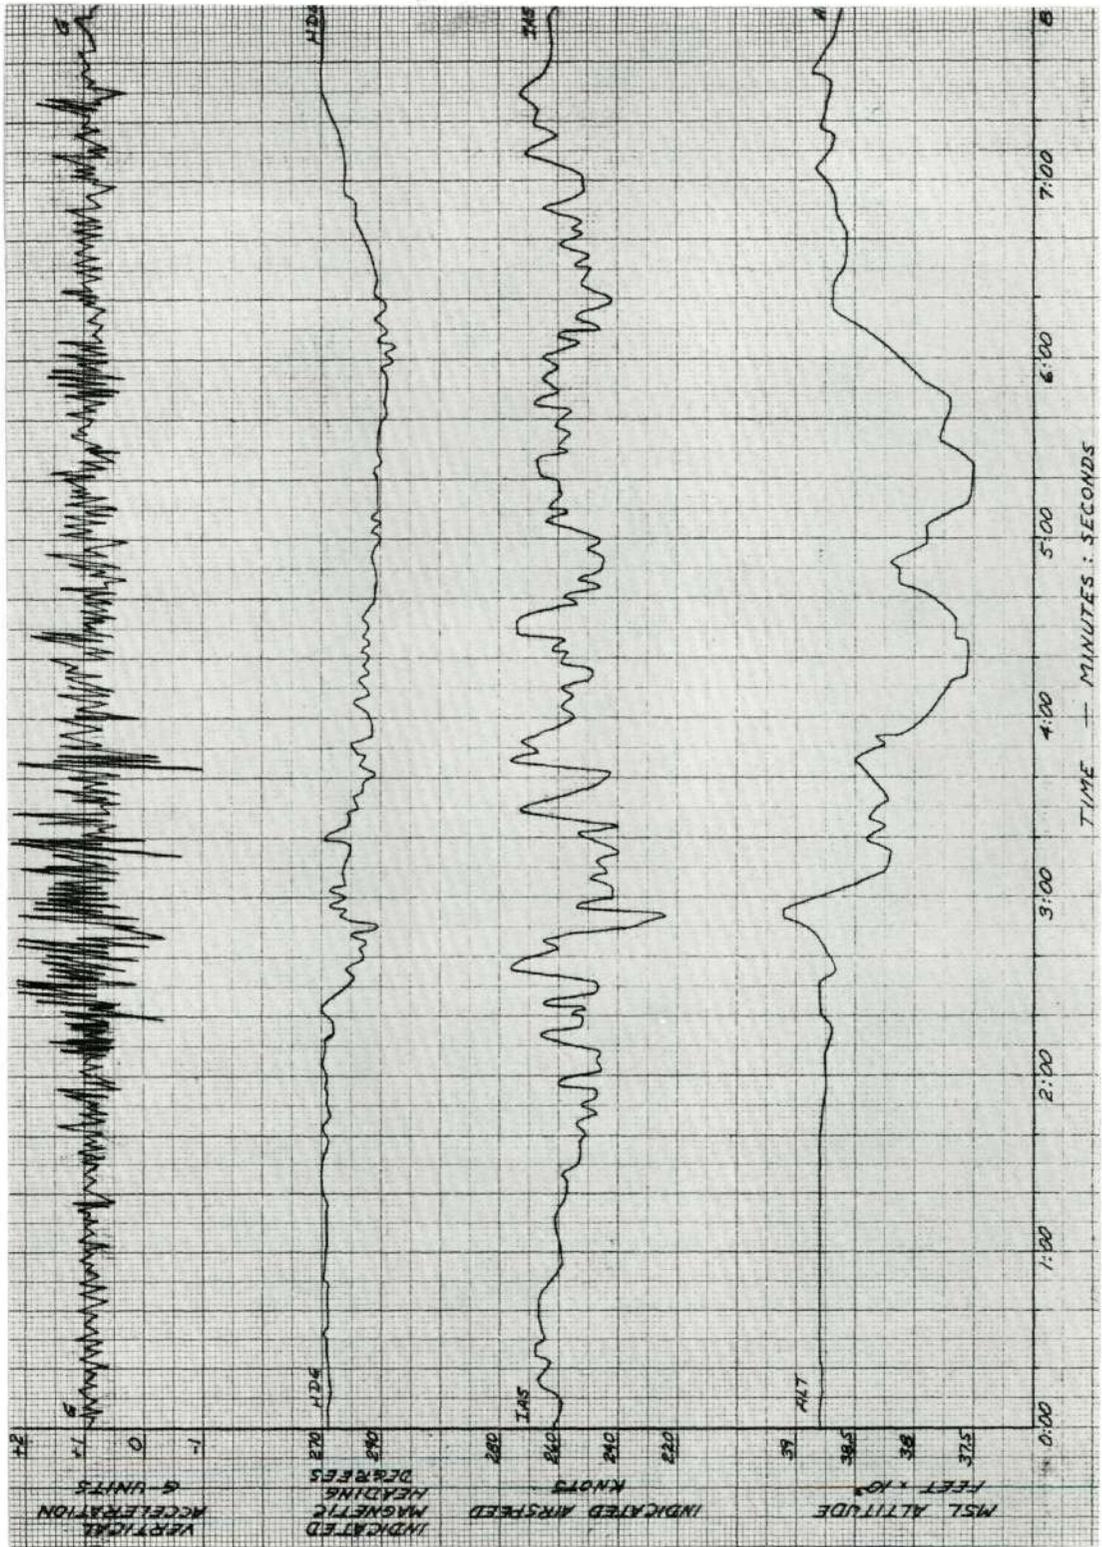
Figure 4 FLIGHT DATA RECORDER GRAPH
THUNDERSTORM PENETRATION

One such case involved a regularly scheduled air carrier flight of a DC-8 which encountered severe turbulence and hail upon penetration of a thunderstorm during cruise westbound over the central United States at Flight Level 390. Six passengers were injured, two of them seriously, and the aircraft was damaged as follows: Nos. 2 and 4 heat exchangers damaged, all four engine chin scoops cracked at island, No. 1 engine PT2 probe damaged and bent, left cabin heat exchanger door damaged, fuselage skin just aft of radome lifted, radome damaged - replaced, splitter between Nos. 3 and 4 compressors damaged, left wingtip window cracked, numerous static wicks missing, five seat tables damaged, hole in right aft lavatory ceiling, isolation band on vertical stabilizer damaged and right horizontal stabilizer damaged.

Fig. 4 is a reproduction of a portion of the flight data recorder graph associated with this accident. It can be seen that the maximum variance in vertical acceleration was from + 2.23 g's to -0.99 g or an incremental peak variation of 3.22 g's, while several variations of more than 2 g's are noted. During the worst of the encounter, airspeed fluctuated as much as 52 knots, the heading varied 20° and there were two successive altitude losses of almost 1,000 ft. Although the turbulence in this case has been categorized as severe, the variations in the parameters above, particularly the variation in vertical acceleration, meet the criteria for extreme turbulence.
