NATIONAL TRANSPORTATION SAFETY BOARD

**COLLISION OF
AERONAVES DE**

**DC-9-32, XA-JED
AND PIPER PA-28-181, N4891F**

NTSB/AAR-87/07

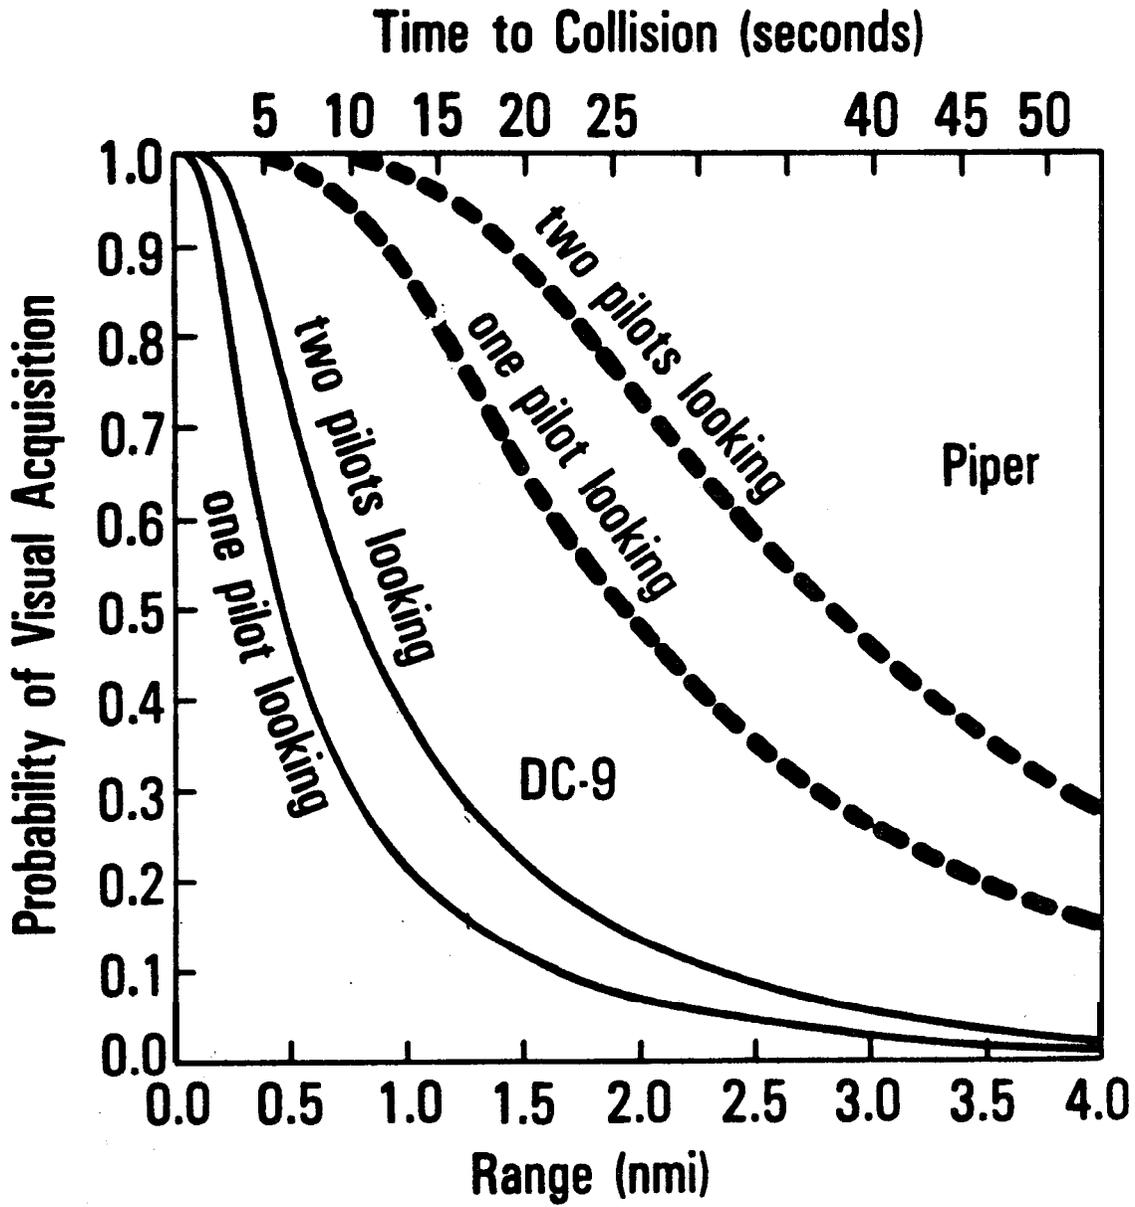
Figure 3.--Probability of seeing the other aircraft as a function of time until collision.

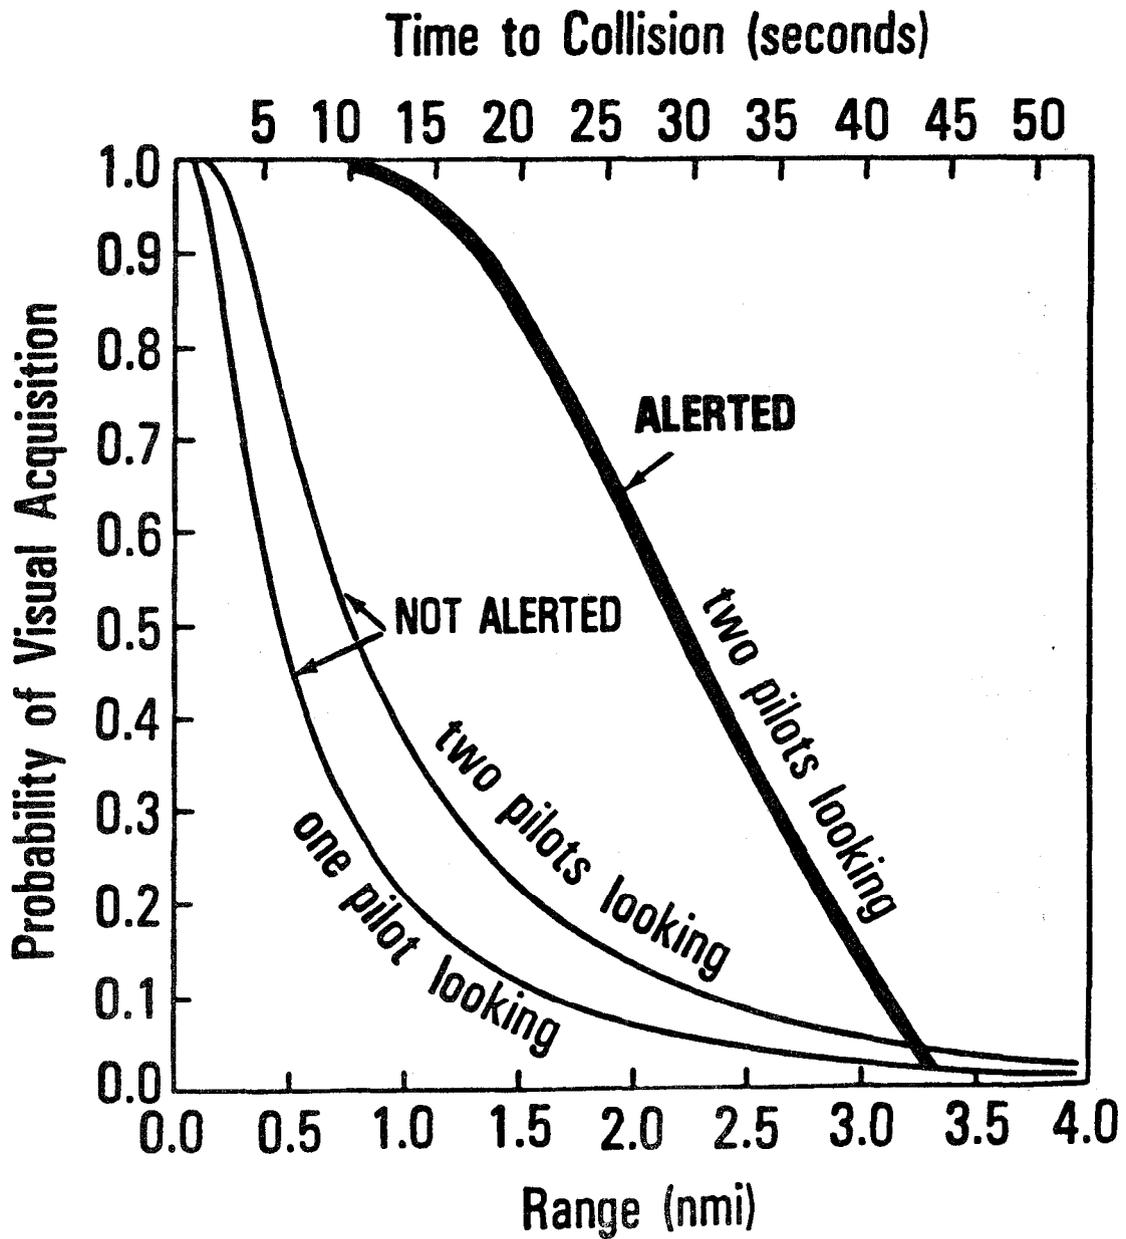
Figure 4.--The effect of TCAS-type alert on the probability that the DC-9 pilot would see the Piper Aircraft.

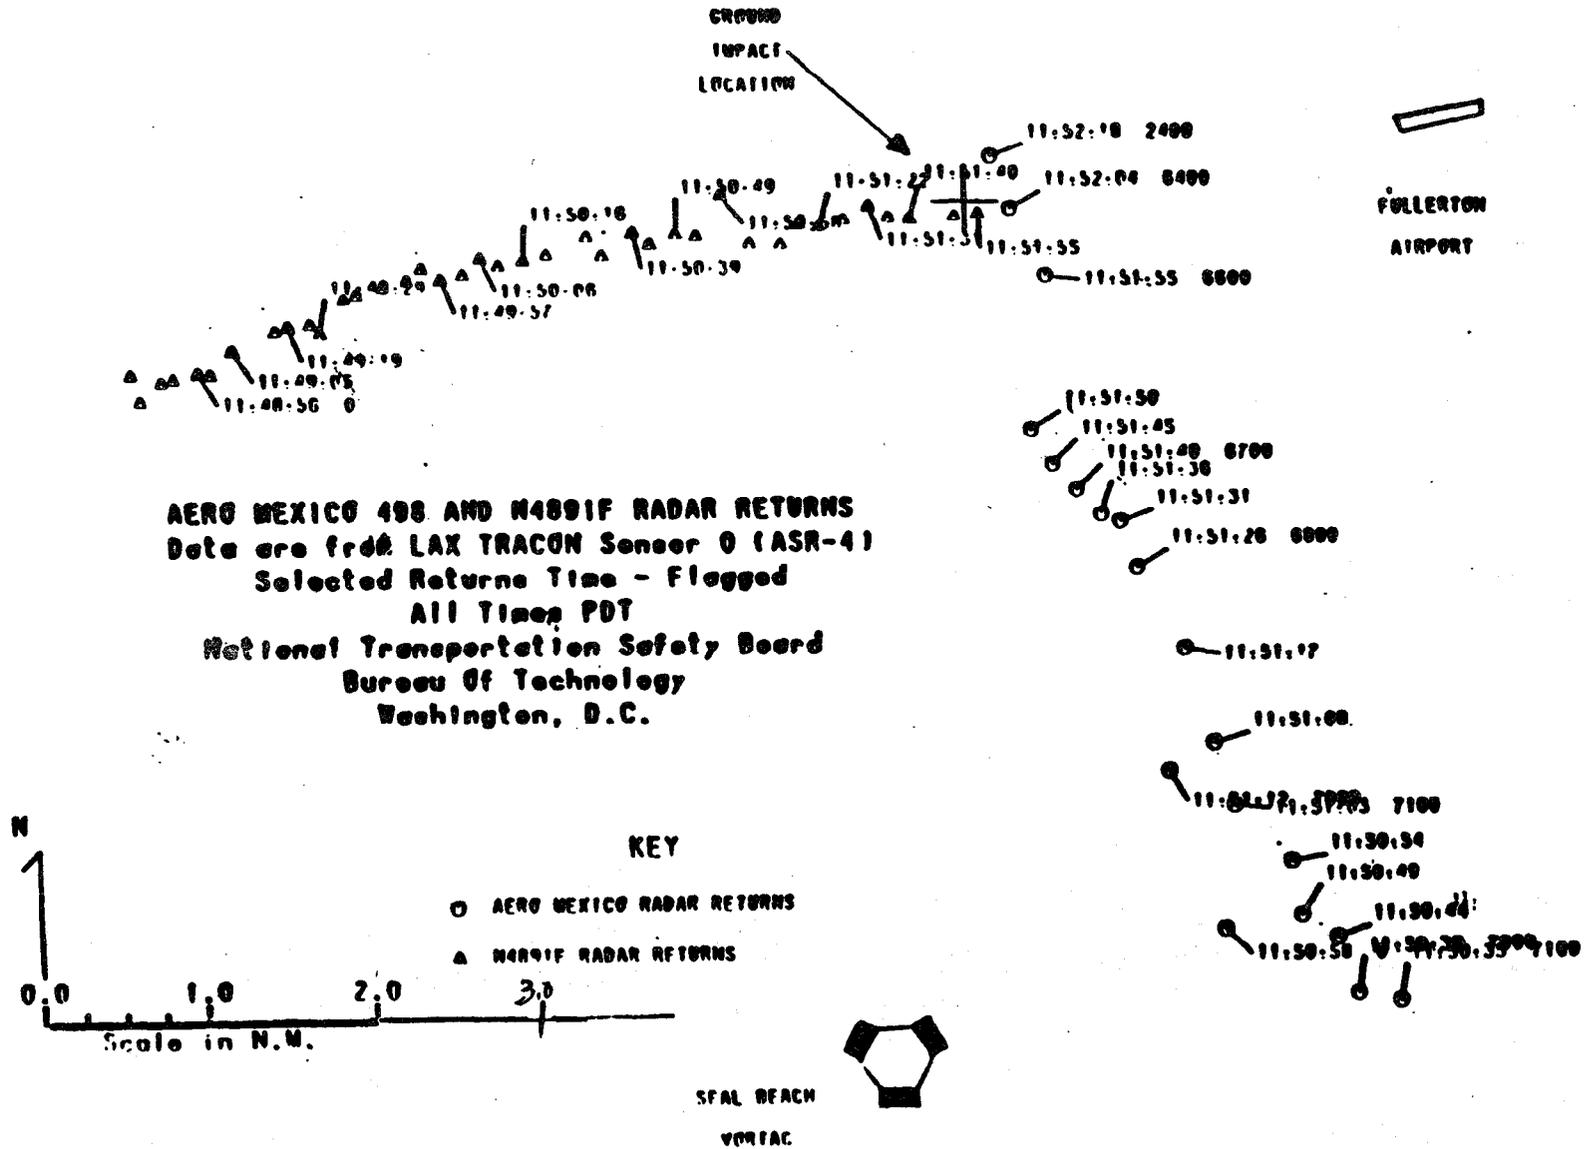
The recorded radar data also indicated that the Piper passed the TCA's lateral boundary about 1149:47 and that the collision occurred about 3 nmi west of that boundary. The manufacturer's climb performance chart was based on a 76-KIAS climb speed. Between 5,000 feet and 7,000 feet, based on the airplane's estimated gross weight and the existing weather conditions, the Piper could have climbed at a rate of about 300 fpm to 350 fpm. Since the collision occurred about 1152:09 at about 6,560 feet, the Piper probably climbed through 6,000 feet-the base altitude of this segment of the TCA-about the same time it crossed the TCA's lateral boundary,

Figure 5.--Beacon targets of DC-9 and Piper during last 3 minutes of flight.

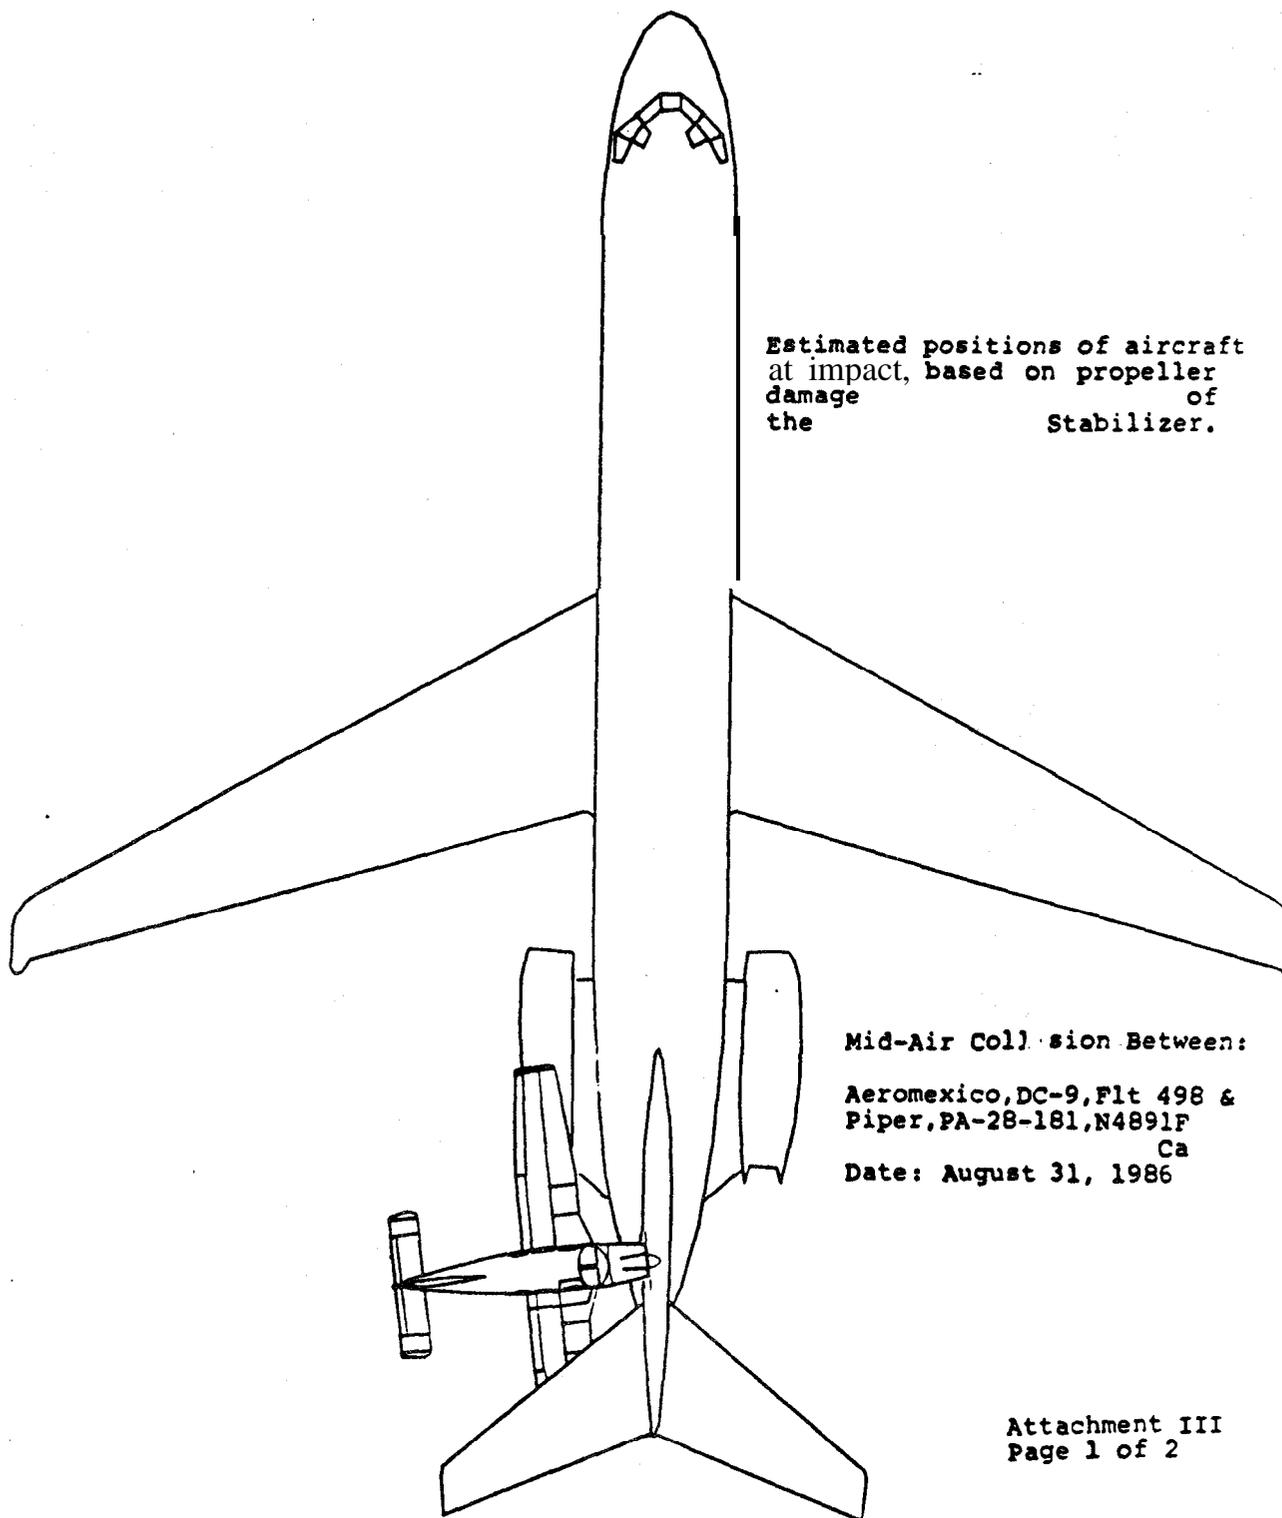
The damaged areas on the DC-9 vertical and horizontal stabilizers contained propeller slice marks, paint transfer marks Rom the nose wheel area and vertical stabilizer of the Piper, and embedded pieces from the cabin roof area of the Piper. **The** location and angles of these marks and damage on the **DC-9**, when matched to their respective locations on an intact Piper PA-28, showed that the front of the Piper had struck the left side of the DC-9 vertical stabilizer and that the impact angle was perpendicular to the longitudinal axis of each airplane. (See figure 6.) The impact angle was generally consistent with the flight tracks of the airplanes shown on the radar data plots.

Figure 6.--Collision geometry as viewed from above the DC-9.

Estimated positions of aircraft at impact, based on the propeller damage and scratch marks on the DC-9 Vertical and Horizontal Stabilizers.
