# **REPORT OF THE BOARD OF INQUIRY INTO THE HELDERBERG AIR DISASTER**

REPORT OF THE BOARD OF INQUIRY INTO THE LOSS OF  
SOUTH AFRICAN AIRWAYS BOEING 747 - 244B COMBI AIRCRAFT "HELDERBERG"  
IN THE INDIAN OCEAN ON NOVEMBER 28TH 1987

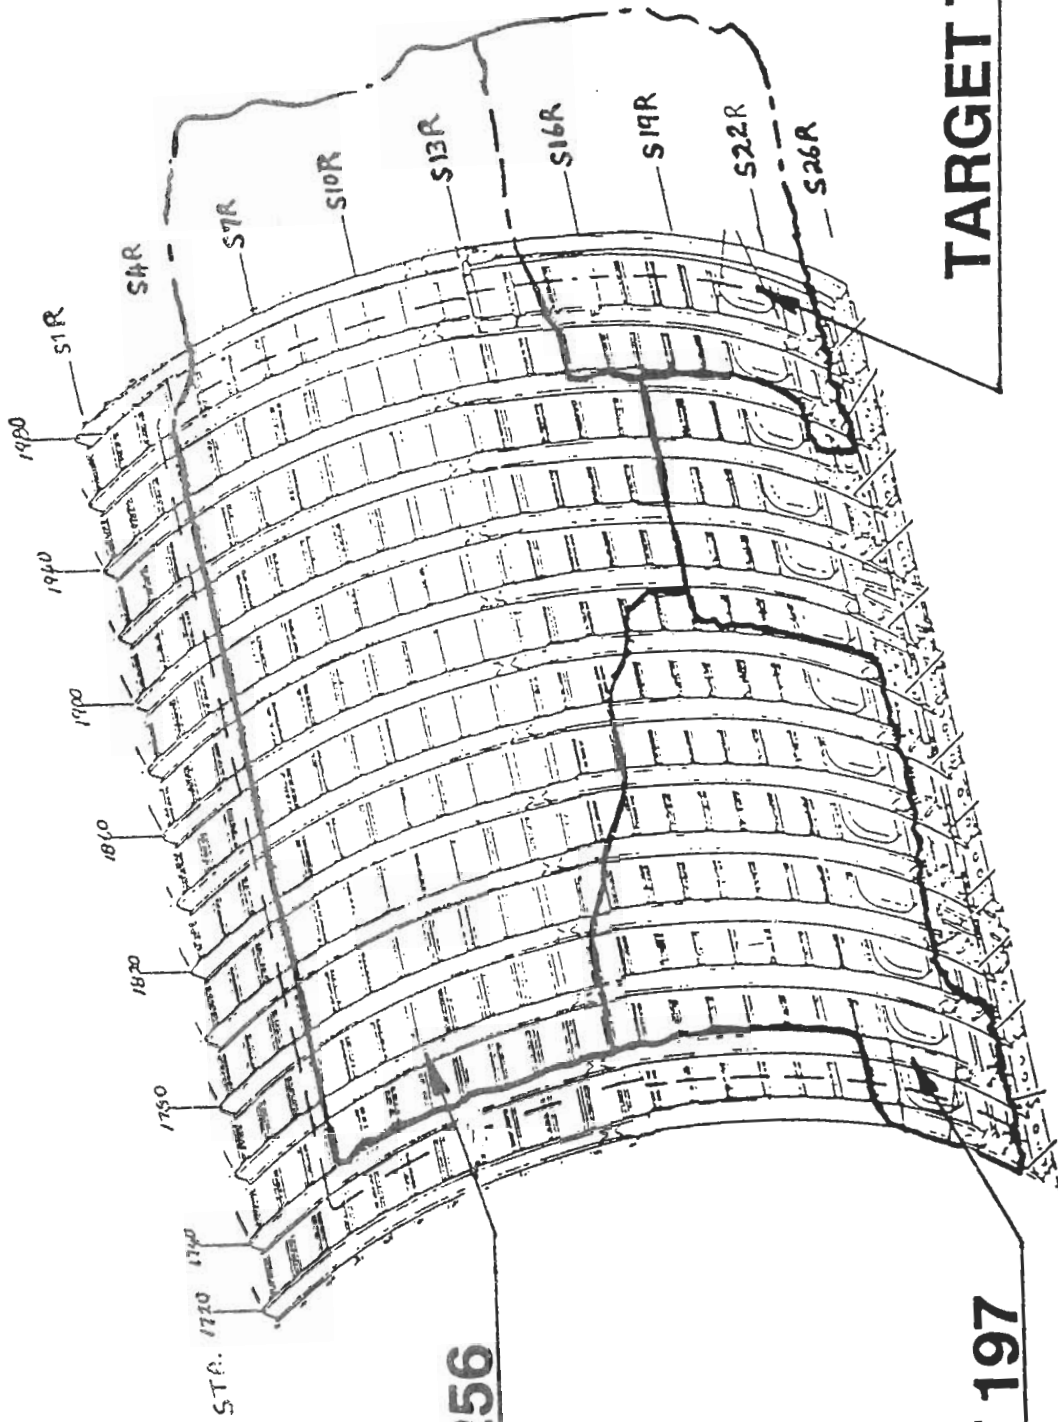
**TARGET T 256**

The structure fractured at body stations 1960 and 2200 and at stringers 5R and 8L. It showed evidence of heavy smoke deposits on the inner surface and heat discolouration of the paint on both the inner and outer surfaces. Deformation of the structure through impact showed a twist due to a high torsional load in a clockwise direction. This deformation is consistent with the mode in which Target 256 fractured at body station 1740.

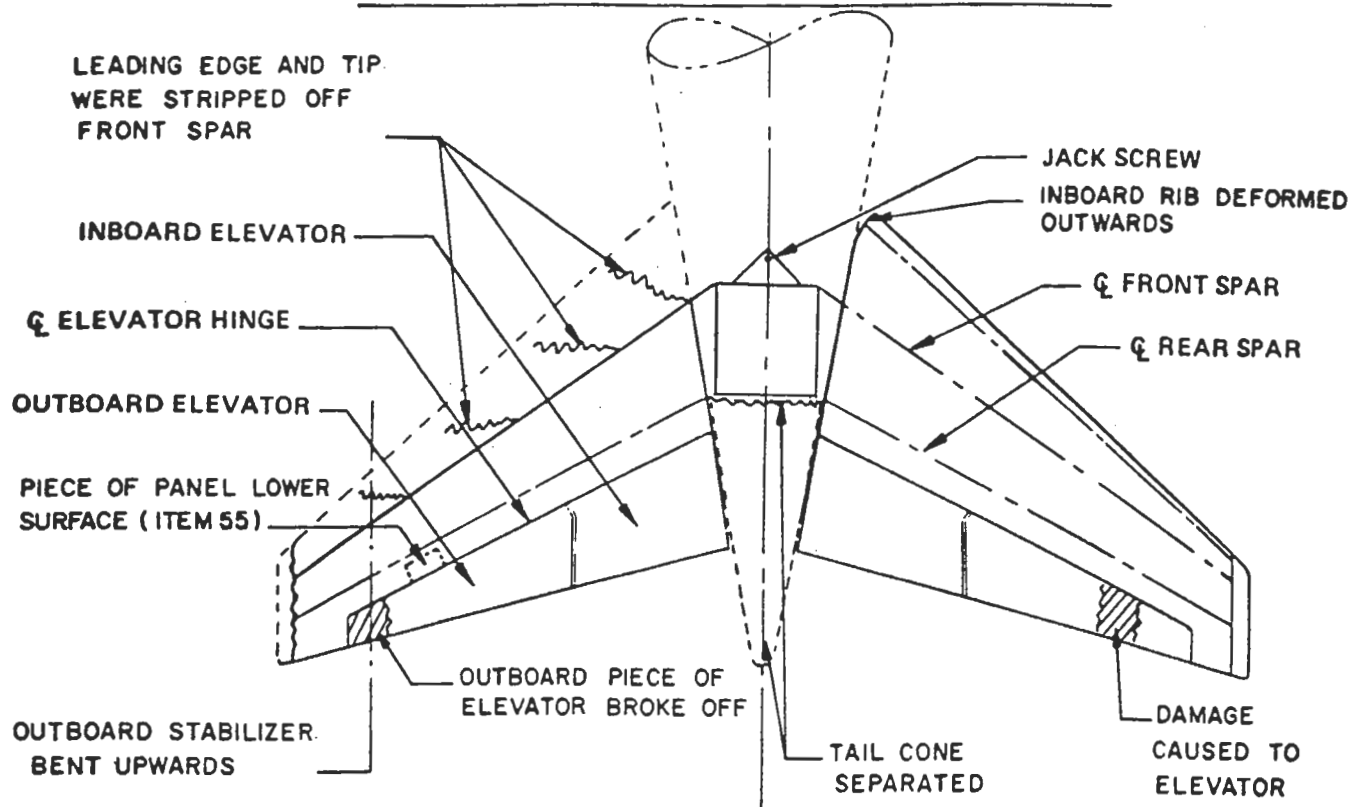
# HORIZONTAL STABILIZER (TARGET T41)

The horizontal stabilizer was found to be complete with elevators attached. There was no evidence of heat or smoke deposits on the skin surfaces. The left stabilizer leading edge was detached from the front spar. The tip and adjacent structure were extensively damaged i.e. split and bent upwards. The outboard elevator tip was detached. It was observed that the stabilizer actuator jackscrew had sheared below the gimbal ball nut with four grooves protruding below the ball nut and nine grooves above. No distortion of the jackscrew was evident. The inboard rib at the

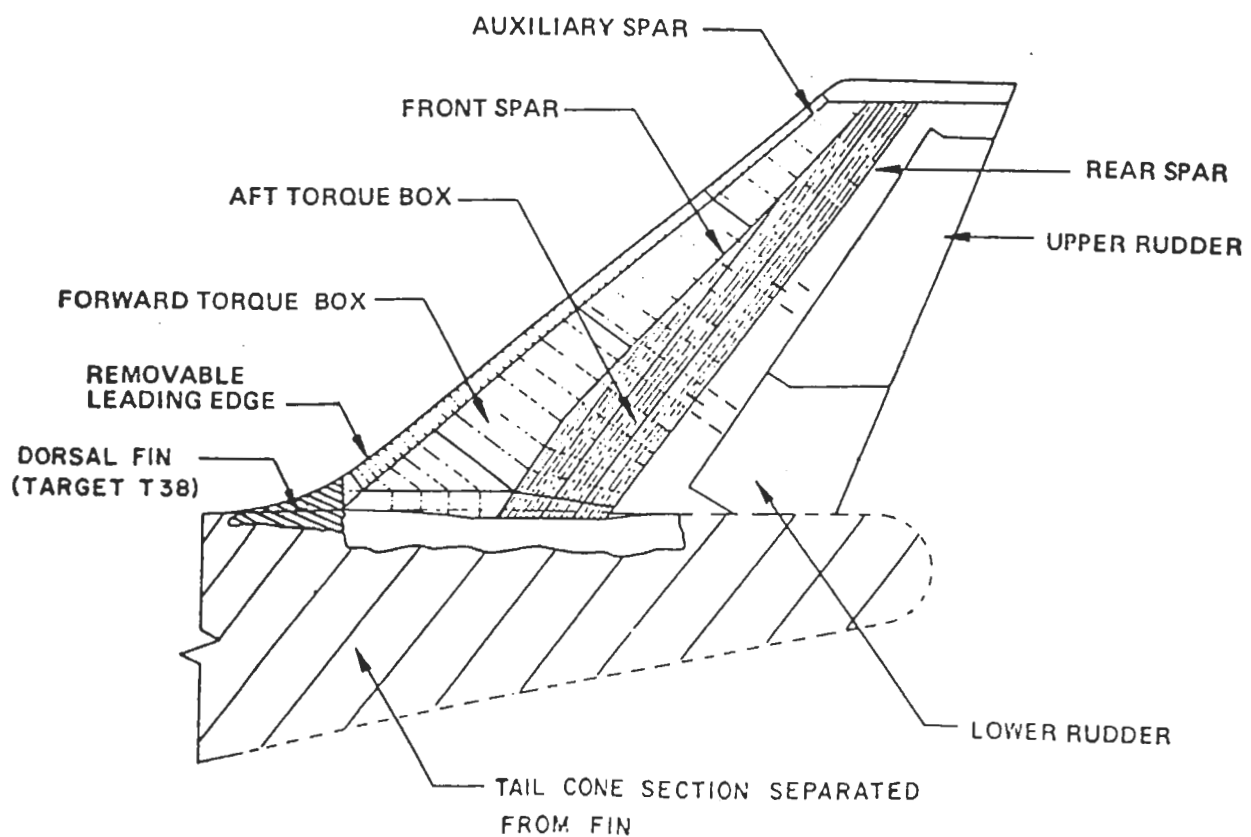
# VERTICAL STABILIZER (TARGET T36)

The stabilizer was complete with both upper and lower rudders intact and a section of empennage structure remained attached to the base. There was no evidence of heat or smoke deposits on the outer surfaces and no significant impact damage was apparent.

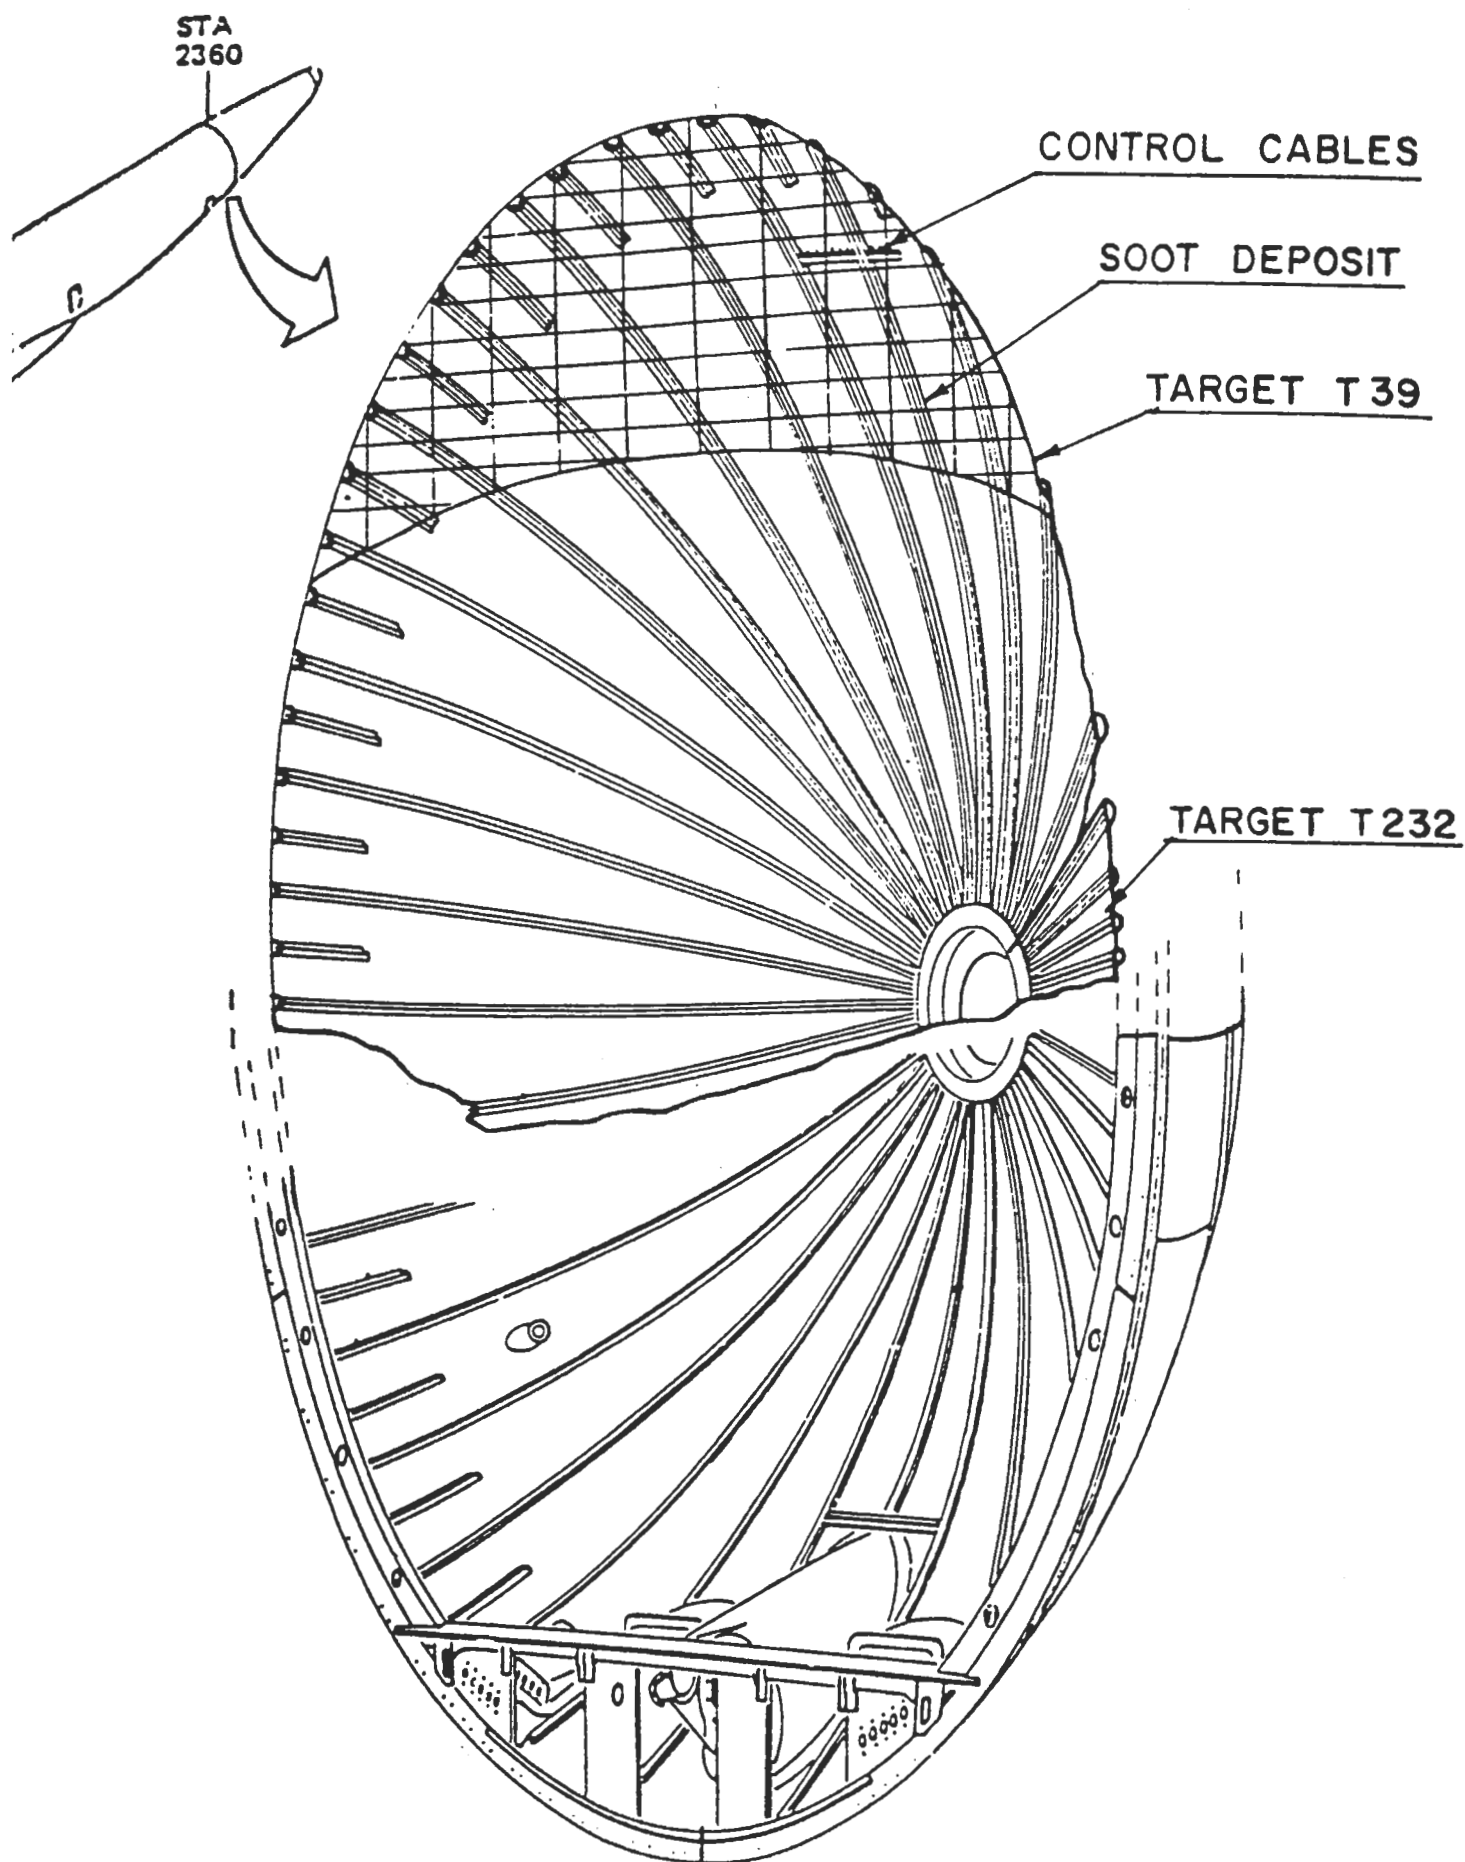
REAR PRESSURE BULKHEAD (RETRIEVED)

Heavy smoke deposits and heat discoloration were evident at the top centre sector location and all control cable aperture seals were damaged. There was evidence of light smoke deposits on the aft surface of the bulkhead.

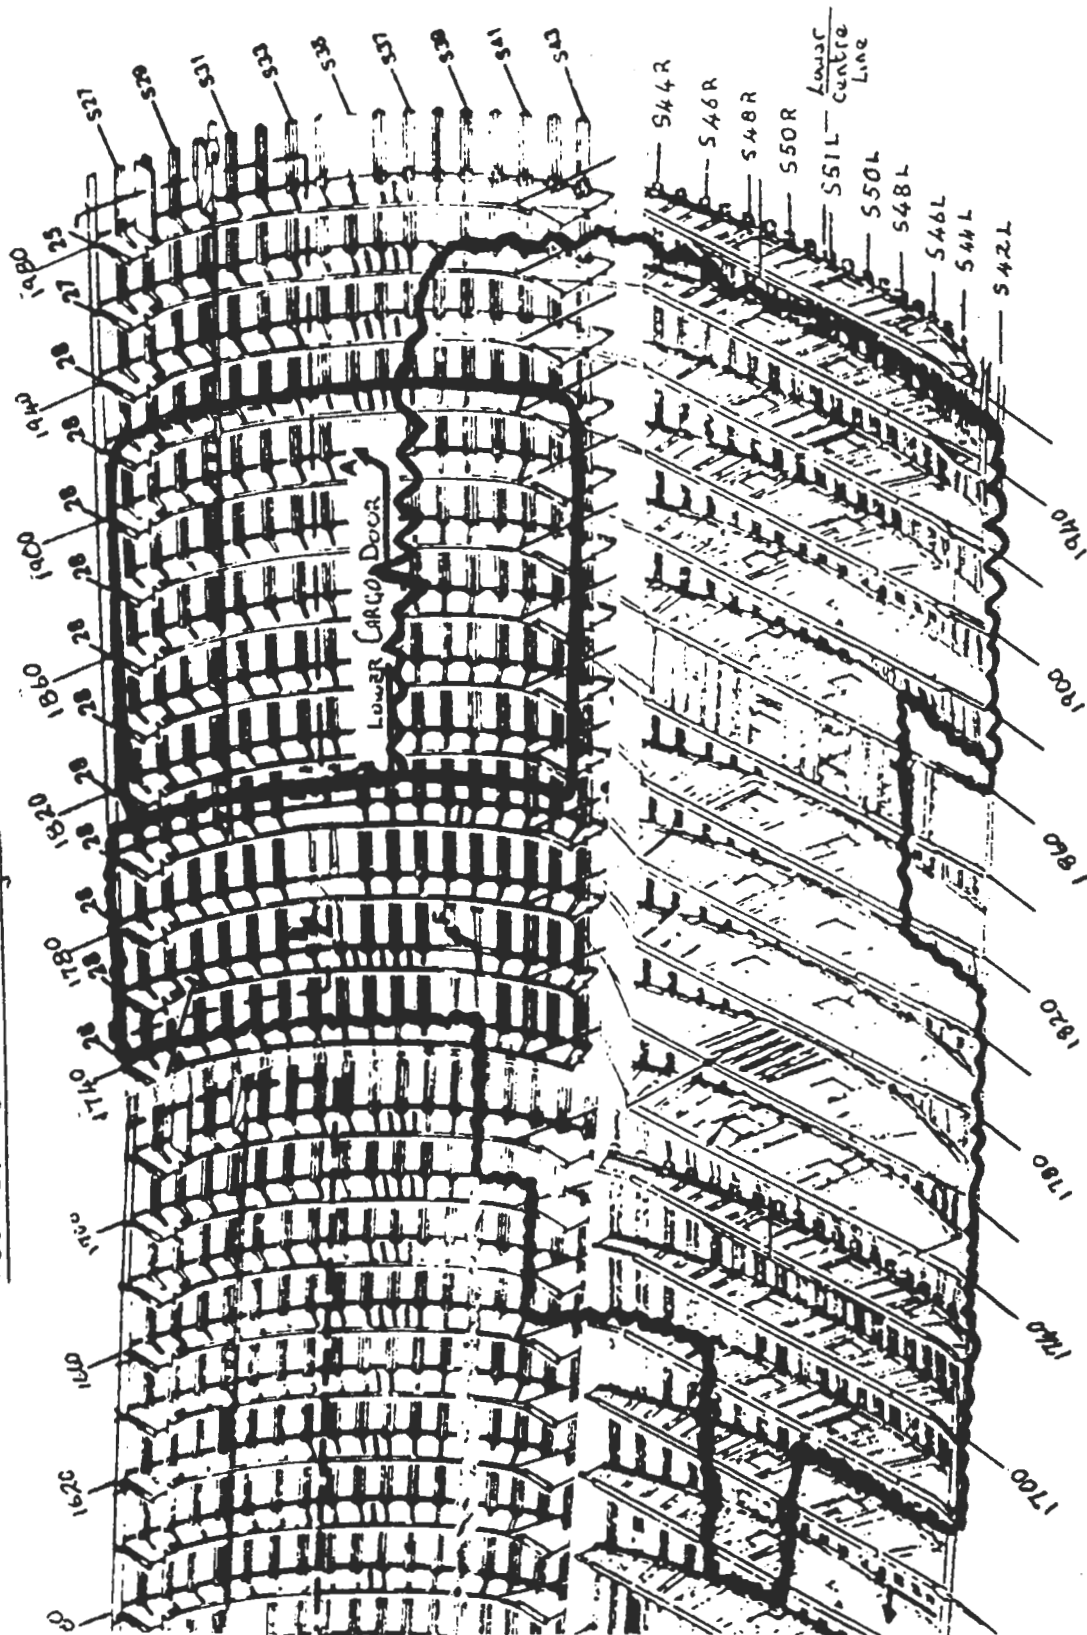
Target 244  
Lower aft fuselage

No signs of heat exposure or smoke deposits were evident on the inner or outer surfaces. The structure showed evidence of water impact damage on the lower right side of the fuselage which is consistent with the impact damage observed on target 219. The lower section of the lower aft cargo door was still
