5. Appendixes

Transcript of a Fairchild Model A-100 Cockpit Voice Recorder S/N UNK which was removed from a Trans World Airlines, Inc., Boeing Commercial Aircraft Co. B747-100 N93119, which was involved in an inflight accident on July 17, 1996 approximately 10 miles south of East Moriches, New York.

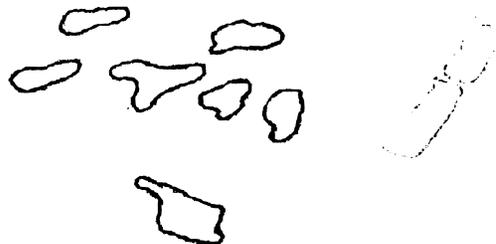
UPPER SKIN - EXTERNAL SURFACE

NOTE: With the exception of the piece noted, the external surface of the upper skin is clean. The control surfaces do show sooting and Arc damage to the composite parts.

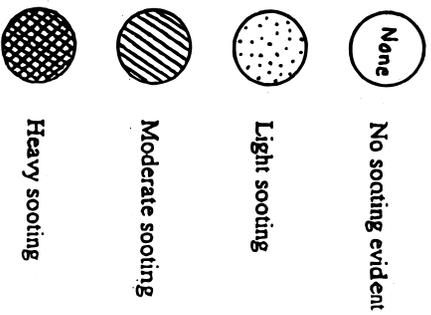
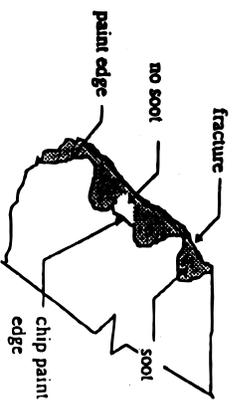
Fuselage sooting diagrams

Surveyed panels are all recovered from the Green debris field and are located from approximately STA 910 to STA 1600. Aft of STA 1600, no sooting is evident internally. On the exterior, there is light to moderate sooting extending aft along the entire length of the fuselage from approximately the main deck window belt on the RHS to approximately S-8 on the LHS

Determination primarily made by examining external paint failures near the fracture edge. Soot deposits remain on underlying paint when the top layer peels near fracture.
