## AIRCRAFT ACCIDENT REPORT

In-flight Breakup Over the Atlantic Ocean  
Trans World Airlines Flight 800  
Boeing 747-131, N93119  
Near East Moriches, New York  
July 17, 1996

**NTSB/AAR-00/03  
DCA96MA070  
PB2000-910403  
Notation 6788G  
Adopted August 23, 2000**

The National Transportation Safety Board determines that the probable cause of the TWA flight 800 accident was an explosion of the center wing fuel tank (CWT), resulting from ignition of the flammable fuel/air mixture in the tank. The source of ignition energy for the explosion could not be determined with certainty, but, of the sources evaluated by the investigation, the most likely was a short circuit outside of the CWT that allowed excessive voltage to enter it through electrical wiring associated with the fuel quantity indication system.

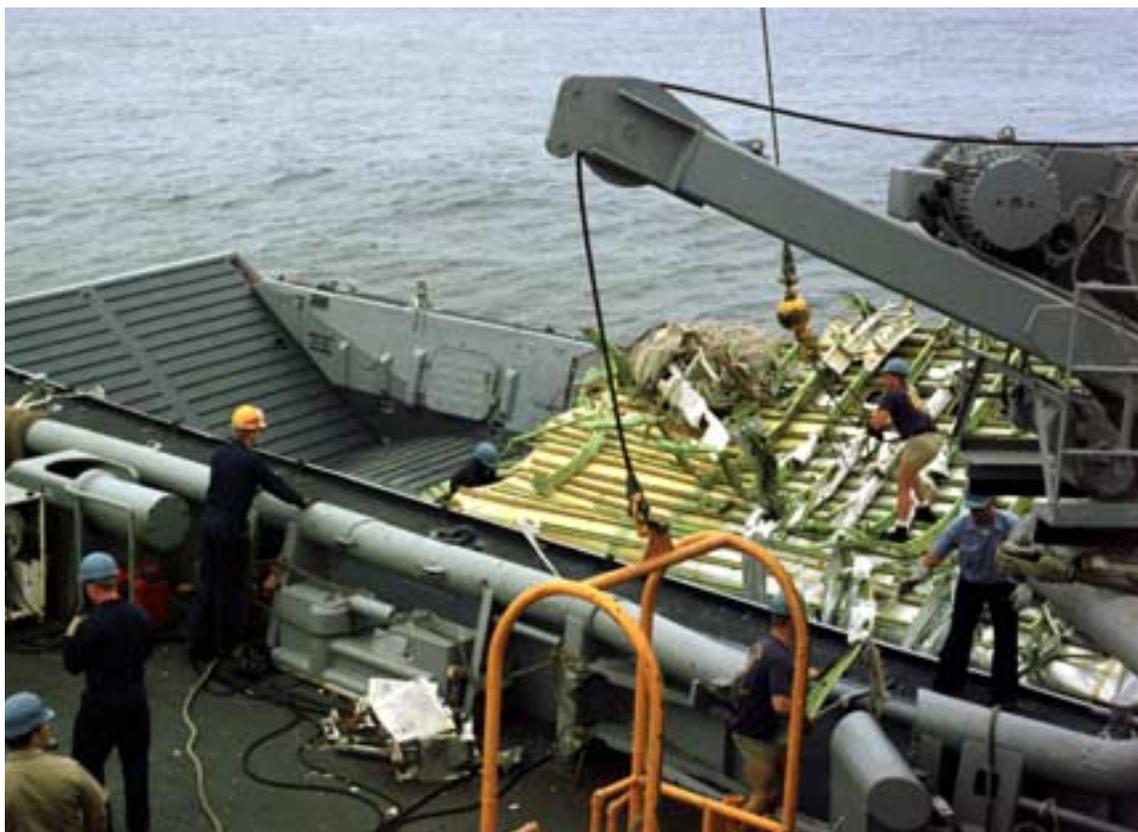
**Figure 24.** A photograph showing wreckage recovered with tangled and damaged wires attached.

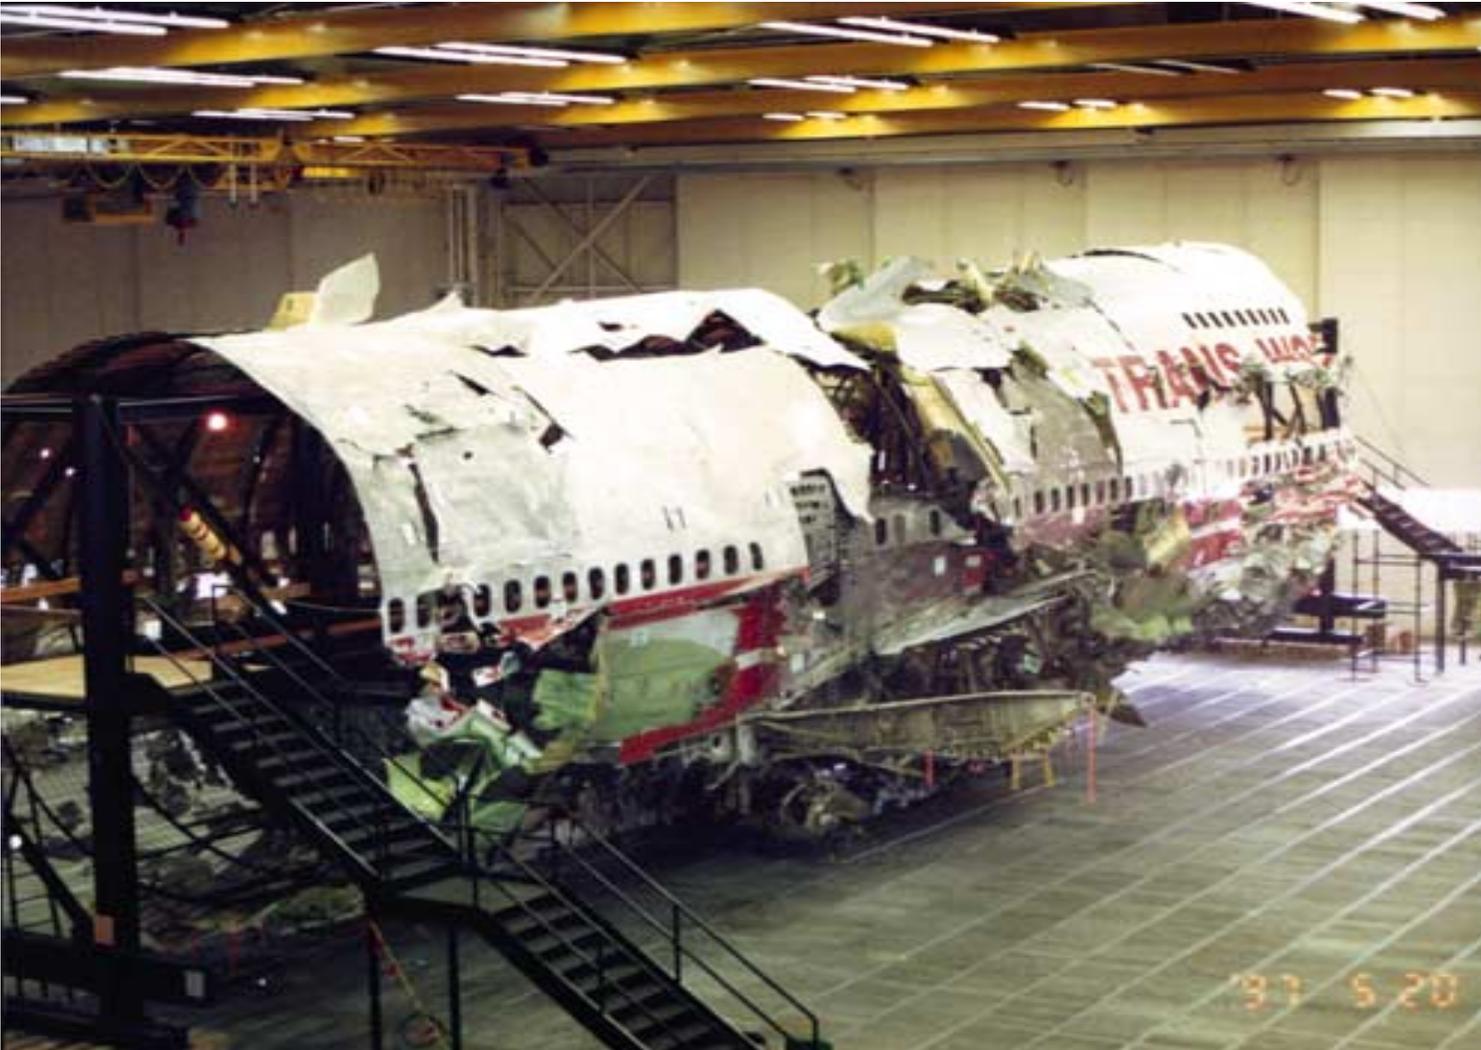
**Figure 29.** A photograph of the right side of the large three-dimensional reconstruction, with the support scaffolding visible.

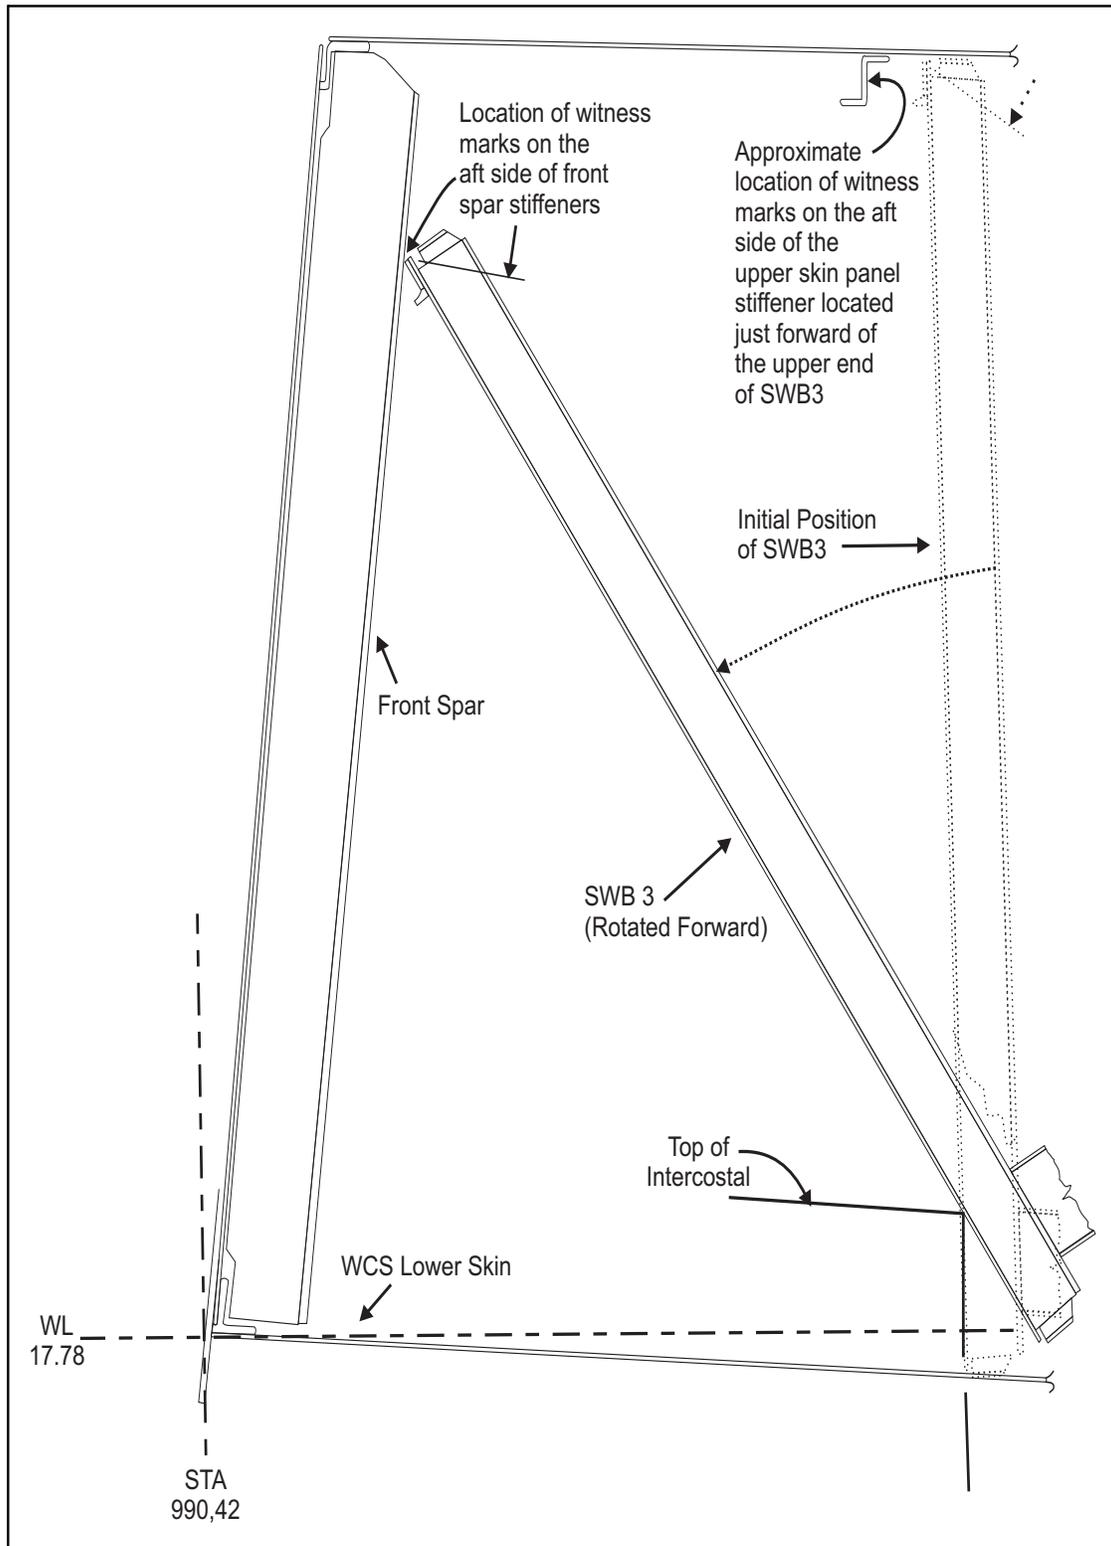
**Figure 31.** Diagram showing the approximate shape of the upper skin panel stiffener and its location before being struck by SWB3 as the beam rotated forward.
