IV. Rudder System Scenarios

A. Rudder System Overview

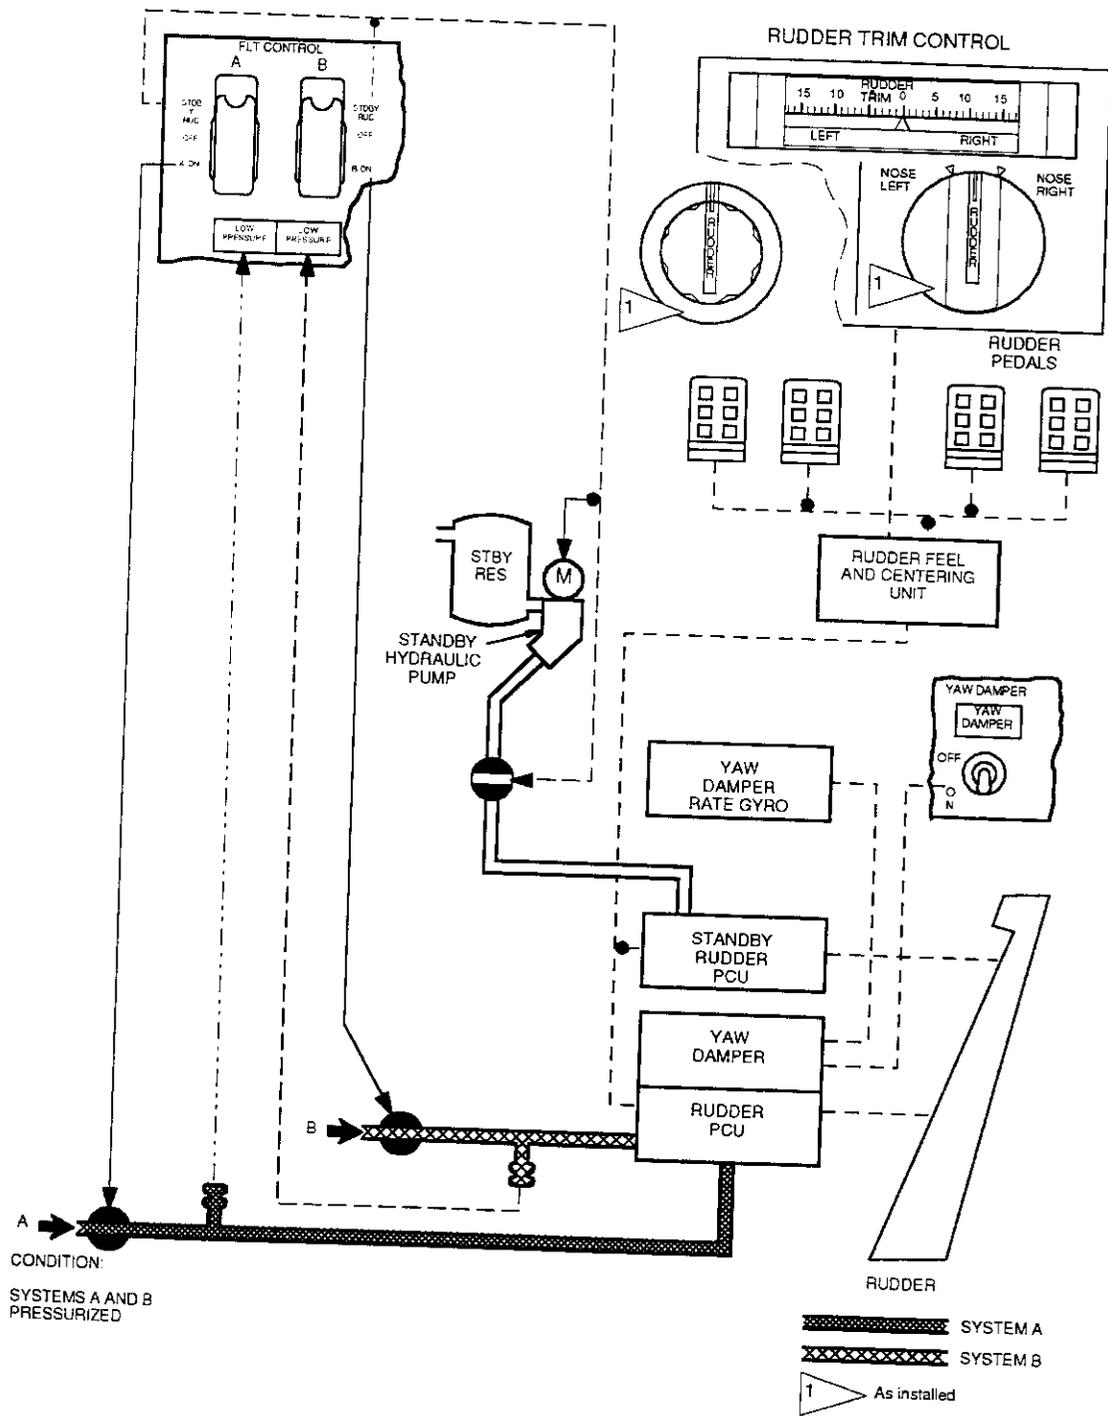
Figure 7: Rudder Control System Schematic

Pilot control of the rudder is provided through the captain's and F/O's rudder pedals. The pedal motion is transmitted by a single cable system to the aft quadrant, and then through linkages to the main and standby PCUs, as shown in Figures 7 and 8. Except for the yaw damper, as discussed below, the rudder surface follows the pedal command. The pedals provide the flight crew with an indication of rudder surface positioning.

Figure 7 also shows the yaw damper system, which is designed to improve airplane ride quality by minimizing small-amplitude yaw oscillations. The yaw damper electronic module, or coupler, provides an electrical signal to the

yaw damper actuator, which is part of the main rudder PCU. The yaw damper and pilot inputs are summed within the PCU such that yaw damper rudder inputs do not move the pedals.

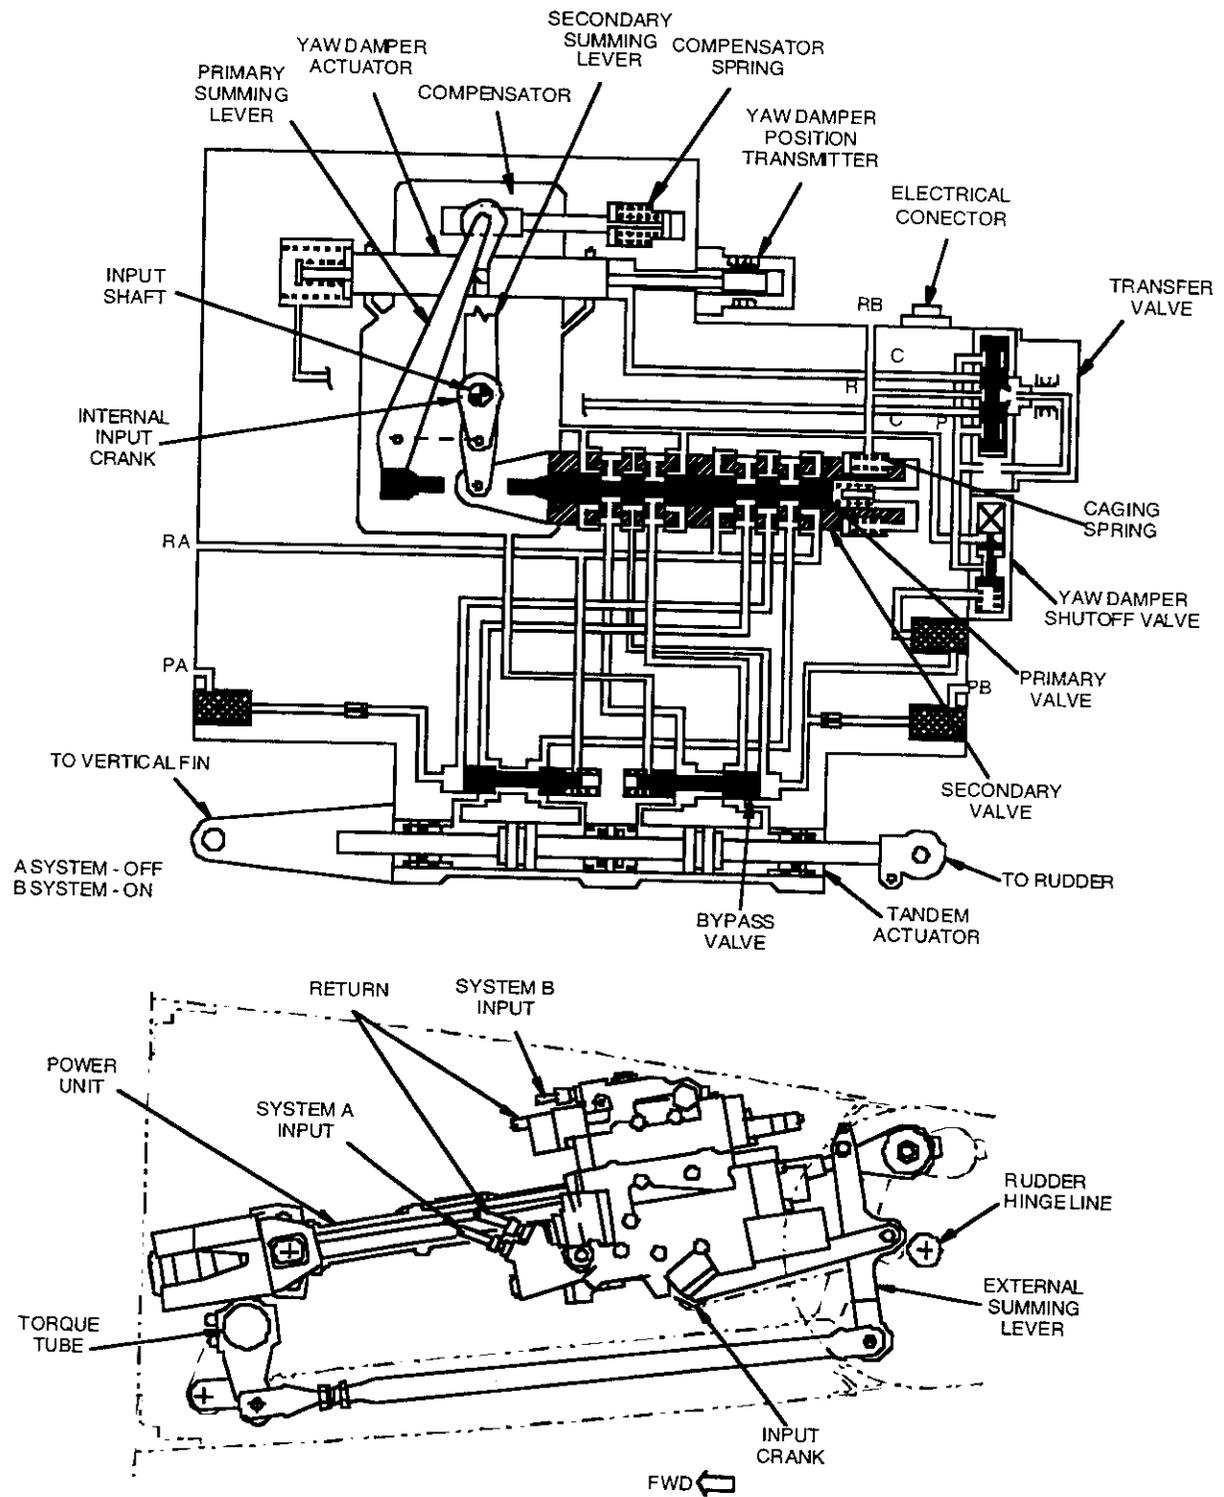
Figure 9: Main PCU Functional Schematic

Figure 9 provides a schematic view of the main PCU. The main control valve is connected through a dual-load-path linkage to both the yaw damper piston and to the pilot input linkage. The linkage sums inputs by the pilots and yaw damper to the control valve. The yaw damper piston is controlled by an electro-hydraulic servo valve that receives an electrical input from the yaw damper coupler. The yaw damper piston in the Flight 427 PCU (as in all 737-300 airplanes) is limited by a mechanical stop that only allows it to command three degrees of rudder.
