PB91-910409
NTSB/AAR-91/08

AIRCRAFT ACCIDENT REPORT

**RUNWAY COLLISION
OF USAIR FLIGHT 1493, BOEING 737
AND SKYWEST FLIGHT 5569 FAIRCHILD METROLINER
LOS ANGELES INTERNATIONAL AIRPORT
LOS ANGELES, CALIFORNIA
FEBRUARY 1, 1991**

**Adopted: October 22, 1991
Notation 5461A**

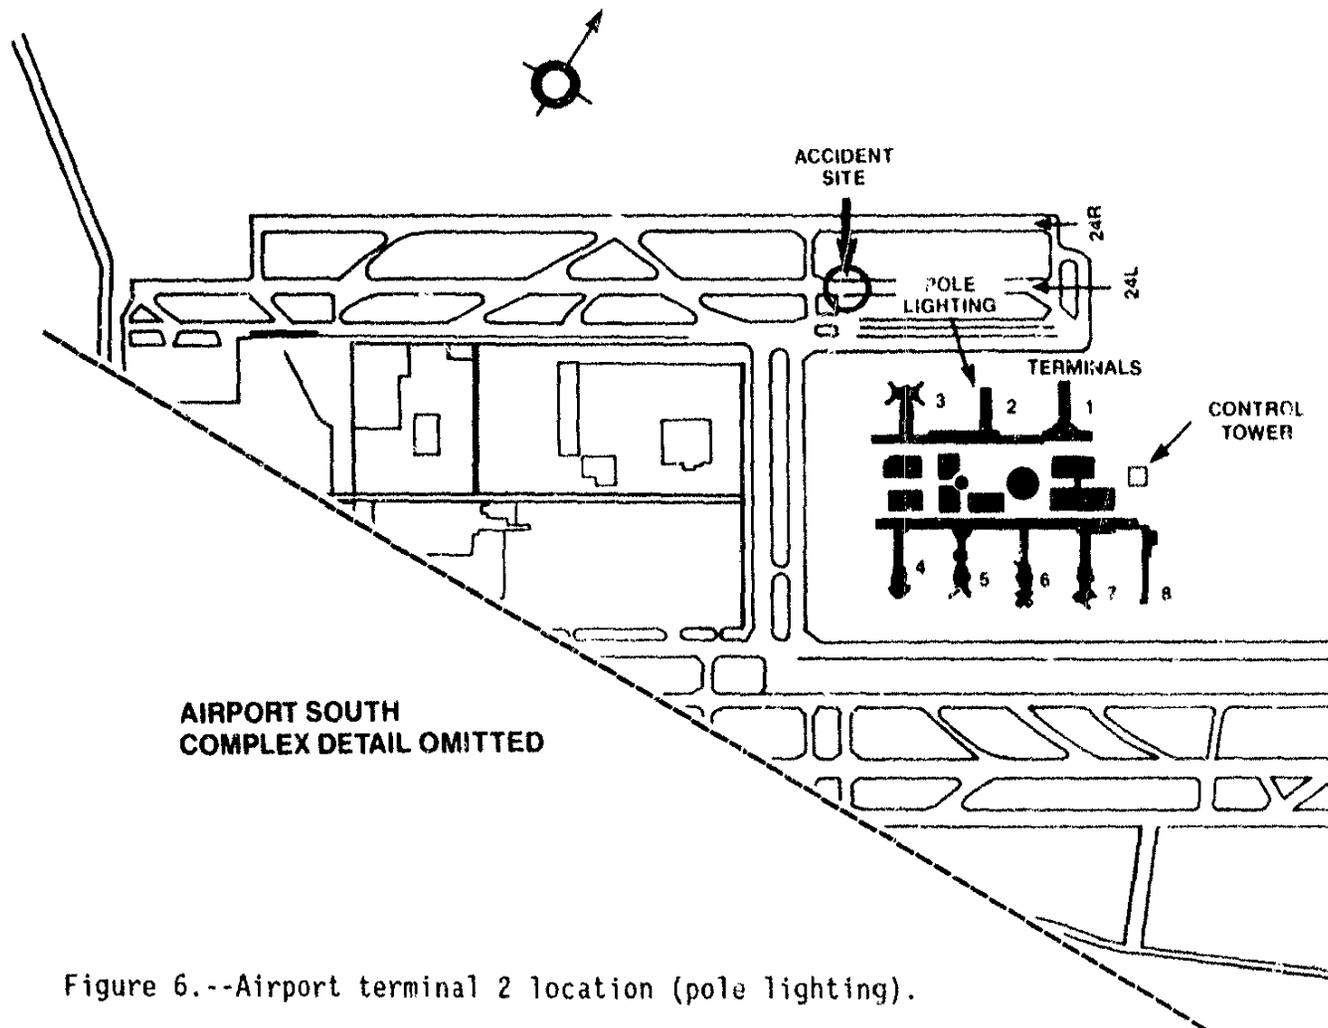
Figure 6.--Airport terminal 2 location (pole lighting).

During interviews, tower personnel stated that a series of four ramp lights on the northernmost portion of the Terminal 2 complex were a restriction to vision during the hours of darkness because of their height, brightness, and relative line-of-sight location to taxiways 45 and 47 and runway 24 left.

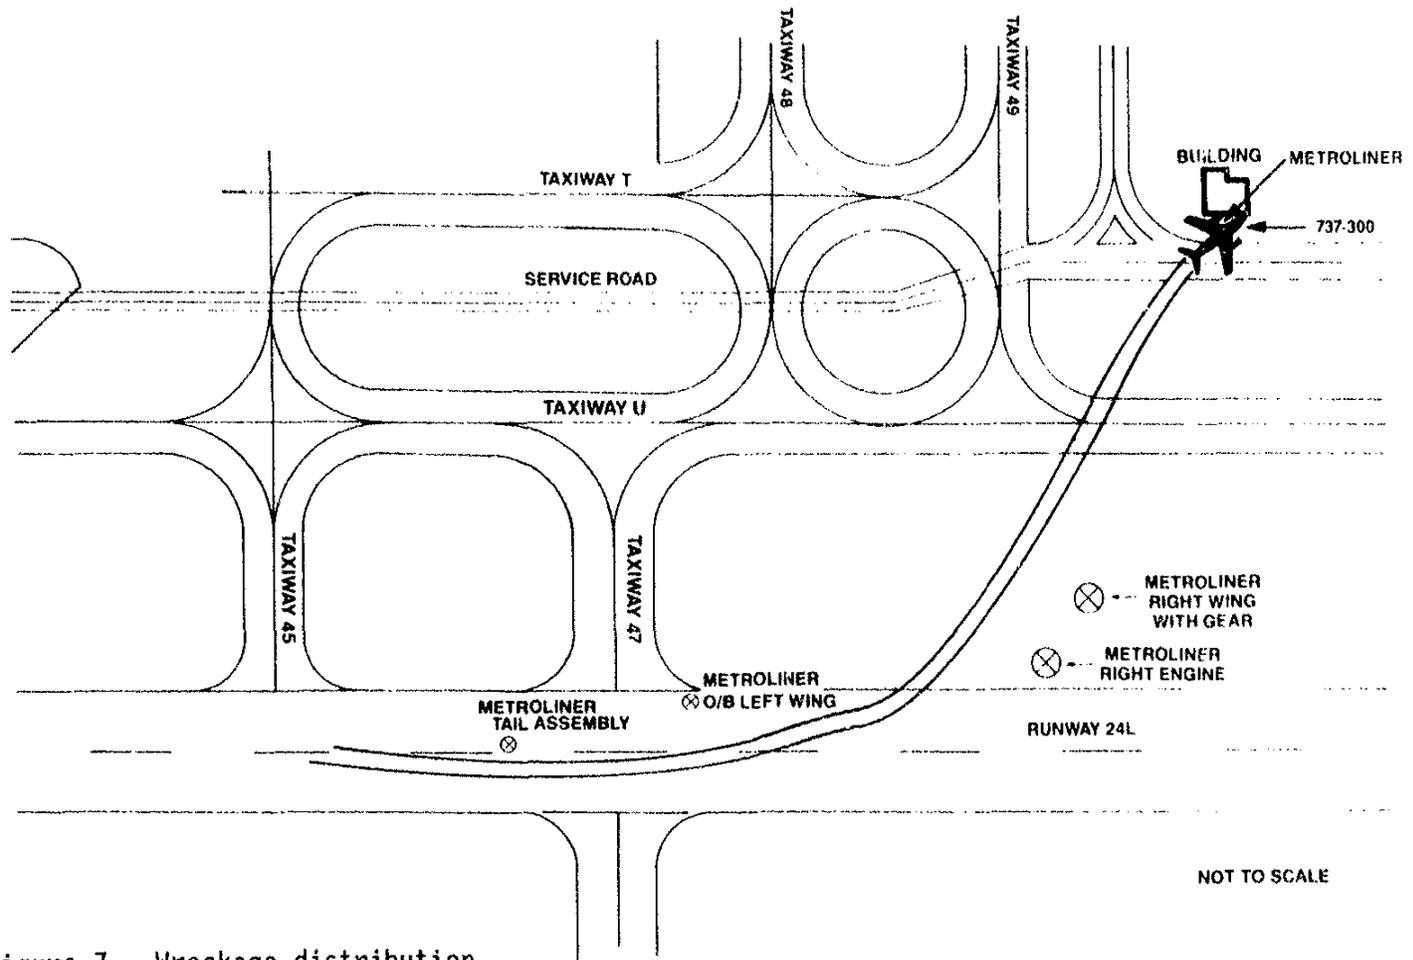
Figure 7.--Wreckage distribution.

After the collision, the B-737 and the part of the Metroliner that was crushed beneath the left side of the B-737 continued 600 feet down runway 24 left before veering left and impacting the vacant fire station, about 1,200 feet from the collision point and approximately 600 feet to the left (southeast) of the runway centerline (See figures 7 and 8). Although parts of the Metroliner were scattered among the wreckage, the only parts of the B-737 that separated from the airplane were the nose cone, nose gear doors, and left pitot tube. The B-737 was destroyed by the resulting ground fire, which burned through the top of the fuselage both forward and aft of the wing, the latter causing the aft fuselage to drop down. The impact with the building destroyed the B-737 cockpit and damaged the left engine and an area of the left wing leading edge. The top and left sides of the cockpit were crushed inward, and the forward section of the cockpit on the captain's side was crushed in, down, and to the right (See figure 9). Both forward cockpit windshields were cracked. Several propeller slashes were on the lower right side of the B-737 fuselage skin in the area of the forward galley door.

The empennage with the vertical stabilizer, rudder and left horizontal stabilizer were located approximately 240 feet from the initial impact location. The left wing section outboard of the engine was located at the intersection of taxiway 47 and the runway. The right wing separated at the root and was found, with the right landing gear attached, between the runway and taxiway Uniform.

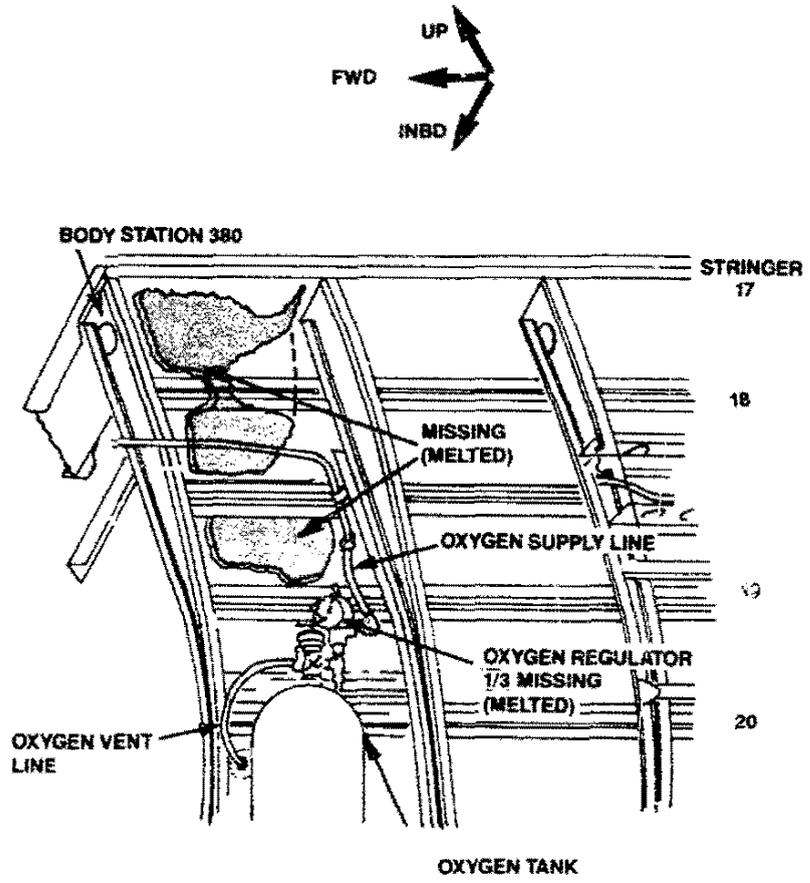
Figure 12.--Fuselage damage/crew oxygen system installation.

The fuselage skin near the oxygen system installation was damaged mechanically, prior to high temperature exposure.
