## Transportation Safety Board of Canada

### Aviation Investigation Report A13C0150

#### Loss of engine power – Collision with terrain

Bearskin Lake Air Service LP (Bearskin Airlines)  
Fairchild SA227-AC Metro III, C-FFZN  
Red Lake, Ontario  
10 November 2013

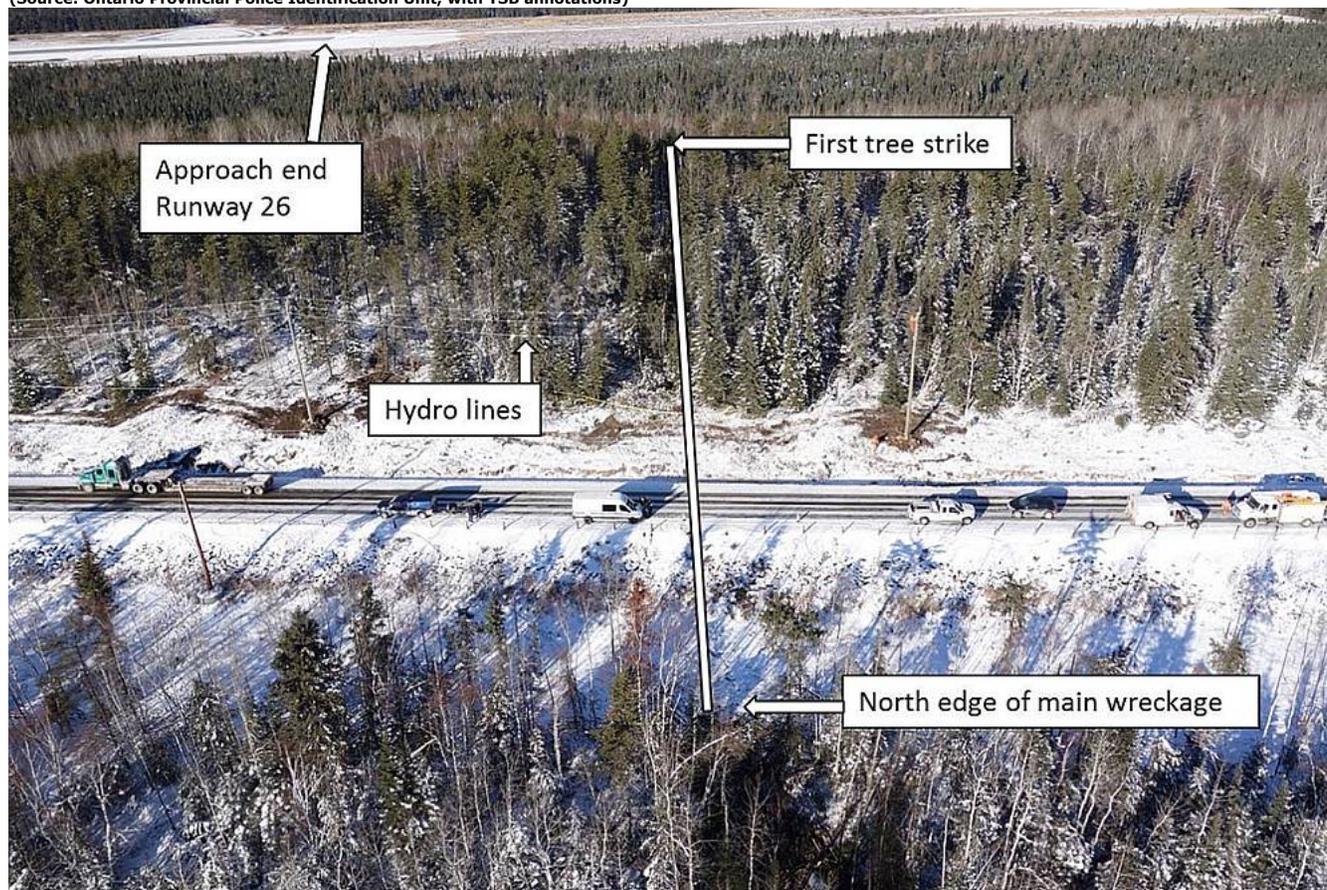
#### Photo 2. Accident impact points

The outboard 8-foot section of the left wing was torn off, and the aircraft travelled approximately 375 feet before striking hydro lines that paralleled Ontario Highway 125 leading to the airport. The aircraft contacted the south edge of the highway road bed, at which point the left engine and propeller separated from the aircraft. The aircraft cartwheeled and slid tail first coming to rest 150 feet from the highway in an area of trees. The left engine came to rest underneath the tail section. The right engine and wing broke off during the impact sequence. Both propellers had detached from their respective engines. The front of the aircraft forward of the wing main spar was severely crushed and deformed; the cabin area aft of the wing trailing edge remained largely intact. Most of the aircraft was consumed by the post-crash fire (Photo 3).

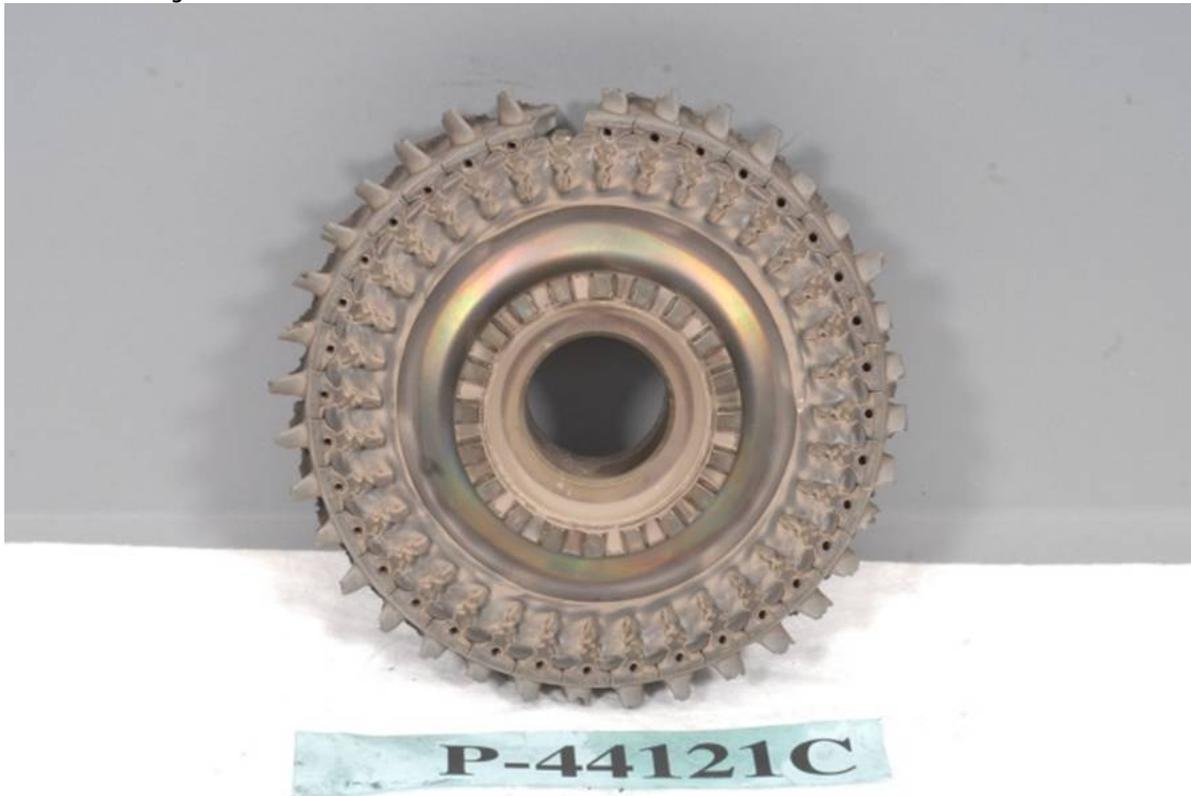
**Photo 4. First-stage turbine wheel**

The first-stage wheel (Photo 4, Photo 5 and Photo 6) was stripped of all blades down to the blade roots with 1 blade failing at the fir tree<sup>11</sup> blade root area. The area of failure exhibited a distinct fatigue zone near the trailing edge of the blade and was sent to the TSB Laboratory for metallurgical examination. The examination concluded that the blade failure occurred as a result of high-cycle fatigue in an area of high porosity.

In summary, the manufacturer's contributing cause analysis determined that the first-stage turbine wheel failed because of high-cycle fatigue which was the result of the following factors:

- Substandard porosity of the turbine blade material which resulted in inadequate fatigue capability and the creation a favourable location for crack initiation.
- A minor increase in the mean stress in the blade fir tree region due to blade platform contact.
- Stator burn-through which resulted in an uneven vibration on the first-stage turbine wheel assembly and heat stress on the turbine blades.

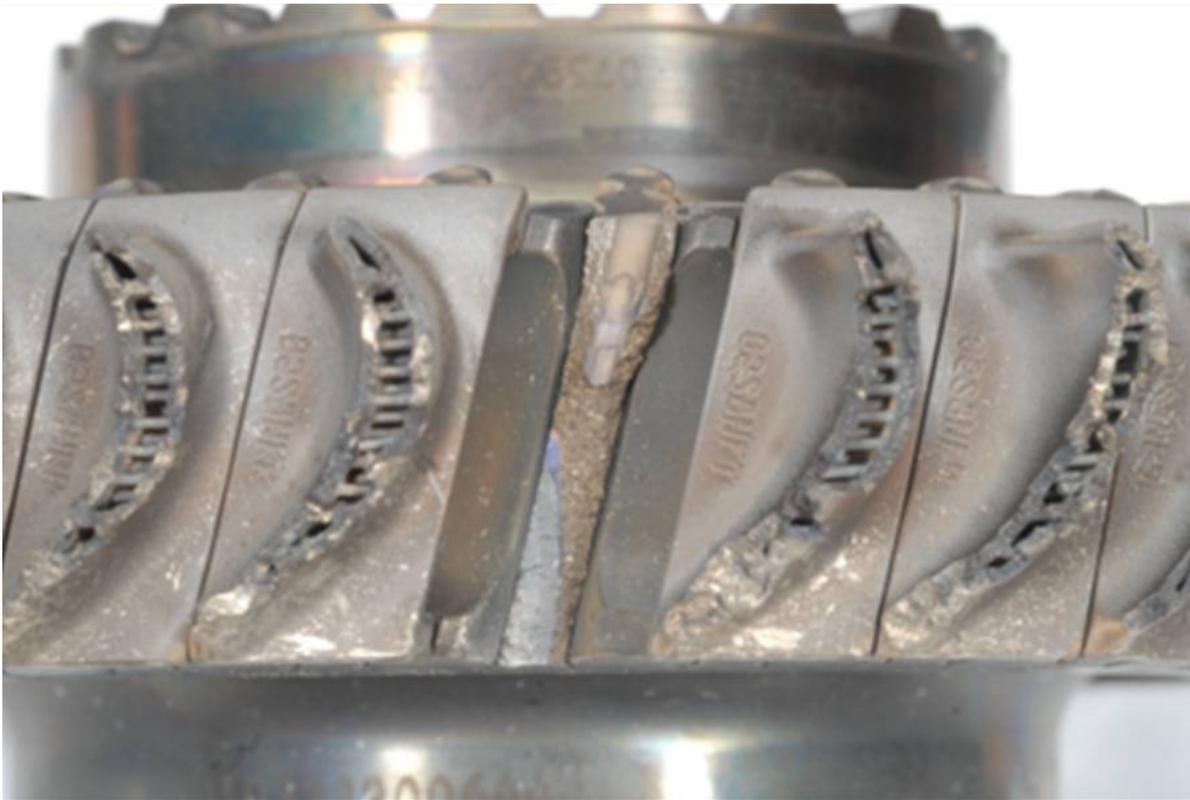
**Photo 5. First-stage turbine wheel failure**

The examination of the engine concluded that, in this occurrence, the failure of the first-stage turbine blade by itself would not have caused the engine to lose all power. However, its failure caused damage to the remaining turbine blades, which reduced the efficiency of the engine and would have greatly reduced the power output of the engine to drive the propeller.

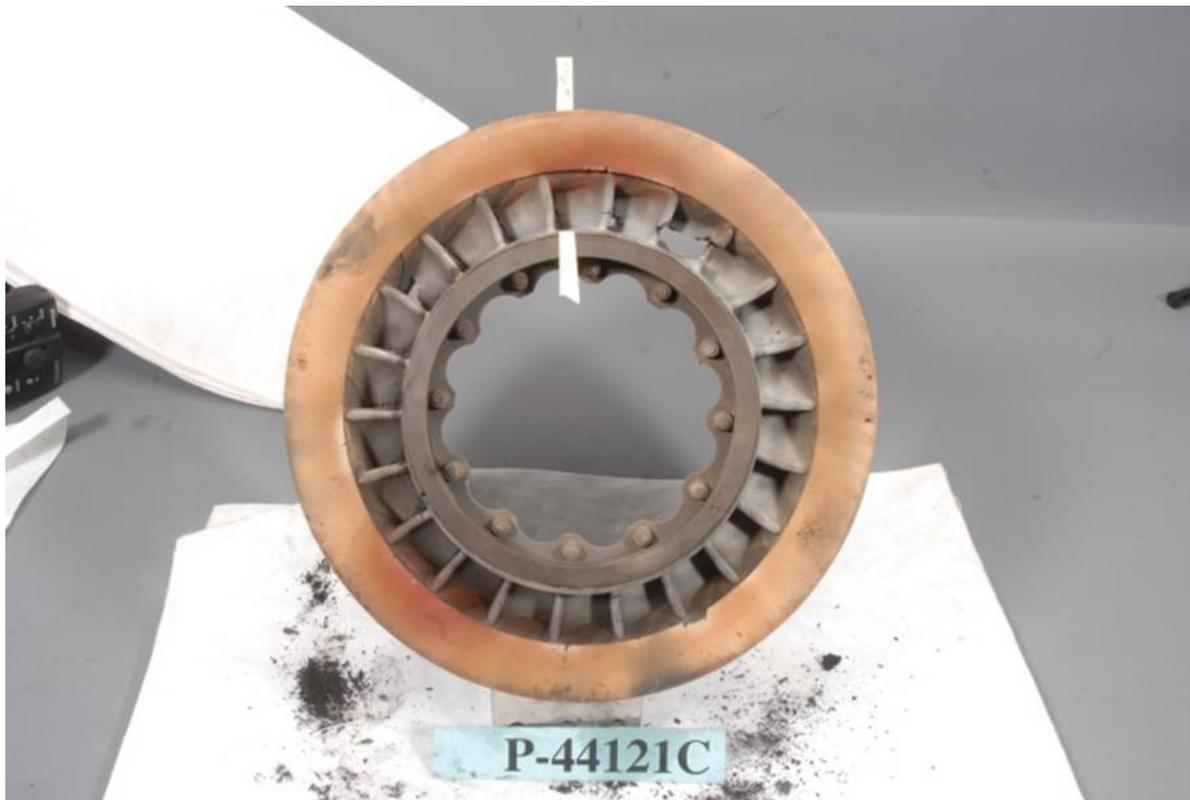
**Photo 7. First-stage stator (nozzle) and liner assembly**

The first-stage stator (nozzle) assembly (Photo 7 and Photo 8) was examined and burn-through was noted on one of the stationary nozzle vanes. Several other nozzle vanes showed areas of cracking, material loss and heat distress. The stationary first-stage stator assembly is upstream of the first-stage turbine wheel and directs hot combustion air onto the rotating turbine wheel.

The engine manufacturer indicated that there had been previous incidents of first-stage turbine wheel blade failures and stator burn-through. At times, the 2 failures occur in conjunction with one another and at other times only the turbine blade fails. The turbine blade failures have been attributed in some instances to porosity issues in the casting process and/or fatigue issues caused by excessive turbine distress due to stator vane burn-through. A burn-through in the stator vane will produce a vibrational response (one per revolution) in the blades that can lead to the blades separating in a high-cycle fatigue mode. Stator vane burn-through has been attributed to streaking fuel nozzles or the blockage of the first-stage stator cooling tubes which could cause hot spots on the stator vane.

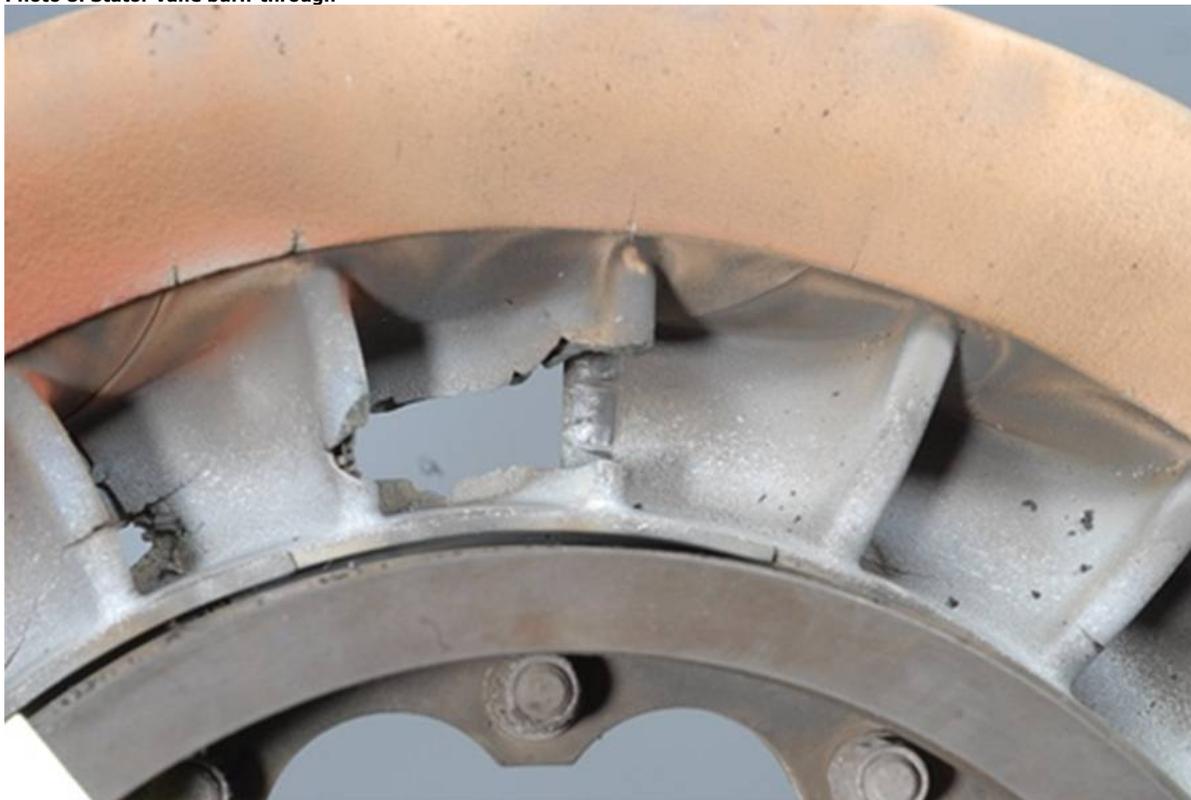
**Photo 8. Stator vane burn-through**

Engineering experience has shown that air gusts through the failed (burnt-through) stator portion will increase the alternating stress experienced by the blade, and stator burn-through was assessed as a contributing cause. Research indicates that stator burn-through could be caused by hot starts and over-temperature operation, a blocked stator vane cooling flow, or streaking fuel nozzles. No evidence of a hot start, an over-temperature condition, or a pre-blocked stator vane cooling flow was found. The cracked fuel nozzle could not be tested for flow or spray pattern, and it could not be determined if it had produced a streaking effect on the burnt-through stator vane. A swirl pattern analysis of the internal engine airflow, taking into account the installed position of the cracked nozzle in relation to the installed position of the burnt-through stator vane, showed that the operation of a fuel nozzle in this position could have had a direct effect on the burnt-through stator vane.

The teardown of the left engine revealed a burnt-through stator vane. The burnt-through stator vane created a one-per-revolution vibrational excitation and allowed excessive heat stress on the first-stage turbine wheel blades. This, combined with higher porosity in one of the blade castings, inadequate fatigue capability and robustness of the blade material, and a minor increase in the mean stress in the blade fir tree region due to blade platform contact, resulted in a high-cycle blade failure.
