**NATIONAL
TRANSPORTATION
SAFETY
BOARD**

AIRCRAFT ACCIDENT REPORT

**CONTINENTAL AIR LINES, INC.,
McDONNELL-DOUGLAS DC-10-10, N88045
LOS ANGELES, CALIFORNIA
MARCH 1, 1978**

AAR-79-1

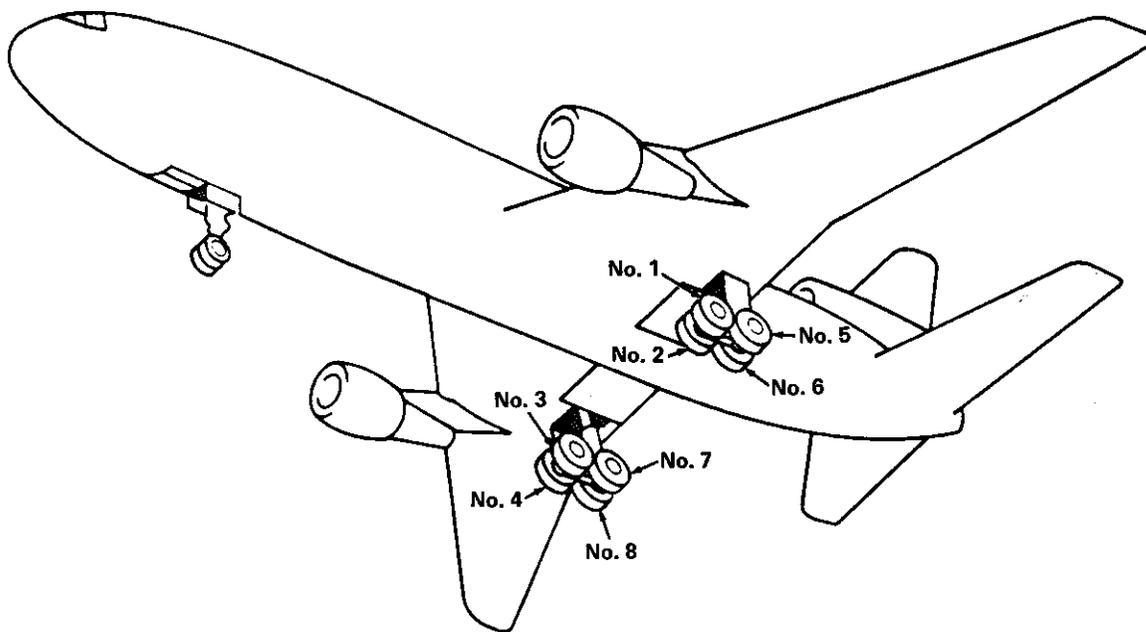
Figure 1. DC-10-10 main landing gear tire/wheel assembly positions.

The No. 1 tire, serial No. 70750273R3, was manufactured by Goodyear Tire and Rubber Company and retreaded by Air Treads, Inc. The wheel was built up on January 25, 1978, and the wheel and tire assembly was installed on the aircraft on January 26, 1978. This wheel and tire assembly had not been written up. The tire had been retreaded three times. The tire carcass had 695 total landings. Since its last retread, the tire had worn 28 percent and had 125 landings.

The No. 2 tire, serial No. 6059AK0593R3, was manufactured by B.F. Goodrich Tire Company and retreaded to specifications by the Company's facility in City of Industry, California. The tire was installed originally on an American Airlines DC-10, where it had The wheel was built up on December 23, 1977, and the wheel and tire assembly was installed on the Continental DC-10 on December 24, 1977. The wheel and tire assembly had not been written up since installation. The tire had been retreaded three times. The tire carcass had 961 total landings. Since its last retread, the tire had worn 69 percent and had 233 landings.

The testing began on March 23 and was completed on April 23, 1978. Results of these tests indicated that both tires had been manufactured to acceptable commercial standards. Tire No. 1 showed catastrophic heat damage in the cords near the beads. Photomicroanalysis showed advanced fatigue in the outer plies of the carcass areas not involved in the latter stages of destruction. Tire No. 2 had excessive heat damage in the sidewalls. There was degradation and excessive working indicated in the outer plies and the breaker ply. Inspection of No. 2 tire revealed that the liner had been repaired in two places. In the repair process, the liner had been buffed and the cords were exposed. These repairs had been made when the tire was originally manufactured. The patches that normally cover such buffed areas were missing. To determine if these buffed areas could have allowed air to leak from the tire between the time the pressure was checked after the previous landing and the tire failure, dynamic leak tests were performed at the B.F. Goodrich Company on both a new tire that had no buffed areas in its liner and on a tire that had buffed areas in its liner. Based on these tests, the Safety Board concluded that if the repair patches were missing before the aircraft departed the airport terminal, the pressure loss during the taxi and takeoff run would have been about 4.5 psi, which would have reduced the tire pressure to about 180 psi.

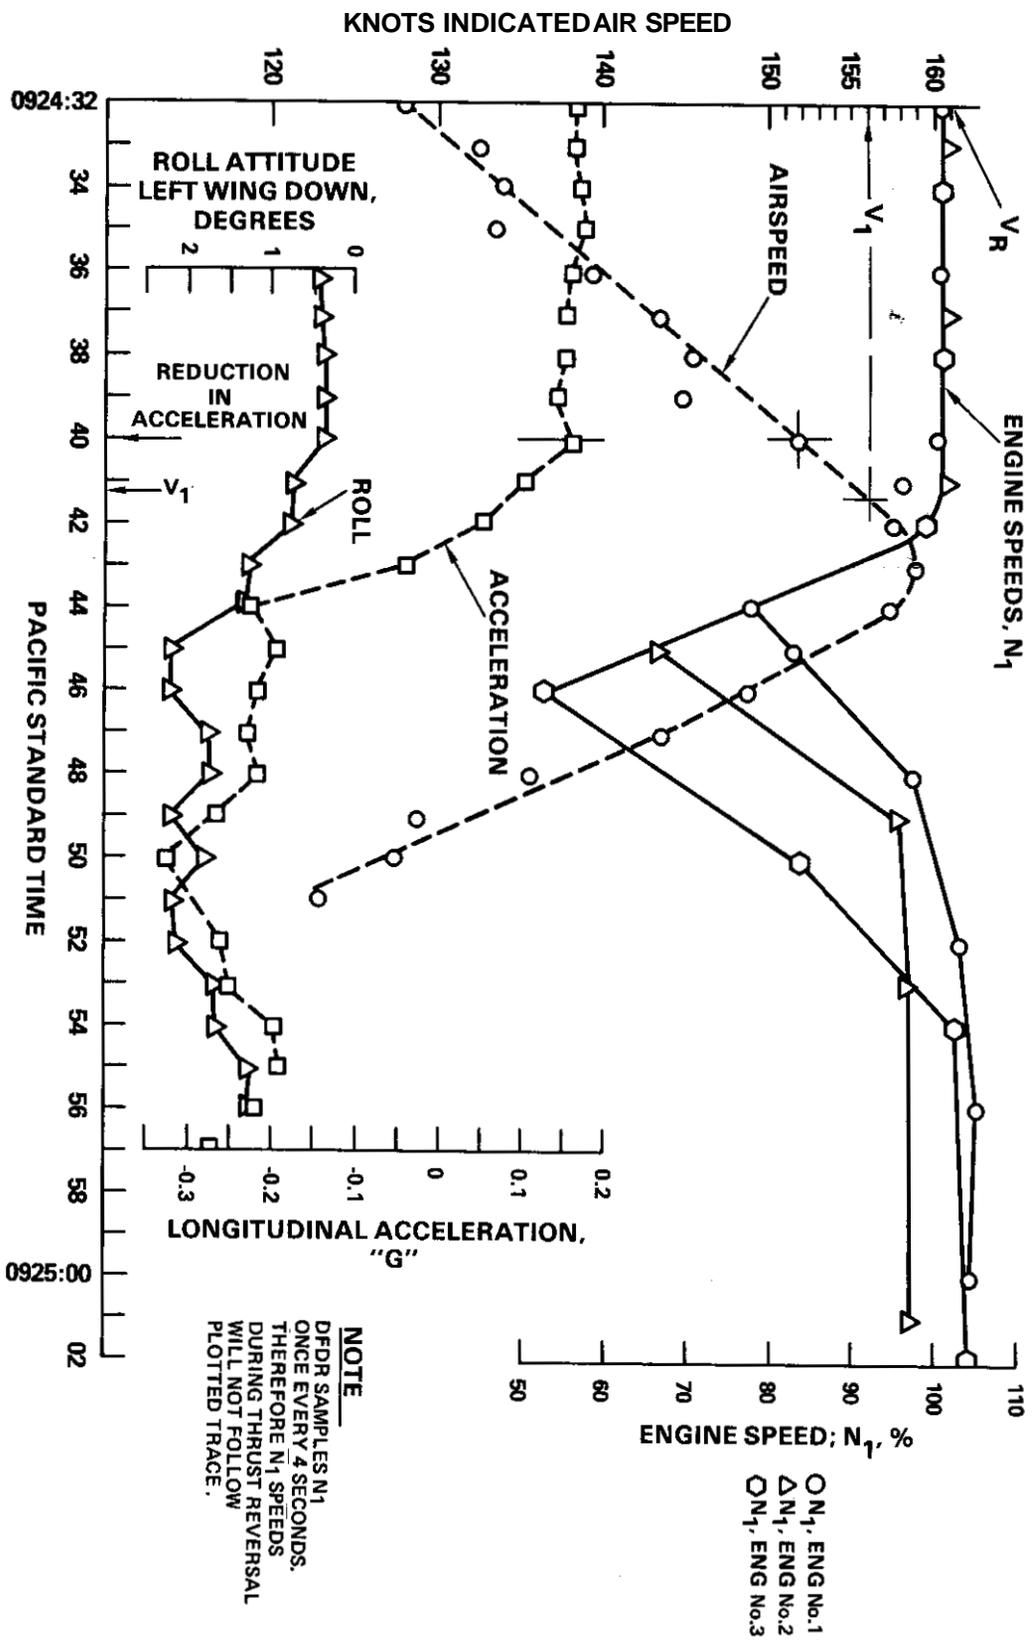
Figure 2. Aircraft performance before, after RTO initiation.

The DFDR data showed that the takeoff roll began from a static position on runway 6R at 0923:54. (See figure 2.) The wing flaps were set at 5°. Takeoff thrust was established at 101-percent N_1 on all engines as the aircraft accelerated through 37 kns. At 152 kns, 46 sec into the takeoff roll and 4 kns below V_1 , the longitudinal accelerometer began recording a marked decrease in the aircraft's acceleration although takeoff thrust was being maintained on all engines. No indications of tire failure were evidenced below 152 kns by the DFDR. At 152 kns, the DFDR roll attitude parameter began to record a gradual lowering of the left wing. V_1 speed, 156 kns, was reached 1.2 sec later, or 47.2 sec after the start of the takeoff roll. Engine thrust began to be reduced less than 0.5 sec after V_1 speed. A maximum speed of 159 kns, 2 kns below V_R , was recorded 1.8 sec after V_1 and 0.5 sec after longitudinal acceleration had changed from positive (acceleration) to negative (deceleration) values. Thrust reversers unlocked while the airspeed was decelerating through 157 kns at a peak deceleration rate of $-0.23g$. About 1.2 sec later, the thrust reversers were deployed at 152 kns as the engines were spooling down for thrust reversal and as the left wing reached its maximum down attitude of 2.1'. The engines began to spool up for thrust reversal 4.8 sec after V_1 ; maximum reverse thrust values were attained in 3 sec on the center engine, in 6 sec on the left engine, and in 8 sec on the right engine. Aircraft heading began to deviate to the right of the runway centerline as full reverse thrust was being attained. The heading reached 079°, the maximum deviation from the centerline, as the aircraft's speed decelerated through 58 kns.

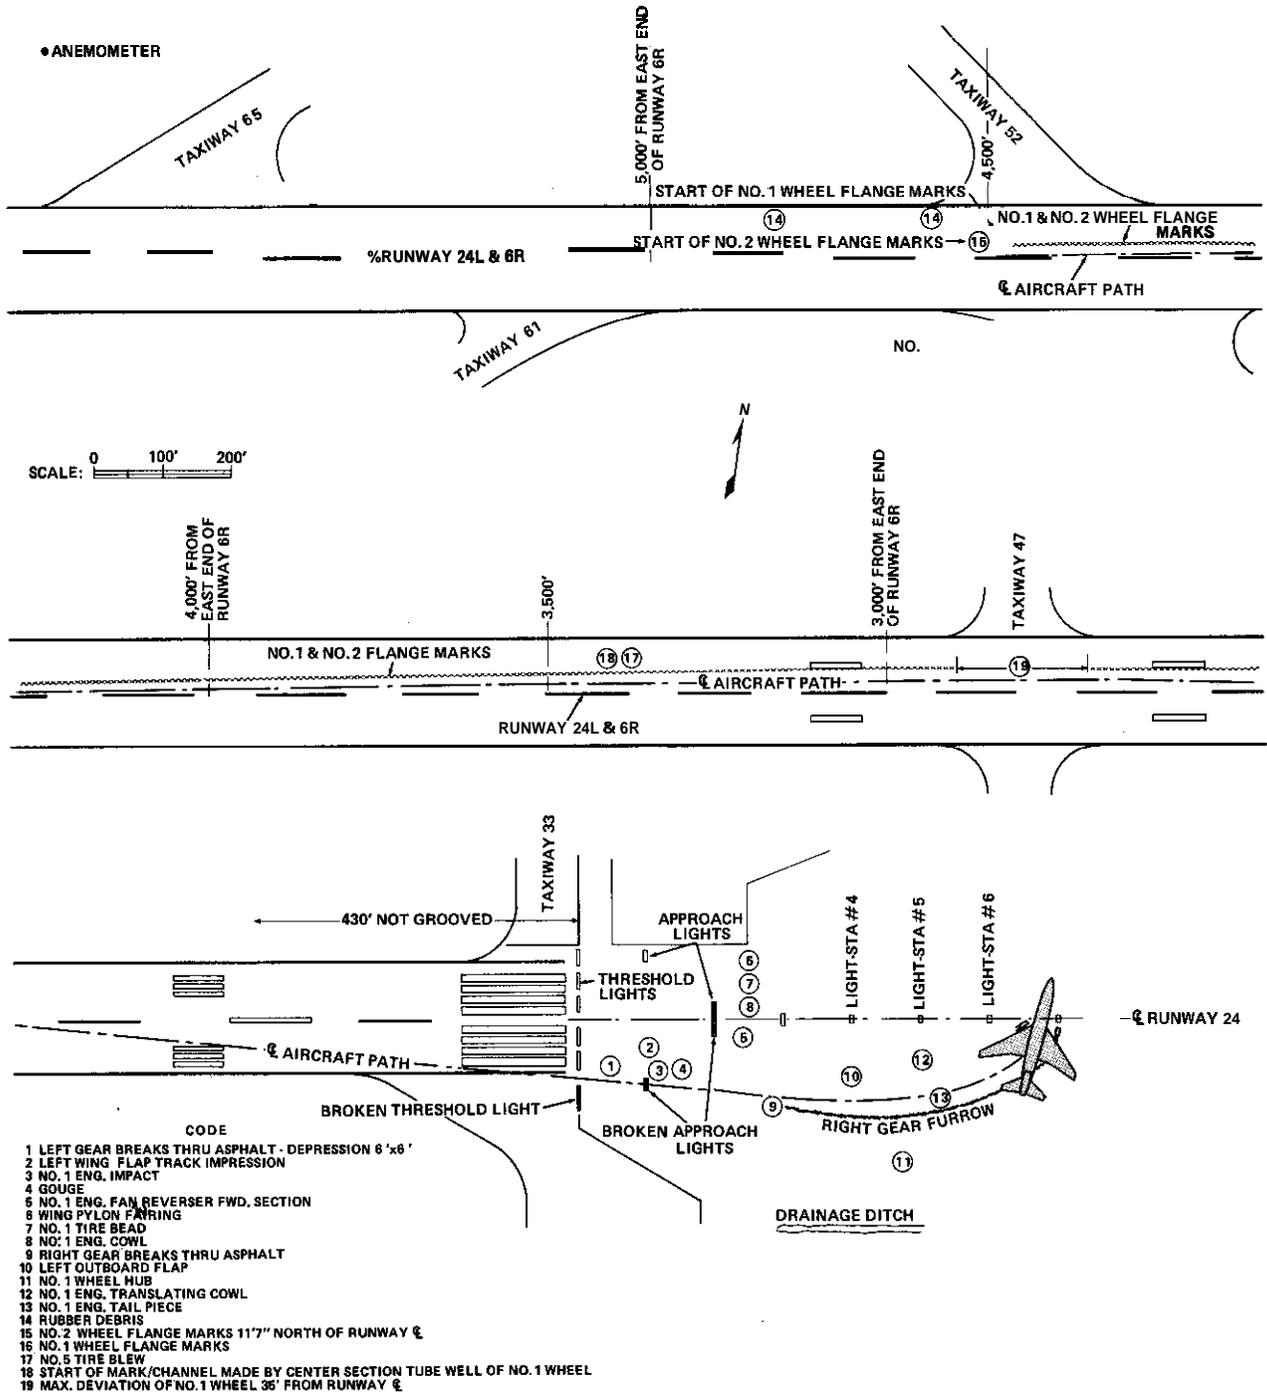
Figure 3. Aircraft wreckage distribution chart.

About 100 ft after the aircraft left the runway surface, the remains of the left main landing gear wheel and tire assemblies broke through the tarmac surface of the nonload-bearing area and the landing gear structure failed aft. The left-main landing gear strut was found trailing behind the wing; the lower end of the strut was supported by the No. 1 wheel and two brake assemblies, which were resting on the ground. The upper end of the Strut was not deformed and was connected to the main landing gear support fitting. The support fitting was not connected structurally to the wing box. Extensions of the wing upper skin, upper doubler, lower skin, and lower doubler aft of the wing rear spar connecting the gear support fitting to the wing box had failed. The upper skin had torn off along the rear spar. The lower skin had torn off aft of the rear spar. The lower doubler was torn off aft of the skin fracture.

The upper and lower auxiliary spar was torn off at the flap hinge fitting. Major fasteners connecting the support fitting to the wing box failed, except for the lower outboard 1 1/2-in.-diameter bolt connecting the support fitting to the wing box internal bulkhead, directly forward of the support fitting.

A trapazoidal portion of the wing rear spar web (about 3 1/2 sq ft) remained attached to the landing support fitting. This opened up the No. 1 fuel tank. The rear spar shear web and doubler had failed. A length of the vertical tang of the rear spar lower cap and a portion of the lower outboard cap of the wing chordwise internal bulkhead also remained attached to the landing gear support fitting. The wing bulkhead upper 1-in. bolts failed 1 in. aft of the rear spar web. The lower inboard 1 1/2-in.-diameter bolt was missing from its hole. A portion of the lower bulkhead cap remained on the lower outboard 1 1/2-in.-diameter bolt. A section of the rear spar web and vertical tang of the lower cap had broken loose at the outboard end of the landing gear fitting, which created a 1-sq-ft hole in the aft wall of the left compartment of the No. 2 fuel tank.

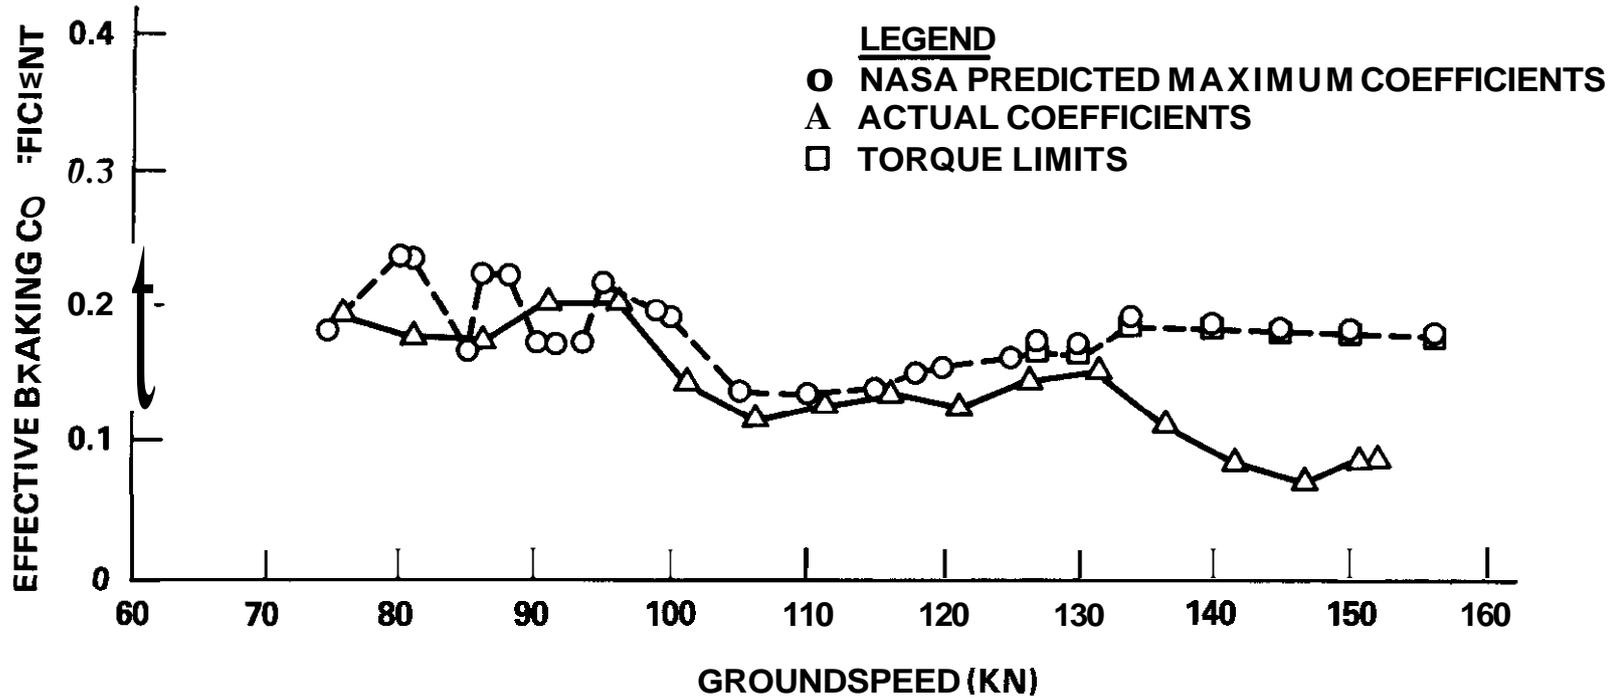
Figure 4. Comparison of actual and predicted maximum braking capabilities.

The actual rejected takeoff braking performance for the Continental DC-10 was calculated using DFDR data and aerodynamic data. These calculations produced a relationship between effective tire-to-pavement frictional coefficients and aircraft groundspeed. When these results were compared to the NASA-predicted maximum braking coefficients over the same speed range, substantial differences were found in the 153 kns to 132 kns groundspeed range, during which the aircraft traveled about 1,200 ft in the initial portion of the takeoff. For groundspeeds between 132 kns and 68 kns (the end of runway speed), the Douglas and NASA braking values substantially agreed, indicating that maximum braking was being achieved over the last 2,250 ft of runway. (See figure 4.) Three possible reasons for the disagreement above 132 kns are: (1) The values predicted by NASA could have been excessive, (2) temporary loss or delay in antiskid system operation, and (3) the crew could have applied less than maximum brake pressure. If the predicted braking levels above 132 kns had been achieved, the aircraft might have stopped intact about 200 ft beyond the departure end of the runway. The Safety Board was not able to quantify the actual amount of braking effort applied by the crew or to accurately determine why the full braking values predicted by the NASA theory were not achieved.
