January 24, 1975
C1-750-33/COM PROGRAMS
10-35-00-05
AOL 10-742A

Subject: PASSENGER OXYGEN SYSTEM MAINTENANCE, DC-10

Applicable to: All DC-10 Passenger Aircraft

This service sketch defines those items necessary to upgrade the passenger oxygen compartments located in the seatbacks, overheads, and partitions for improved reliability.

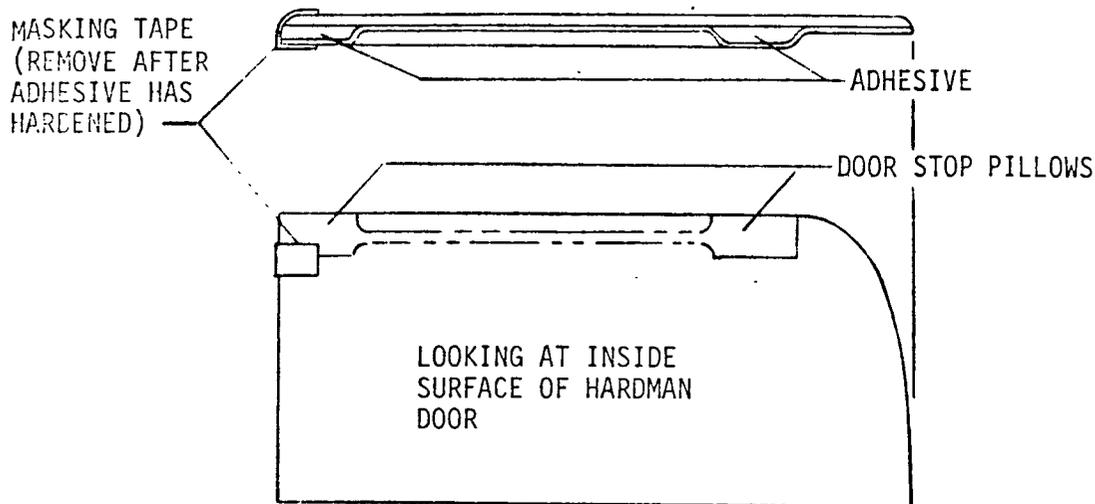
III. HARDMAN DOOR REWORK

- A. Fill flush door stop pillows on Hardman seats only using epoxy adhesive or equivalent rigid filler.

NOTE: It is suggested that masking tape be placed on adjacent door faces to prevent adhesive from defacing door.

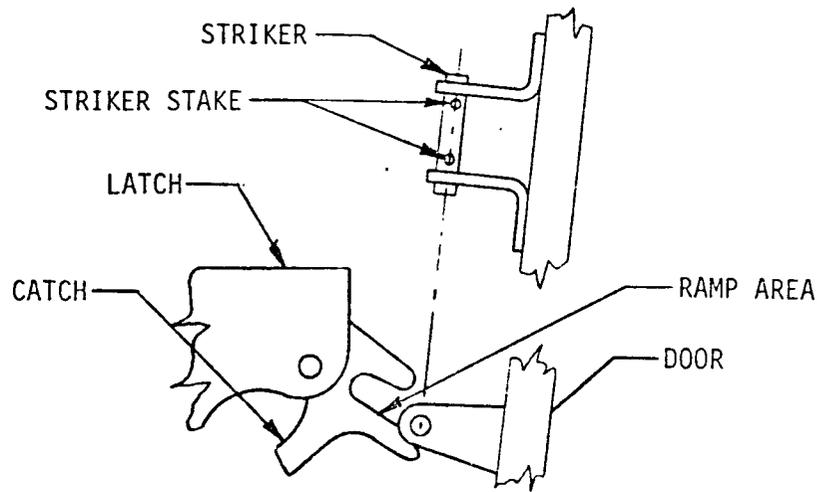
The striker shall be parallel to the top of the door. The latch catch shall be normal to the plane of the door stops. The striker shall approach the latch catch and contact the catch in the ramp area as shown below. The catch shall not contact the staked area of the striker and the

striker shall not contact any portion of the body (or spring) of the latch in any position of the door including side play (see sketch below).

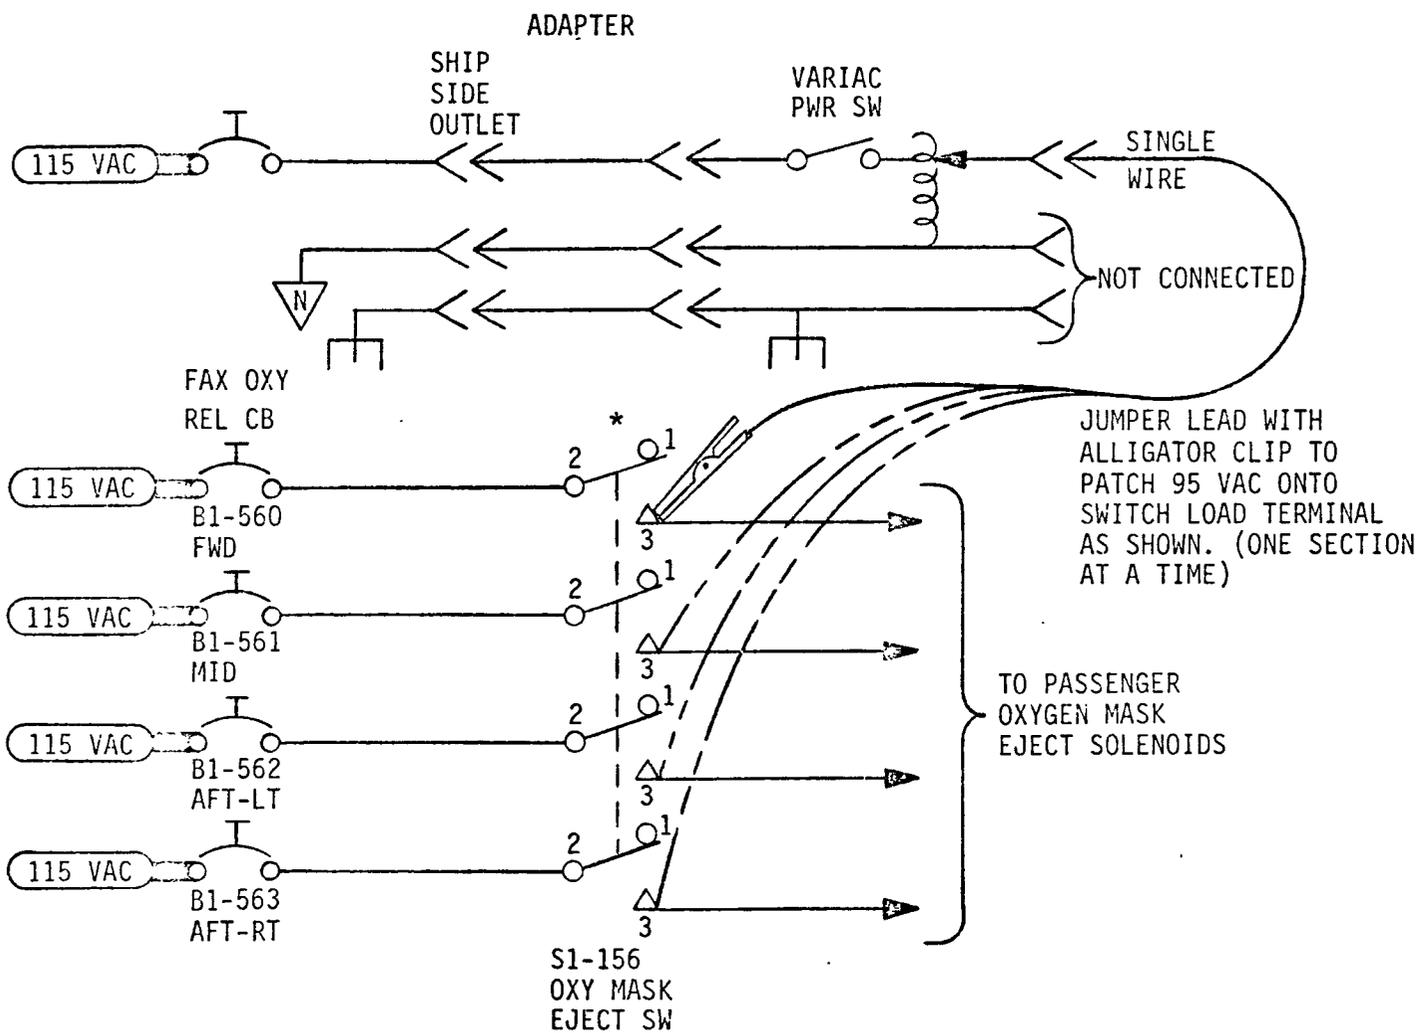
FIGURE I

- A. Add restraint to all oxygen compartment doors to prevent full opening and inadvertent generator firing.
- B. De-energize the four "PAX OXY REL" circuit breakers located on the Flight Engineers circuit breaker panel.
- C. Set up the electrical test circuitry shown in Figure 1, Page 6, Connect the power jumper lead from the VARIAC to the respective section switch screw terminal as noted below:

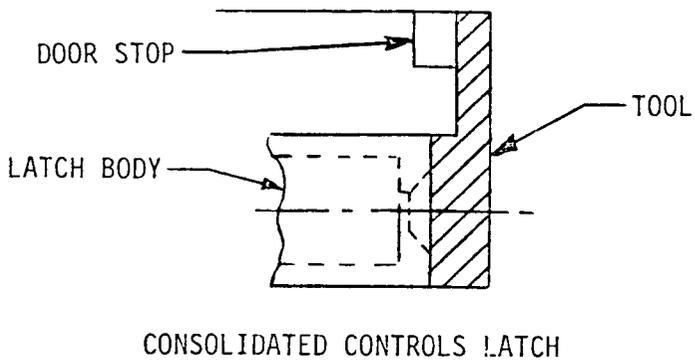
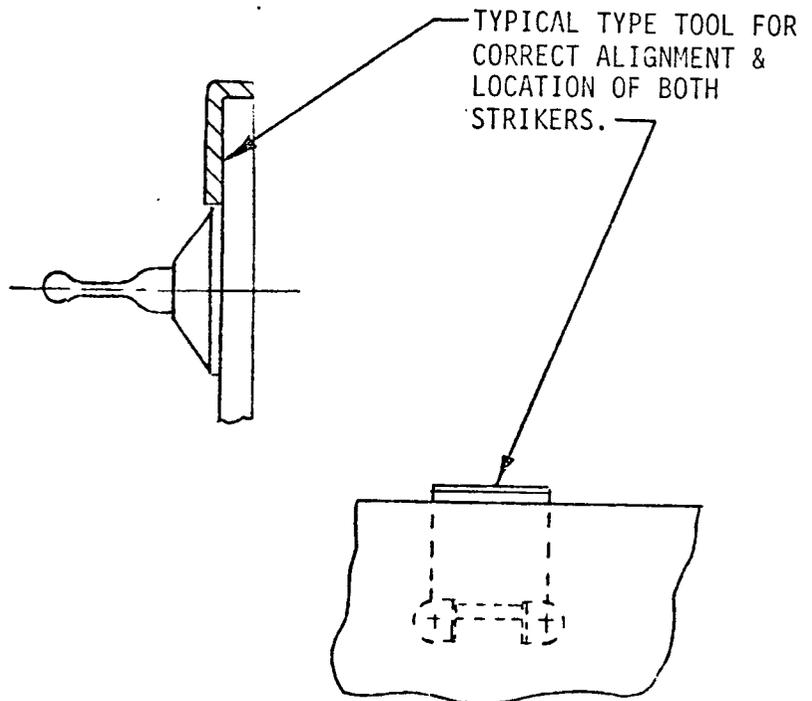
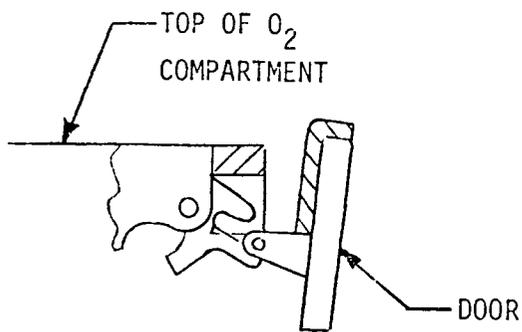
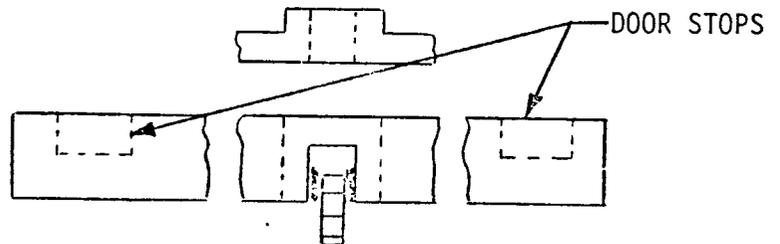
FIGURE II

C. See sketch for typical tool aids, Page 7, Figure II

TYPICAL TYPE TOOL FOR ALIGNMENT AND CORRECT LOCATION OF BOTH LATCHES.
