AIRCRAFT ACCIDENT REPORT

PAN AMERICAN WORLD AIRWAYS, INC
BOEING 707-121, N709PA
NEAR ELKTON, MARYLAND
DECEMBER 8, 1963

SYNOPSIS

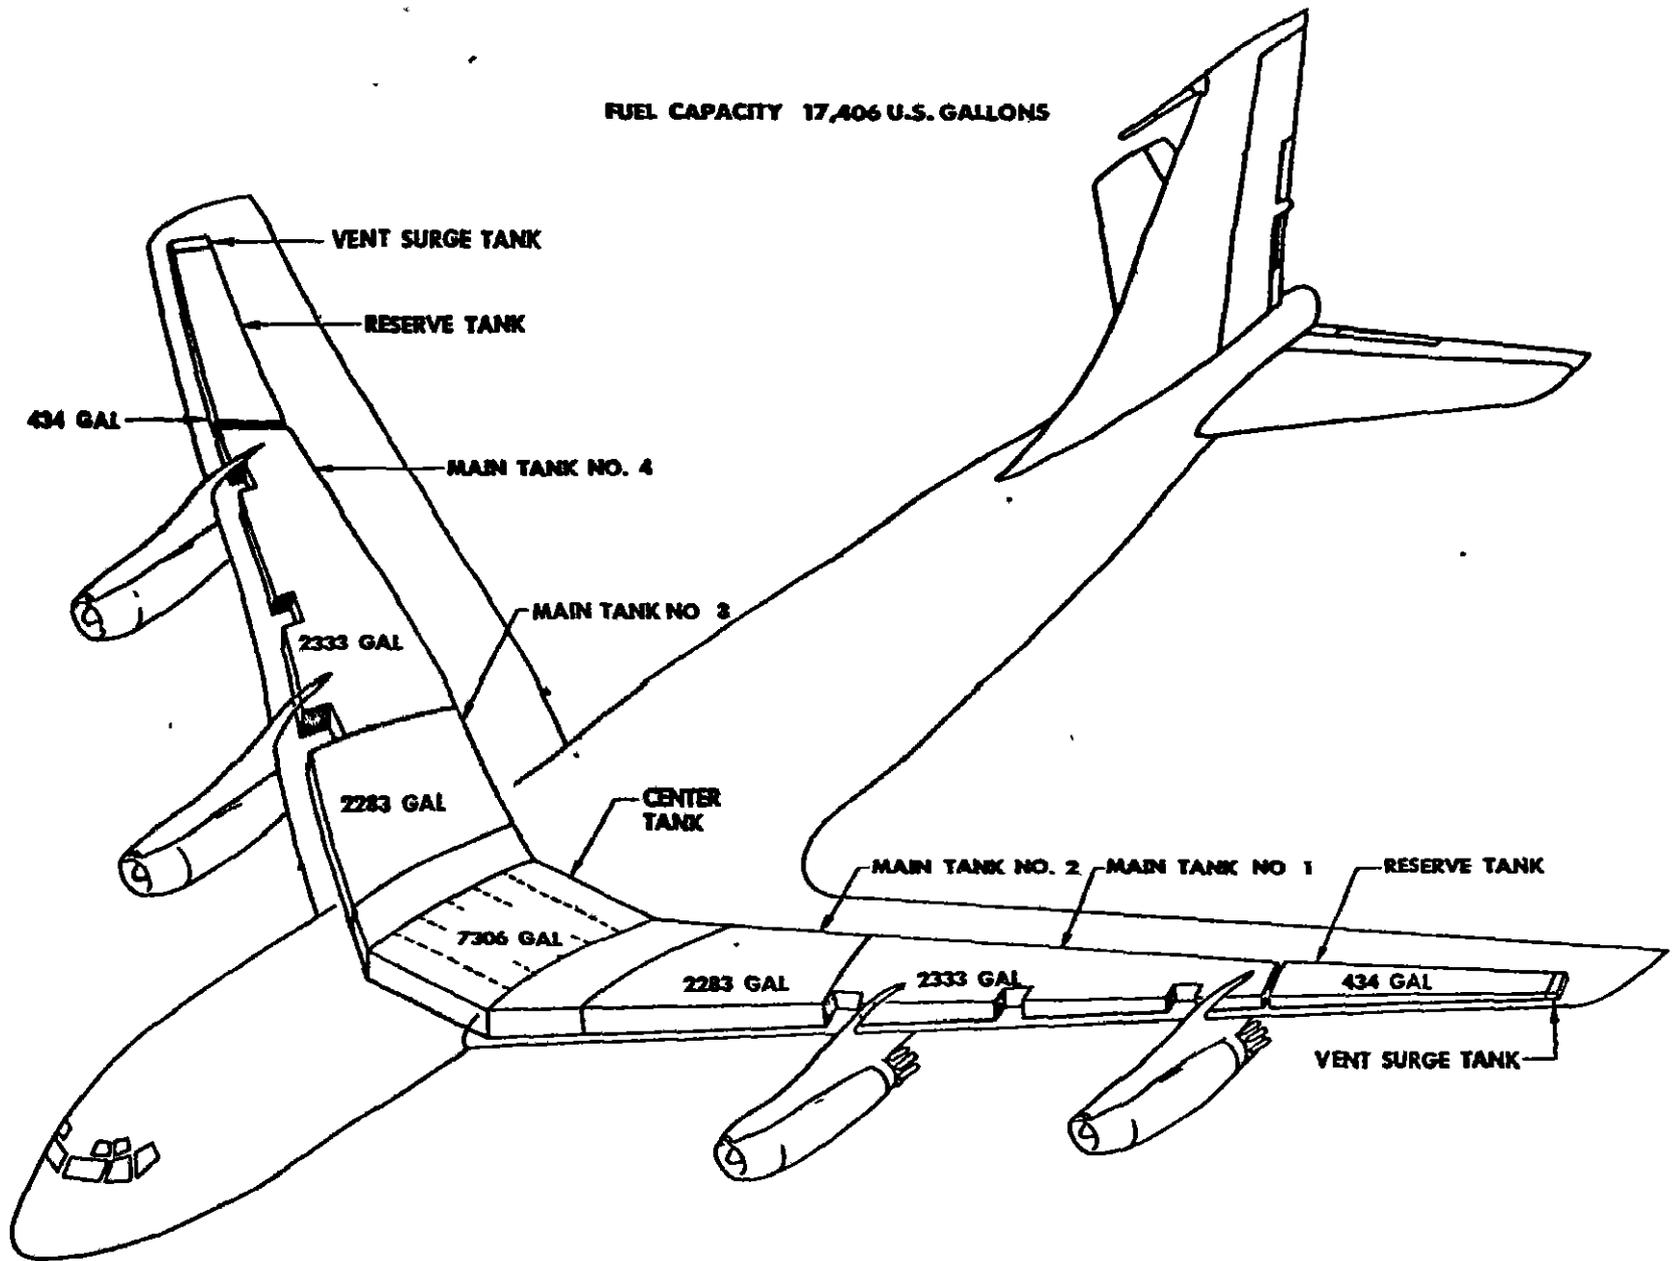
FUEL TANK ARRANGEMENT

The surge tank box^{7/} was intact except for a 2.2 inch opening along the top extending from spar to spar. This opening encompassed the surge tank end of the vent passages from the fuel tanks. The ends of the fracture curled up and were moderately sooted. The bottom surge tank skin was curled downward at a fracture line along the tank end closure rib. Very slight outward bulging of the tank end rib was noted. The interior of the surge tank was heavily sooted on all sides and the sealant was burned inside.

The center tank ^{8/} bottom skin was separated in three pieces. Stiffeners and access doors were bowed outward. The largest section was bowed chordwise in an outward direction. There were no signs of fire damage
