Bulletin 52-27
DC-10 SC 612

SERVICE BULLETIN

BULLETIN 52-27
DC-10 SC 612

DOORS - Cargo - Revise Door Latch Actuator Wiring.

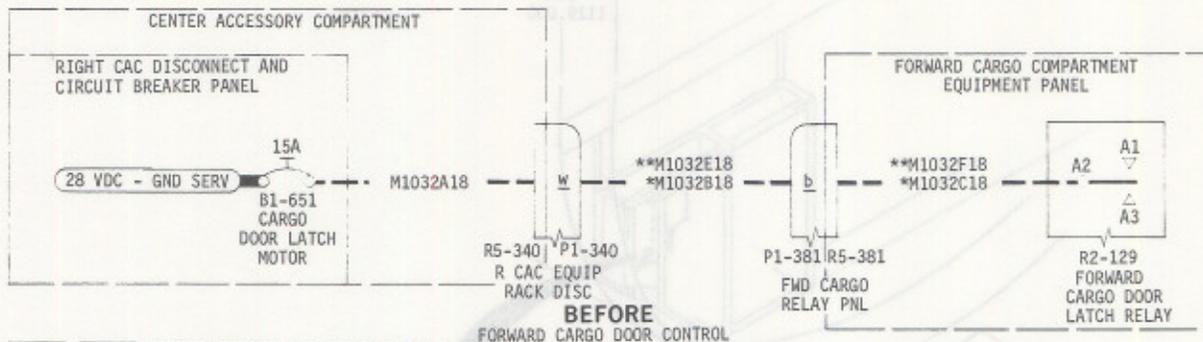
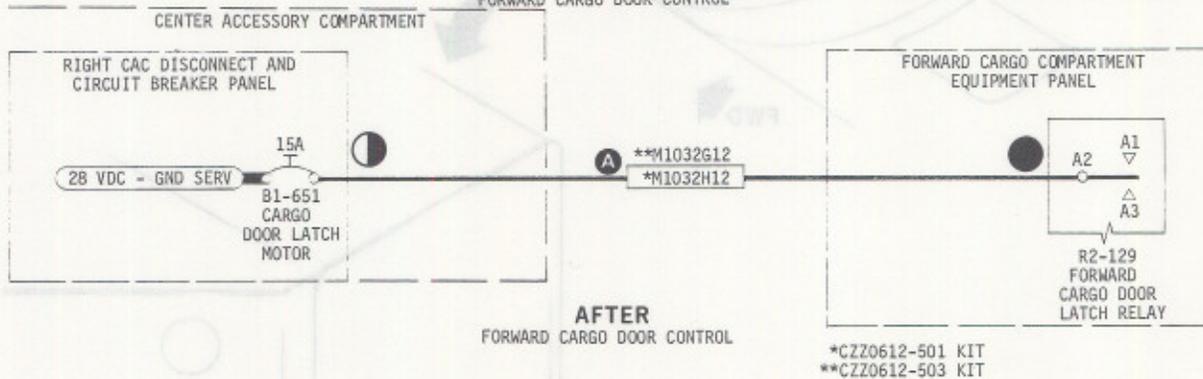
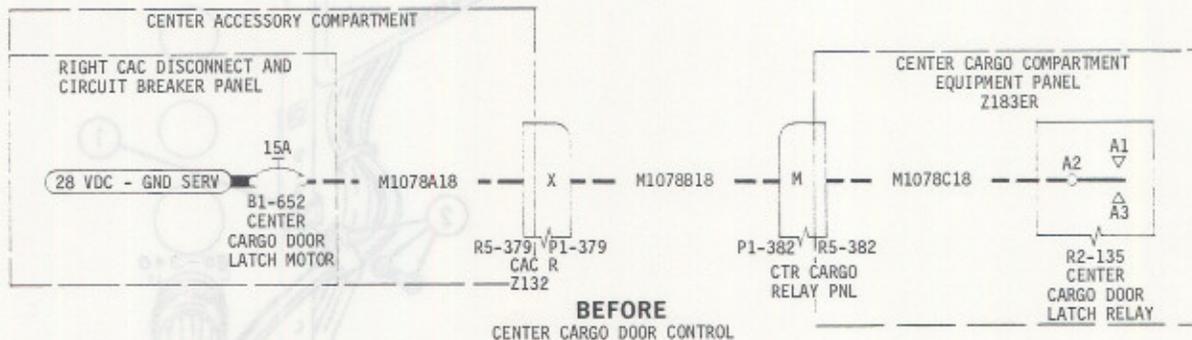
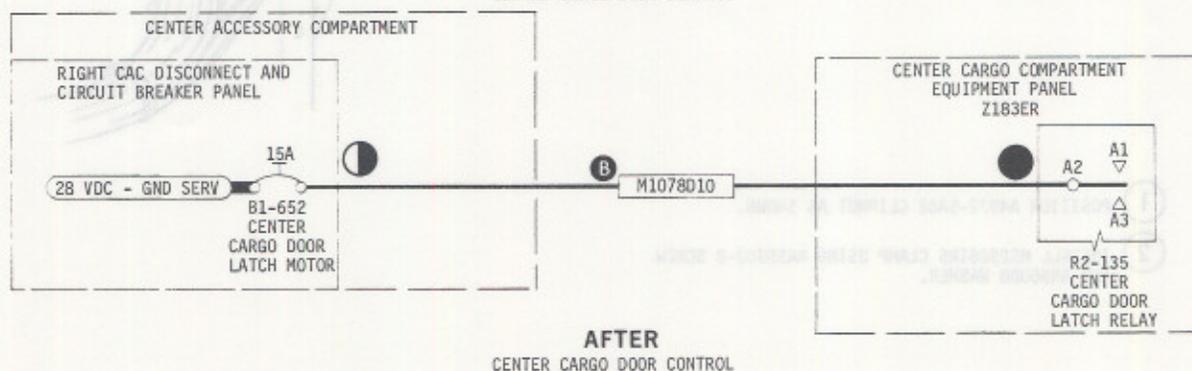
FIGURE 2 (SHEET 1 OF 2)

REVISION IS TYPICAL FOR CZZ0612-501 AND -503 KITS, EXCEPT AS NOTED

- B. Install clamp in center accessory compartment as shown on Figure 1.
- C. Revise forward, center, and aft cargo door latch actuator wiring as shown on Figure 2, using CZZ0612-3 or -5 wire package as applicable. Perform continuity checks during installation.

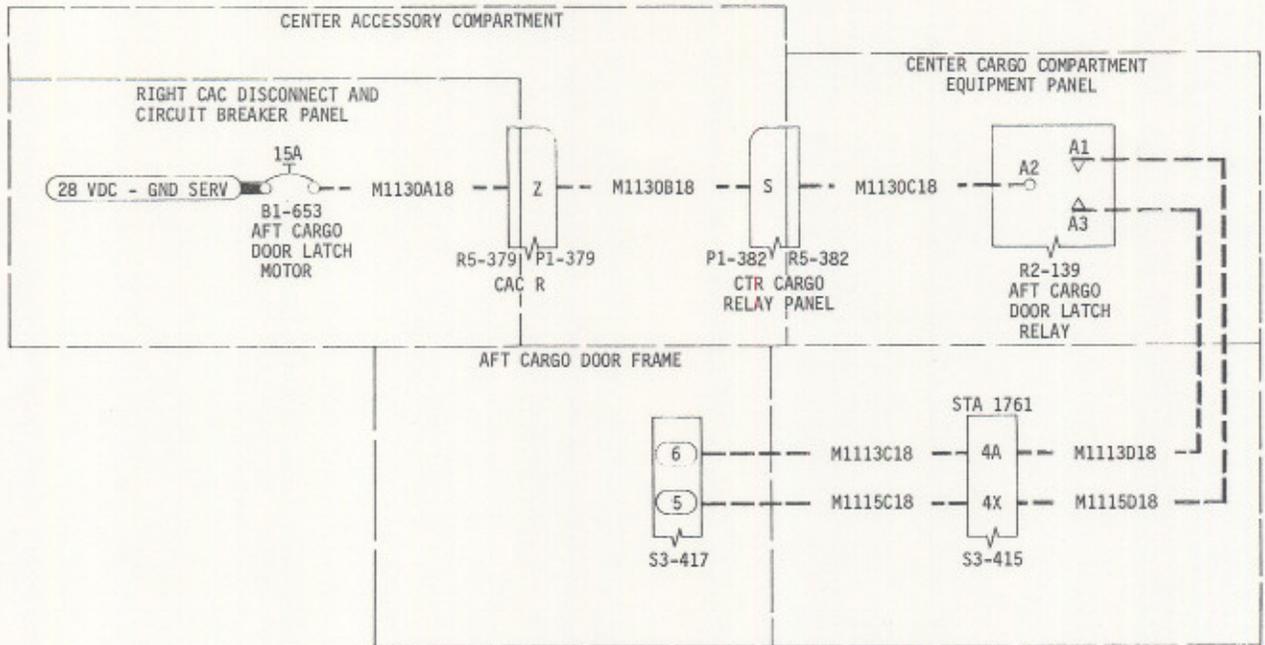
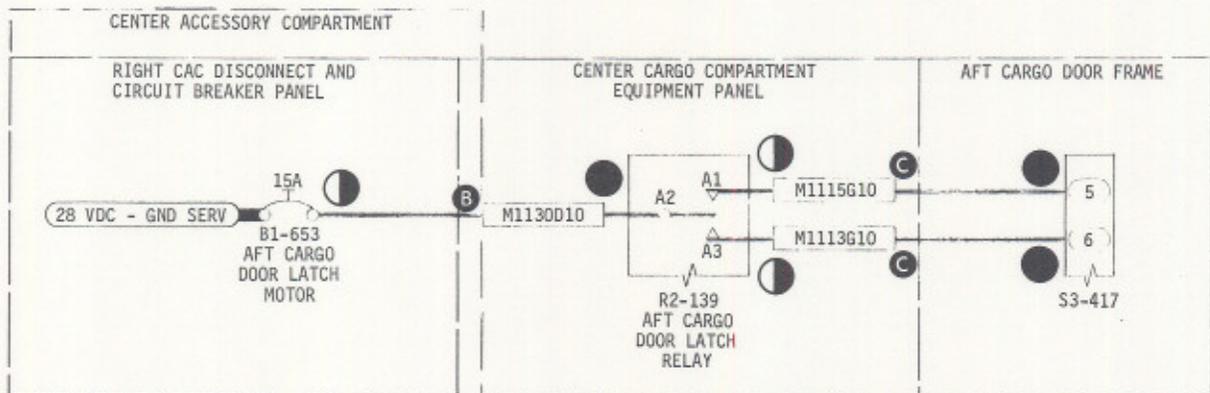
FIGURE 2 (SHEET 2 OF 2)

BEFORE
AFT CARGO DOOR CONTROL

AFTER
AFT CARGO DOOR CONTROL

- B. Install clamp in center accessory compartment as shown on Figure 1.
- C. Revise forward, center, and aft cargo door latch actuator wiring as shown on Figure 2, using CZ30812-3 or -5 wire package as applicable. Perform continuity checks during installation.
