**DC-10****SERVICE BULLETIN**

Bulletin 52-38
DC-10 SC 858/1003

DOORS - Cargo - Replace Cargo Door Latch Access Covers.

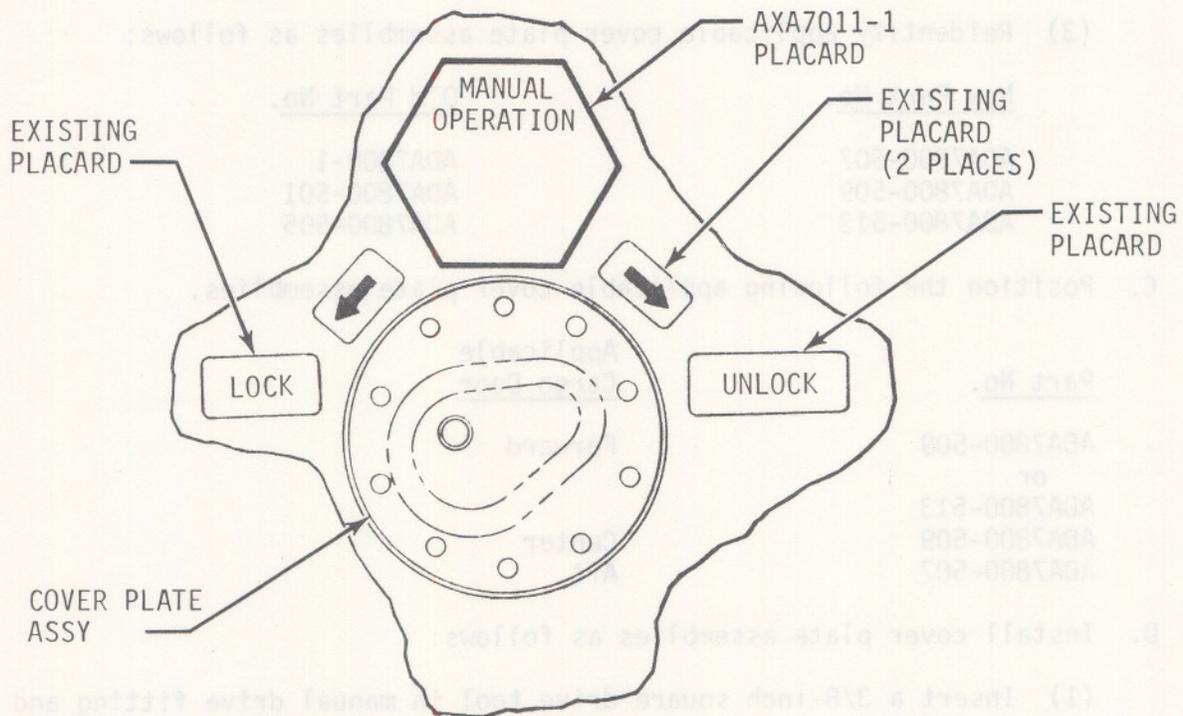
TYPICAL PLACARD INSTALLATION
(3 PLACES)

The affected operators have reported 130 flight delays due to the inability to electrically latch the cargo doors. If the door fails to latch electrically, an access door must be removed to latch the door manually. Installation of a new cover plate assembly incorporating a latch tool opening will delete the requirement to remove the access door.

- (2) Drill ten .190/.194-inch diameter holes through cover plate assembly using holes in cargo door as guides.
 - (3) Countersink holes in cover plate assembly 100° x .391-inch diameter.
 - (4) Install cover plate assembly using PR-1422 sealant and retained screws.
- E. Install new AXA7011-1 placard above each cover plate assembly approximately as shown on sketch.
- F. Reidentify applicable cargo door assemblies as follows:
