NATIONAL TRANSPORTATION SAFETY BOARD

AIRCRAFT ACCIDENT REPORT

EASTERN AIR LINES, INC.
L-1011, N310EA
MIAMI, FLORIDA
DECEMBER 29, 1972

Report Number: NTSB-AAR-73-14

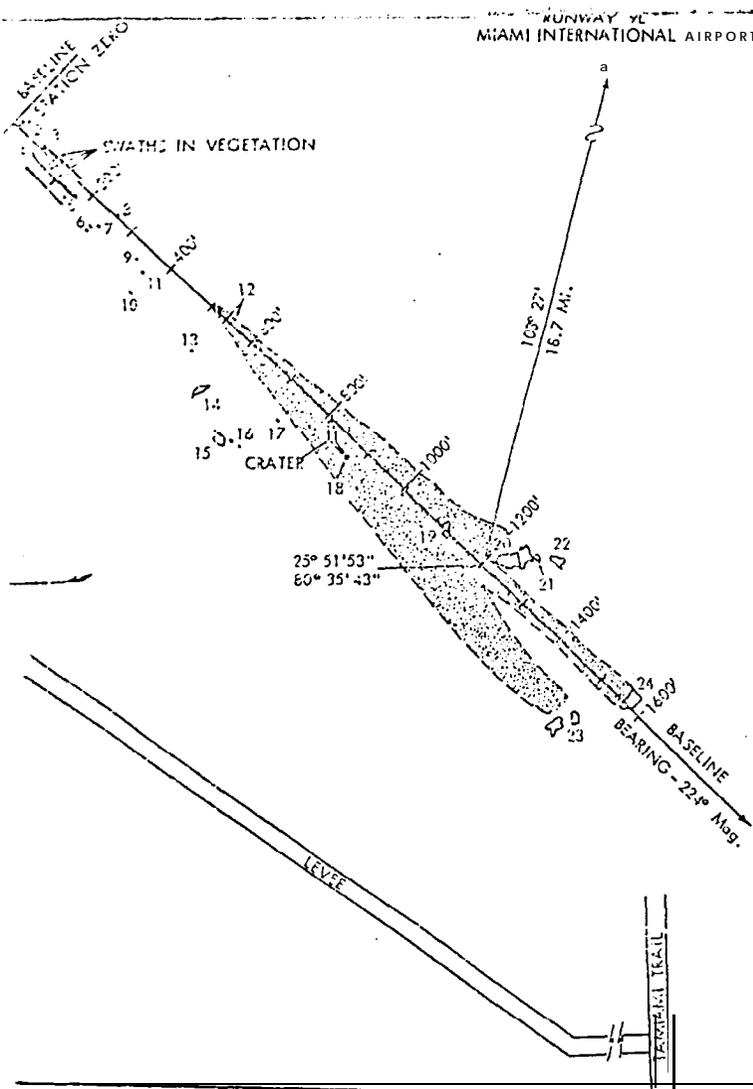
APPENDIX D

The left outer wing structure impacted the ground first; the No. 1 engine, and then the left main landing gear, followed immediately. The aircraft disintegrated, scattering wreckage over an area approximately 1,600 feet long and 300 feet-wide. No complete circumferential cross-section remained of the passenger compartment of the fuselage, which was broken into four main sections and numerous small pieces. The entire left wing and left stabilizer were demolished. No evidence of in-flight structural failure, fire, or explosion was found.

- 1-4. Small pieces of left-hand wing, outer structure.
5. Small engine parts - fan blades, Oil cooler.
6. Engine mount frame, part of No. 1 fan case, oil scavenge filter.
