# Aircraft Accident Report

**Crash Into The Sea After An In-Flight Fire**

**Boeing 747-400F, HL7604**

**28 July 2011**

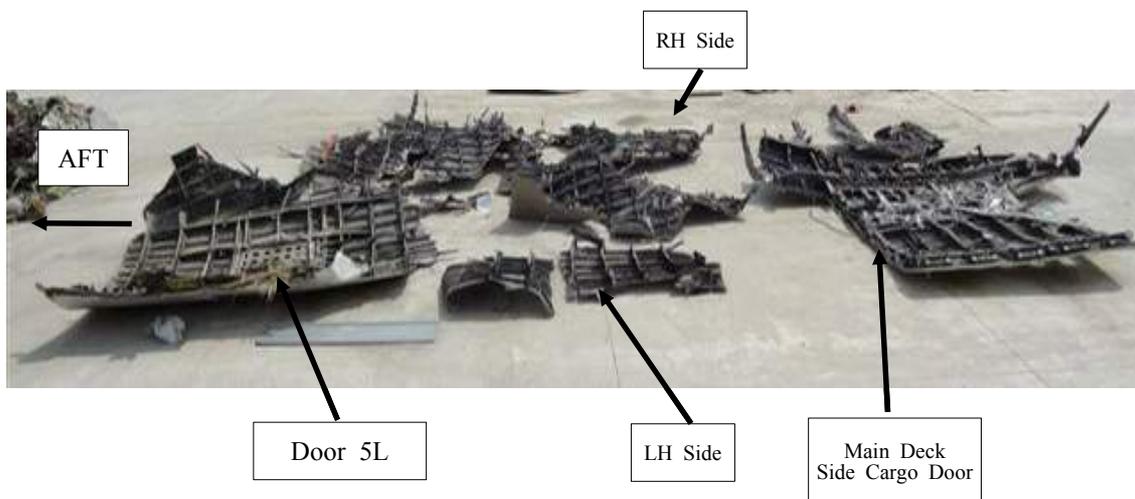
[Figure 16] Severely Fire Damaged Aft Fuselage Structure

As shown in [Figure 16] and [Figure 17], the wreckage items were positioned in relative close proximity to one another in the yard of the Incheon wreckage storage facility in accordance with the level of fire damage, and their levels of damage and trace of fire were examined and documented.

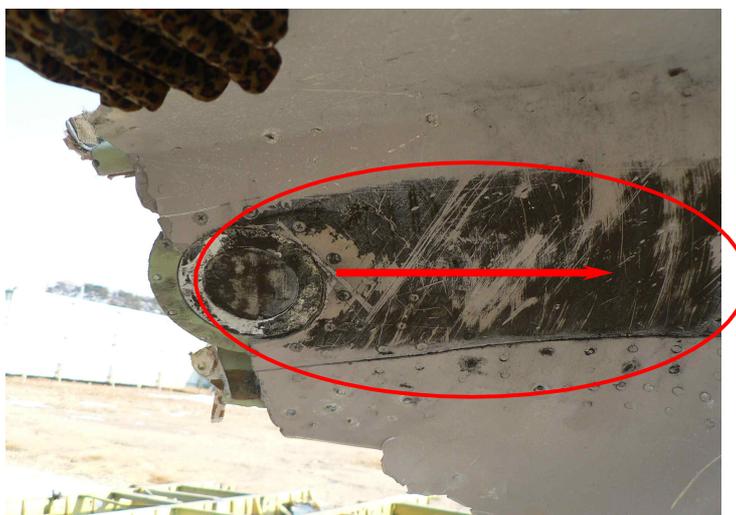
[Figure 19] Sooting on the Exterior Skin of Cockpit Smoke Evacuation Shutter

As shown in [Figure 19], the cockpit smoke evacuation shutter was found closed, but a well defined soot trail was discovered on the exterior skin of the shutter in the rear fuselage direction.

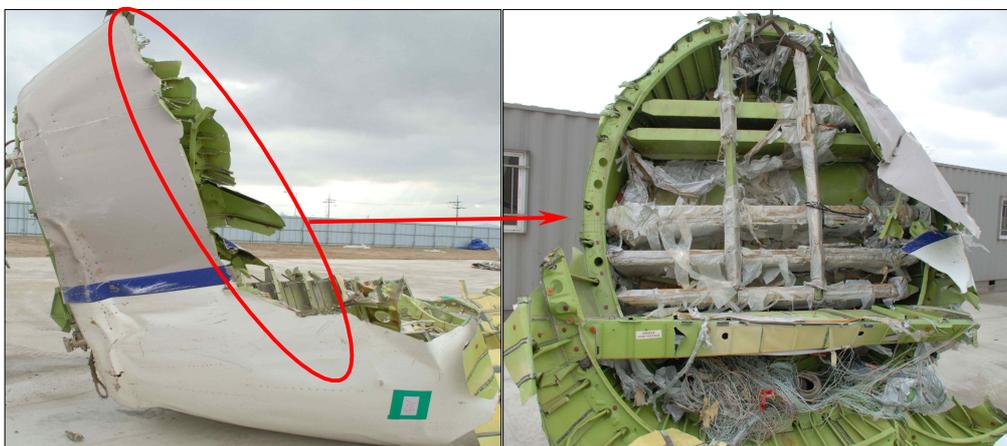
[Figure 24] Forward Cargo Door

As shown in [Figure 24], a forward section of the nose cargo door was separated from the fuselage at FS 160/180, and the radome was missing. The skin demonstrated compressive buckling 360 degrees along the leading edge. The forward pressure bulkhead was hydro formed. Upper portions of both sides of the door, including the hinges, were recovered with the cockpit section.

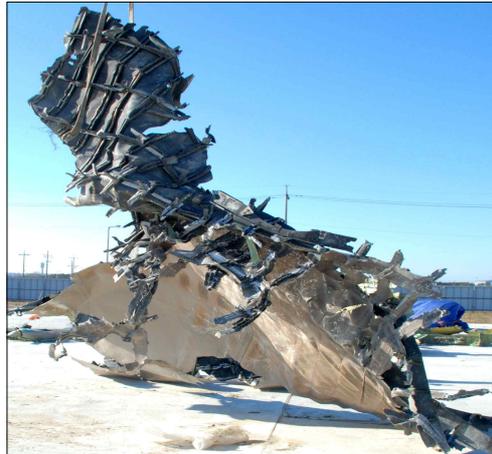
[Figure 26] Fire Damage to the Skin Between FS2180 & FS2360

Portions of the wreckage in the region between FS1740 and FS2360 contained direct thermal damage on the exterior skin as evidenced by melting of internal metal structure and discoloration of the exterior paint. As shown in [Figure 26], the skin panel that extended from FS2180 and FS2360 sustained severe thermal damage as evidenced by twisted and melted stringers and ribs, holes on the surface, and paint discoloration on the exterior of the skin. The skin panel also contained areas which were burned through.

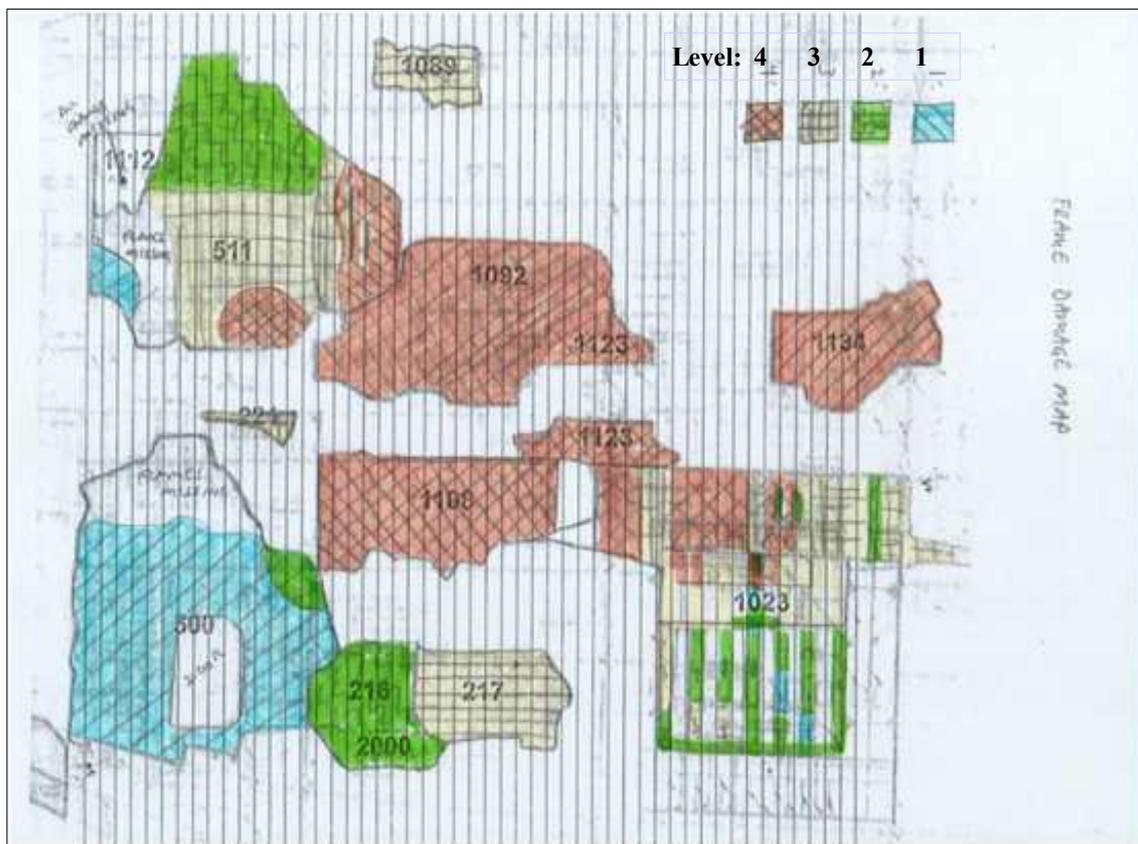
[Figure 33] Fuselage Frame Thermal Damage Map of the Wreckage Between FS1700 & APB

The wreckage between FS1700 and APB sustained the most severe fire damage. Detailed thermal damage maps were generated for these portions of the aircraft. These portions were mostly between the aft main deck cargo door and the L5 door as shown in [Figure 33]. This area can be characterized overall as having been exposed to high temperatures as evidenced by severe thermal damage on the interior structure and discoloration of the paint on the exterior of the aircraft's skin.

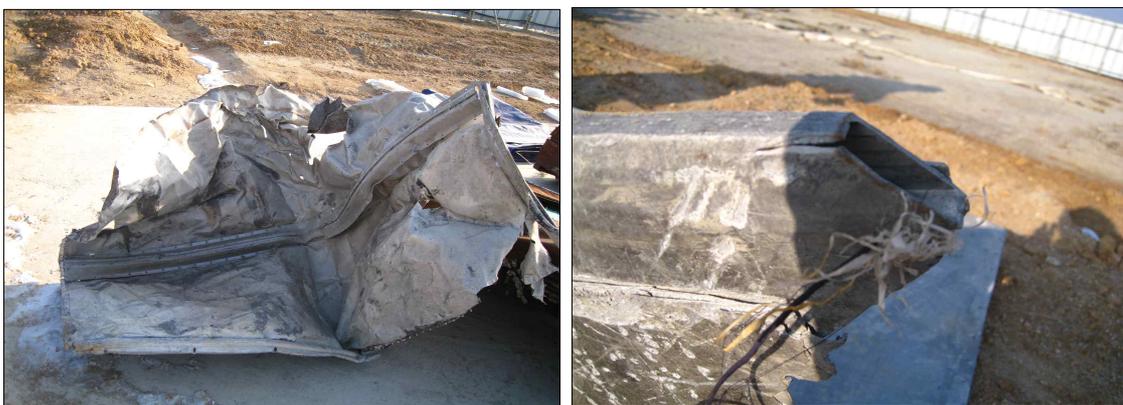
[Figure 38] Inside (Left) & Outside (Right) of the ULD Container

The cargo configuration of the main deck and lower cargo compartments on AAR991 can be found in [Figure 5]. The main deck cargo compartment was loaded with pallets and one ULD container (at position LL) which was recovered. No evidence of fire damage was found on the inside of the ULD as shown in [Figure 38], but the outside of it was heavily covered in soot.

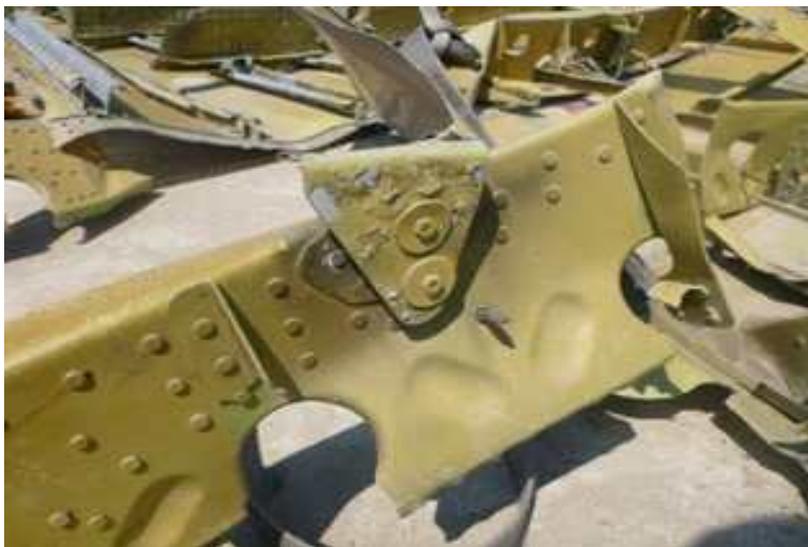
[Figure 42] Fuselage Frame at FS500 on LH Side in the Main Deck Cargo Compartment

As shown in [Figure 42], among the farthest forward wreckage (FS480 - 700), sooting was found on the fuselage frame at FS500 on the LH side in the area of the main deck cargo compartment. As shown in [Figure 43], sooting was also found on the upper deck floor beams as far forward as FS520.
