# DC-10 Type Certificate Lifted

**FAA action follows finding of new cracks in pylon aft bulkhead forward flange; crash investigation continues**

By David M. North

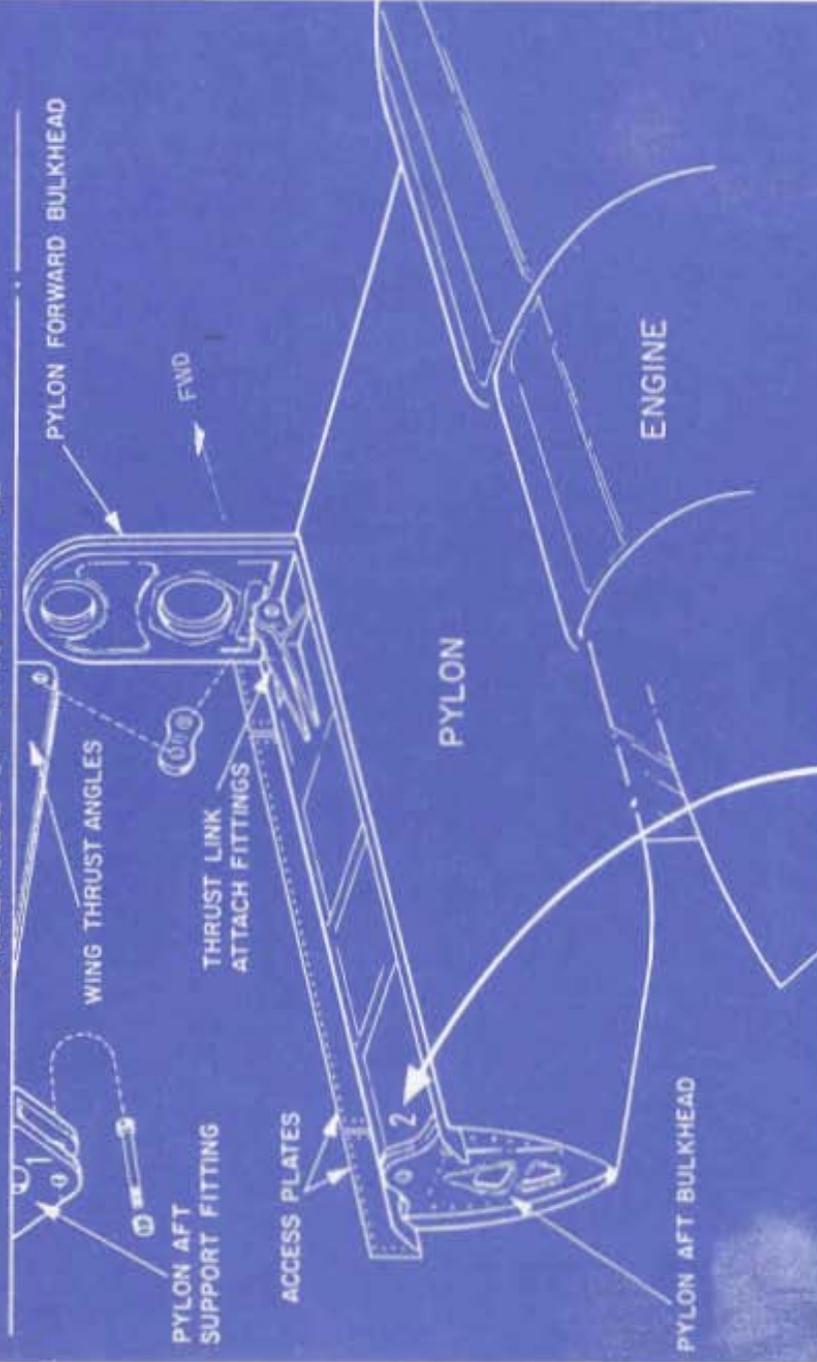
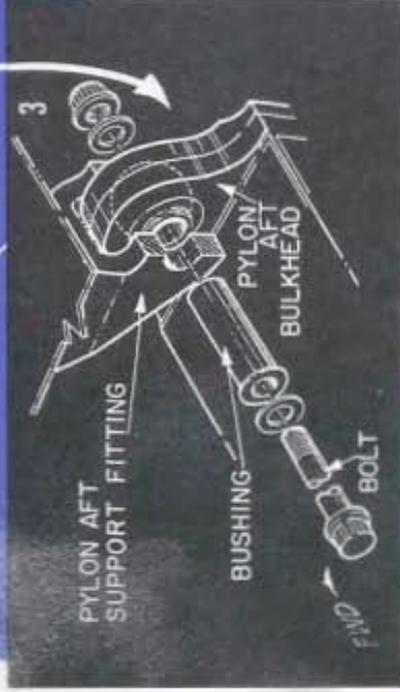
## UNDERSIDE OF WING SURFACE

Current National Transportation Safety Board and the Federal Aviation Administration investigations are centered on cracks found in the forward flange on the pylon aft bulkhead fitting. The safety board said the 2-in. and 5-in. cracks found in the flanges of two American Airlines DC-10s and the 10-in. crack found in the crashed DC-10 could have been caused by the pylon aft support fitting (1) impacting the upper flange assembly (2) when the pylon, with engine attached, was lifted for assembly to the wing by a forklift. Fig. 3 is a detailed drawing of the assembly, with flange cracks directly beneath the attachment fitting.

"The damage observed on both N106AA and N119AA was a crack in the center of the horizontal upper flange directly beneath the attachment bearing. The crack on N106AA was reportedly 2 in. long and the crack on N119A was reportedly 5 in. long. When inspected visually, it was apparent that the crack on N106AA was caused by physical impact. Further investigation disclosed that this impact probably occurred when the pylon was installed during previous maintenance.

"Board personnel who observed this procedure noted that the forklift operator had limited control in the precise placement of the aft bulkhead fitting into the wing-mounted clevis during reinstallation of the pylon. Vertical misalignment of a fraction of an inch can result in the pylon aft bulkhead upper horizontal flange assembly striking the forward ear of the wing-mounted clevis, causing the flange to crack.

More specifically on the DC-10 accident, the safety board's recommendation to the FAA said: "While the investigation of the accident involving N110AA is continuing, preliminary evidence indicates that the forward flange on the No. 1 pylon aft bulkhead fitting had failed completely. Metallurgical examination disclosed that there was a preexisting crack about 10 in. long in the same area where cracks were evident on the other two aircraft. N110AA had been subjected to the engine removal and reinstallation procedure on Mar. 30, 1979. The aircraft had accrued 430 flight hours since that time."

In the June 4 recommendation, the NTSB asked the FAA to issue a telegraphic airworthiness directive requiring an immediate inspection of all DC-10 aircraft in which an engine pylon assembly has been removed and reinstalled during the recent inspections and another recommendation that the practice of lowering the pylon with the engine attached be discontinued by the DC-10 operators.

The supplement was directed at those operators who had used the pylon and engine assembly procedure, and required they perform a new inspection of the pylon aft bulkhead and reinstall the pylon and engine separately prior to further revenue flight. The directive was believed by FAA to be applicable to six DC-10s, four of U. S. registry and two foreign registered.

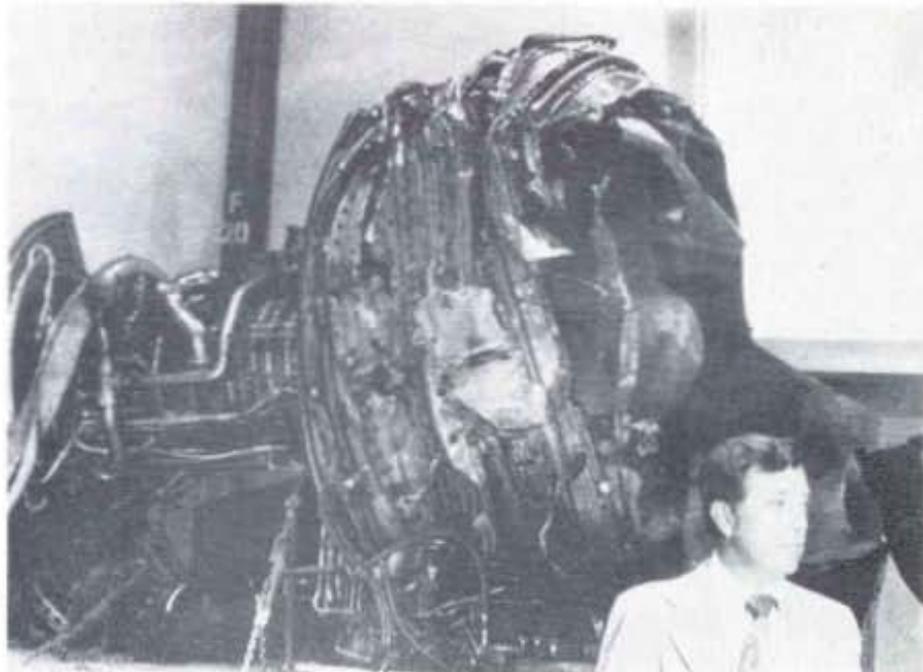
General Electric CF6 engine from the American Airlines DC-10 Chicago crash is inspected at American Airlines' maintenance center in Tulsa, Okla. (Wide World)
