NATIONAL TRANSPORTATION SAFETY BOARD

REPORT

**AIR CANADA FLIGHT 797
McDONNELL DOUGLAS DC-9-32, C-FTLL
GREATER CINCINNATI
INTERNATIONAL AIRPORT
COVINGTON, KENTUCKY
JUNE 2, 1983**

NTSB/AAR-86/02

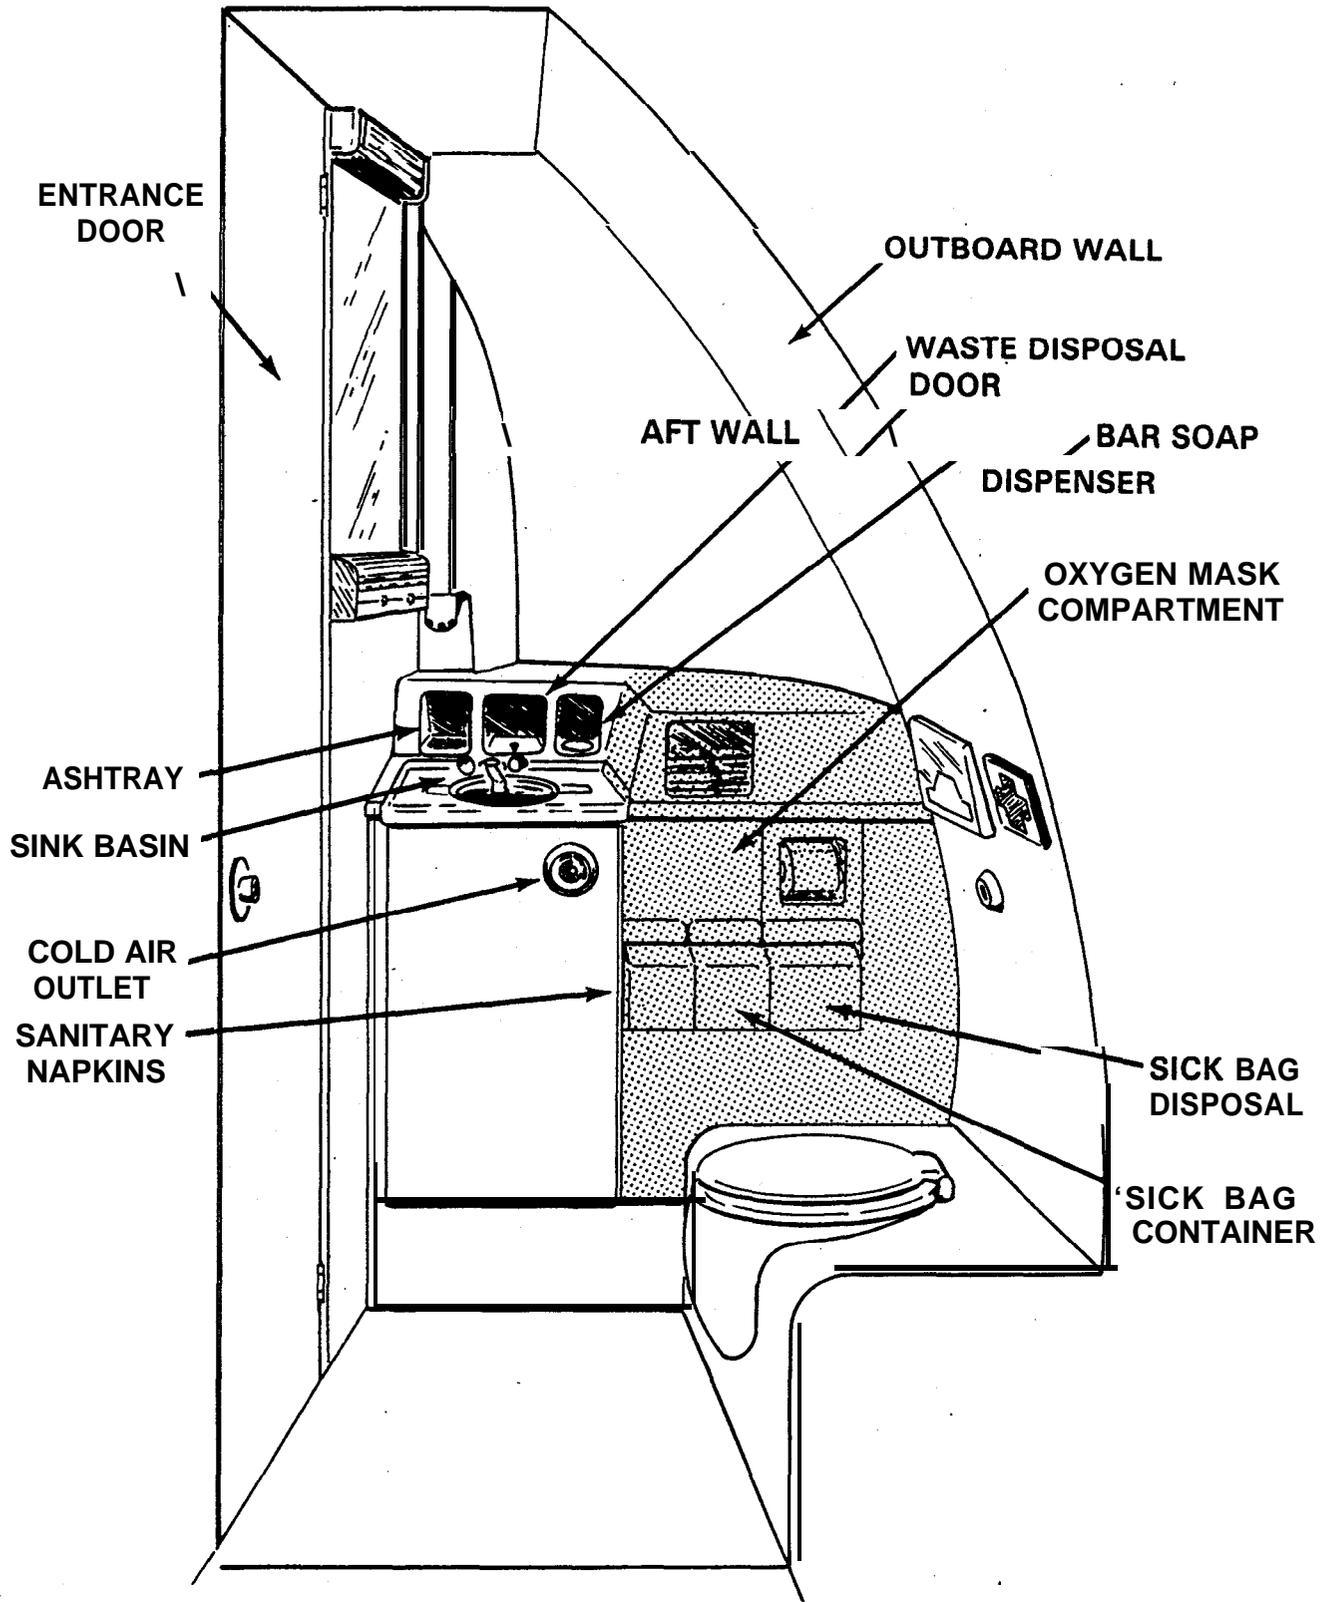
Figure 9.—Diagram of aff

The aft lavatory was on the left side of the cabin, and began at FS 965 and extended aft to FS 1019, or just forward of the aft pressure bulkhead. The lavatory's outboard wall conformed essentially to the shape of the airplane's fuselage. There was a vanity section containing a stainless steel sink and amenities located along and extending forward from the aft wall. The commode containing a flushing motor was located along the lavatory's outboard wall. A trash chute and container were located below and behind the sink, and a fresh air supply outlet was positioned below the sink in the door of the vanity. Also, below the trash container, an aluminum shelf was installed. In addition, there was an oxygen outlet located in the oxygen mask compartment in the amenities section. (See figures 9 and 10.)

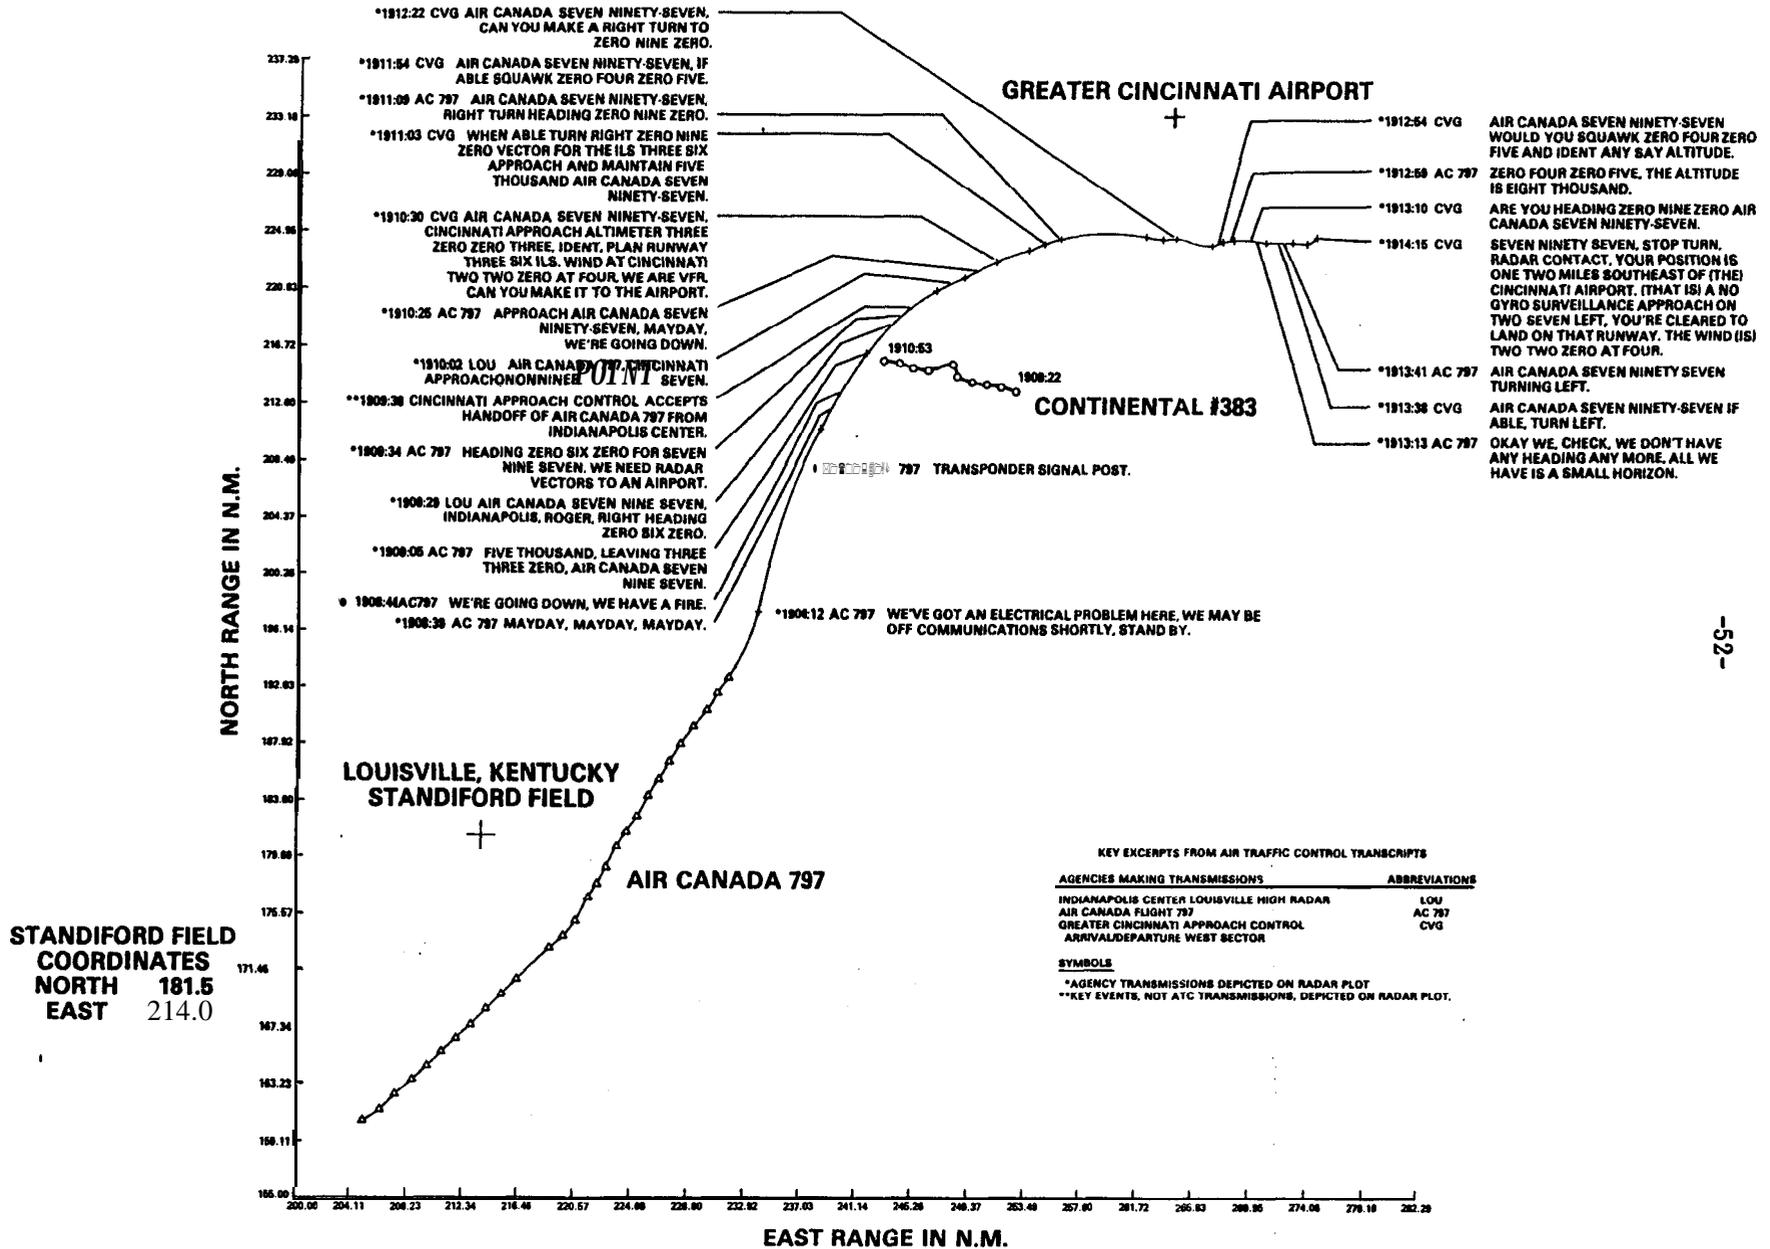
Figure 13.-Ground radar tracks for Flights 797 and 383.

18-36 of the Greater Cincinnati Airport were digitized and plotted with the ground tracks. Times of key transmissions and selected key events were included along Flight 797's radar ground track. The last radar fix retrieved from the DART's data occurred at **1914:15**, and the last transponder information from Flight 797 was received at **1906:12**. (See figure 13.)
