AIRCRAFT ACCIDENT INVESTIGATION REPORT

China Airlines
Airbus Industrie A300B4-622R, B1816
Nagoya Airport
April 26, 1994

July 19, 1996

Aircraft Accident Investigation Commission
Ministry of Transport

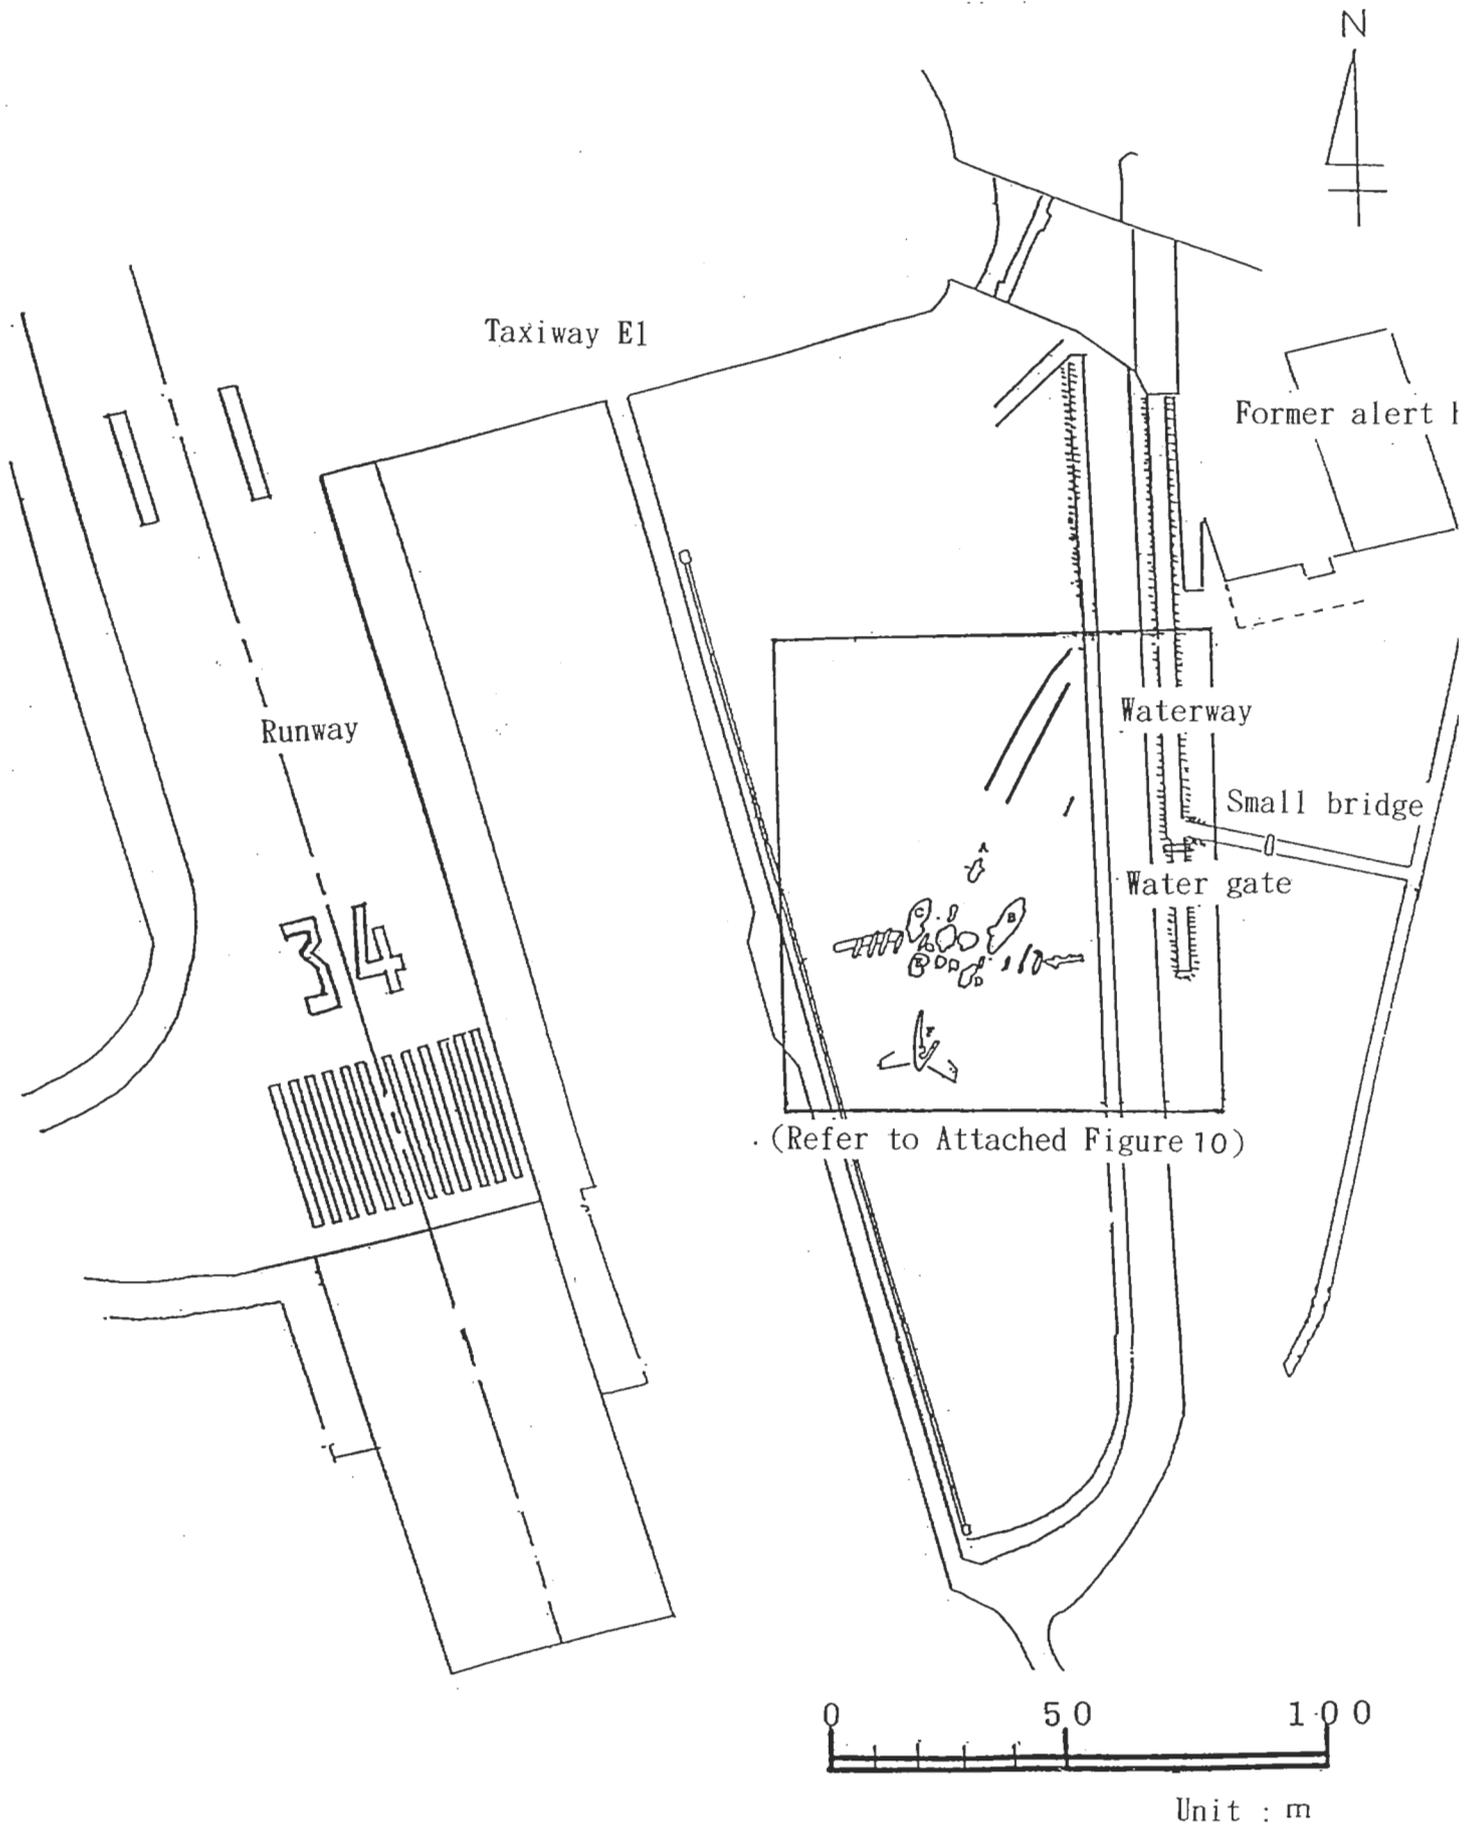
Attached Figure 9 Sketch of Wreckage on the Ground after the Crash

The direction of the linear marks which are made when the center section of the fuselage scratched the ground, coincided with magnetic bearing of about 22°. (See attached Figures 9, 10, and Photographs 49 and 50.)

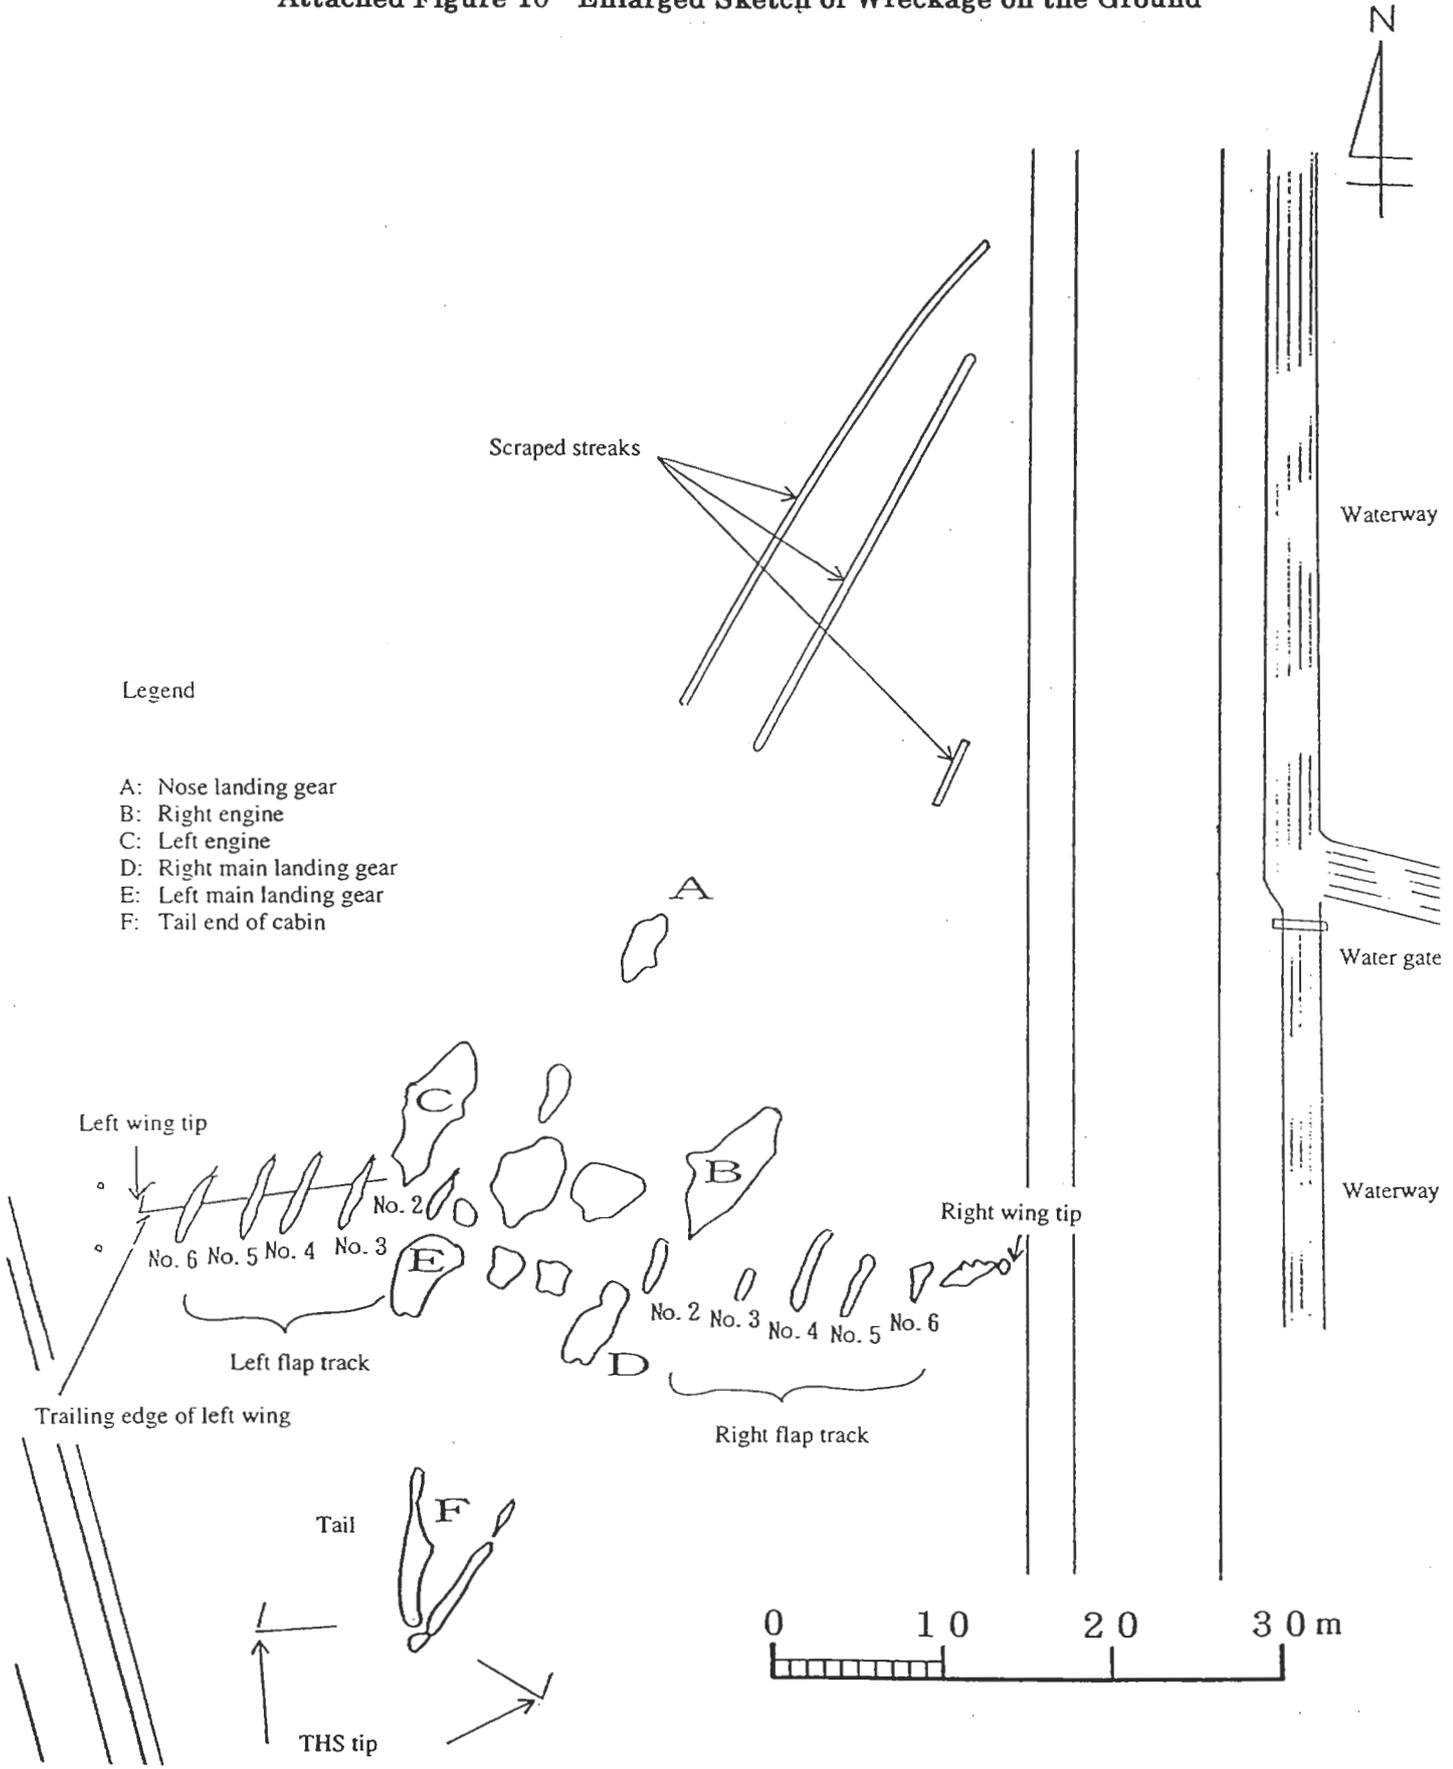
Attached Figure 10 Enlarged Sketch of Wreckage on the Ground

The positions of the marks left by the nose landing gear, LH and RH main landing gears, LH and RH engines, LH and RH wingtips, and THS are as shown in attached Figure 10.

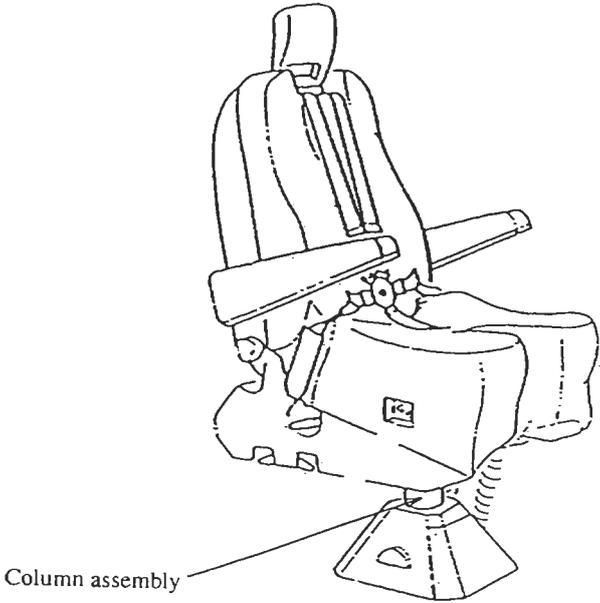
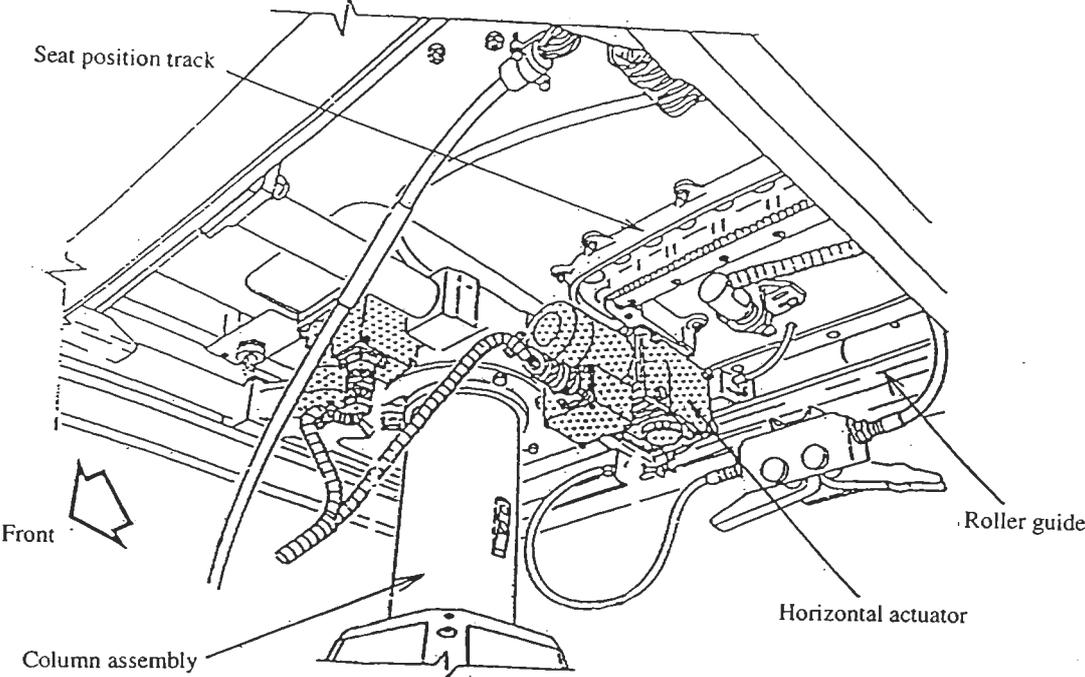
Attached Figure 24 External View of Pilot's Seat

According to their airman medical certificates, the CAP and the F/O were 162.5 cm and 178.1 cm tall, respectively. (See attached Figures 24 and 25.)

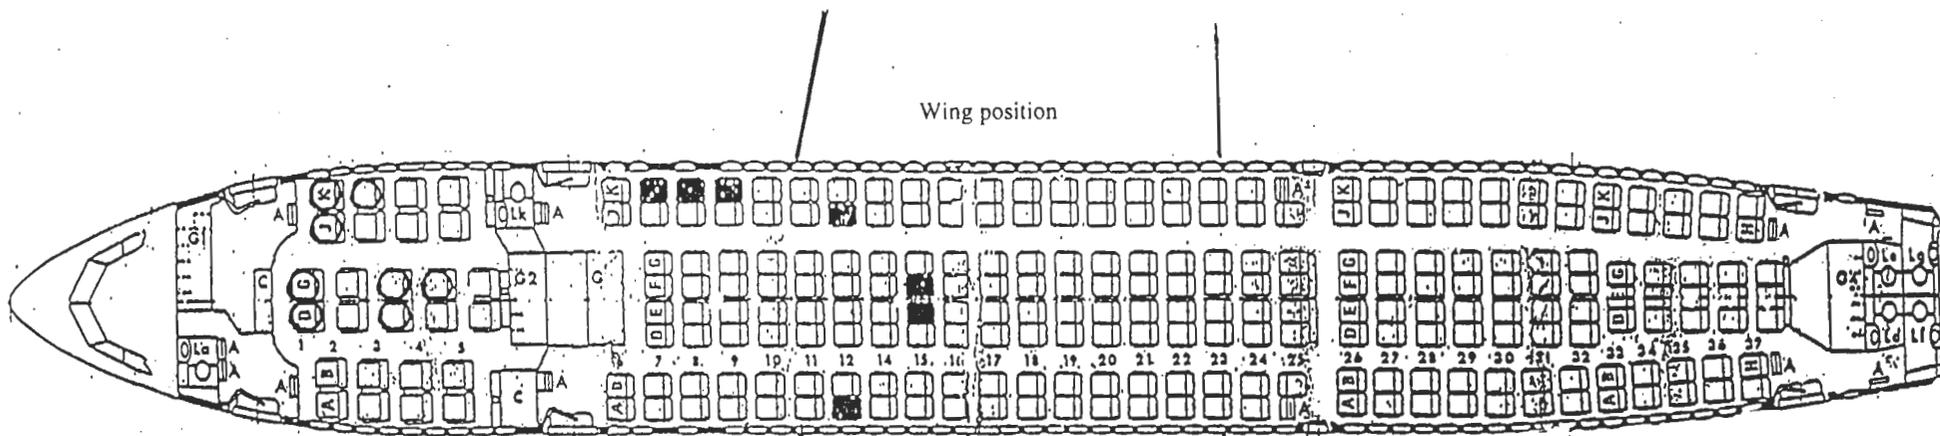
Attached Figure 26 Seat Arrangement Chart

Seven passengers survived -- all of them had been seated in Rows 7 through 15. Four had been in the right block of seats, two in the center block, and one in the left block. (See attached Figure 26.)

✖ ■ seats occupied by survivors.

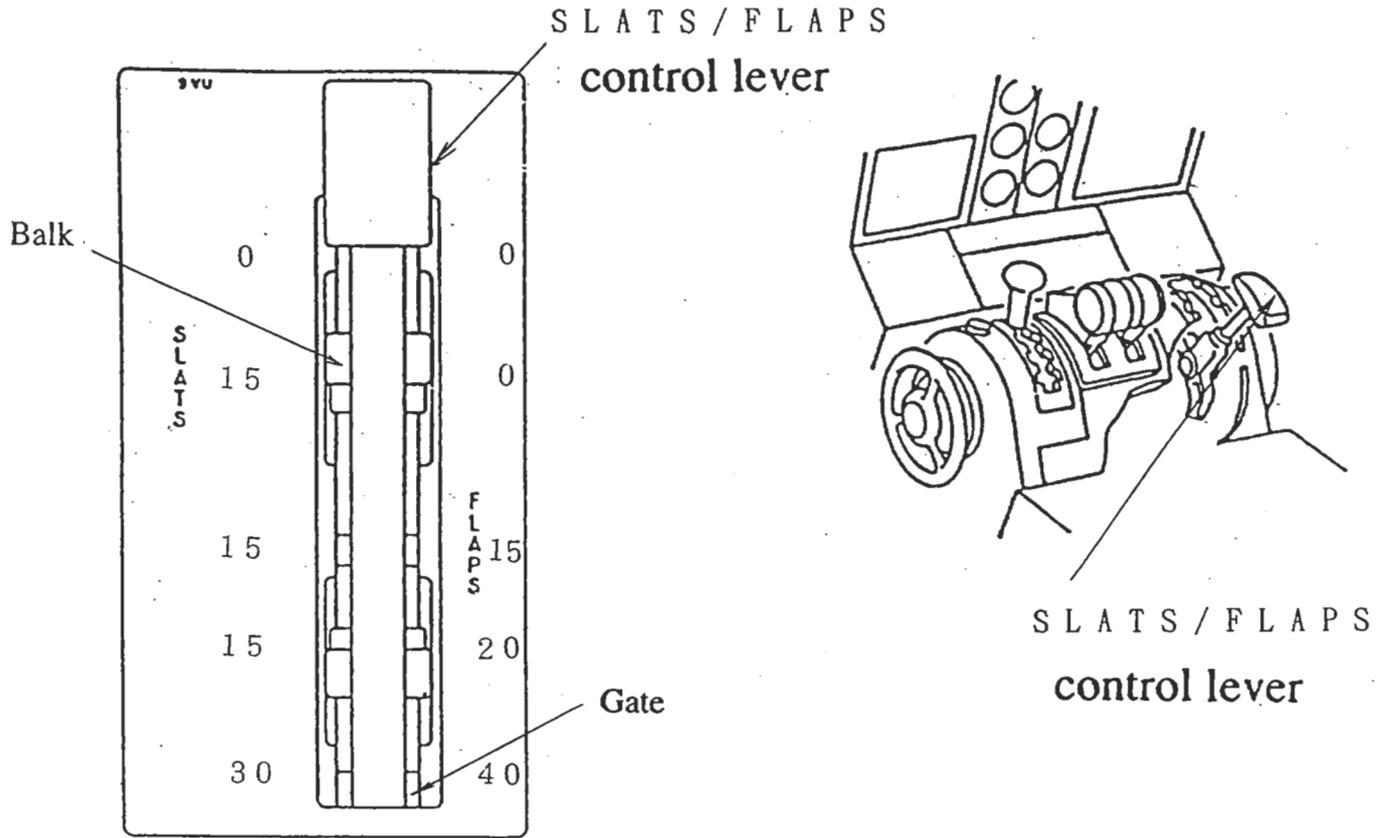
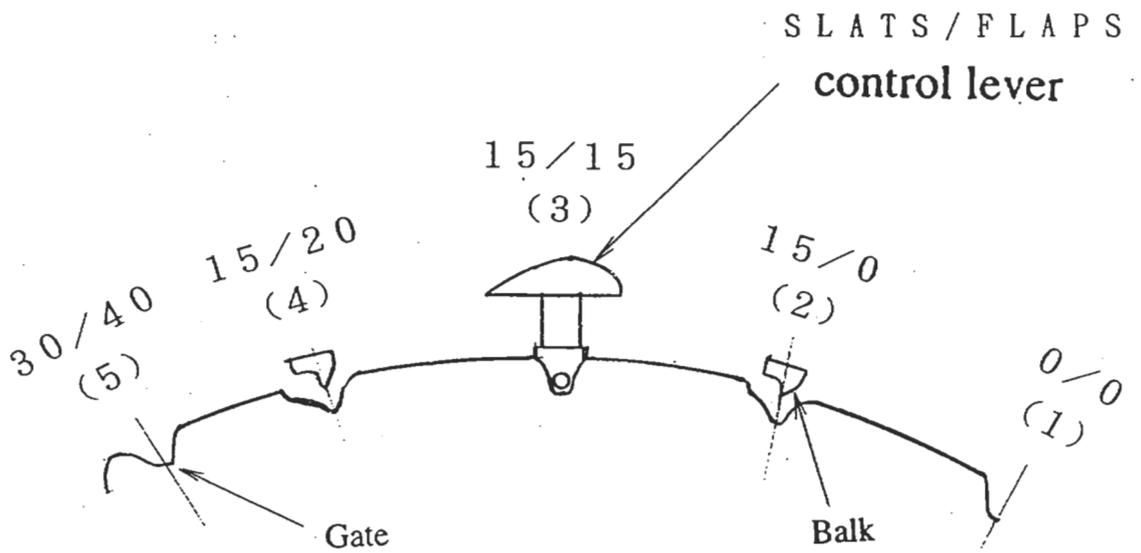
Attached Figure 27 Sketch of SLATS/FLAPS Control Lever Gate and Balk

- 1115:18 The sound indicating passage of the SLATS/FLAPS lever through the baulk attached gates was recorded twice (see attached Figure 27).
According to normal go-around procedure, the SLATS/FLAPS lever should be moved from the 30/40 position one step higher to 15/20. However, judging from the numbers of times the SLATS/FLAPS lever sound was recorded, it may have been moved beyond the 15/20 position, perhaps to the even higher 15/0, or 0/0 position. Later, at 15:27, a sound presumably indicating the SLATS/FLAPS lever's downward movement passing through the baulk attached gate was recorded on the CVR. Also on the DFDR is a record showing that the SLATS/FLAPS lever was set on the 15/15 position at 1115:28.

While the SLATS/FLAPS lever should be moved from 30/40 to 15/20, from the CVR record it is considered possible that the lever was moved to 15/0 or even higher, to the 0/0, before being lowered again to the 15/15 position. The landing gears were left in the down position (See attached Figure 27.).

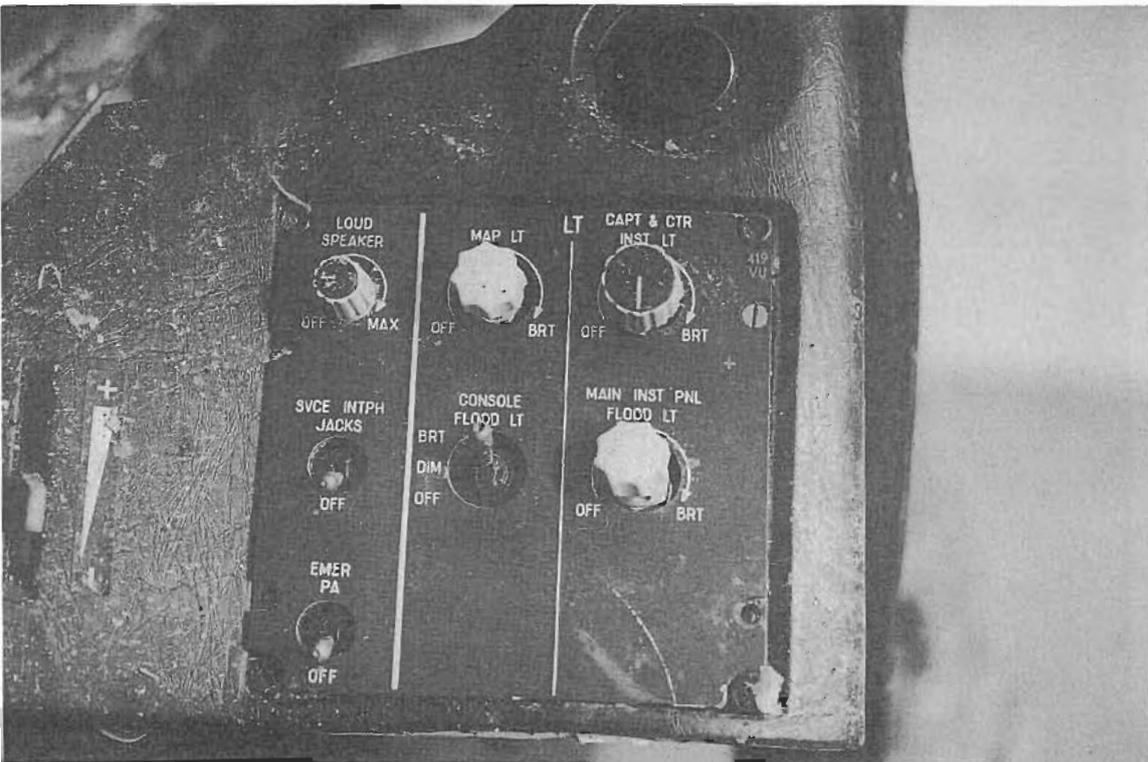
Photo.42 Captain and Center Light Panel

- ④ Lights operated from CAP's or F/O's seat through a knob on the pedestal:
 - Pedestal and overhead panel light
- ⑤ Lights operated from CAP's seat (also from F/O's seat) through controls on the cockpit light panel in front of the overhead Panel CAP's seat:
 - Dome light
 - Storm light
- ⑥ Lights operated from CAP's or F/O's seat through the glareshield lightning controls :
 - Each window of the glareshield panel
 - Push-button switch integrated light (See attached Figure 23 and Photograph 42.)

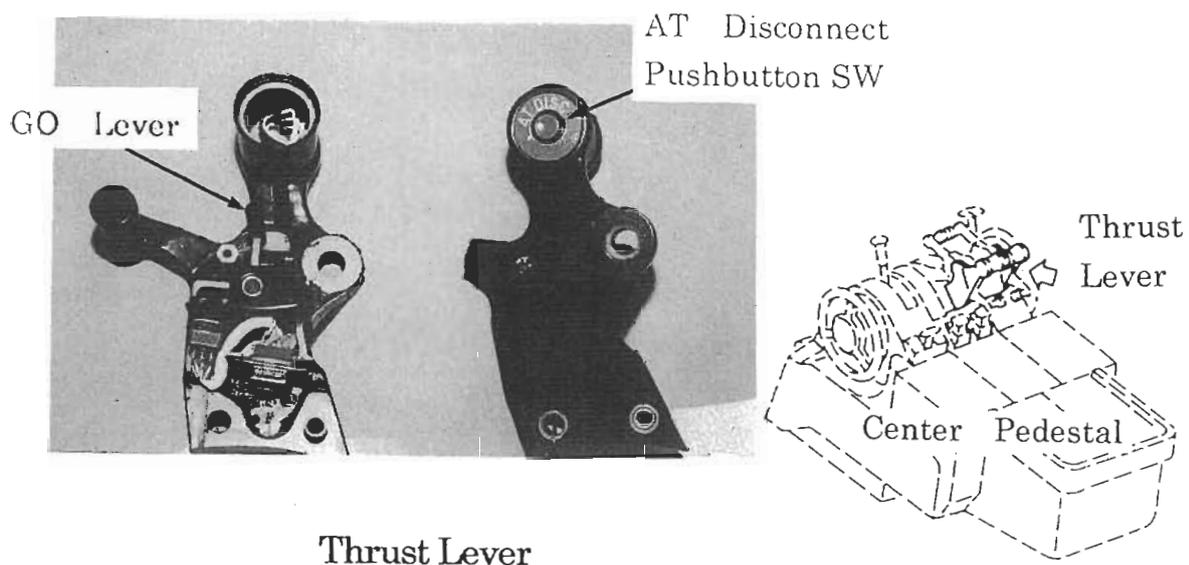
Photo.51 GO Lever Alignment with Thrust Lever

The GO lever of the A300-600R type aircraft is positioned below the thrust lever knob. The direction that the GO lever is operated in is the same as the direction in which the thrust lever is retarded, or as the same direction that the fingers move when gripping the thrust lever knob. With this arrangement, the possibility exists for an inadvertent activation of the GO lever during normal operation of the thrust levers (See attached Photograph 51).
