Aviation Occurrence Report Volume I

IN-FLIGHT BREAKUP OVER THE TAIWAN STRAIT

CHINA AIRLINES FLIGHT CI611

BOEING 747-200, B-18255

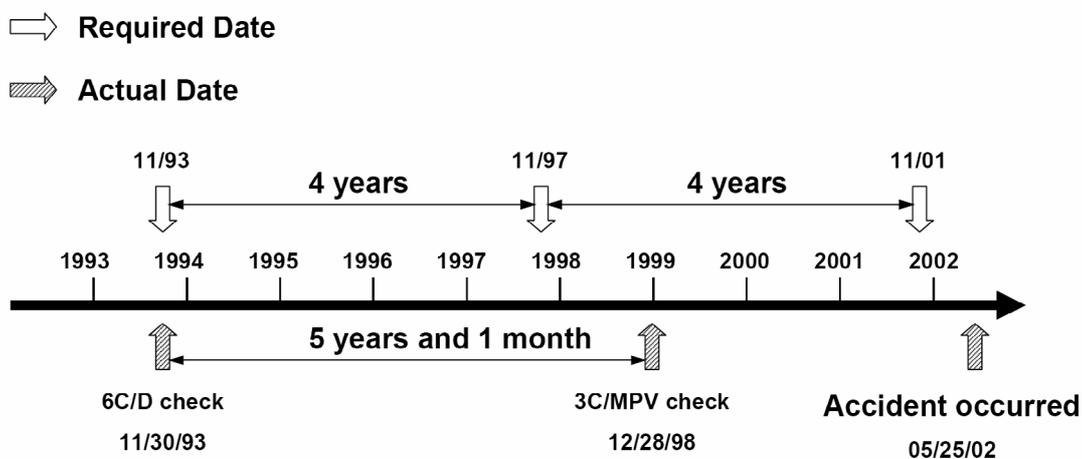
Figure 1.6-6 Deviations on CPCP item 53-125-01 required for B-18255

When the Safety Council reviewed the CAL B747-200 AMP with respect to B-18255's maintenance history, it was noted that AMP CPCP item 53-125-01 inspection of the bilge was delayed in implementation for 13 months until the 1998 MPV check. The AMP required this item to be inspected every 4 years.

Other than CPCP item 53-125-01, another 28 items were found to have been deferred beyond the time intervals of the AMP required scheduled inspection dates. Neither CAL nor the CAA were aware of this CPCP schedule delay issue before November 5, 2003, the time when the Safety Council conducted investigation of this issue.

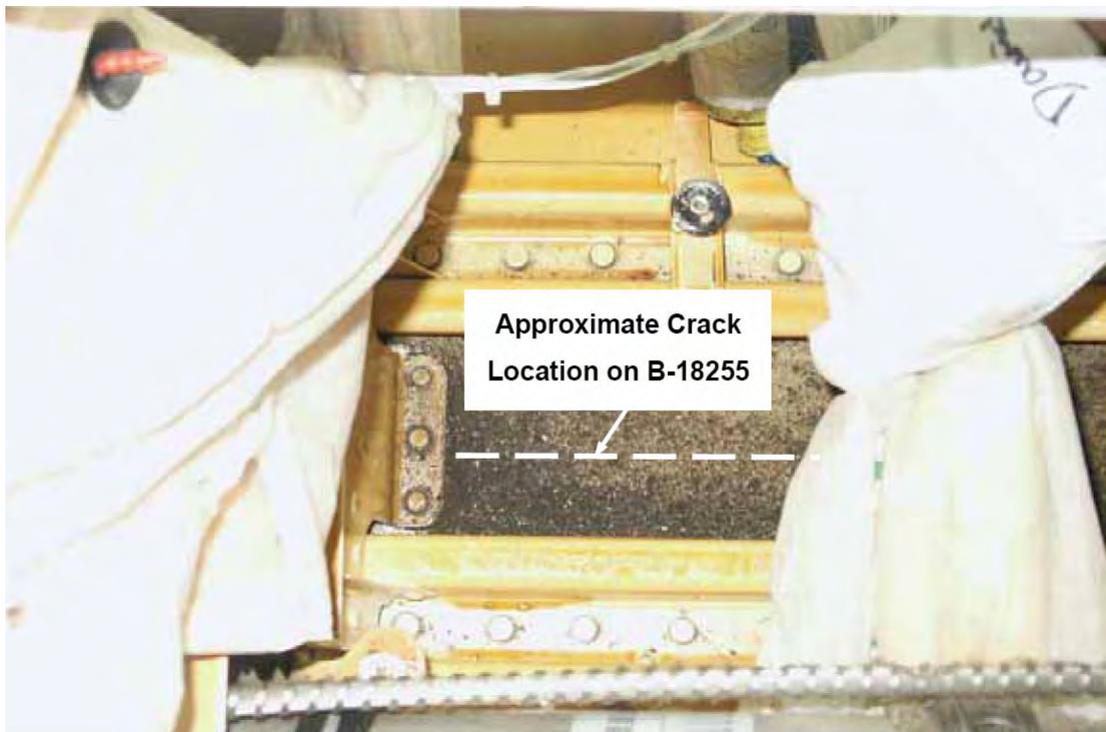
Figure 1.6-13 A B747-400 aircraft bilge area without removing CIC and dust

Figure 1.6-12 shows a B747-200 freighter bilge after cleaning. Figure 1.6-13 shows the bilge before corrosion inhibit compound and dust was removed from a B747-400 freighter. The stain on the lower lobe skin cover part of the paint. The bilge was covered with dirt and residue on two adjacent insulation blankets in the bulk cargo lower lobe bay.

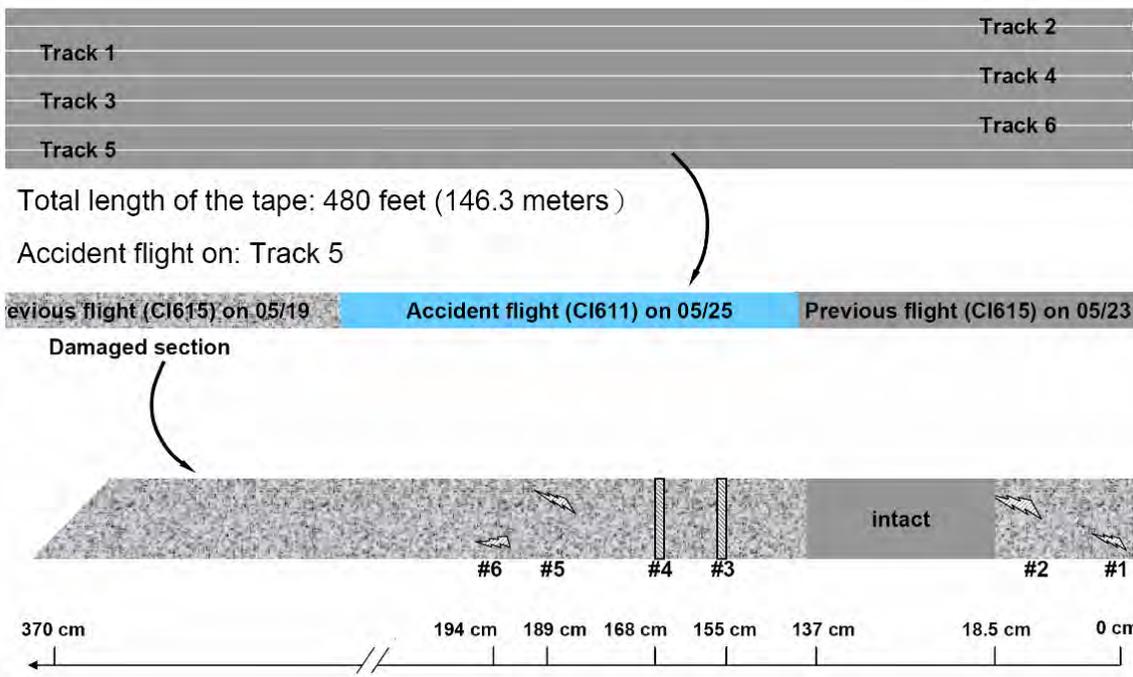
Figure 1.11-4 Sketch of damaged tape locations and conditions

Upon arrival, the FDR enclosure was open immediately and the magnetic tape was found damaged. Pictures of the damaged FDR tape are shown in Figures 1.11-3 and 1.11-4. There are six crinkle marks on the tape.

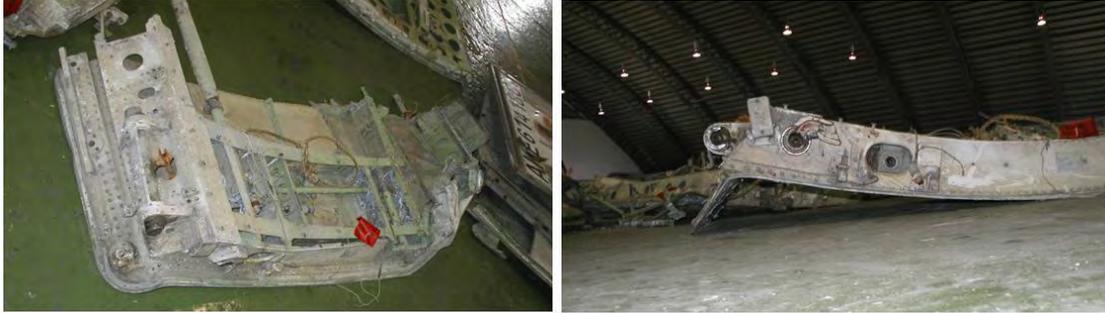
Figure 1.12-5 Item 2019

The lower aft portion of the door (item 2019 in Figure 1.12-5), including the aft pair of latches, was found separately. The lower portion of the door skin was bent

outboard approximately in 45 degrees. Examination of the hinge, latches, and the other mechanisms was consistent with the aft cargo door being closed at the time of the aircraft breakup.

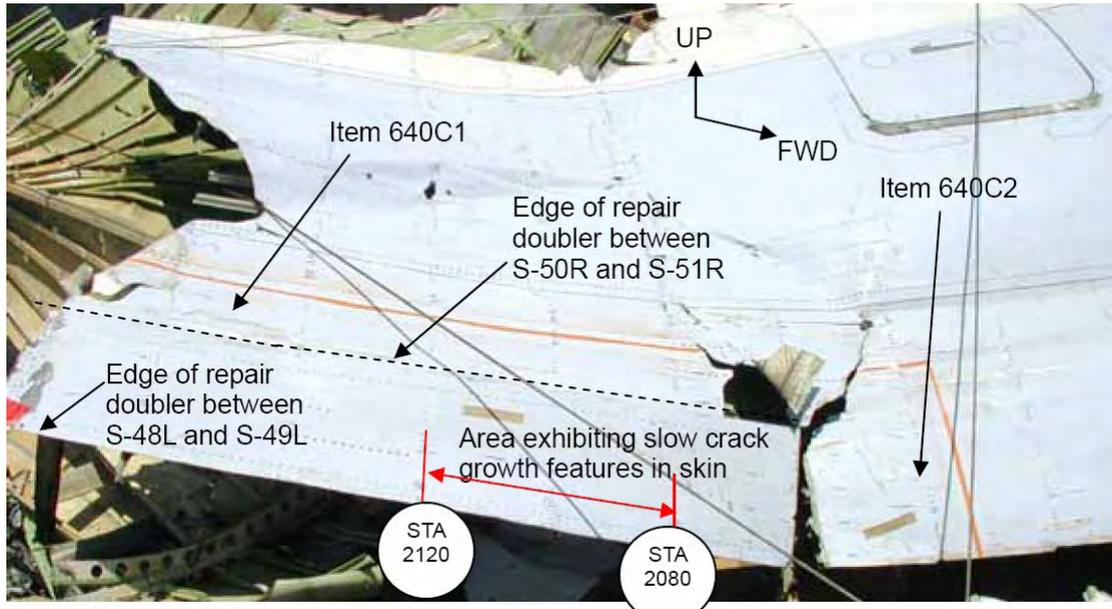
Figure 1.12-6 Item 640

Also included in item 640 is the bulk cargo door. The segment was recovered with the door closed and latched. The lower portion of the bulk cargo door seal protruded through the space between the door and the sill.

The forward portion of item 640 includes the aft portion of the aft cargo door cut out frame. There are deformations at the lower latch fitting attachment location.

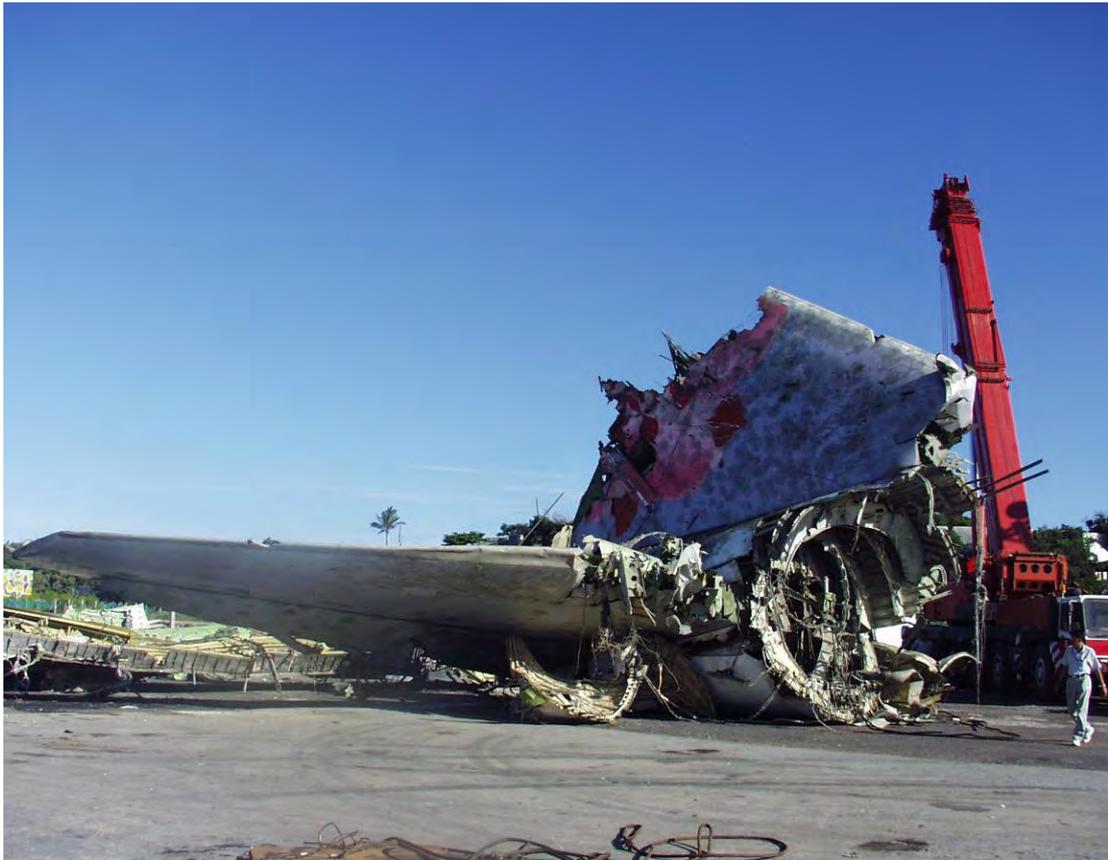
Figure 1.12-9 Item 630

The section 48 and empennage structure (the aft pressure bulkhead and all structure aft) was found in the red zone (Figure 1.12-8). The horizontal stabilizer, the majority of the skin/stringer/bulkhead structure, and the lower third of the vertical fin were found attached with very little damage (Item 630, Figure 1.12-9).

The right horizontal stabilizer (RHS) is considerably more damaged than the left horizontal stabilizer (LHS). The inboard portion of the RHS leading edge is deformed upwards. At the root of the RHS, the inboard 10 feet showed considerable impact damage along with upwards deformation of the compromised structure. A portion of seat support was found inside a puncture common to the lower surface of the LHS. A small segment of fuselage stringer was also found imbedded in the RHS elevator (Figure 1.12-10 left-down). A small fastener and shim from a stowage bin assembly were found inside a puncture common to the RHS leading edge (Figure 1.12-10 right).

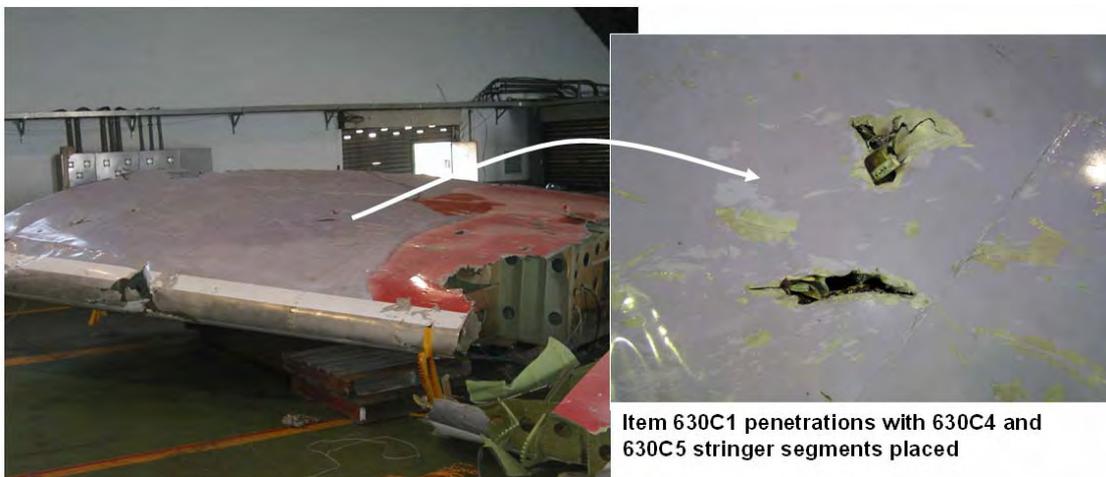
Figure 1.12-12 Item 630C1

The lower portion of the fin (item 630C1), the upper portion of the fin (item 2035), and several of the floating pieces (item 22) show similar evidence of impact damage on the right side.

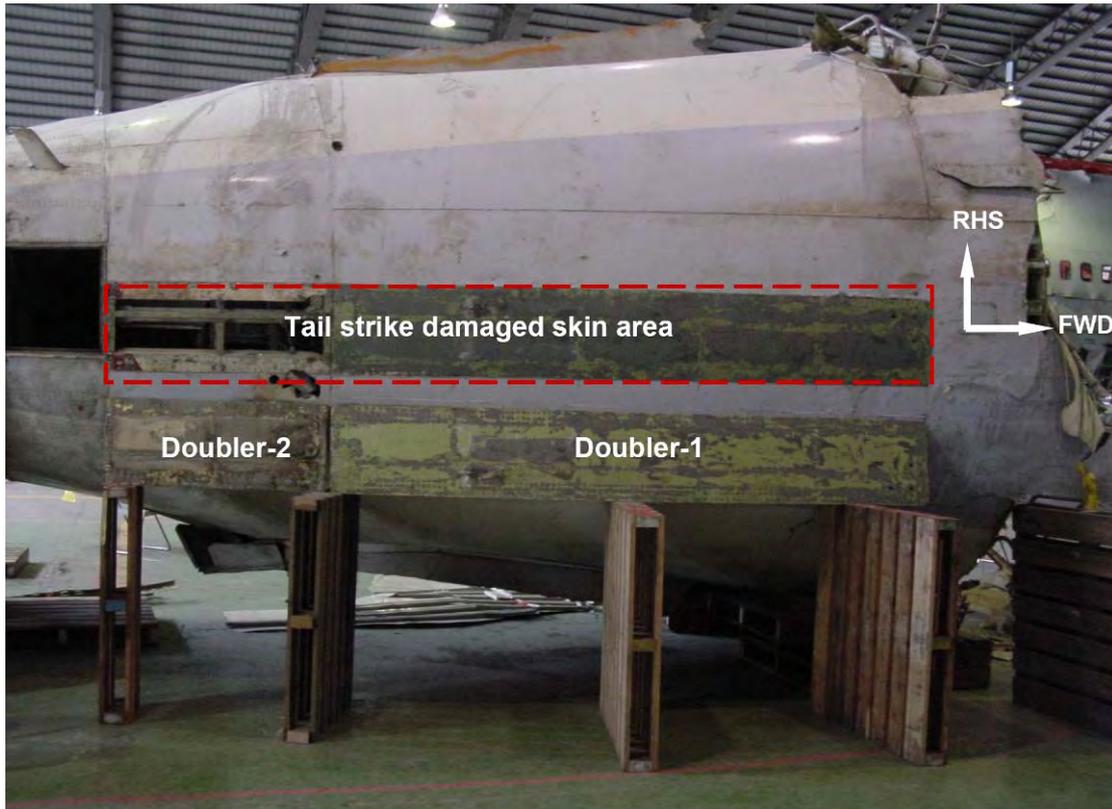
Figure 1.12-13 Doublers in section 48

The belly area of item 630 between STA 2484 to STA 2658 was examined, and two adjacent doublers were removed during wreckage examination as shown in Figure 1.12-13.

The B-18255 Aircraft Log Book stated the belly skin area between STA 2578 to STA 2638 had serious abrasion damage. Examination of the skin underneath the two doublers revealed that, skin underneath Doubler-1¹⁸ (STA 2484 to 2598) had damage consisting of fore to aft (longitudinal) scratching with the most severe scratching at the locations of skin stiffening members. The damaged area had not been cut out or removed (trimmed), however, blending was found over much of the repair surface. Skin beneath the Doubler-2 (STA 2598 to STA 2658) was cut out as shown in Figure 1.12-13.

and starts from STA 2535 with the length of 42 inches. No evidence of crack was identified in this region. There are dents at STA 2567 and STA 2610, which was the result of wreckage handling.

It was noted that the former topcoat, enamel and primer (original painting before the skin repair) remained on the skin covered by Dubler-2.

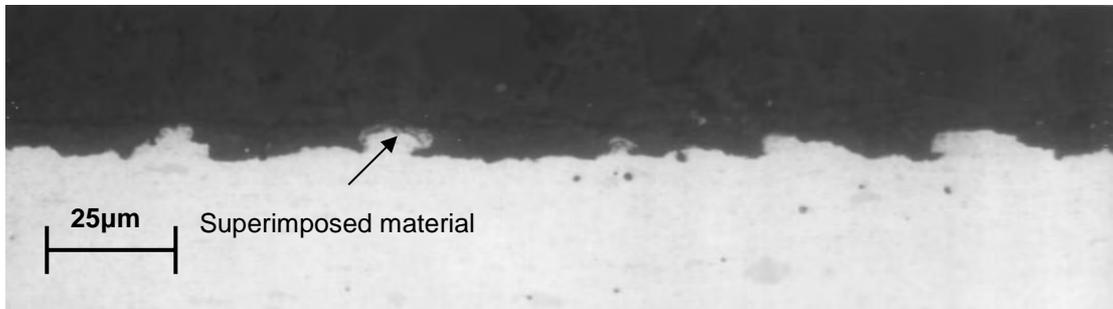
Figure 1.16-10 Metallographic photograph of the profiles marked by data sampling cut #1 in Figure 1.16-9

- The fretting marks observed from STA 2061 (hole +16) to STA 2132 (hole 49) are associated with most of the rivet locations. The most significant fretting damage was present between holes 8 and 43.
- The fretting marks near hole 32 and an optically magnified photograph of the area of contact is shown in Figure 1.16-9. It shows that the area of contact exhibits many colors and some hoop-wise scratches (marked by arrows).
- Two cross-section locations were chosen to characterize the area of contact. Figures 1.16-10 and Figure 1.16-11 show the metallographic photographs through the area marked by data sampling cut #1 and data sampling cut #2 respectively. It is observed that there was some material superimposed over the grooves of the scratches.

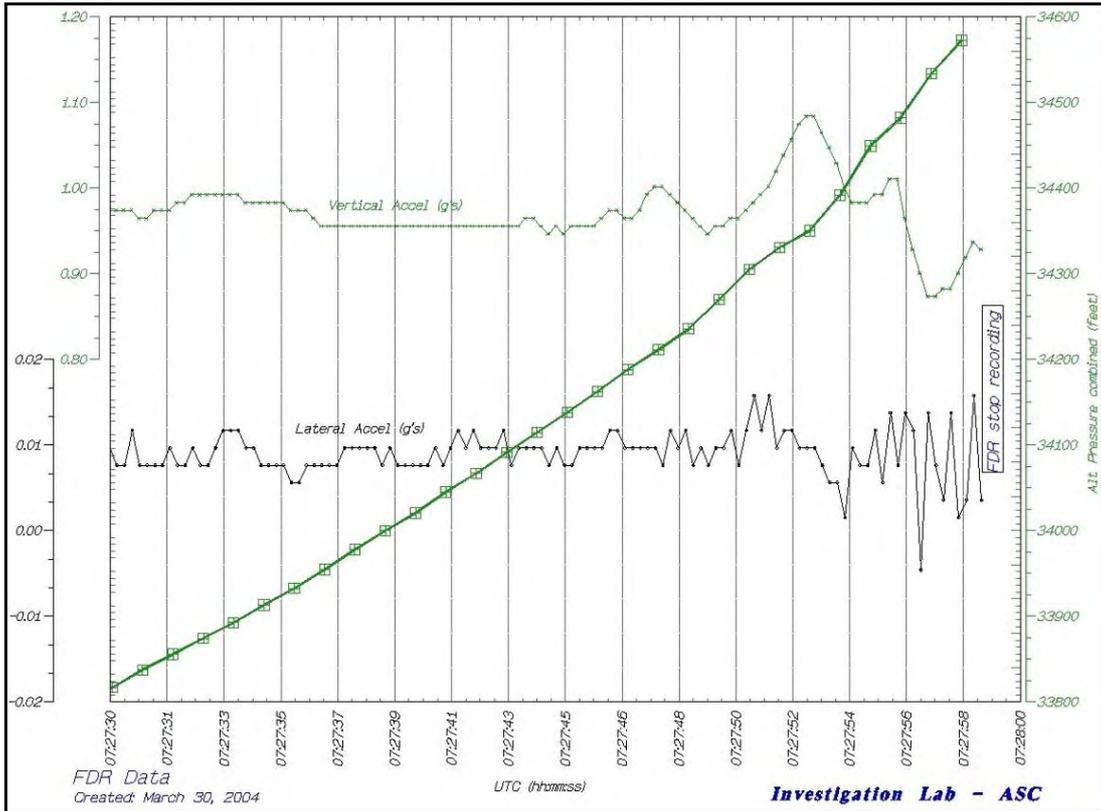
Figure 2.1-1 CI611 vertical and lateral acceleration data (last 30 seconds)

By carefully examining the acceleration data from the FDR, one can observe that 10 seconds prior to the loss of power of the flight recorders, there was a slow increase in both the vertical acceleration and lateral acceleration, as shown in Figure 2.1-1. By comparing the lateral acceleration parameter of the previous two flights of B-18255, before approaching its cruising altitude of 35,000 ft, similar oscillatory behaviors were found, as shown in Figure 2.1-2. Comparison was also made of the vertical acceleration parameter of CI611 and the two previous flights. A more pronounced increase in magnitude of the vertical acceleration was observed. These data led to the consideration that a preliminary breakup of the fuselage structure might have been in progress before the power loss of the FDR.

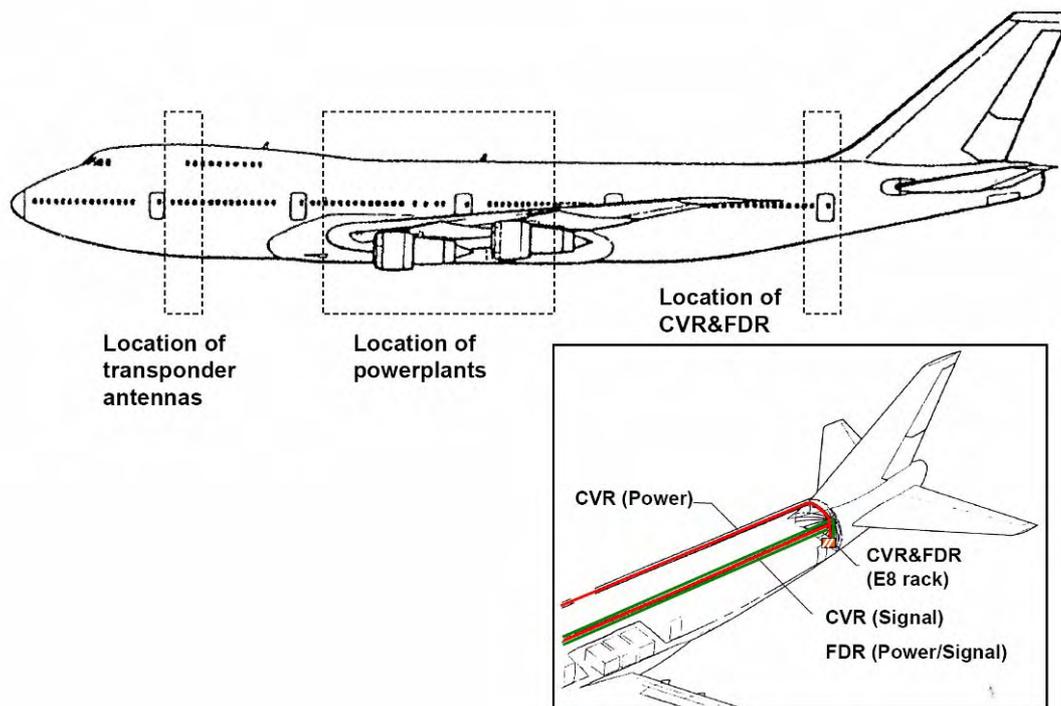
Figure 2.2-1 Locations of flight recorders, transponder antennas, and power plants

In addition, both recorders were located in the aft portion of the aircraft (above ceiling near to door 5L) and both transponder antennas were installed behind door 1 (Figure 2.2-1). The power of the CVR and FDR was interrupted simultaneously at 1527:59. However, the radar transponder continued to transmit for about 15 seconds longer. Therefore, the breakup should occur between the power plants and the recorders.

The Aviation Safety Council concludes that the loss of power to the CVR and FDR was the result of damage to electrical wires in the aft-pressurized fuselage area as the aircraft began to breakup. The forward portion of the aircraft continued to have power to the Mode-C transponder system for about an additional 15 seconds, before power to the transponder was interrupted.

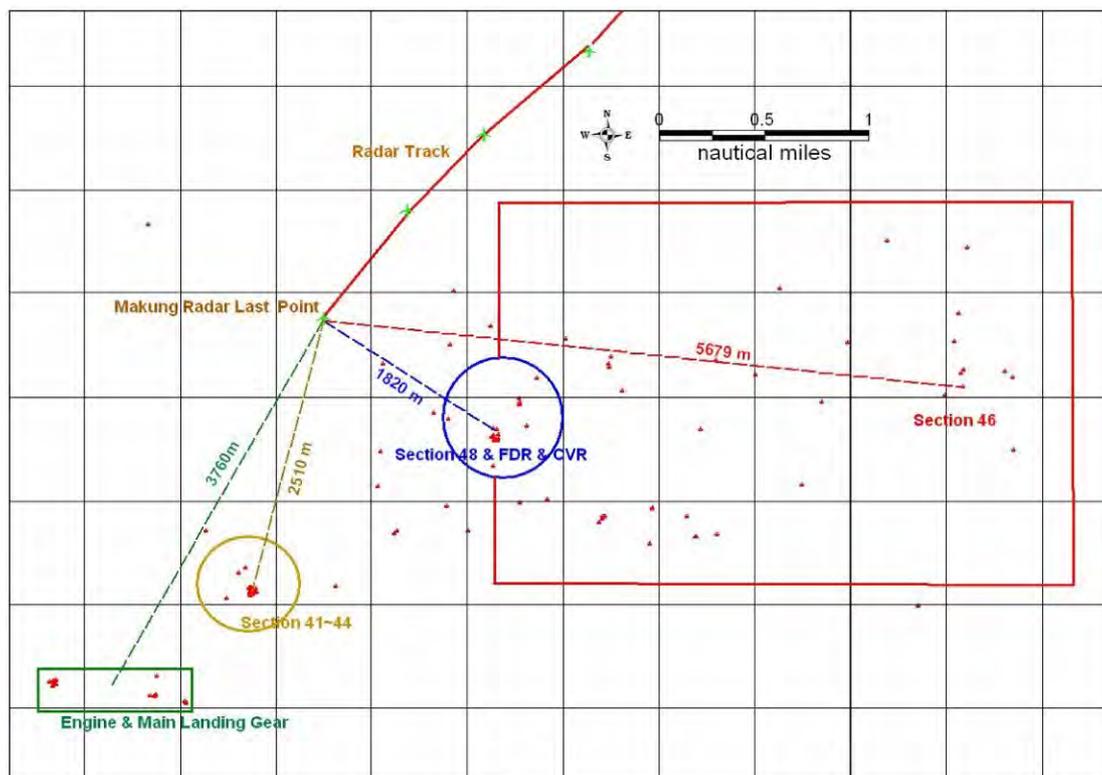
Figure 2.2-3 Relative location of the wreckage

Figure 2.2-3 shows the relative locations of the CI611 wreckage. The wreckage distribution pattern matches the four groups of aircraft wreckage detected by PSR.

The wreckage distribution data show that the distance between the tail (section 48 with lower portion of fin) and forward portion of fuselage (section 41-44) was 1.5 nautical miles. The distance between the tail and most eastbound wreckage (section 46), which was recovered under water, was 3 nautical miles.

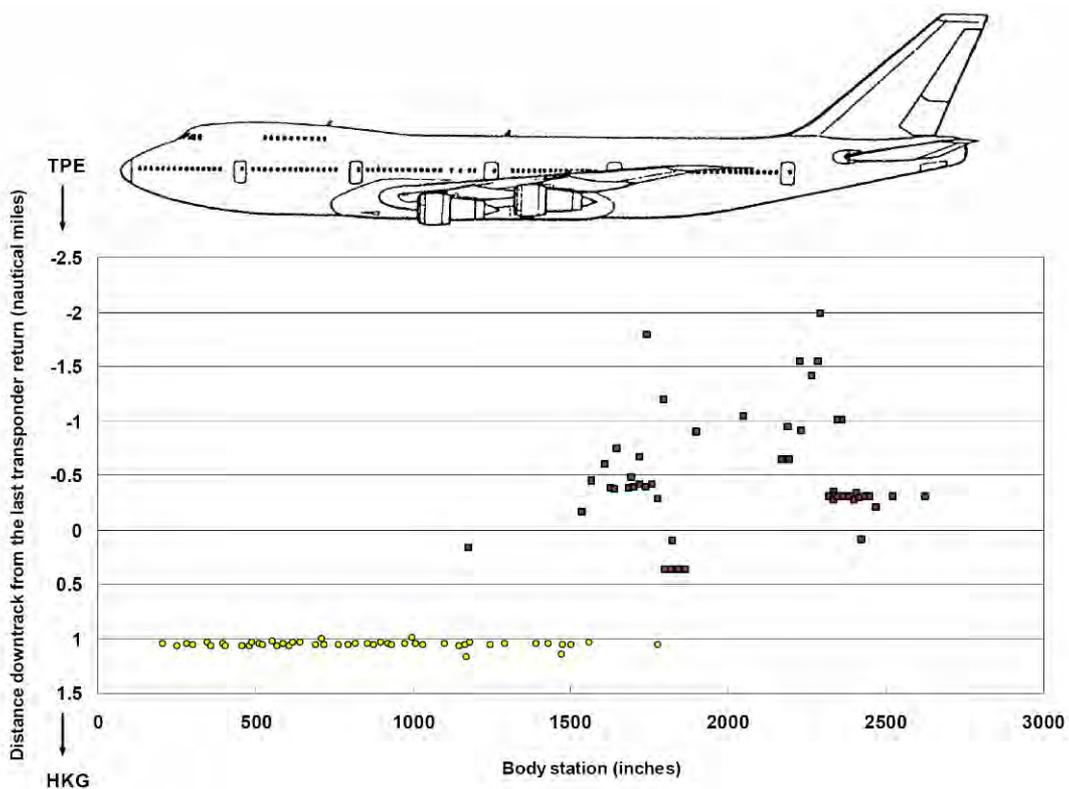
Figure 2.2-4 Wreckage distributions along the flight path

Hong Kong, which is shown in Figure 2.2-4. One can readily see that the wreckage pieces from the cockpit, engines, wings, all landing gears, and sections 41, 42, and 44 are distributed along a very concentrated segment while section 46, 48, and the tail empennage are spread widely.

The figure also shows a step jump from the forward portion of the aircraft to the aft sections. It shows that the fuselage section 46/48 structure aft of the aft wheel well bulkhead at STA 1480 was separated from the rest of the aircraft.

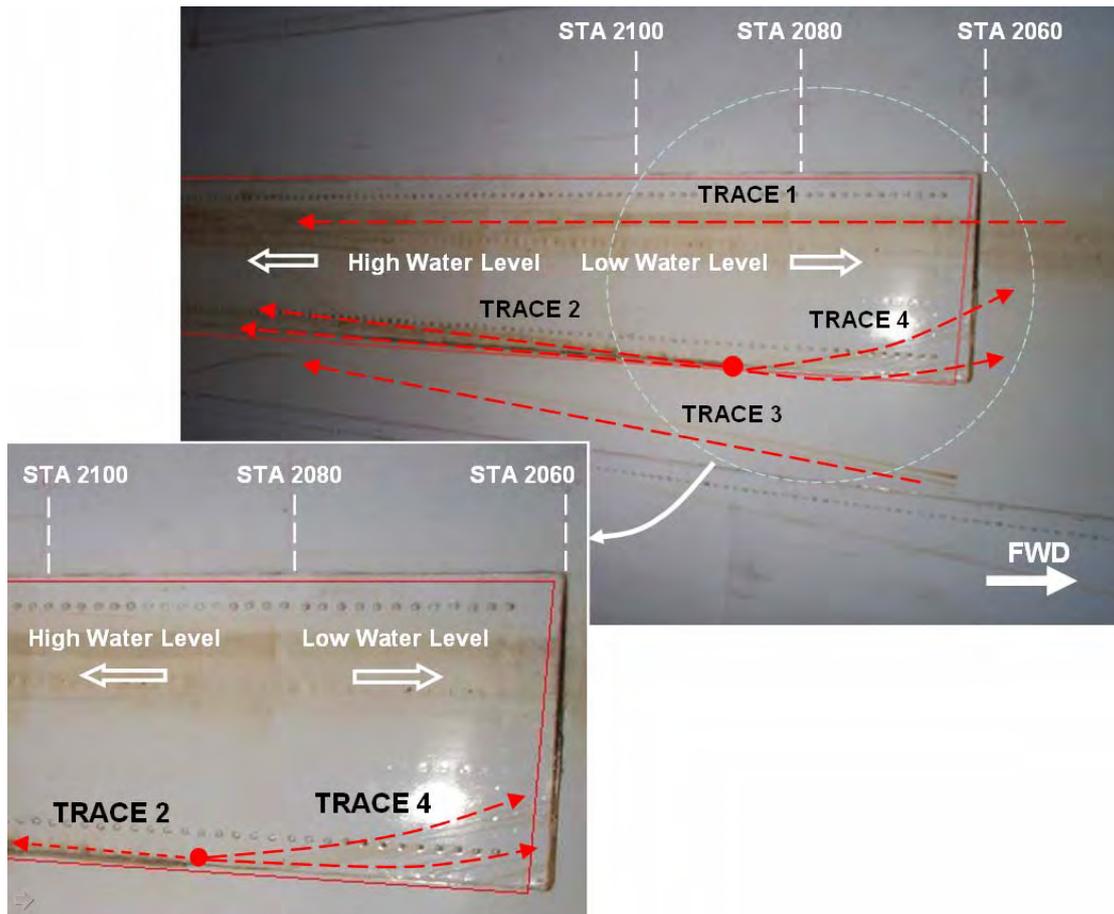
Figure 2.2-5 Comparison of Trace 1,2,3 (straight line) and 4 (curve)

The photograph was taken from underneath the aircraft looking up towards the fuselage. This area of the aircraft belly slopes upward towards the rear of the aircraft. When the aircraft is parked, the forward end of the doubler is closer to the ground than the aft end. There were several traces observed on the doubler and the skin around STA 2100. Traces 1, 2, and 3 are brown in color and straight toward the aft of the aircraft, suggesting that the traces were induced by the relative wind during flight. Trace 4 shows several curved lines of transparent condensate liquid that flowed from STA 2090 toward the forward (lower) end of the doubler, consistent with flow due to gravity when the aircraft was parked. The traces seen in the November 2001 photographs were not evident on the wreckage when it was recovered.

Traces 2 and 4 began at the same origin but went in different directions. It suggests that trace 2 occurred as the aircraft was in the air, but trace 4 occurred when the aircraft was on the ground. The darkness of the traces shows the accumulated time and quantity of the flow. The color of trace 2 is the darker, which suggests a larger quantity of flow escaped into the air stream in flight.

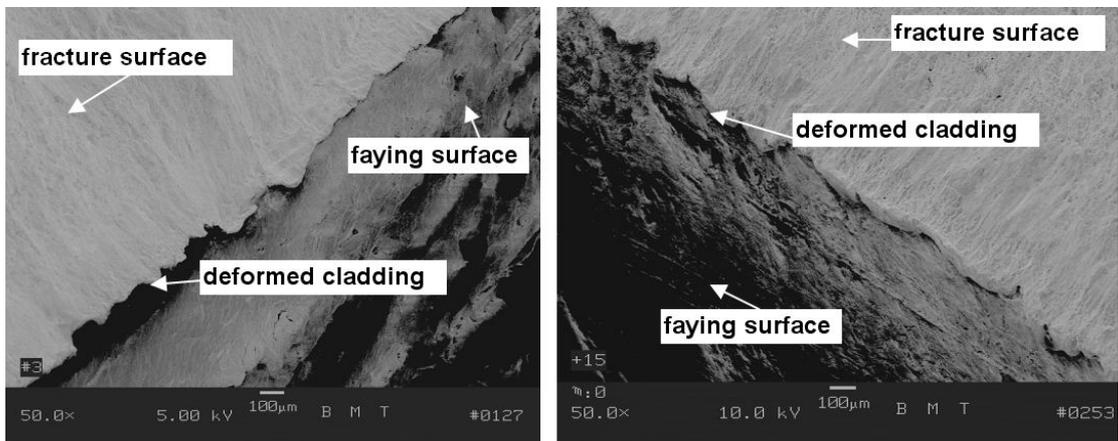
Figure 2.2-10 SEM photographs of the cladding near hole 3 (left) and +15 (right)

Cyclic rubbing of the fracture surface and associated compressive deformation of the cladding was observed along the faying surface shown in Figure 2.2-10 providing additional evidence of pre-existing crack. The cladding displayed compressive deformation due to cyclic crack closure as far forward as hole +17 and as far aft as hole 62. The remaining fracture aft of hole 62 displayed “necking”, which is typical of continuous tensile loading to ultimate tensile separation (Figure 2.2-11).

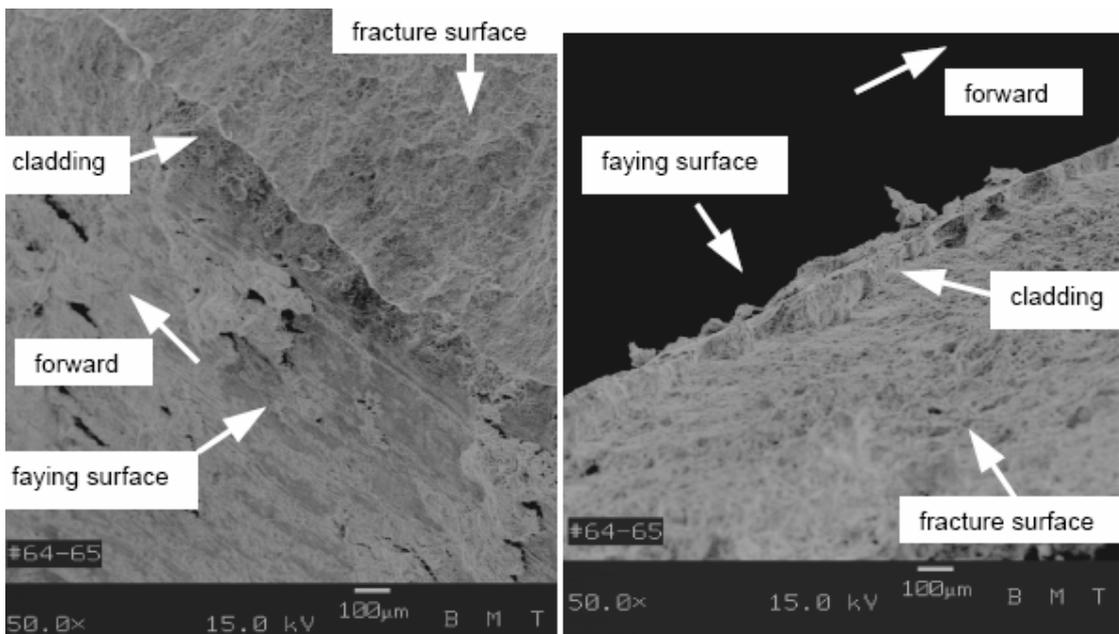
Figure 2.2-11 SEM photographs of the cladding between hole 64 and 65

According to these observations, the BMT report suggested a pre-existing crack in the skin continuously from STA 2055 to 2146, or approximately 93 inches in length prior to the in-flight breakup. The diagram of different length of crack was shown in Figure 2.2-12.

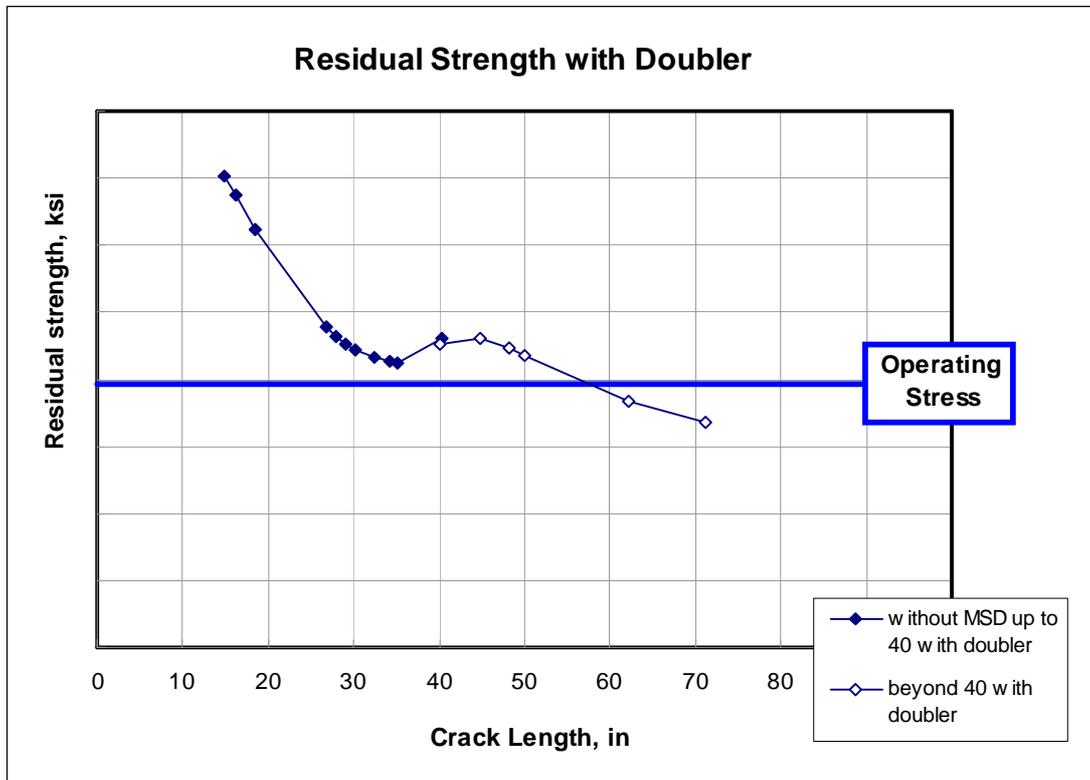
Figure 2.2-13 Residual strength of cracking

From the residual strength analysis discussed in section 2.5, when the crack was over 58 inches, the residual strength of the skin assembly would go below the operating stress (Figure 2.2-13), therefore caused the skin assembly beyond the capability limit under the application of normal operational loads.

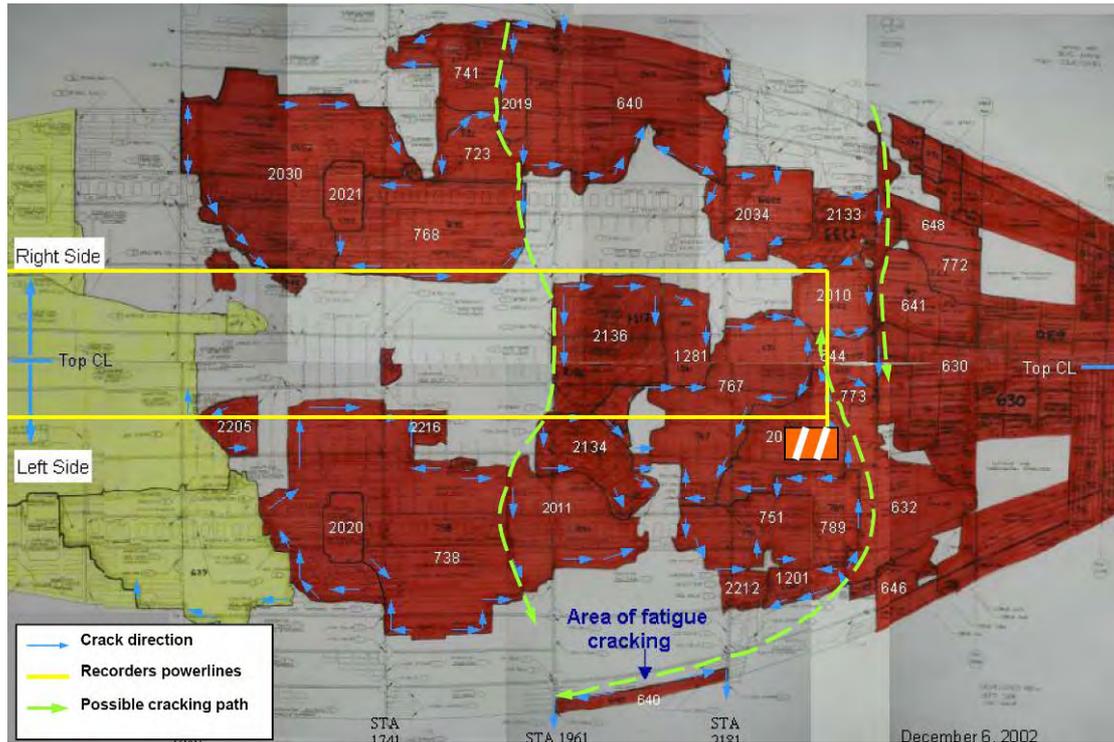
Figure 2.2-14 Directions of fracture propagation

Figure 2.2-14 shows the direction of the crack propagation on each piece of the wreckage in section 46. The methodology used to determine the direction of the cracking is described in Appendix 18. Once a portion of the structure failed, it could no longer sustain the integrity of the entire fuselage structure. The propagation pattern of the fracture is highly nonlinear and extremely dynamic. Without the recovery of all the wreckage pieces, it was nearly impossible to draw a conclusive break-up sequence of the aircraft. Therefore, the following observation only provides one possibility for the cracking to link together accordingly and formed a possible propagating sequence.

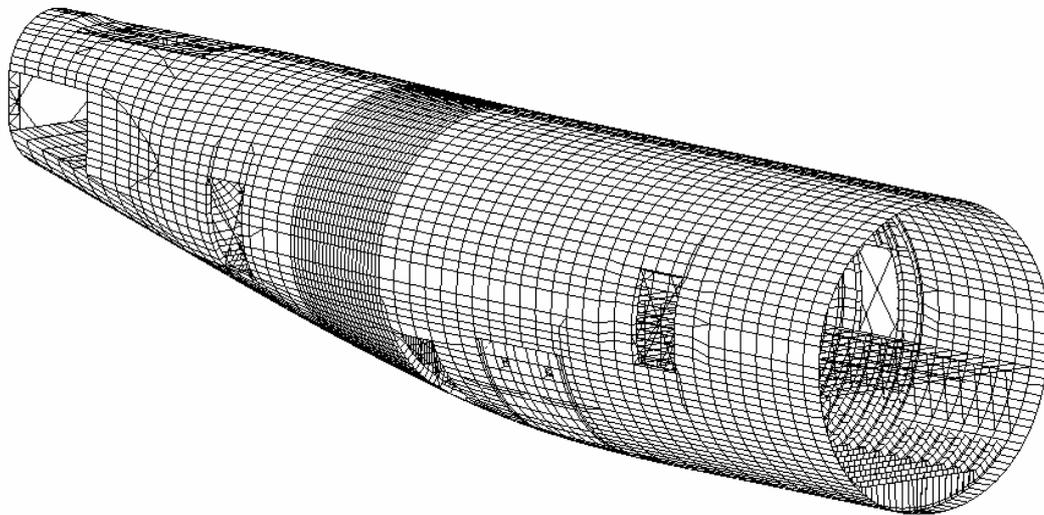
Figure 2.5-1 The linear finite element model of B747-200 aft fuselage

A linear finite element method was used to evaluate the operating stress field. The aft-body structure (fuselage structure from STA 1480 aft) was modeled using a NASTRAN FEM as shown in Figure 2.5-1. This model consists of local refinement (Figure 2.5-2) in the vicinity of STA 2100 frame to allow placement of skin discontinuities (representing a skin crack) and to provide enhanced visibility on local stresses.

The operating stress calculated by the FEM was then verified by the real plane pressure gauge measurement test, which indicated that the model overestimated the skin stress by 6%. Therefore, a 6% reduction of the operating stress model calculated by the FEM is used for the residual strength analysis.

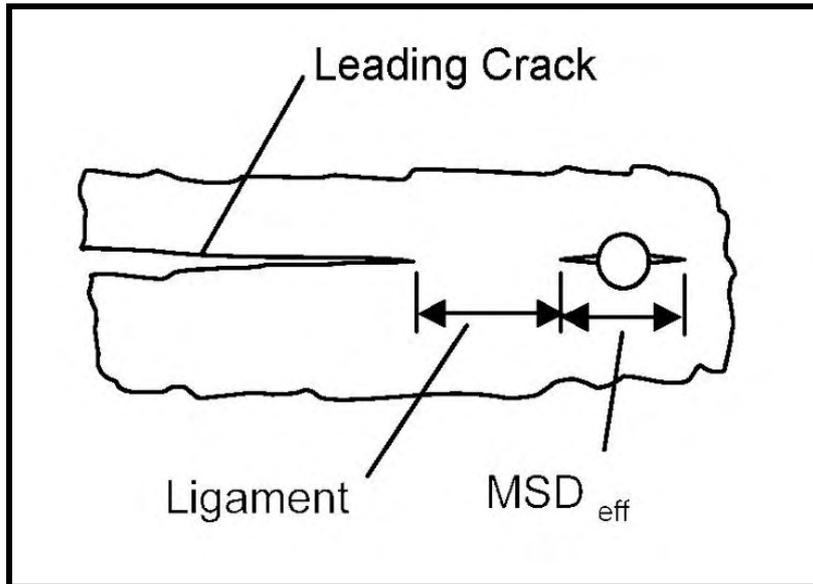
Figure 2.5-3 The relation between the leading crack and MSD

Phase one of the analysis was to determine the capability of the skin given the stable, flat-fracture, through-thickness fatigue crack as confirmed by the CSIST and BMT. It considered the main 15.1-inch long through thickness fatigue crack centered at STA 2100 frame as well as the MSD. MSD adjacent to the leading crack could further reduce the residual strength of the skin. The degree of reduction in its residual strength is dependent on the size of the MSD, and its proximity to the leading crack defined by the length of the ligament. A local ductile fracture could occur between the leading crack and the adjacent MSD once the reduced residual strength of the skin is lower than the applied stress (Figure 2.5-3).

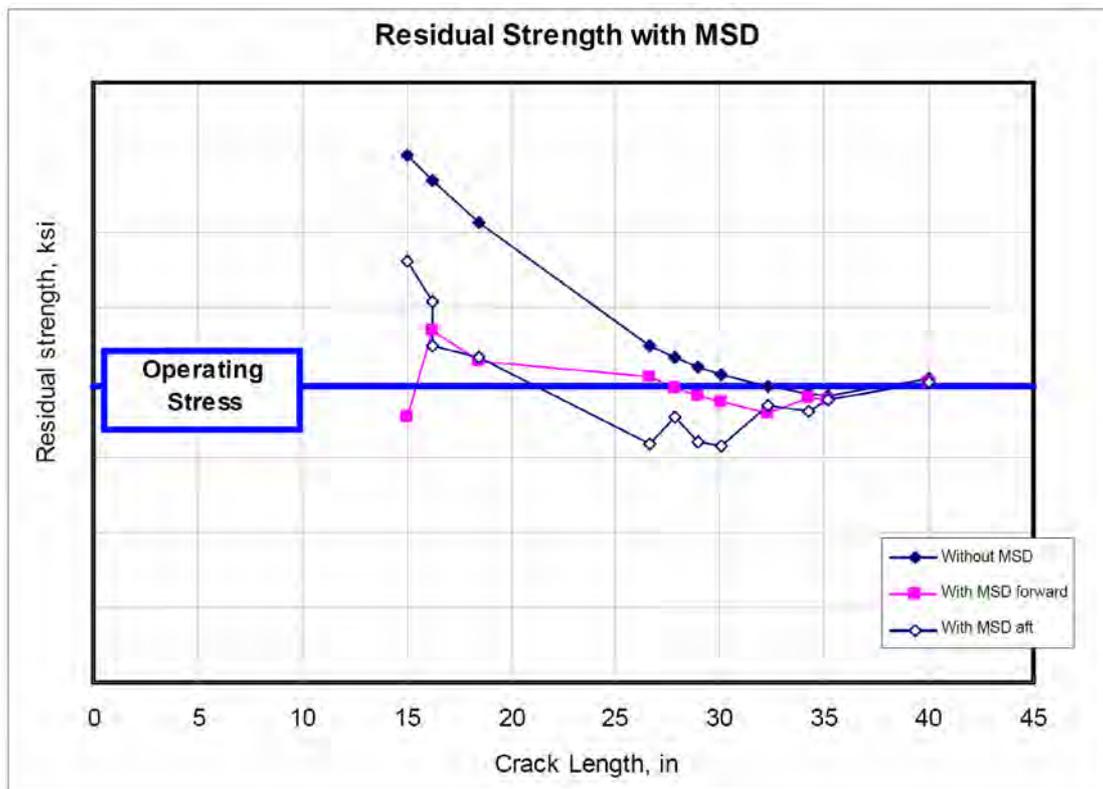
Figure 2.5-4 The residual strength of the crack length up to 40 inches

The reduction factors were calculated for the forward and afterward MSD adjacent to the leading crack. The leading crack would link to the MSD hence yield a relatively lower strength and then a new leading crack formed. The result of the final calculation was shown in Figure 2.5-4.

The upper curve of the Figure 2.5-4 shows the capability of the discontinued skin assembly without MSD. The lower two curves represent the residual strength capability of the skin assembly reduced by MSD effect within the two-bay region. These two curves indicated that the fatigue cracks identified in the two bay region should begin linking together as an overall crack length of 21 inches formed. For Item 640, once the crack grew to 35 inches, the MSD is no longer a factor in the residual strength capability, and then only the upper curve (without MSD) should be considered. Noted that at a two bay length (40 inches), the calculated residual strength capability and the operating stress are essentially equivalent.

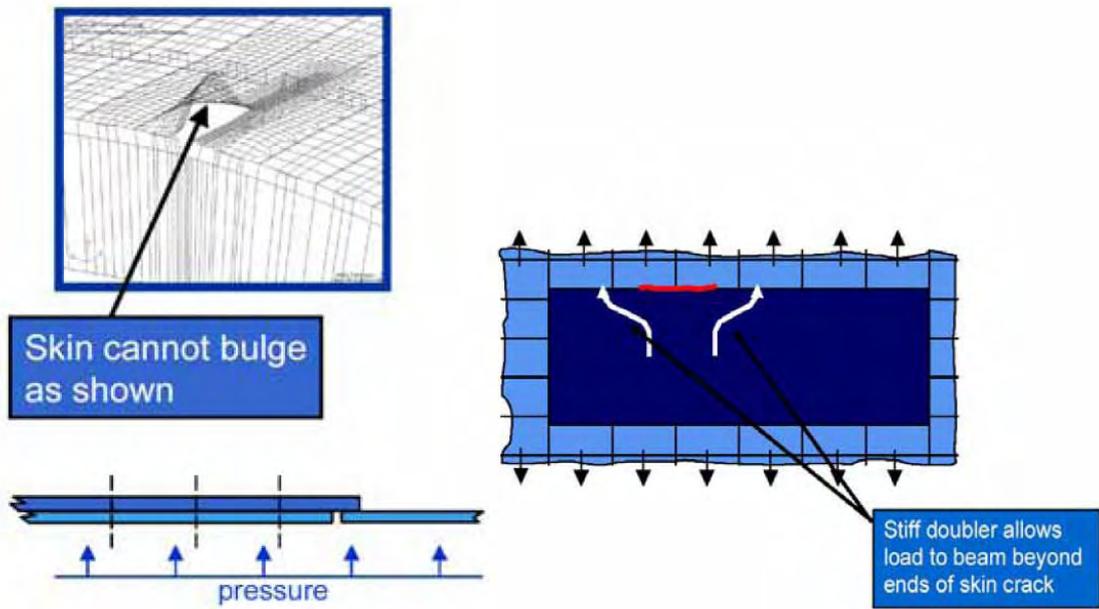
Figure 2.5-5 The influence of the repair doubler

The repair doubler could prevent the skin from bulging outward when the aircraft was pressurized as Figure 2.5-5 shows. It also allows increased load redistributing around the cracking area to increase the residual strength of the skin. The factor of the influence on the residual strength was determined by a non-linear finite element model developed for the case of C1611. The model provides values that can be compared to and correlated with the established analysis in Section 2.5.2. Employing this model, with the effect by incorporating the repair doubler to determine the resulting increase in residual strength when the skin is not allowed to bulge, was evaluated. The upper curve in Figure 2.5-6 represents the calculated increase in residual strength with the effect of the repair doubler for up to a two-bay skin crack.

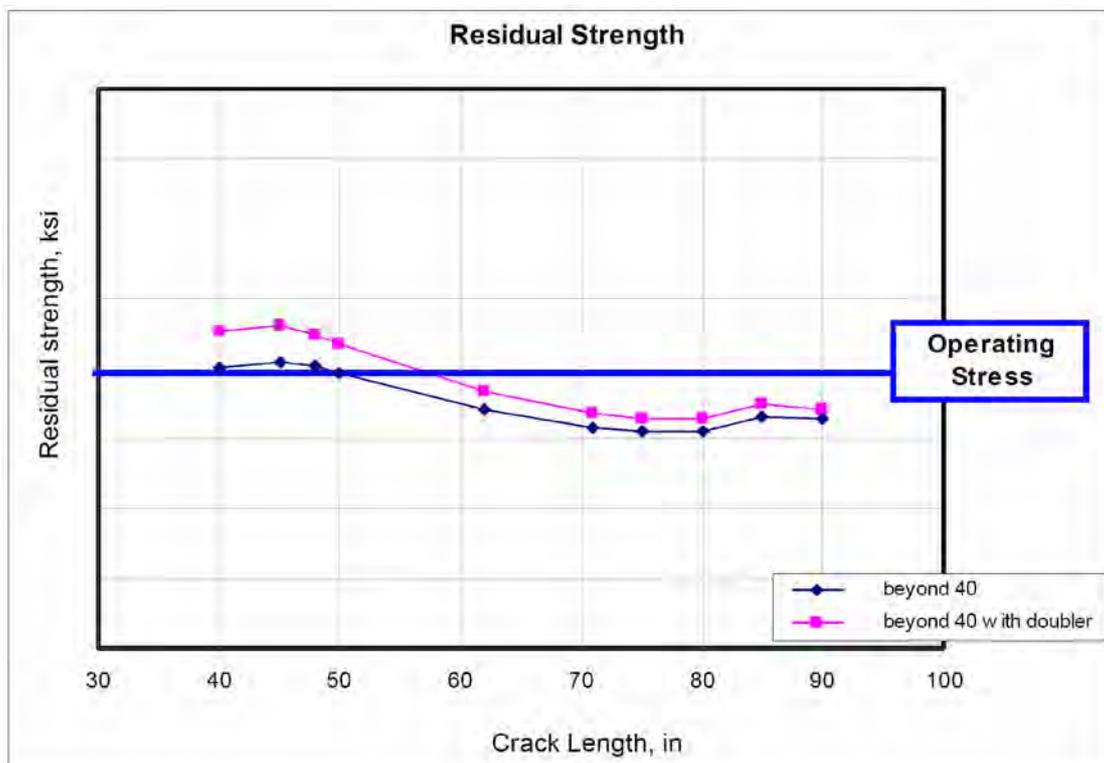
Figure 2.5-7 The residual strength of the extents of the crack up to 90 inches

The nonlinear FEM was also used to assist in determining the values for the residual strength beyond two bays (40 inches) of skin damage. Figure 2.5-7 represents a comprehensive residual strength analysis for the skin assembly, showing the calculated capability of the skin for cracks extending beyond 40 inches. This analysis includes both the basic residual strength for a cracked panel and the increased residual strength with the installation of the repair doubler. It can be seen that the influence of the repair doubler is less pronounced toward the extents of the pre-existing crack. This is primarily due to the inability of the repair doubler to sustain beam loads around the cracked area as the crack starts to approach the ends of the repair doubler.

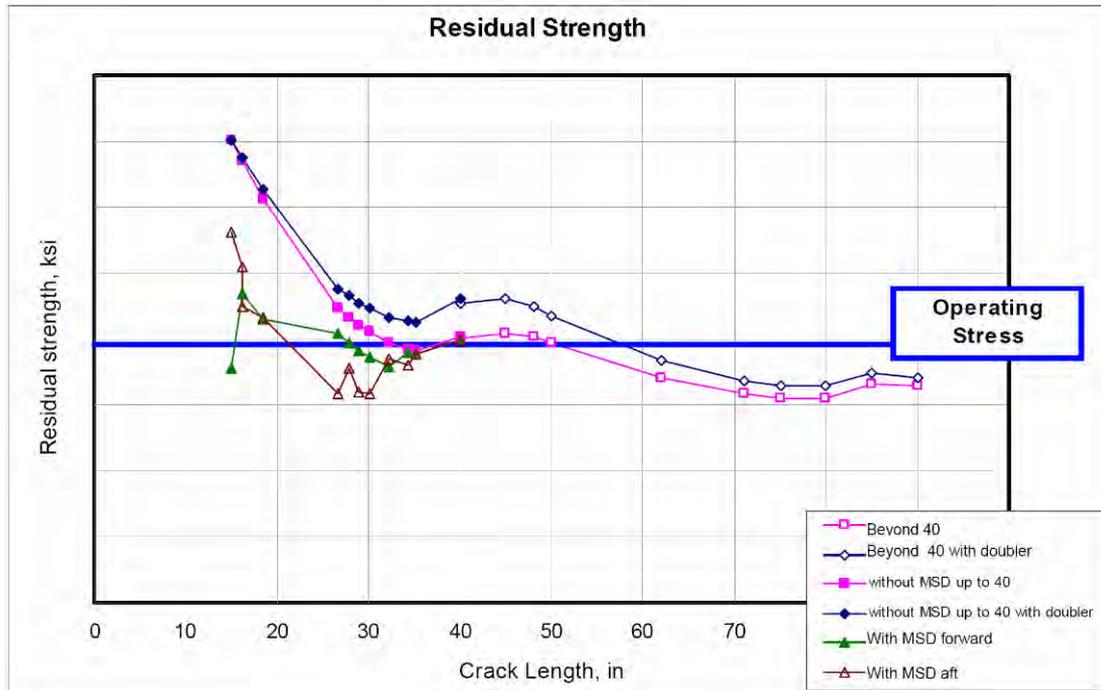
Figure 2.5-8 The combination of the two-stage residual strength analysis

A combination of all the above results is shown in Figure 2.5-8. It shows the MSD region, the residual strength without MSD, and the repair doubler effects for crack lengths ranging from 15 to 90 inches.

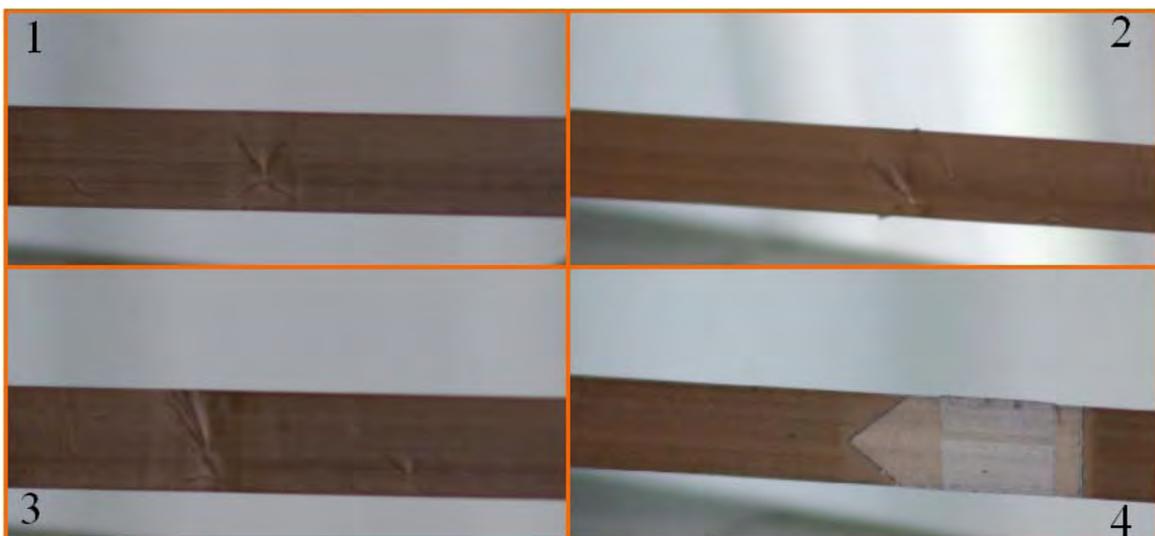
Figure 2.6-1 Damaged and spliced tape areas

Eight unidentified sounds were attributed to the tape damage and one with no signal was attributed to the tape splicing. Figure 2.6-1 frame #1 to #3 shows the typical tape damage and frame #4 shows the spliced area. Several sounds were identified as possible sounds from a toggle switch, or other switches. Because of high noise background, sounds from switches are difficult to be identified, such as momentary switch, switch movements, keyboard entries on the INS panel, switch on the audio selector panel, etc. Some unidentified sounds are likely the sound of crew motions but they might not be directly related to any operational action. Table 2.6-2 lists the unidentified sounds and their associated possible events.
