Aviation Occurrence Report Volume I

IN-FLIGHT BREAKUP OVER THE TAIWAN STRAIT

CHINA AIRLINES FLIGHT CI611

BOEING 747-200, B-18255

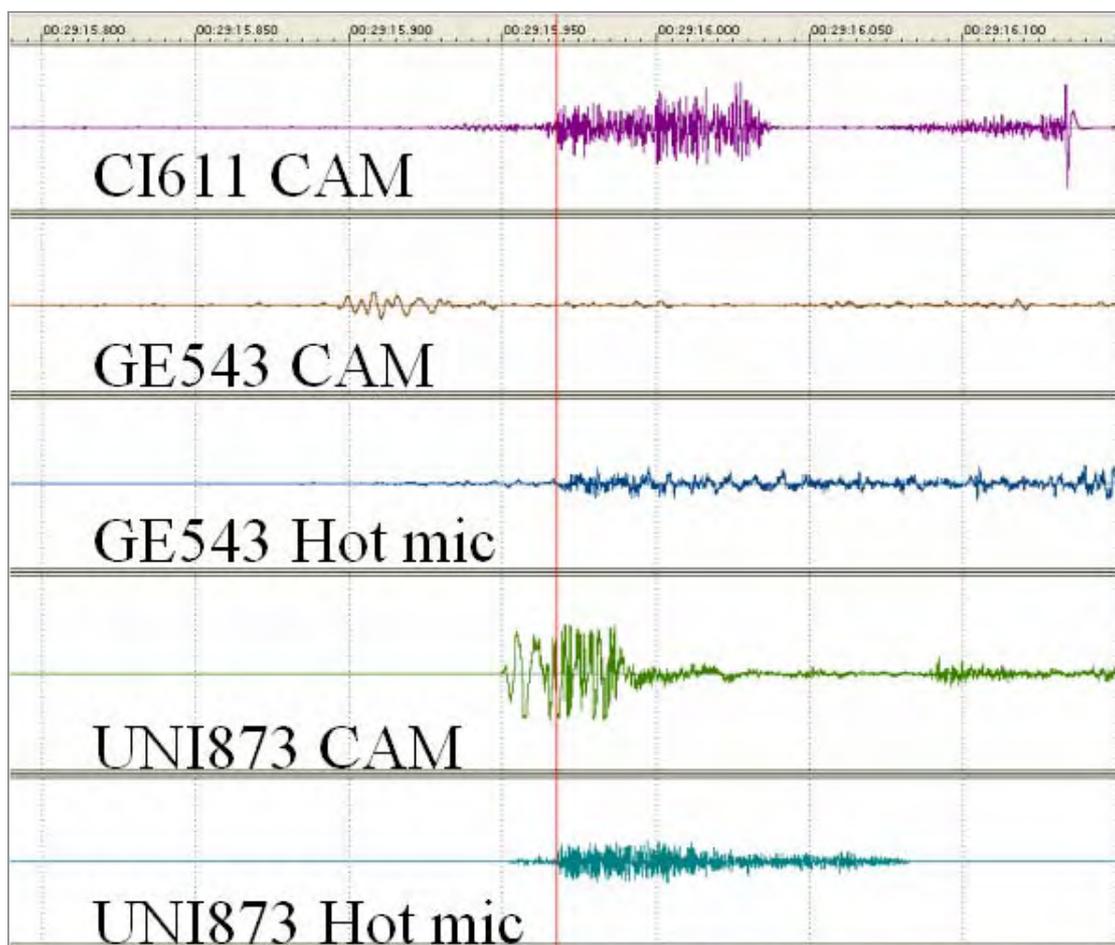
Figure 2.6-2 Comparison of the sound spectrum of three accidents

If the event sound propagated via air in cabin and cockpit, but without the fuselage attenuation, the event sound level would be recorded with significantly higher energy. For instance, the UNI Air 873 accident; an explosion took place on the left overhead luggage compartment of the forward fuselage of a MD-90 aircraft in the landing roll. The energy level of the event sound was very high on the CAM channel, because the explosion area is very close to the cockpit; the level of precursor is also high (Figure 2.6-2).

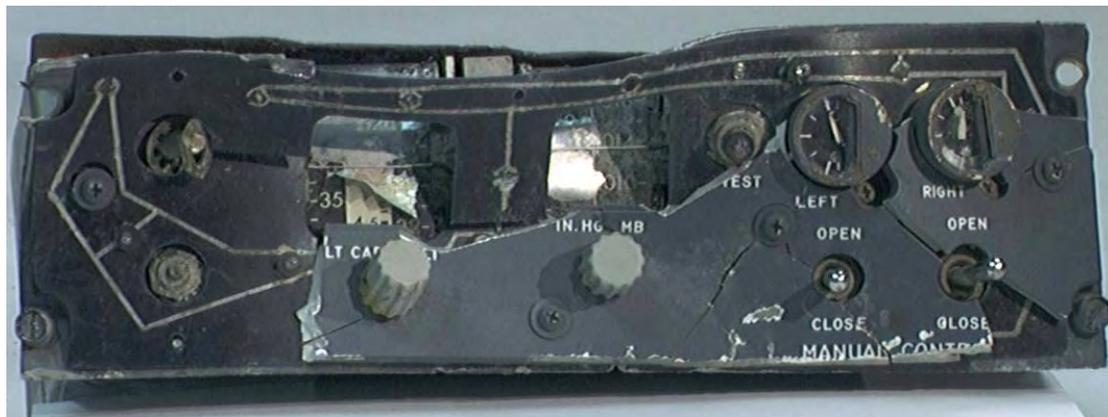
Figure 2.7-1 Cabin pressure control selector panel

Based on the examination, the Cabin Pressure Control Selector Panel (shown in Figure 2.7-1) is deformed, delaminated and fractured. The examination and test results show that the mode switch was in the “MAN” (manual) position.

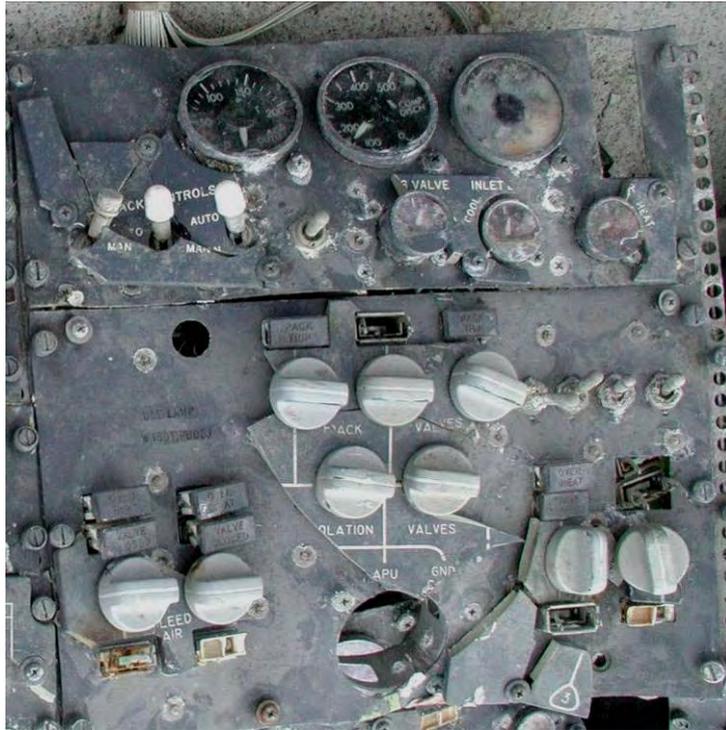
Figure 2.7-2 Air conditioning panel

Examination and test results of the air conditioning panel revealed that two of the three air conditioning “pack” valve selectors were found in the “Closed” position and another one was found in the near closed position. The normal operating procedures for CAL B747-200 specify that at least two pack valves be in the “open” position after engine start, and CM3 shall check the setting after takeoff and during climb. Also, CM3 is required to verify two packs “Open” after takeoff and during the initial climb. The CVR transcript reveals that CM3 verbally confirmed that two packs were “Open.”

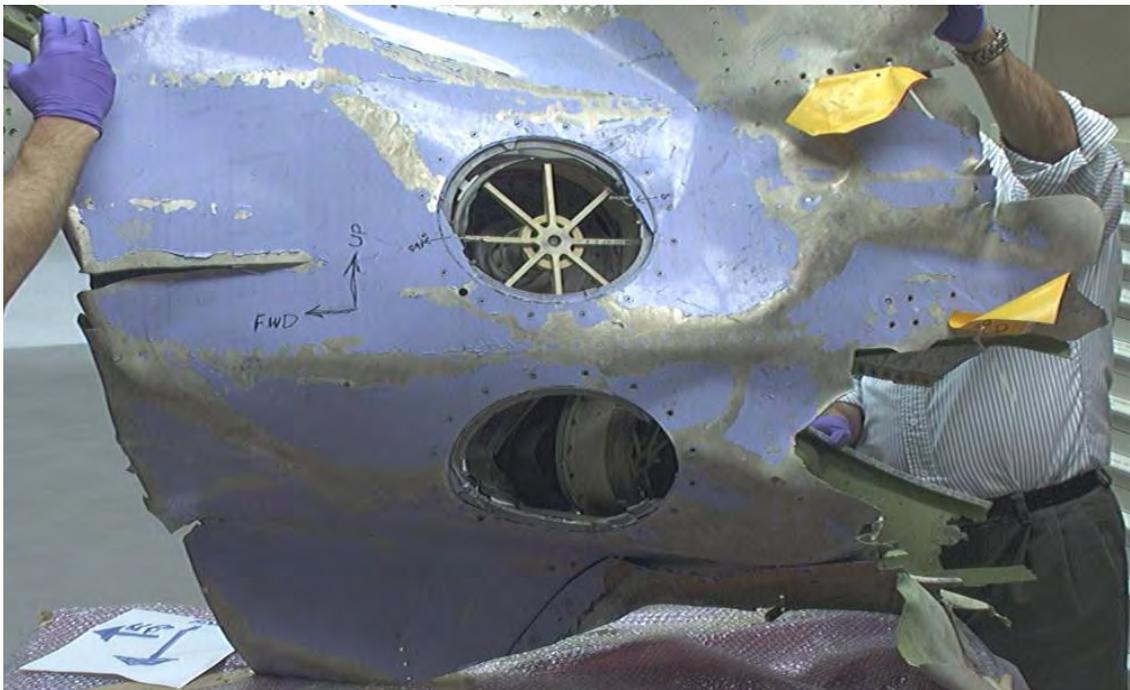
Figure 2.7-3 Pressure relief valves.

Two cabin pressurization relief valves are installed to relieve excessive pressure in the cabin. Both valves were recovered as shown in Figure 2.7-3. All flapper (blowout) doors (upper and lower for both valves) and some hinge pins are missing. The Lower Pressure Relief Valve was no longer attached to the structure. The structure between the upper and lower valves was buckled outward.

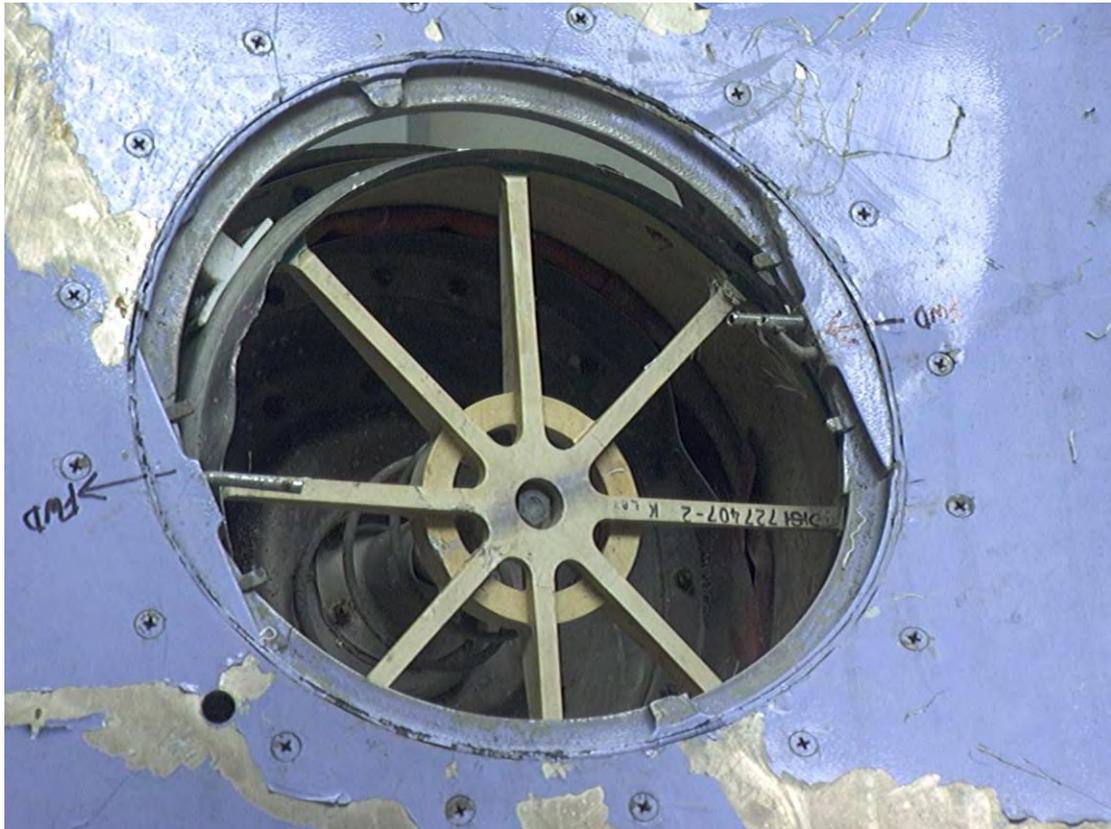
Figure 2.7-5 Upper pressure relief valve

The visual inspection result shows the Upper Pressure Relief valve (Figure 2.7-5) has been deformed inward, the blowout doors are missing, the gate web fractured, FWD upper hinge pin is bent, lower hinge pin missing, AFT lower hinge pin is bent and all hinge pins are moveable.

The wreckage examination results show that the upper pressure relief valves had been deformed inward, the flapper doors were missing and the three out of four existing shear pins were bent-in, but moveable. It could be that outside-in forces crushed the relief valve and damaged the flapper doors and the web gate. Those three pins of item 275 were still attached to the shear pins and are parallel to the relief valves housings (aircraft fuselage skin) that might indicate the valve doors was open before the water impact. However, based on the test results, the Safety Council could not conclude whether the door was open prior to the water impact.

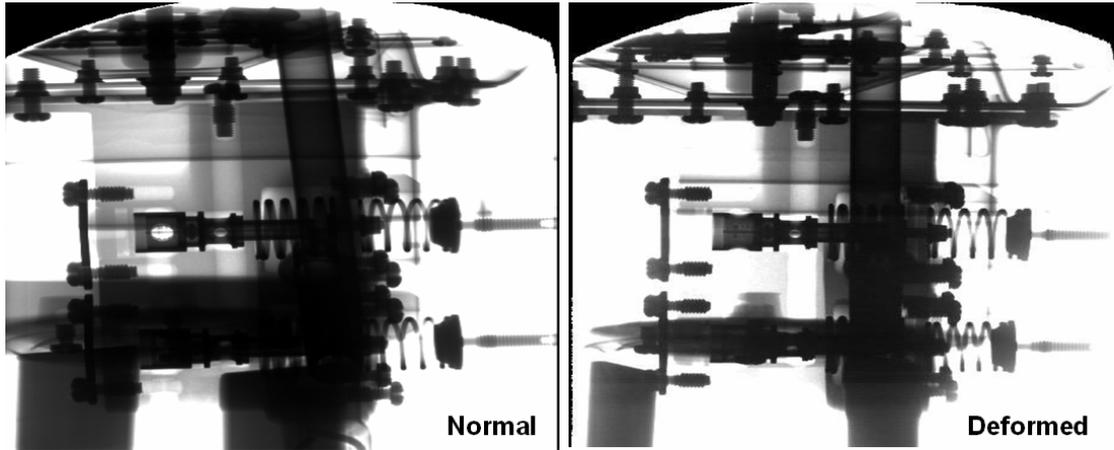
Figure 2.7-6 X-ray check results

X-Ray on the upper relief valve control switch was conducted. The results show that the control sensor assemblies were deformed from their original setting as shown in Figure 2.7-6.

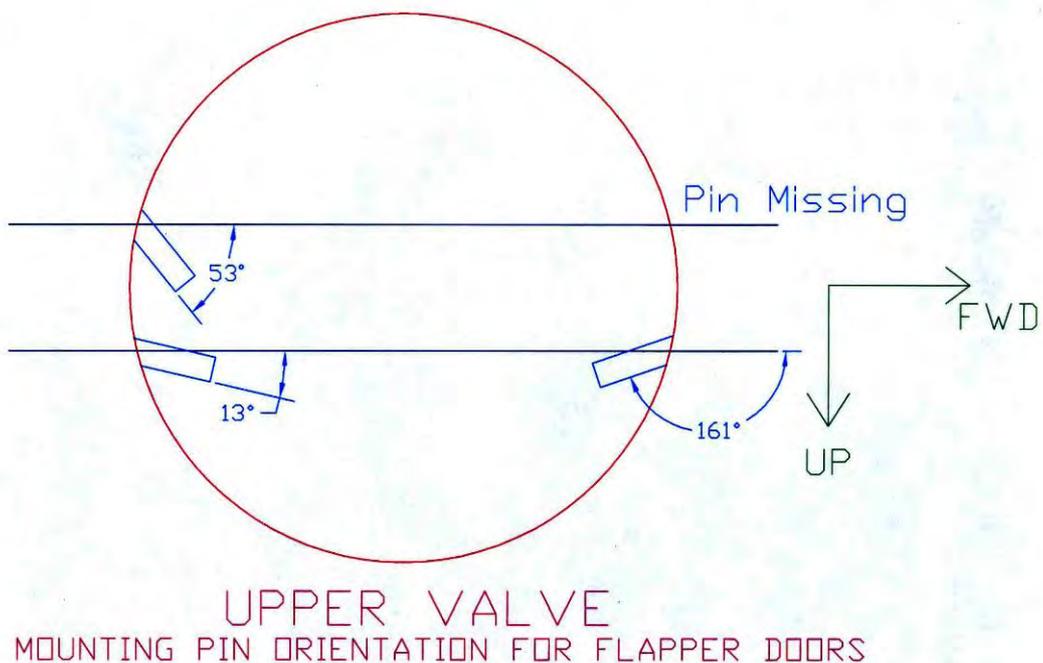
Figure 2.7-7 Upper flapper doors pins measurement results

The measurement of pin angles was performed using a flat reference plane (outer skin of aircraft); using two imaginary reference lines running between the centerlines of the pin mounting holes (upper fwd to upper aft) & (lower fwd to lower aft). All angular measurements were based from these two imaginary lines as shown in Figure 2.7-7. Results of the measurements are:

Upper aft pin was approximate 13°; Upper fwd pin was approximate 161°; Lower aft pin was approximate 53°

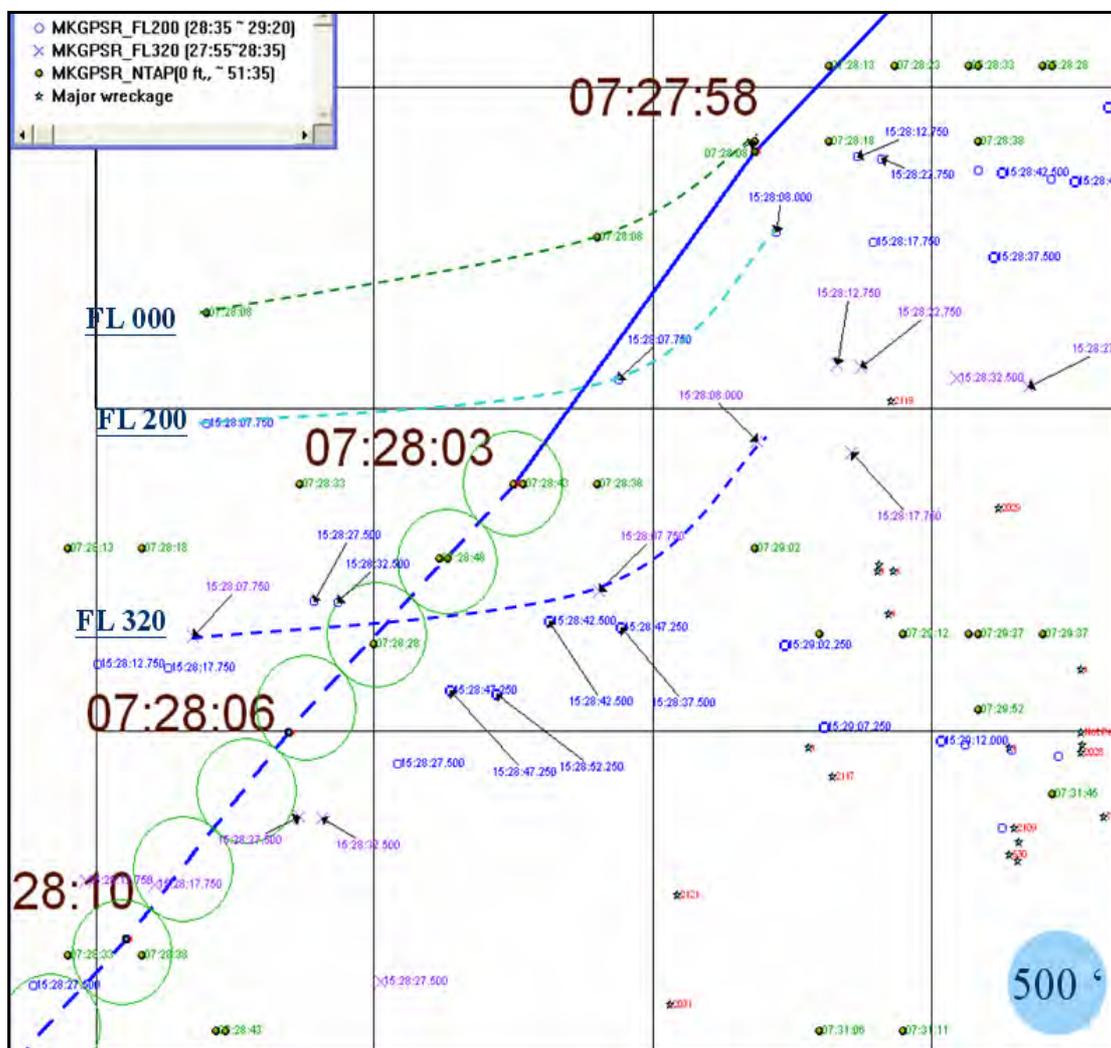
Figure 2.9-1 SSR track, PSR returns with altitude correction (red zone).

There are three initial PSR returns at 1528:08 surrounding the SSR radar track of CI611. After correction, one position was re-located to the up-wind side and two positions were re-located to the down-wind side. Figures 2.9-1 and 2.9-2 superimpose the corrected PSR return signals, the SSR radar track from 1527:58 to 1528:10, and positions of major wreckage pieces. Three dashed lines on Figure 2.9-1 represent the three initial primary radar returns at FL320, FL200, and 0 feet.

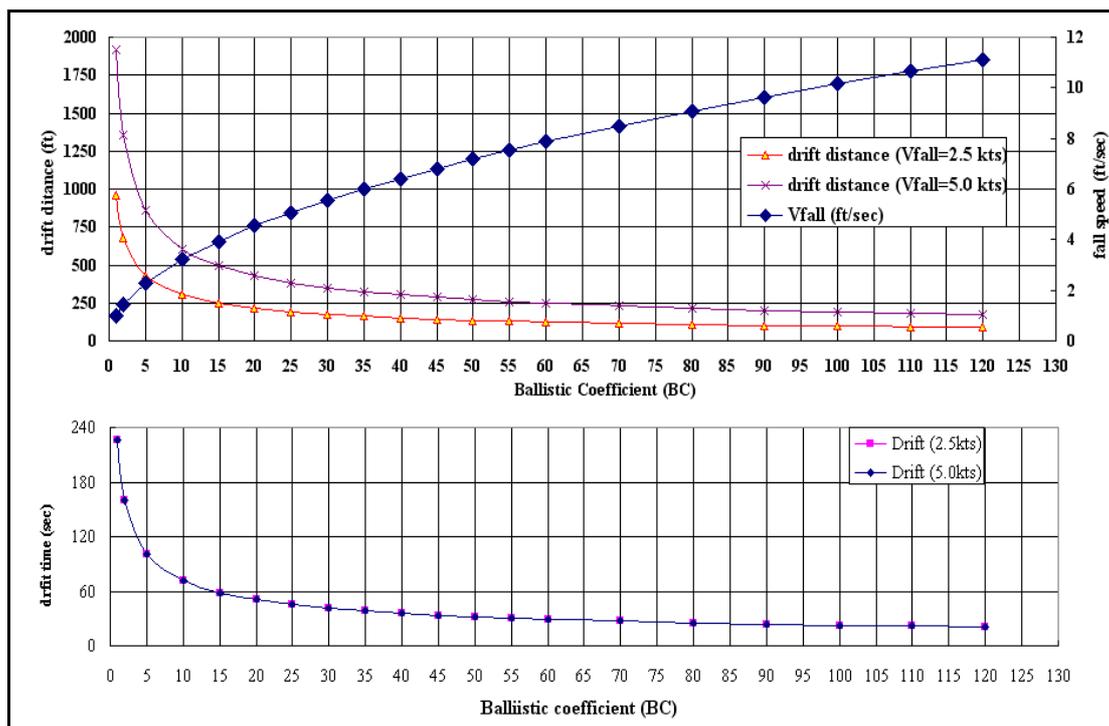
Figure 2.9-4 Comparison of drifting distance on the wreckage of different ballistic coefficients

The estimated drift effect of ocean current does not take into account the effect of buoyancy⁴⁹. Ocean depth at the accident site is about 230 ft. The ocean current at the time of the accident was predicted by NCOR to be 2.5 knots to 5.0 knots, northern direction. It is desirable to determine the drift effect of the current on wreckage locations. Figures 2.9-4 shows the relationships of drift distance and different ballistic coefficients (BC). The drift effect of ocean currents on heavy wreckage position (BC greater than 10) is less than 500 ft; 1,000 ft to 2,000 ft for the lighter wreckage (BC less than 10).

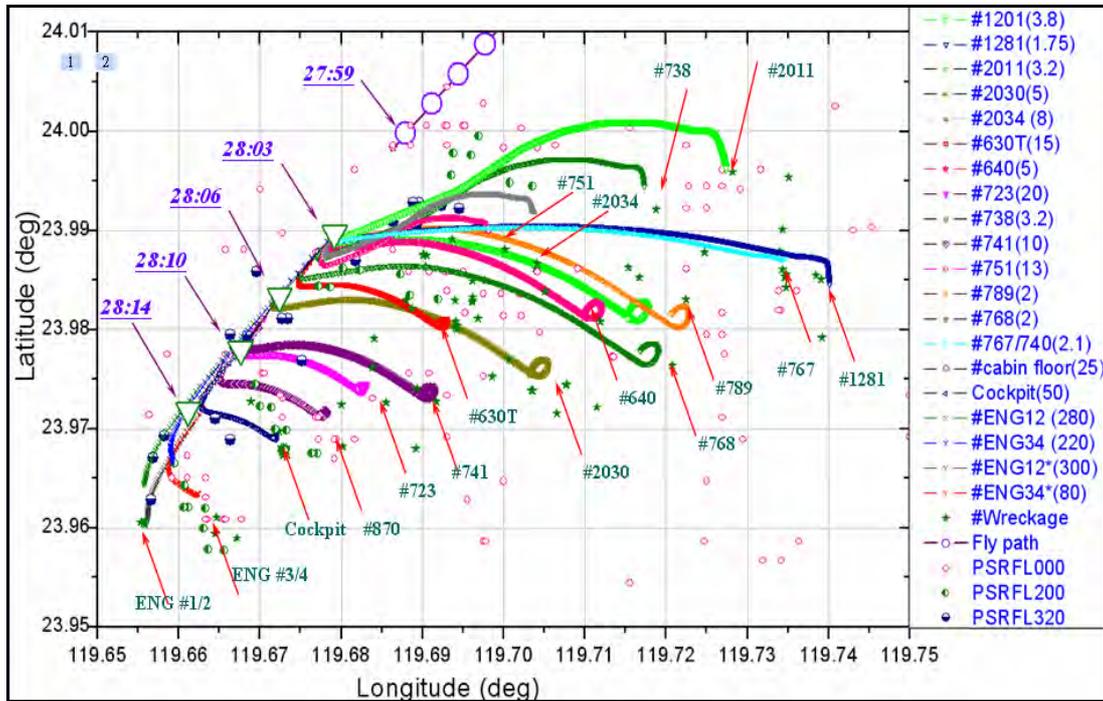
Figure 2.9-5 Two-Dimensional plot of ballistic trajectories

The ballistic analysis indicated that initial breakup of CI611 may have occurred more than 4 seconds after the ending of the FDR recording for all or some of the segments. Larger segments may have separated into smaller segments after the initial breakup. It should be re-emphasized that partial lift and buoyancy effects were not taken into account in the analysis.

The analysis results showed that the main forward body descended to sea level at 1530:34. The engines descended to sea level about 1529:15. The initial condition of assuming the engines separated from the main forward body at FL290 yields resulting trajectories closest to the salvaged positions of the four engines.

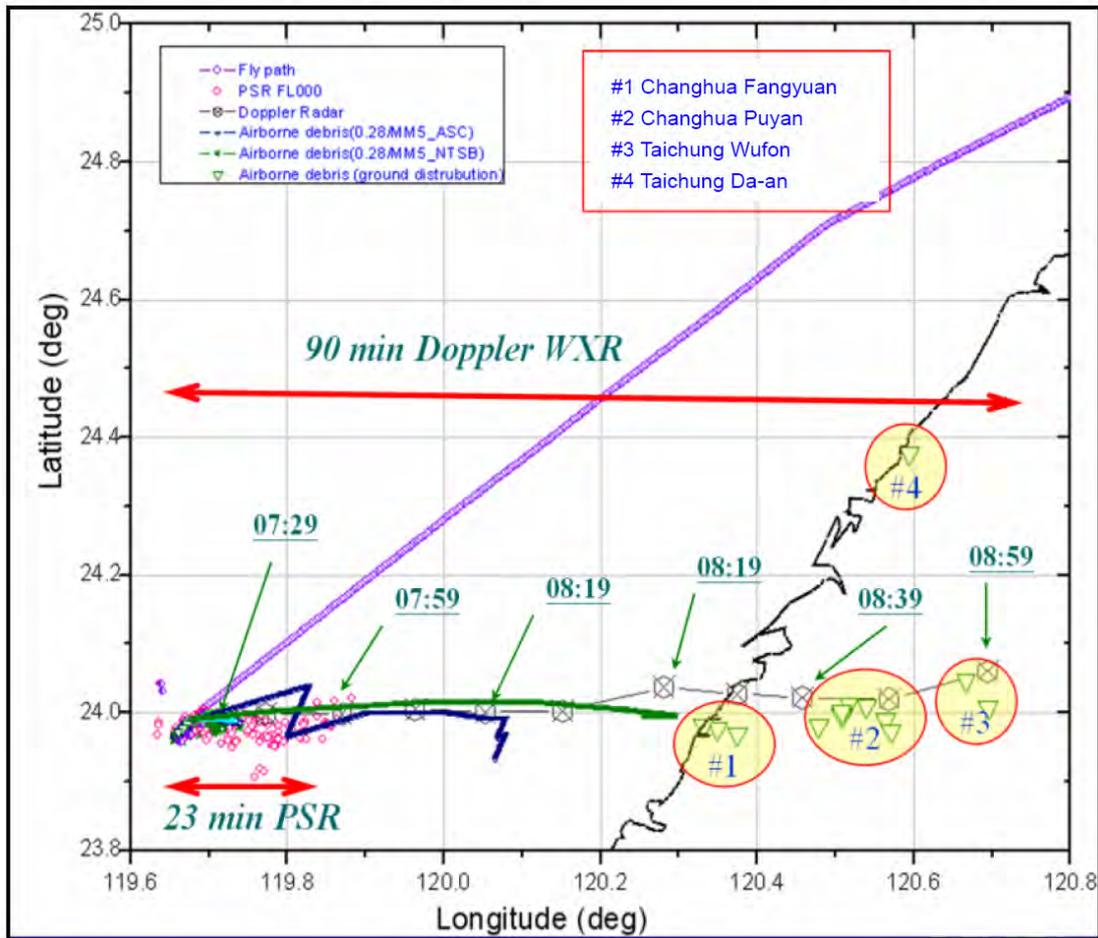
Figure 2.9-7 2D ballistic trajectories, SSR, PSR returns, and airborne debris

All the ballistic trajectories were consistent with the salvaged wreckage positions. The average distance error is less than 1,000 ft. Figure 2.9-7 (denoted as blue and green) shows the superposition of ballistic trajectories, SSR track, PSR returns, Doppler weather radar trajectory, and airborne debris distribution. Two

trajectories using different wind profiles with the same breakup initial condition (BC assumed to be 0.28). These trajectories indicated that airborne debris initiated descent at the altitude about 35,000 ft. Doppler radar trajectories and the recovered location of those light pieces of debris match with the computed ballistic trajectory.
