## REVISED FINAL REPORT

# Accident on 6 November 2002 in Luxembourg to the Luxair Fokker 27 Mk050 registered LX-LGB

REVISED ISSUE: JULY 2009

**Report N° AET-2009/AC-01**

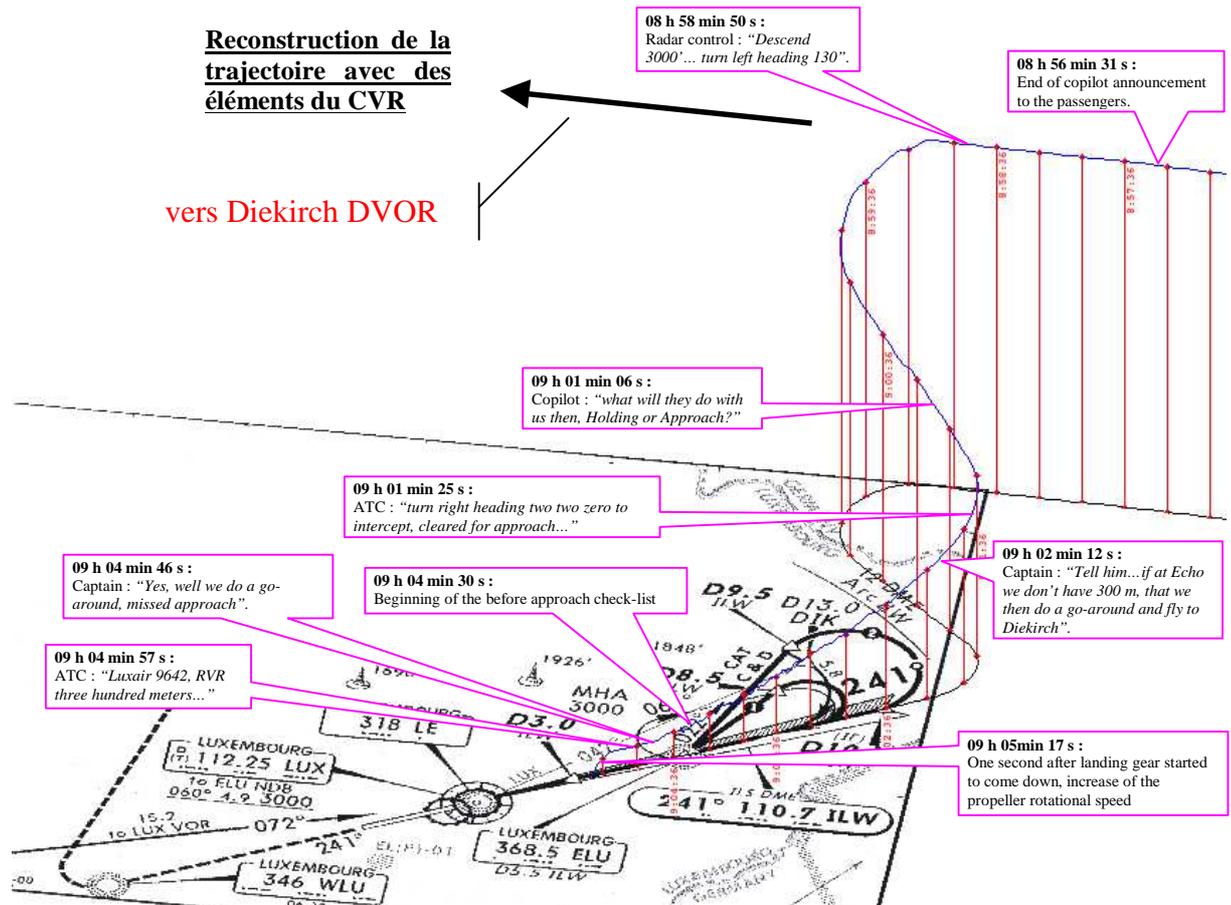
This three dimensional trajectory has been made up on the basis of Luxembourg radar data. Synchronisation precision between DFDR and CVR is one second.

The vertical profile of the trajectory shown in appendix 17 represents radar data illustrating that the final descent of the aircraft started markedly after the ELU beacon.

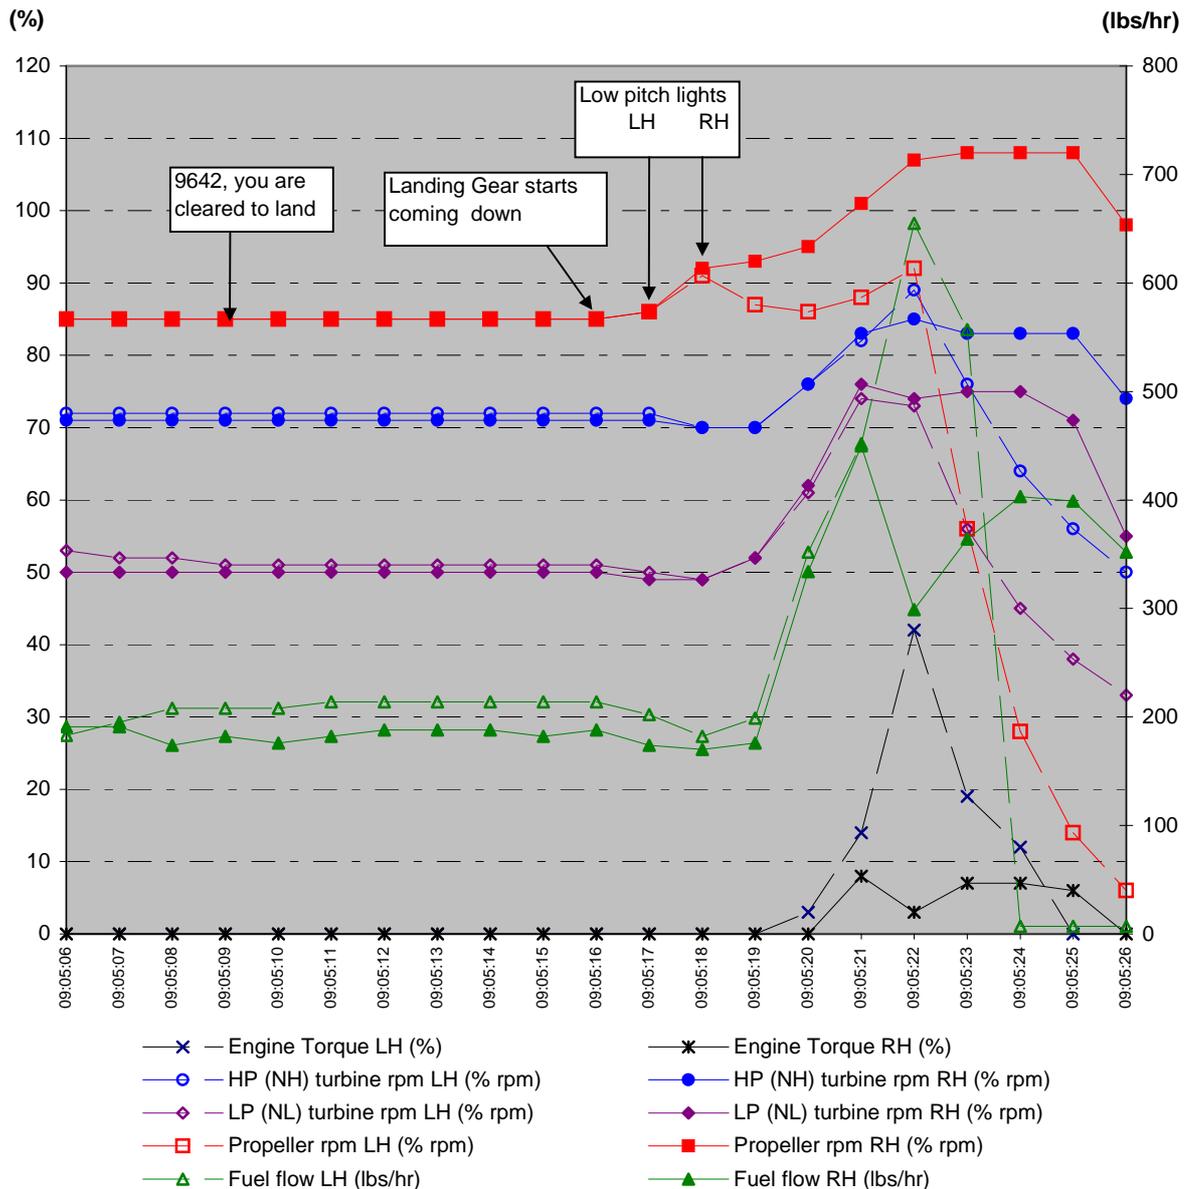
According to the engine manufacturer's information, the HP (NH) values for Flight Idle in flight are 74%. Flight Idle corresponds to zero torque, which is easily recognized for the recorded engine parameters. It can be noted that the engines never stabilised on this setting.

Analysing all the data recorded (19 approaches available) on the DFDR, this HP value of 74% can be found for all flights where the engines are on flight idle with a zero torque value.

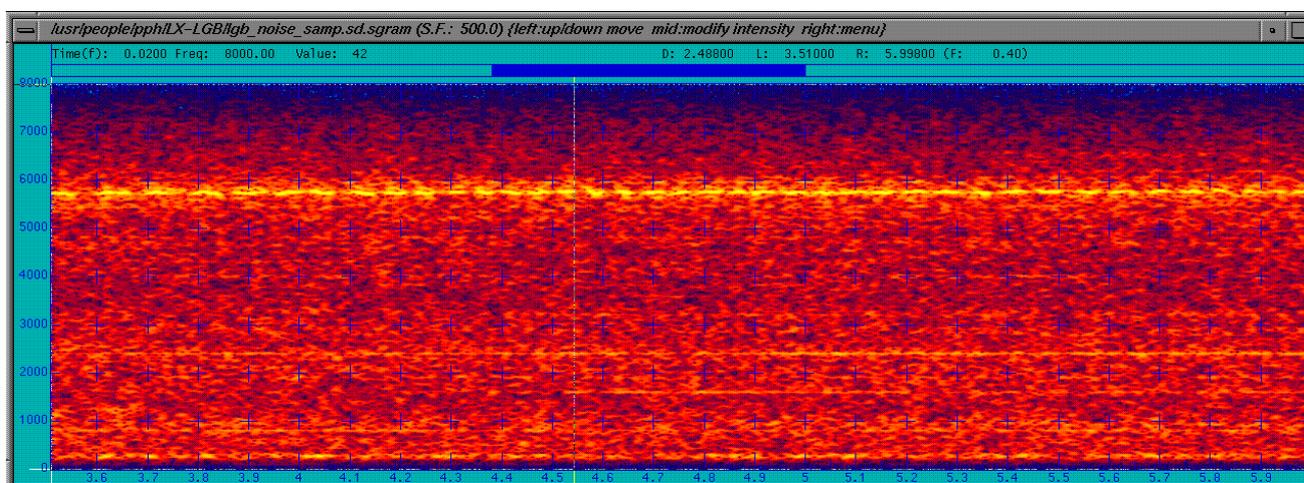
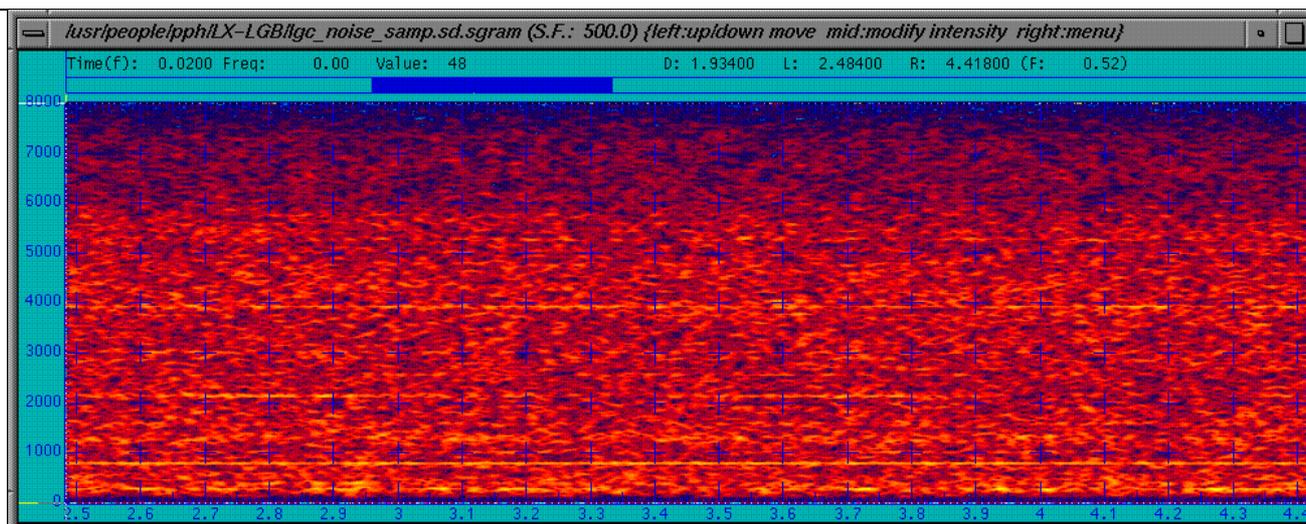
**Fig. 1: Représentation Temps – Fréquence du bruit de fond du LX-LGB en vol. Time – Frequency representation of the background noise on LX-LGB in flight.**

**Fig. 2: Représentation Temps – Fréquence du bruit de fond du LX-LGC au sol. Time – Frequency representation of the background noise on LX-LGC on the ground.**

Comme l'illustrent les deux figures précédentes, le LX-LGB (fig. 1) présente un signal plus bruité que celui du LX-LGC (fig. 2). Les hautes fréquences (autour de 5700 Hz) correspondent au bruit de la turbine de l'avion. Le bruit de fond est globalement plus élevé en raison du bruit aérodynamique caractérisé par un spectre large bande.

*As shown in the previous figures, LX-LGB in flight (Fig. 1) shows a signal with more noise than on LX-LGC on the ground (fig.2). Higher frequencies (around 5,700 Hz) match with the turbine noise whereas the global background noise has a wide range spectrum, consistent with aerodynamic noise.*

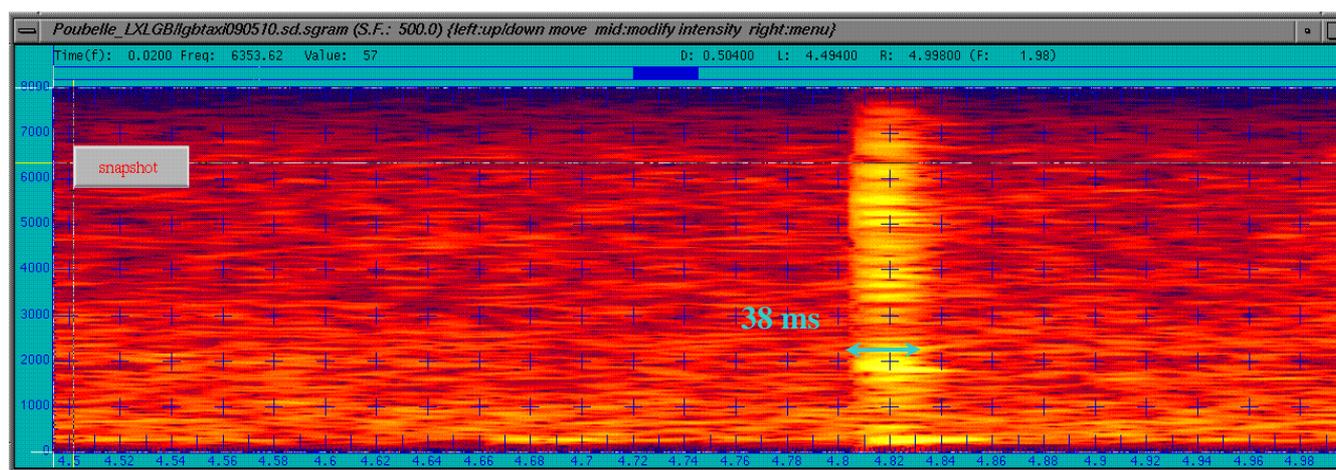
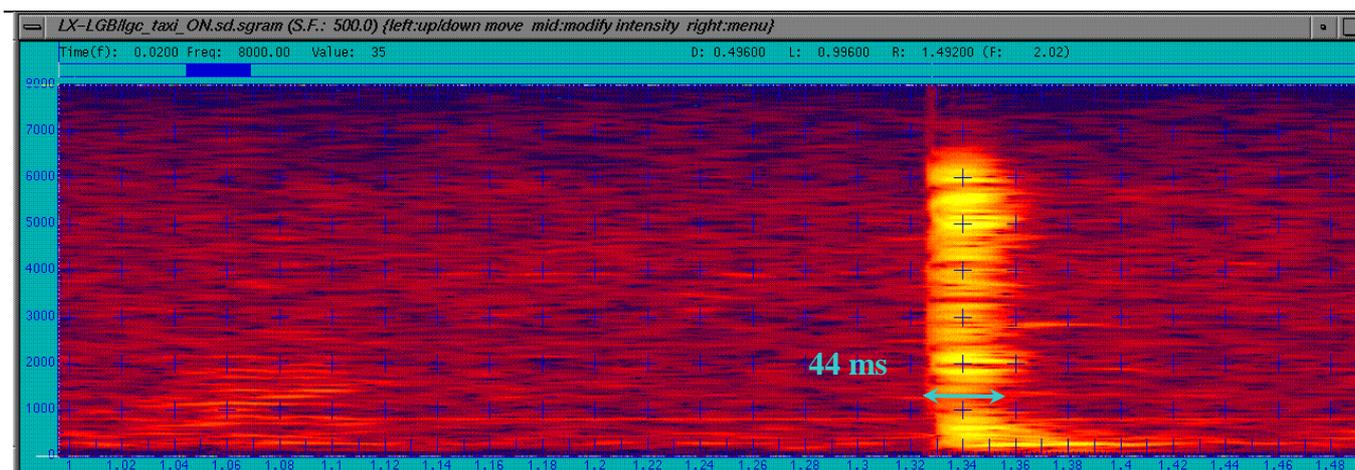
**Fig. 3: Représentation Temps – Fréquence du bruit transcrit. Time – Frequency representation of the transcribed noise.**

La figure ci-dessus représente le bruit enregistré sur le CVR de l'accident et transcrit comme l'activation des taxi lights. La figure suivante représente un enregistrement du bruit généré par l'activation des taxi lights lors des essais au sol.

**Fig. 4:** Représentation Temps-Fréquence du bruit généré. *Time – Frequency representation of the generated noise.*

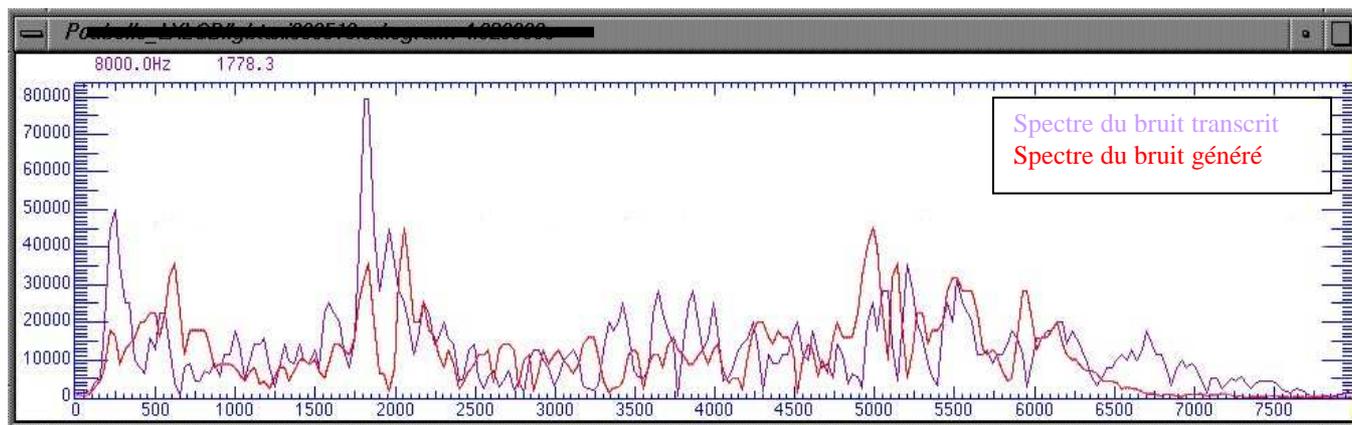
**Fig. 5: Comparaison des composantes fréquentielles des bruits transcrit (en mauve) et généré (en rouge). Spectrum comparison between the transcribed noise (in mauve) and the generated noise (in red)**

On retrouve les mêmes composantes fréquentielles, notamment aux basses fréquences et autour de **2000** et **5000** Hz.

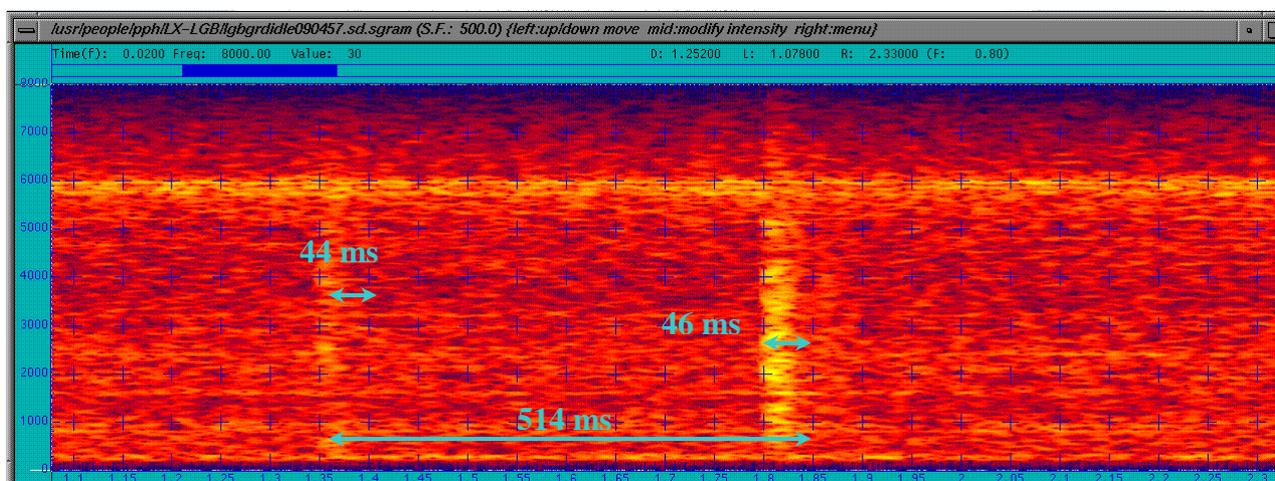
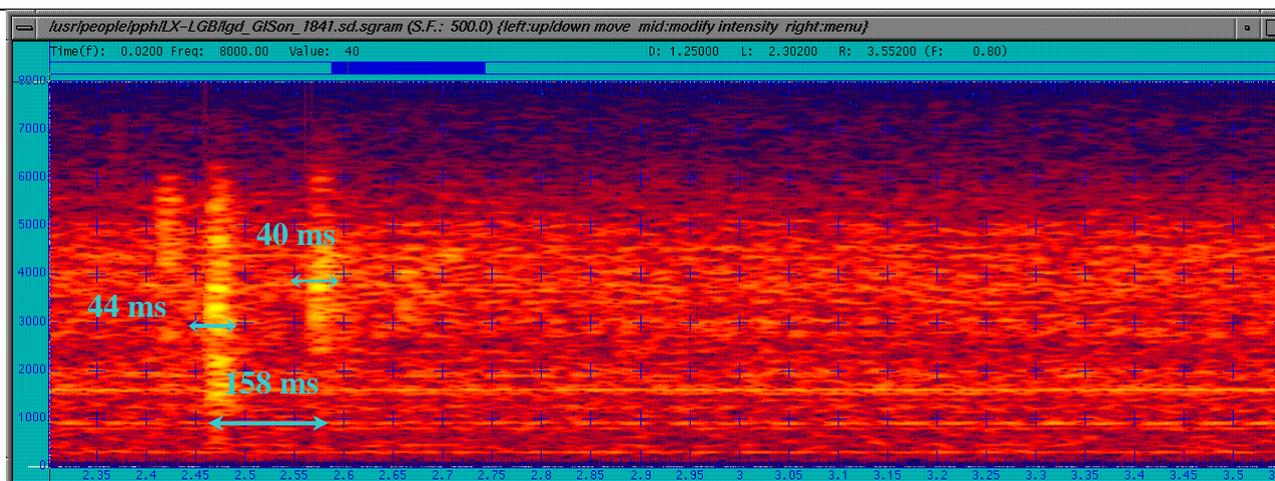
**09 h 04 min 58 s : "Bruit de sélecteur similaire au déplacement du Ground Idle Stop" / "Sound similar to the operation of the Ground Idle Stop Selector"**

**Fig. 6: Représentation Temps – Fréquence du bruit transcrit. Time – Frequency representation of the transcribed noise.**

**Fig. 7: Représentation Temps-Fréquence du bruit généré. Time – Frequency representation of the generated noise.**

La figure précédente représente le bruit du déplacement du Ground Idle Stop vers la position OFF, dans le domaine temps- fréquence.

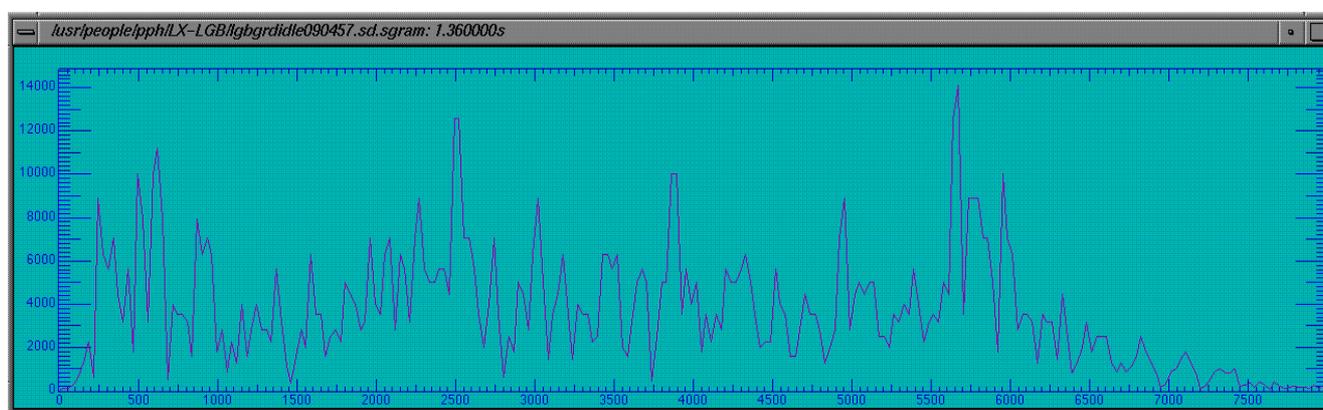
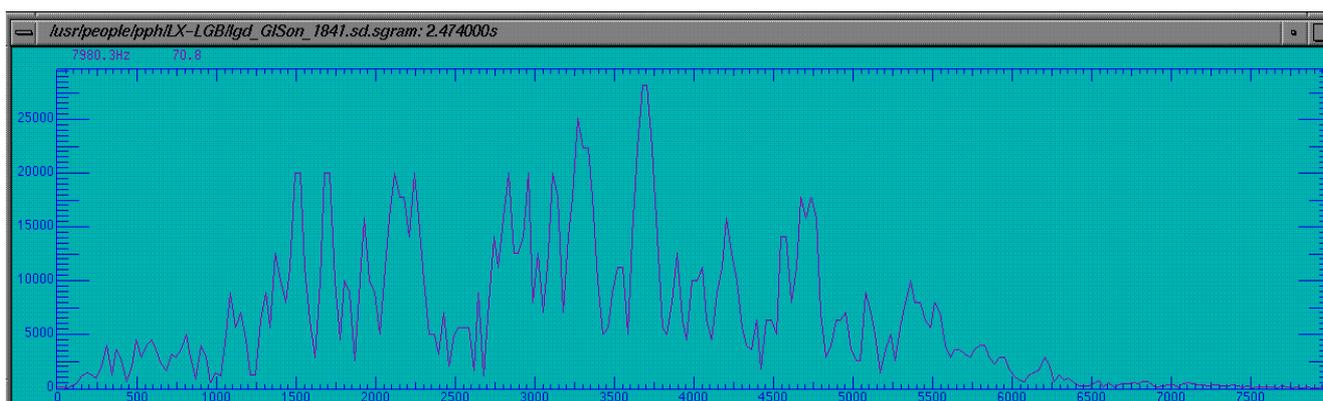
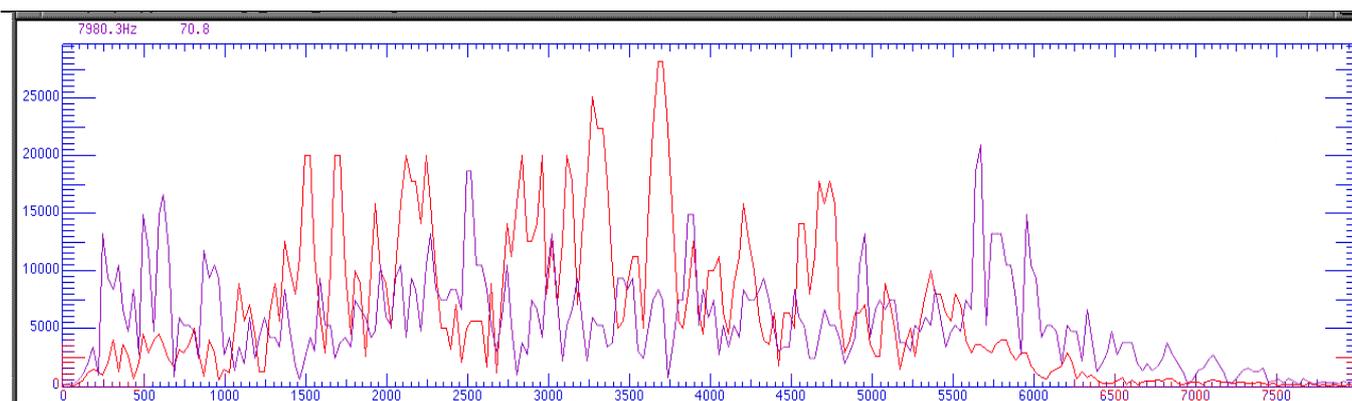
**Fig. 8: Représentation Fréquentielle du bruit à identifier. Frequency representation of the noise to be identified.**

**Fig. 9: Représentation Fréquentielle du bruit généré. Frequency representation of the generated noise.**

**Fig. 9bis : Comparaison des composantes fréquentielles des bruits transcrit (en mauve) et généré (en rouge). Spectrum comparison between the transcribed noise (in mauve) and the generated noise (in red)**

Comme expliqué précédemment, les figures 5 et 6 illustrent les différences de bruit de fond entre les deux CVR. Dans le cas du LX-LGB, le spectre est plus large en raison des bruits aérodynamique et des moteurs.

*As explained above, figures 5 and 6 show the difference in the background noise between the two CVRs. In the case of LX-LGB, the spectrum is wider due to aerodynamic and engine noises.*

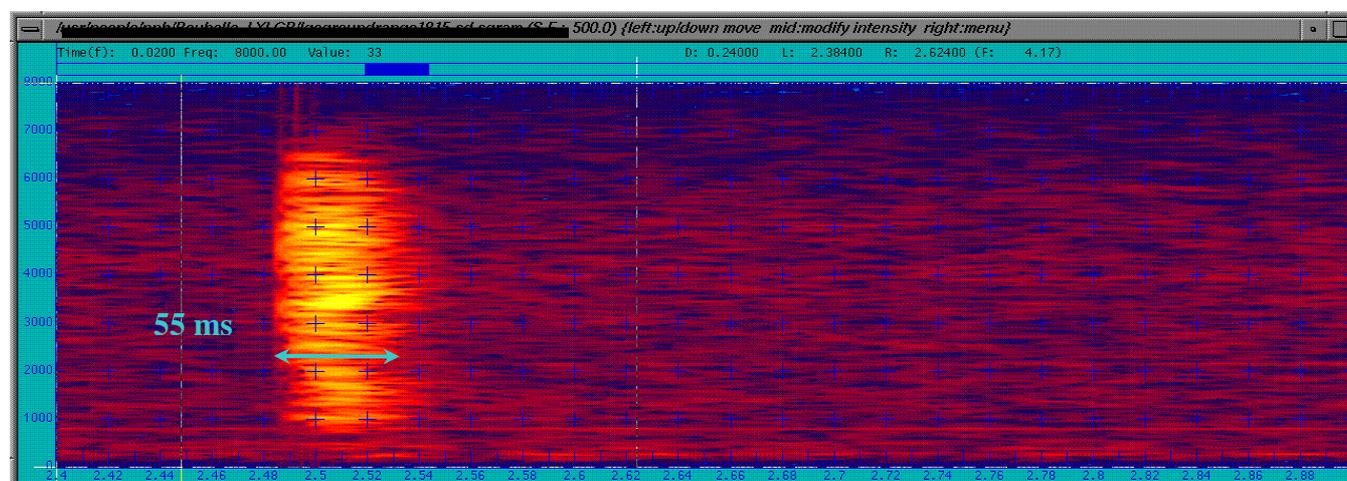
**Fig. 11: Représentation Temps-Fréquence du bruit généré. Time – Frequency representation of the generated noise.**

La figure ci-dessus représente le bruit du déplacement des *Ground Range Selector* dans le domaine temps - fréquence dans le cas où les deux leviers sont soulevés simultanément afin de retrouver une forme semblable à celle obtenue avec le bruit transcrit.

Durée du bruit généré / *Duration of the generated noise: 55 ms*

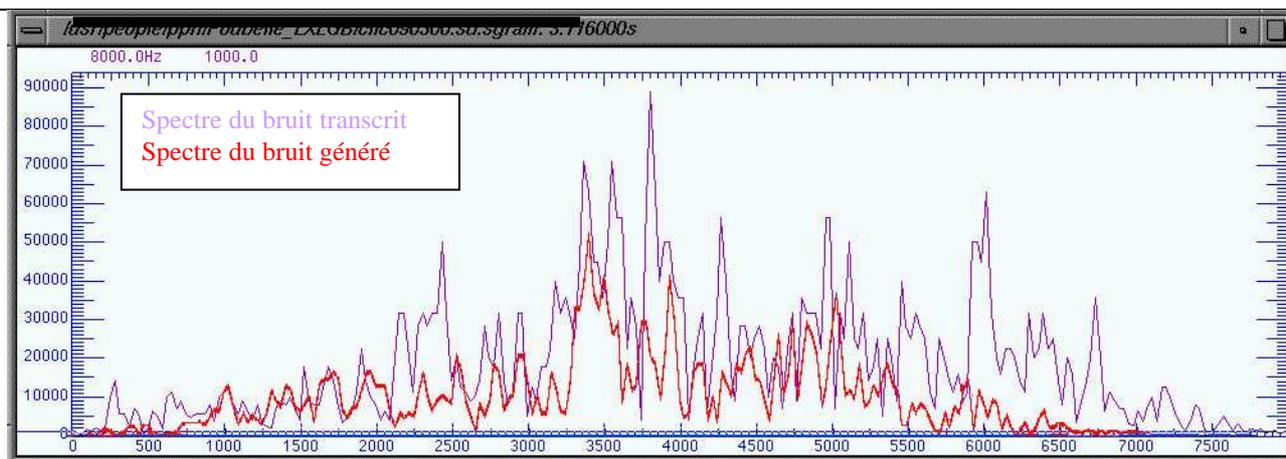
**Fig. 12:** Comparaison des composantes fréquentielles des bruits transcrit (en mauve) et généré (en rouge). **Spectrum comparison between the transcribed noise (in mauve) and the generated noise (in red)**

La figure ci-dessus est une superposition des représentations fréquentielles du bruit transcrit et du bruit généré. Les intensités du spectre du bruit transcrit apparaissent logiquement supérieures à celles du bruit généré (voir paragraphe **3.2 Environnement sonore / Acoustic environment**).

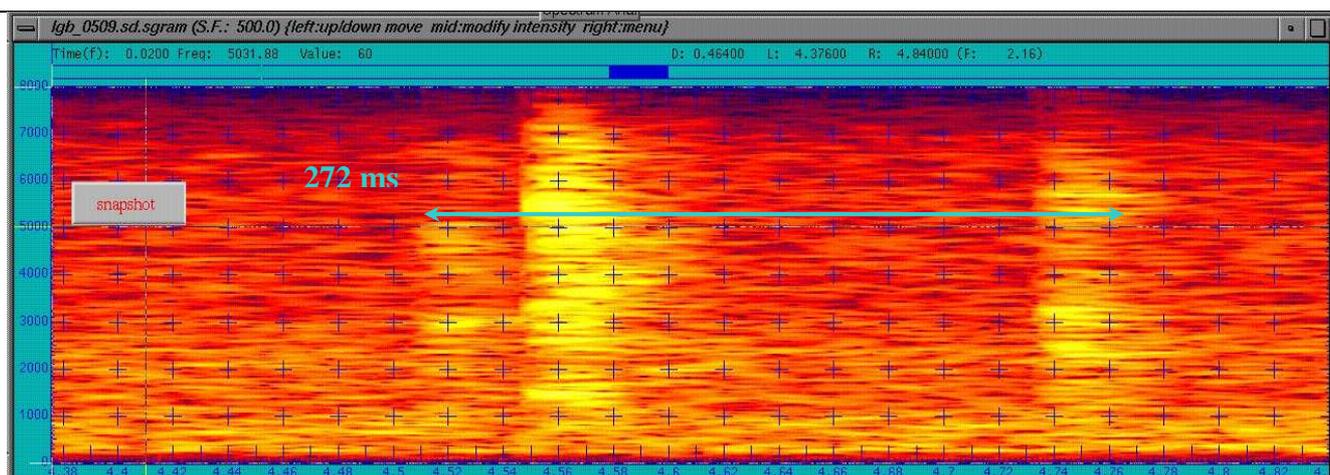
Ce bruit intervient alors que l'équipage vient de mentionner la position des volets. A la suite de cette annonce et de ce bruit, les données du FDR indiquent un déploiement des volets vers la position dix degrés.

*This noise occurs as the crew members talk about the flaps position. After this communication and this noise, the FDR data show that the flaps extended to ten degrees.*

**Fig. 13: Représentation Temps – Fréquence du bruit transcrit. Time – Frequency representation of the transcribed noise.**

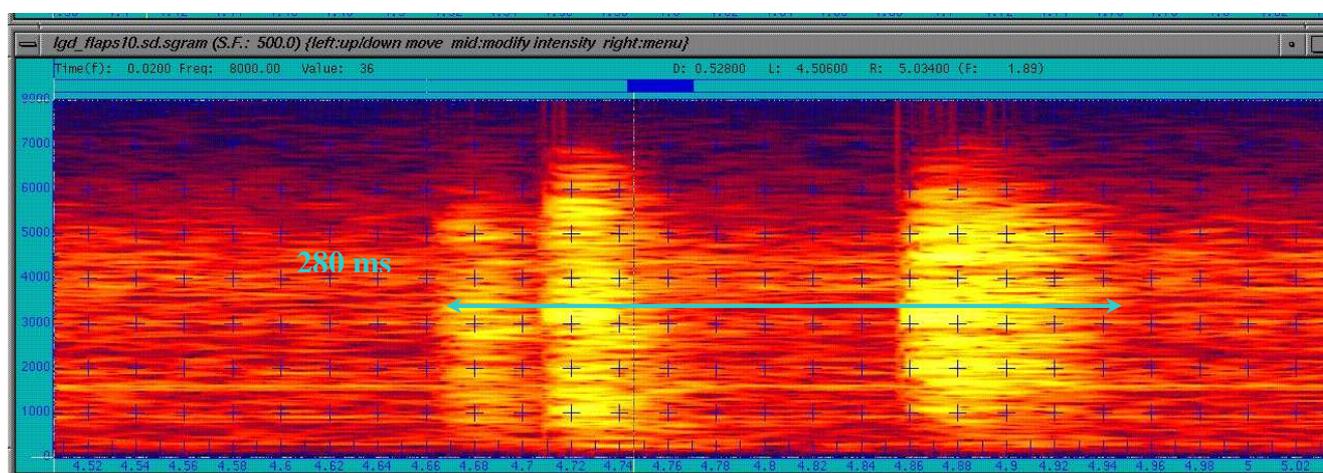
*As seen in figure 14, the same frequencies are visible, especially for low frequencies and around 2000 and 5000 Hz.*

**Fig. 14: Représentation Temps-Fréquence du bruit généré. Time – Frequency representation of the generated noise.**

*The preceding figures illustrate the similarities between the two noises, where the same signature shape and rates are found.*

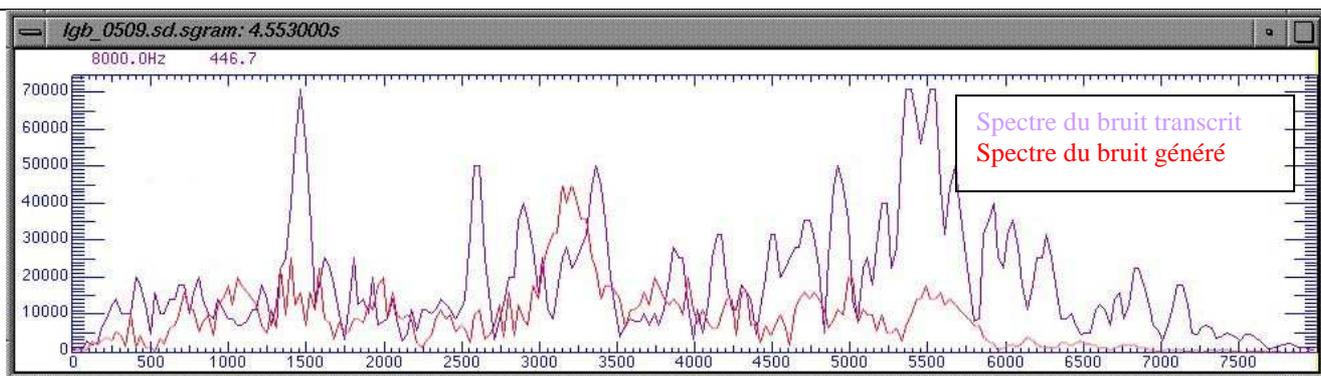
**Fig. 15:** Comparaison des composantes fréquentielles des bruits transcrit (en mauve) et généré (en rouge). **Spectrum comparison between the transcribed noise (in mauve) and the generated noise (in red)**

Bien que moins évidents, les résultats de la figure ci-dessus permettent de retrouver les points communs entre les deux bruits, notamment autour de **3250, 3800, 5000 et 5500 Hz**.

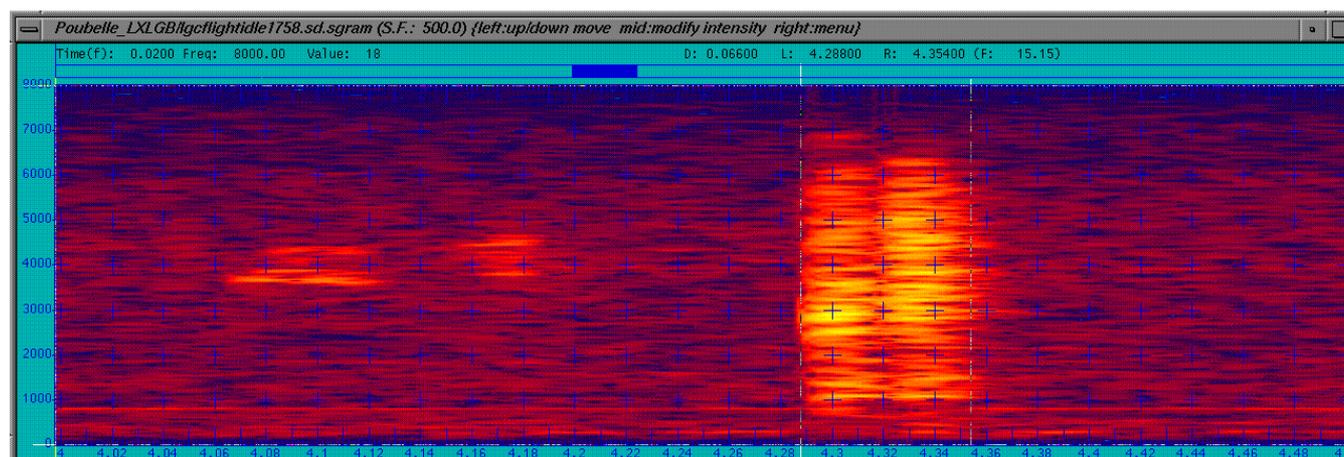
**Fig. 17:** *Représentation Temps - Fréquence du mouvement de la manette des gaz mise en position « Flight Idle ». Time Frequency representation of the operation of the throttle moved to « Flight Idle » position.*

La figure ci-dessus correspond à la manipulation des manettes des gaz sur le Fokker 50 immatriculé LX-LGC. Ces manettes étant en position *Ground Idle*, elles sont ramenées en position *Flight Idle*. On retrouve ici cette décomposition en deux clics distincts. La durée totale de ce bruit est de **70 ms**.

*The above figure corresponds to the movement of the thrust levers on the Fokker 50 registered LX-LGC. The thrust levers were moved to the Flight Idle position from the Ground Idle position. The same two separate clicks can be seen. The total duration of this noise was 70 ms.*

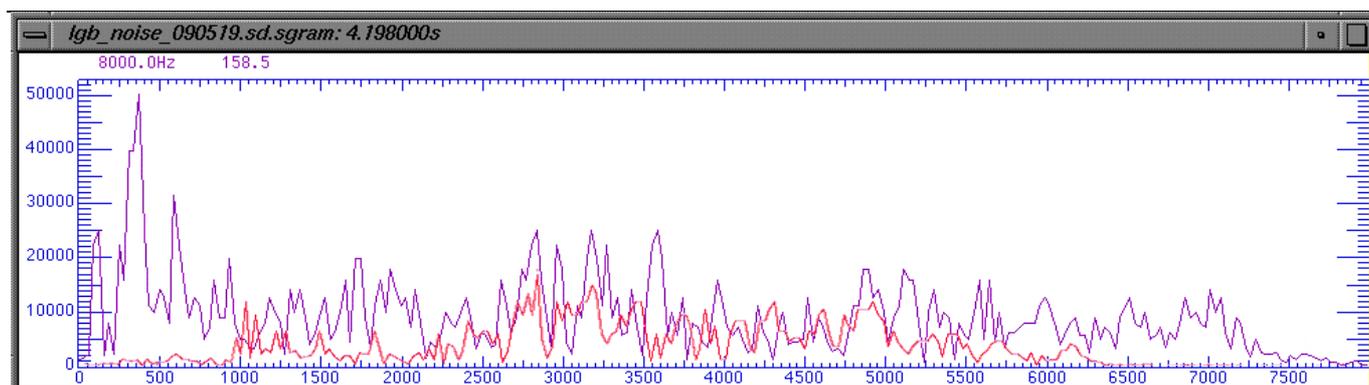
**Fig. 18:** Comparaison des composantes fréquentielles des bruits transcrit (en mauve) et généré (en rouge).  
**Spectrum comparison between the transcribed noise (in mauve) and the generated noise (in red)**

Le bruit à identifier est rapproché de celui de mouvement de la manette des gaz dans la mesure où ce dernier est cohérent avec le faciès du signal (deux clics). La figure ci-dessus illustre les fréquences communes à ces deux bruits (2800, 3200, 5000 Hz...). Il s'agit ici du déplacement des manettes des gaz vers la position *Flight Idle*.

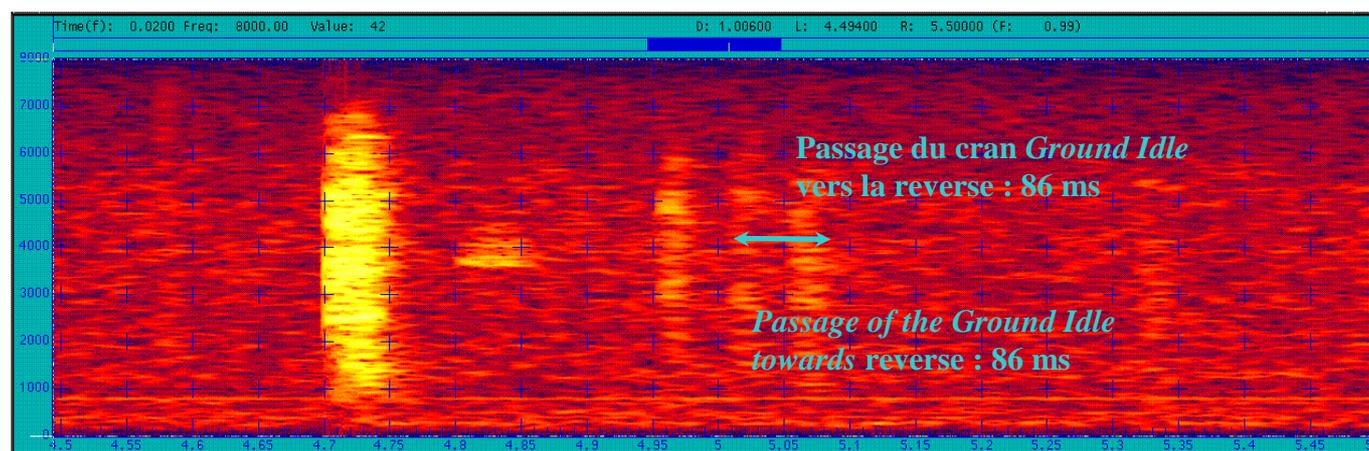
**Fig. 19:** Représentation Temps - Fréquence issue du mouvement de la manette des gaz mise en position « Reverse » depuis la position *Flight Idle*.  
**Time Frequency representation of the movement of the throttle from the Flight Idle position to the « Reverse » position.**

La figure ci-dessus illustre tout le mouvement des manettes de gaz de la position *Flight Idle* à la position *Reverse*. Les flèches indiquent le passage du cran *Ground Idle*.

S'agissant d'un mouvement de manette, on retrouve encore la même décomposition du bruit. Dans le cas présent, ce bruit est plus long que celui transcrit, avec les causes connues décrites au paragraphe 3.4.2. Les comparaisons des spectres donnent :

*Since this is a movement of a lever, the same double signature of the noise is obtained. In this case, this noise is longer than the one transcribed, the known causes being as described in section 3.4.2. The comparison of the spectra shows :*

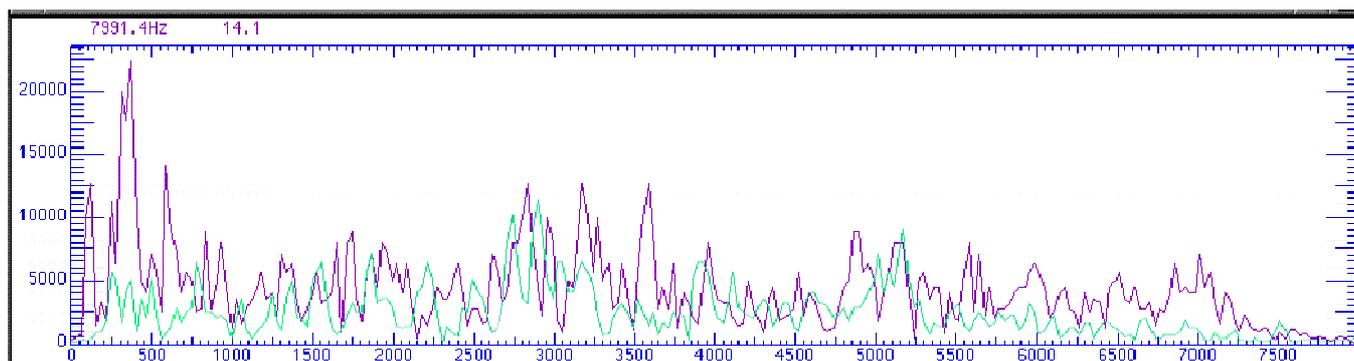
**Fig. 20:** Comparaison des composantes fréquentielles des bruits transcrit (en mauve) et généré (en vert). **Spectrum comparison between the transcribed (in mauve) and the generated noise (in green)**

Là encore, les spectres présentent des similitudes autour de **700, 1500, 3200, 4000 Hz, ...** C'est pourquoi les deux précédents bruits testés ont été comparés entre eux afin d'établir une identification différentielle. On obtient alors les résultats de la figure suivante.

*Here again, both spectra show similarities around 700, 1500, 3200, 4000 Hz... This is why the two previous noises tested were compared with each other in order to obtain a differential identification. The results in the figure below were thus obtained.*

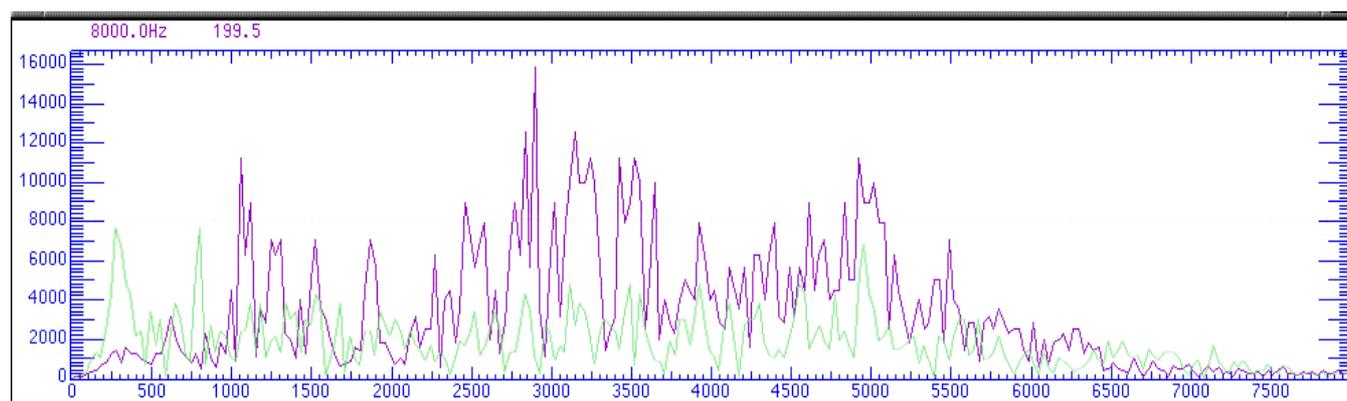
**Fig. 21:** Comparaison des composantes fréquentielles entre les manettes poussées en position Flight Idle (en mauve) et en reverse (en vert). **Spectrum comparison between the throttle set to Flight Idle position (in mauve) and Reverse position (in green)**

Les deux spectres présentent des caractéristiques générales proches ne permettant pas de distinguer les deux mouvements de manettes entre eux de manière systématique. Il convient donc de conclure que l'identification du bruit transcrit est **probablement celle d'un mouvement de manette, sans que l'on puisse conclure vers quelle position**. L'enregistrement FDR montre une montée en régime des moteurs

*The two spectra show similar general characteristics, which makes it impossible to make a positive distinction between the two different lever movements in a systematic manner. It can thus be concluded that the identification of the transcribed noise is probably that of a thrust lever movement, though no conclusion can be reached as to which position it was moved to. The FDR recording shows an increase in engine RPM following this noise and the recorded parameter for the propeller pitch switches to "Low Pitch". This is consistent with the hypothesis of the Reverse mode of the propeller.*

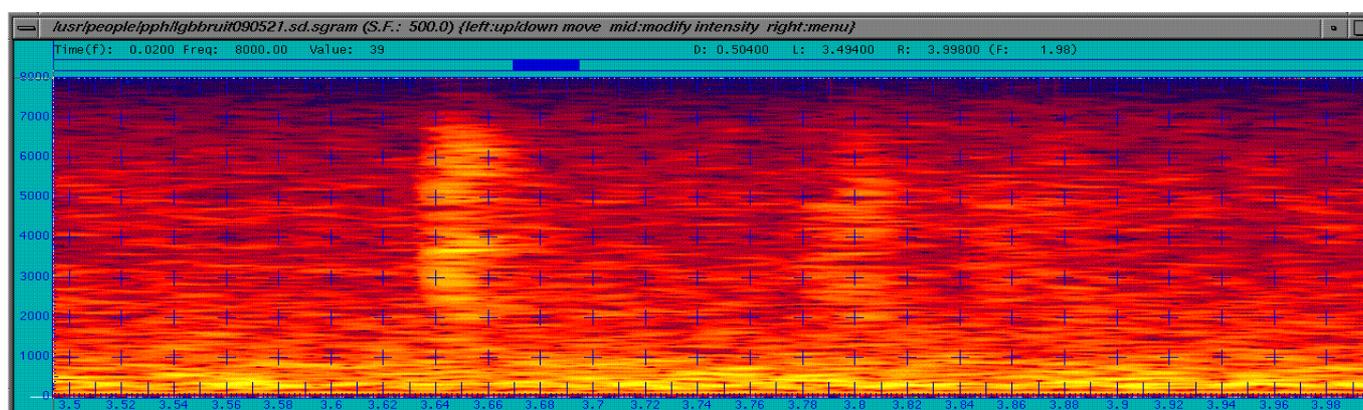
**09 h 05 min 21 s : "Bruit similaire à la manoeuvre de la commande des flaps" / "Sound similar to the operation of flaps control"**

**Fig. 22 : Représentation Temps – Fréquence du bruit. Time – Frequency representation of the noise.**

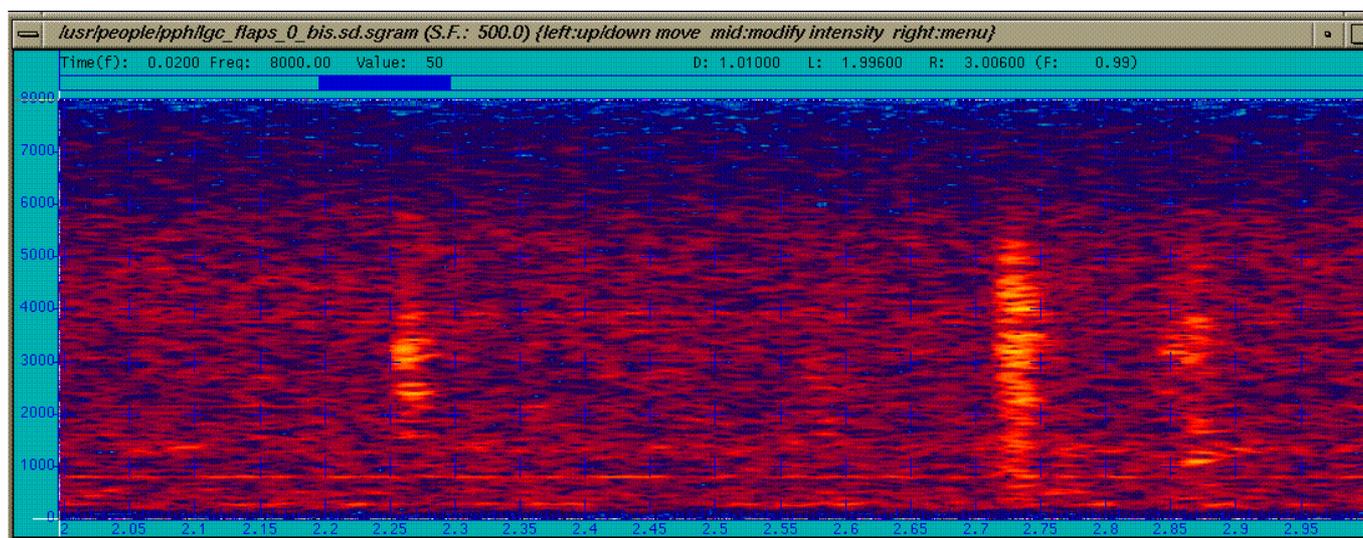
**Fig. 23 : Représentation Temps – Fréquence du bruit de la commande des volets ramenée en position 0°. Time – Frequency representation of the flaps command noise moved to 0°.**

Ce bruit intervient juste avant que les données FDR indiquent un repliement des volets vers la position « rentrés ». A l'écoute, ce bruit est perçu comme proche des bruits de commande des volets. Cependant, les essais effectués ne permettent pas de valider cette identification, les spectres de fréquence (non représentés ici) ne présentant que peu de similarités.

*This noise occurs just before the FDR data show that the flaps returned to the retracted position. When listening to this noise, it sounds similar to the noise of the flaps control. However, this could not be validated by the tests performed due to the small similarities between the frequency spectra (not represented here).*

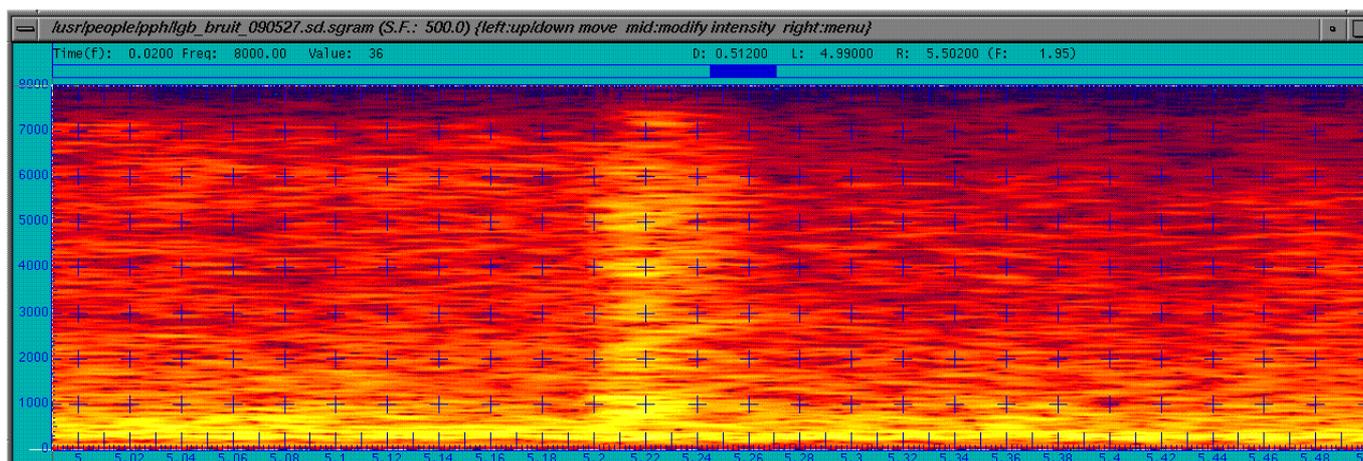
**09 h 05 min 27 s : "Bruit" / "Noise"**

**Fig. 23 : Représentation Temps – Fréquence du bruit. Time – Frequency representation of the noise.**

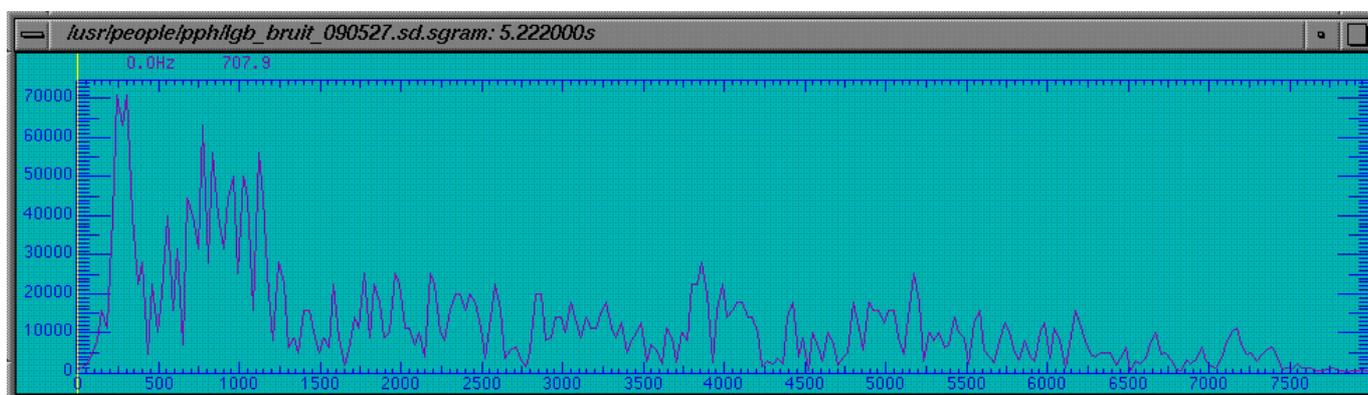
**Fig. 24 : Spectre du bruit inconnu. Spectrum of the unidentified noise.**

Ce bruit, caractérisé par de fortes énergies en basses fréquences, n'a pas pu être identifié par les essais.
