FINAL REPORT

ON THE ACCIDENT OF 6 NOVEMBRE 2002
AT LUXEMBOURG
TO THE LUXAIR FOKKER 27 MK050
REGISTERED LX – LGB

December 2003

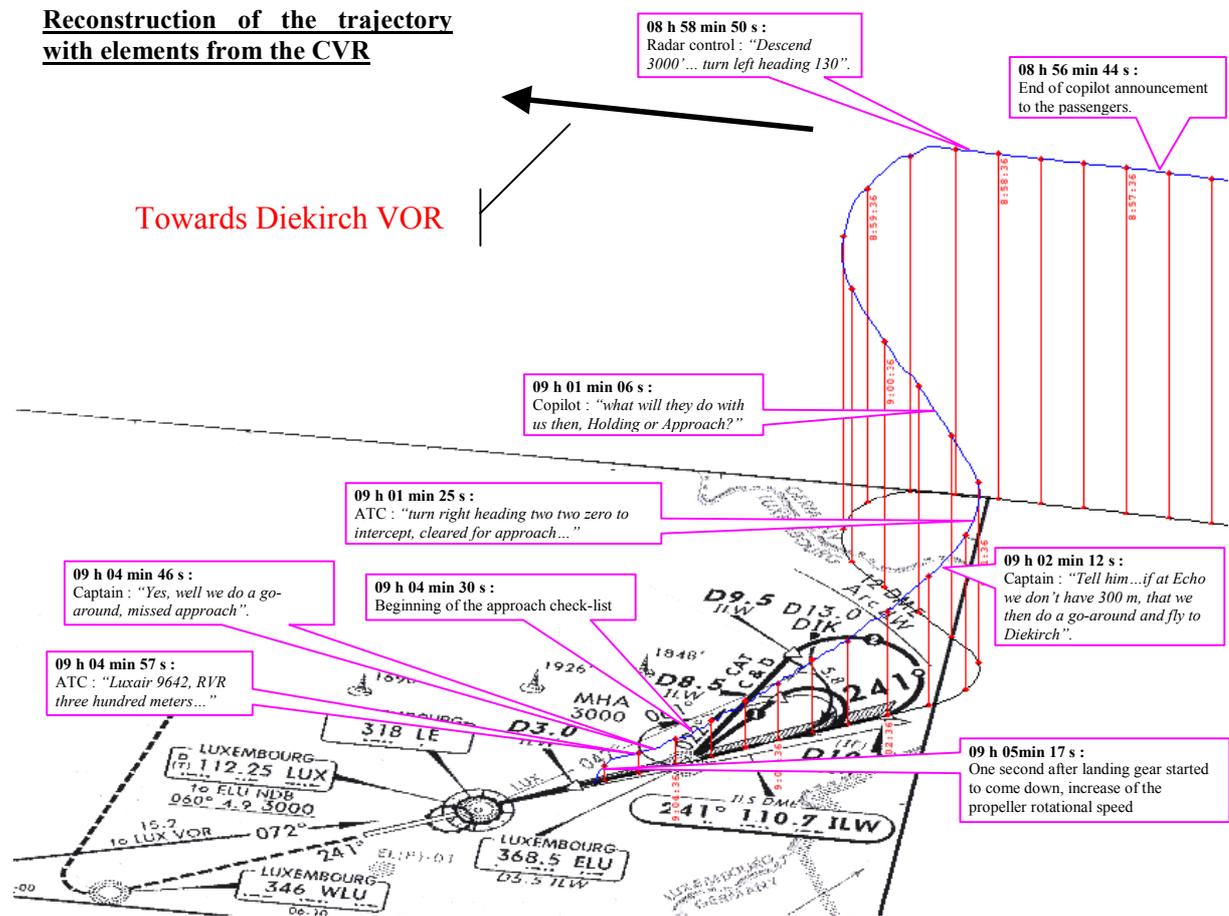
This three dimensional trajectory has been made up on the basis of Luxembourg radar data. Synchronisation precision between FDR and CVR is one second.

The vertical profile of the trajectory shown in appendix 17 represents radar data illustrating that the final descent of the aircraft started markedly after the ELU beacon.

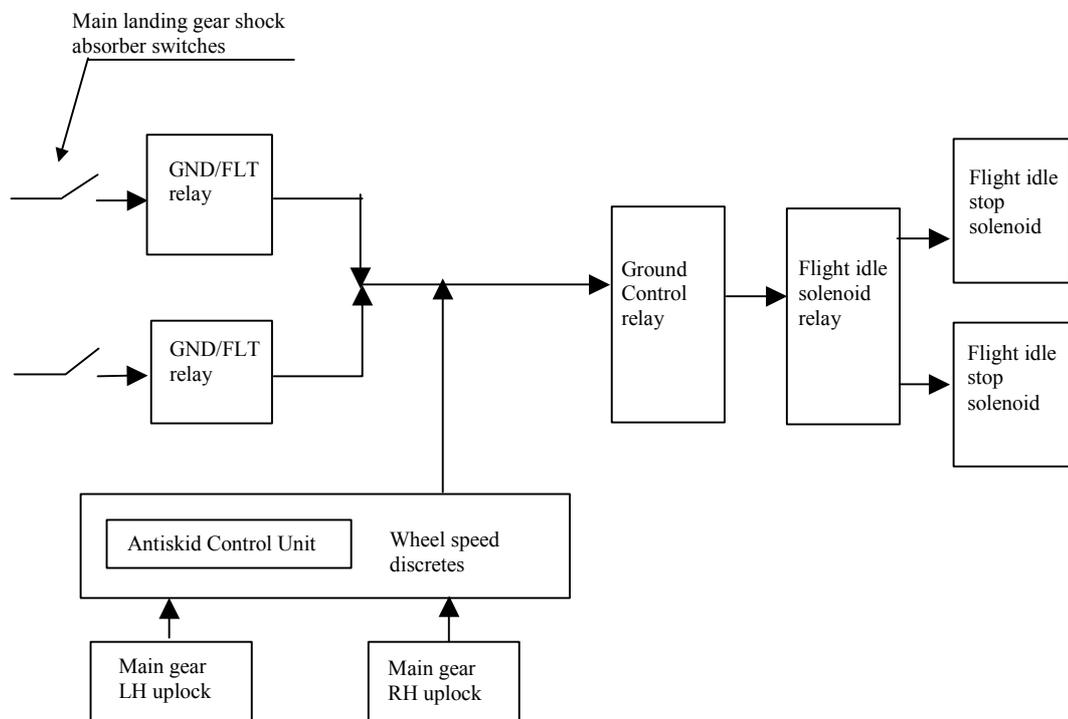
The wheel spin-up signals or the GND/FLT relays switches energise the flight idle stop solenoids through the ground control relay. The antiskid control unit senses the wheel spin-up signals. The main gear switches initiate the transmission of GND/FLT signals.

Power up of the skid control unit is via the main gear uplocks switches.

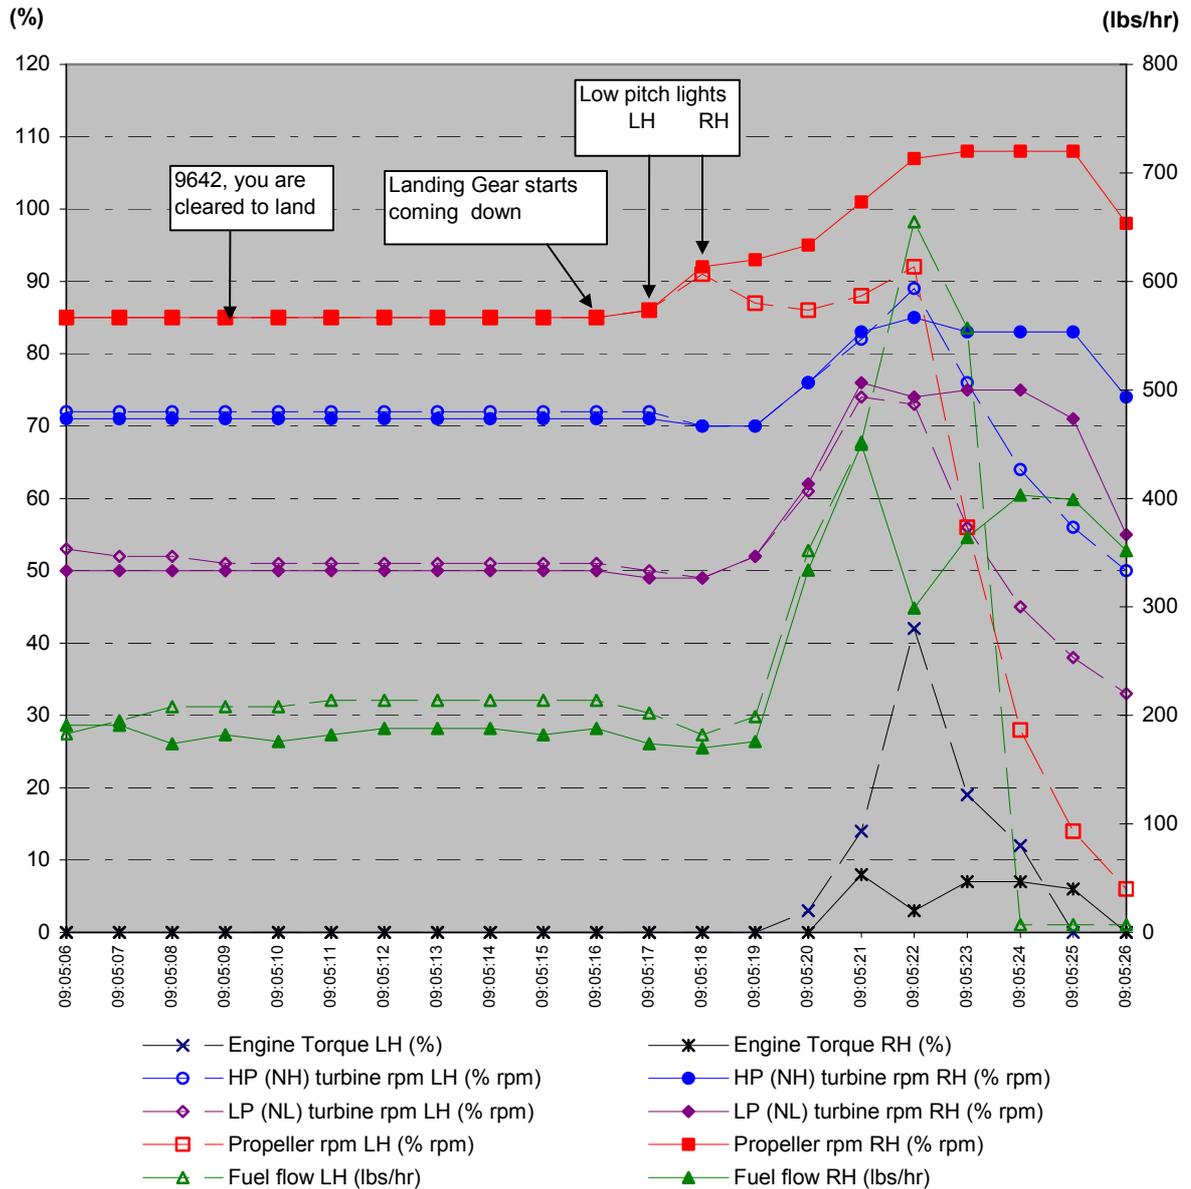
According to the engine manufacturer's information, the HP (NH) values for Flight Idle in flight are 74%. Flight Idle corresponds to zero torque, which is easily recognized for the recorded engine parameters. It can be noted that the engines never stabilised on this setting.

Analysing all the data recorded from the FDR, this HP value of 74% can be found for all flights where the engines are on flight idle with a zero torque value.
