NATIONAL
TRANSPORTATION
SAFETY
BOARD

**STUDY OF
LESSONS TO BE LEARNED
FROM ACCIDENTS
ATTRIBUTED TO TURBULENCE**

**NATIONAL TRANSPORTATION SAFETY BOARD
Washington, D. C. 20591
REPORT NUMBER: NTSB-AAS-71-1**

ADOPTED: DECEMBER 15, 1971

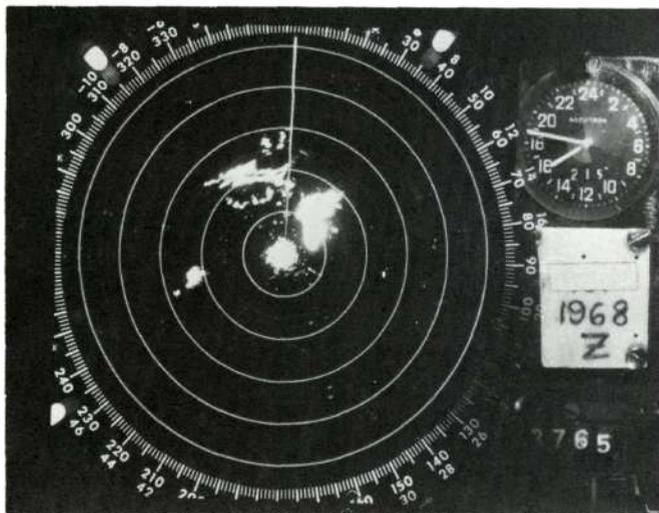
Figure 1

The turbulence was encountered between about 1545 and 1552 G.m.t. within approximately 50 nautical miles of an operating WSR-57, long range, ground-based weather radar, whose operator was photographing the Plan Position Indicator (PPI) scope. Figs. 1, 2, and 3, are enlargements of several of those photographs. In all three photographs, the radar was on the 250-mile range and the range markers were at 50-mile intervals. In Fig. 1 and 2, which were taken during the turbulence encounter, there was 1/2 degree antenna uptilt, while in Fig. 3, taken shortly after the encounter, the antenna uptilt was 3°. Cell penetration is estimated to have occurred at about the 50-mile range marker east-northeast of the antenna. Tops in that cell at the time of the encounter
