NATIONAL TRANSPORTATION SAFETY BOARD

**COLLISION OF
AERONAVES DE**

**DC-9-32, XA-JED
AND PIPER PA-28-181, N4891F**

NTSB/AAR-87/07

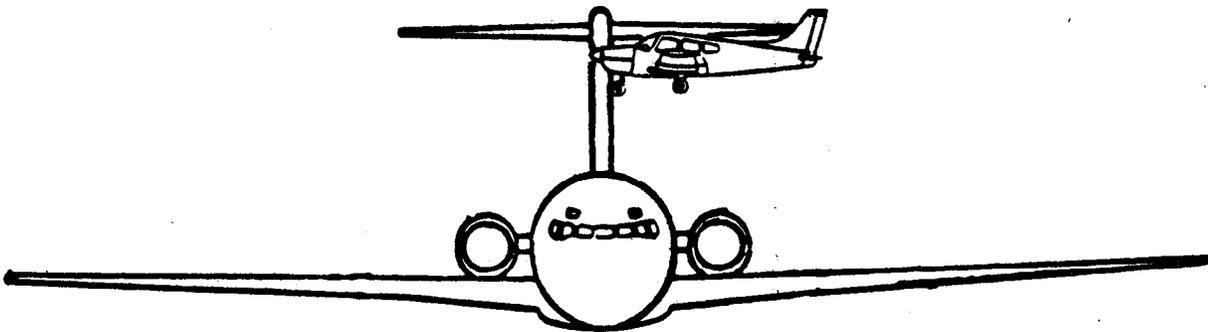
Figure 6.--Collision geometry as viewed from above the DC-9.

The damaged areas on the DC-9 vertical and horizontal stabilizers contained propeller slice marks, paint transfer marks Rom the nose wheel area and vertical stabilizer of the Piper, and embedded pieces from the cabin roof area of the Piper. **The** location and angles of these marks and damage on the **DC-9**, when matched to their respective locations on an intact Piper PA-28, showed that the front of the Piper had struck the left side of the DC-9 vertical stabilizer and that the impact angle was perpendicular to the longitudinal axis of each airplane. (See figure 6.) The impact angle was generally consistent with the flight tracks of the airplanes shown on the radar data plots.

Estimated positions of aircraft at impact, based on the propeller damage and scratch marks on the DC-9 Vertical and Horizontal Stabilizers.
