## AIRCRAFT ACCIDENT REPORT

In-flight Breakup Over the Atlantic Ocean  
Trans World Airlines Flight 800  
Boeing 747-131, N93119  
Near East Moriches, New York  
July 17, 1996

**NTSB/AAR-00/03  
DCA96MA070  
PB2000-910403  
Notation 6788G  
Adopted August 23, 2000**

The National Transportation Safety Board determines that the probable cause of the TWA flight 800 accident was an explosion of the center wing fuel tank (CWT), resulting from ignition of the flammable fuel/air mixture in the tank. The source of ignition energy for the explosion could not be determined with certainty, but, of the sources evaluated by the investigation, the most likely was a short circuit outside of the CWT that allowed excessive voltage to enter it through electrical wiring associated with the fuel quantity indication system.

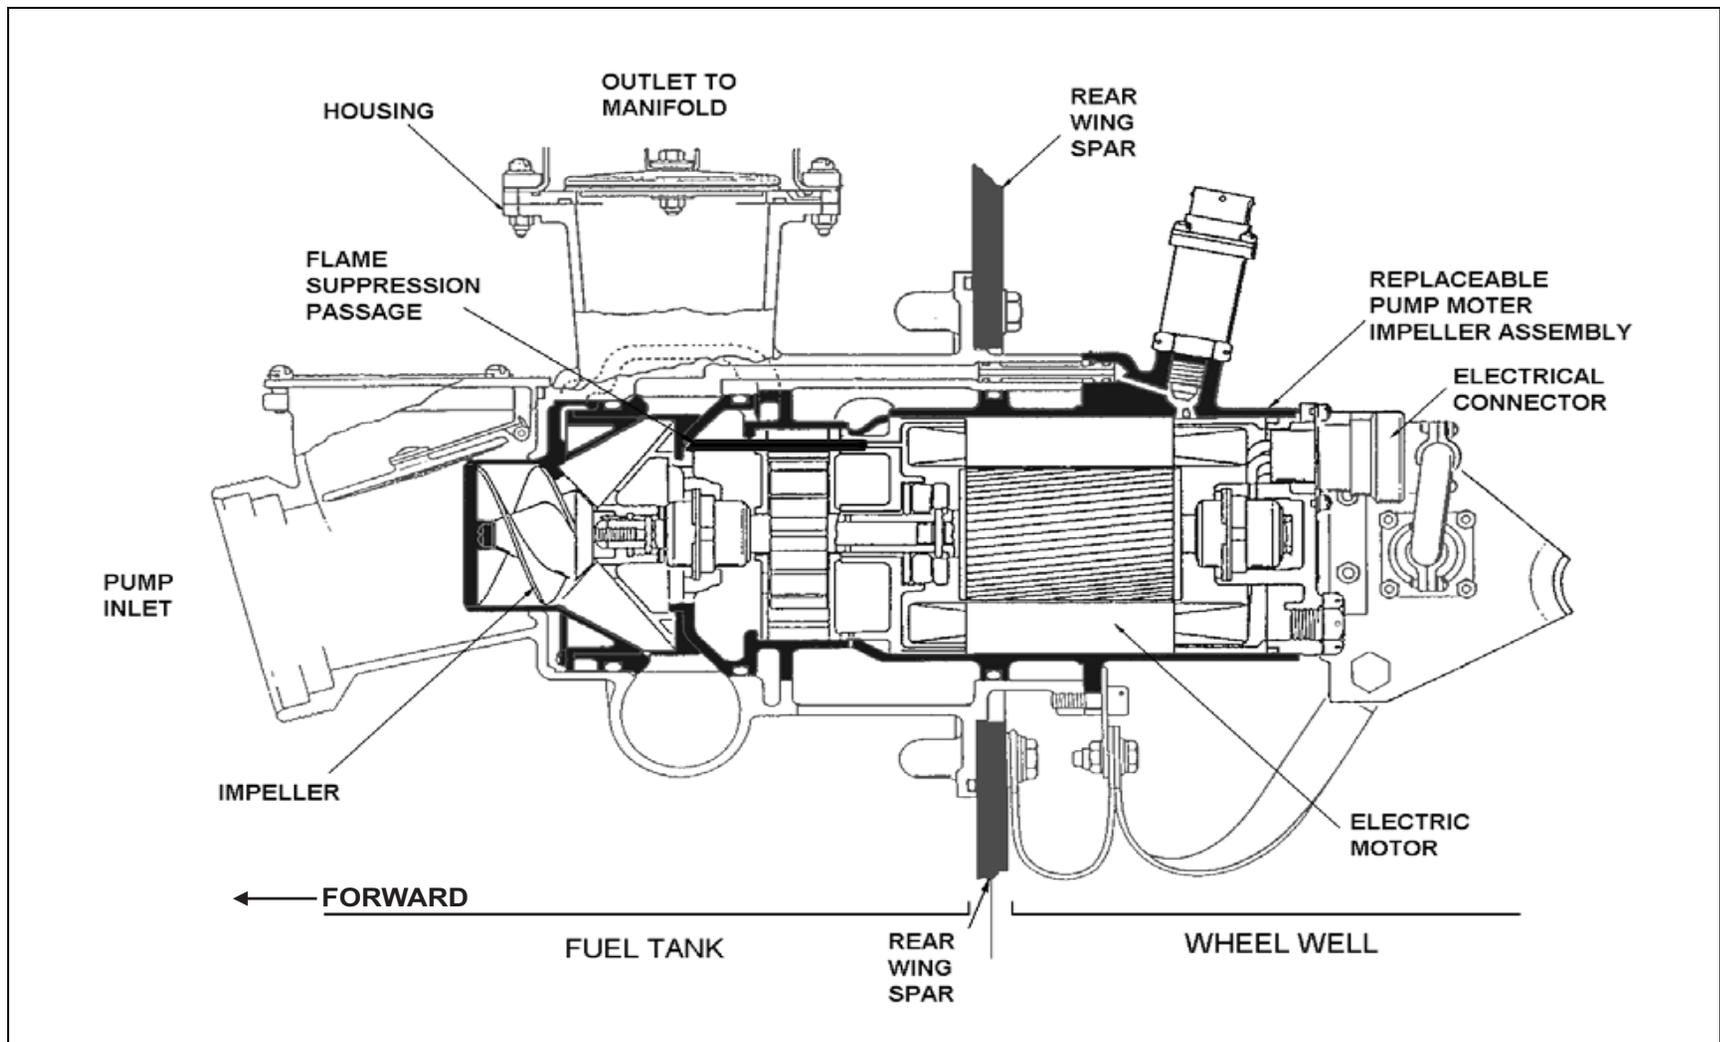
Figure 23. A diagram of a jettison/override fuel pump.

Both jettison/override pumps from the CWT were recovered, examined, and tested. The jettison/override pumps were impact damaged (especially at the aft ends, where they had been attached to the rear spar), but exhibited no evidence of electrical shorts, arcing, preimpact breaching of the housing, or discoloration of the pump shaft. (Figure 23 is a diagram of a jettison/override fuel pump.) Examination revealed that the jettison/override pumps' thermal fuses and flame arrestor tubes were intact and exhibited no evidence of thermal or flame exposure. The CWT jettison/override pump motors exhibited no evidence of heat-related discoloration; the motor windings were the same tan color as those from the wing fuel tanks. (A similar jettison/override pump was heated in a laboratory test until the thermal fuse melted at slightly less than 400° F, and the motor windings were subsequently found to have darkened substantially.)

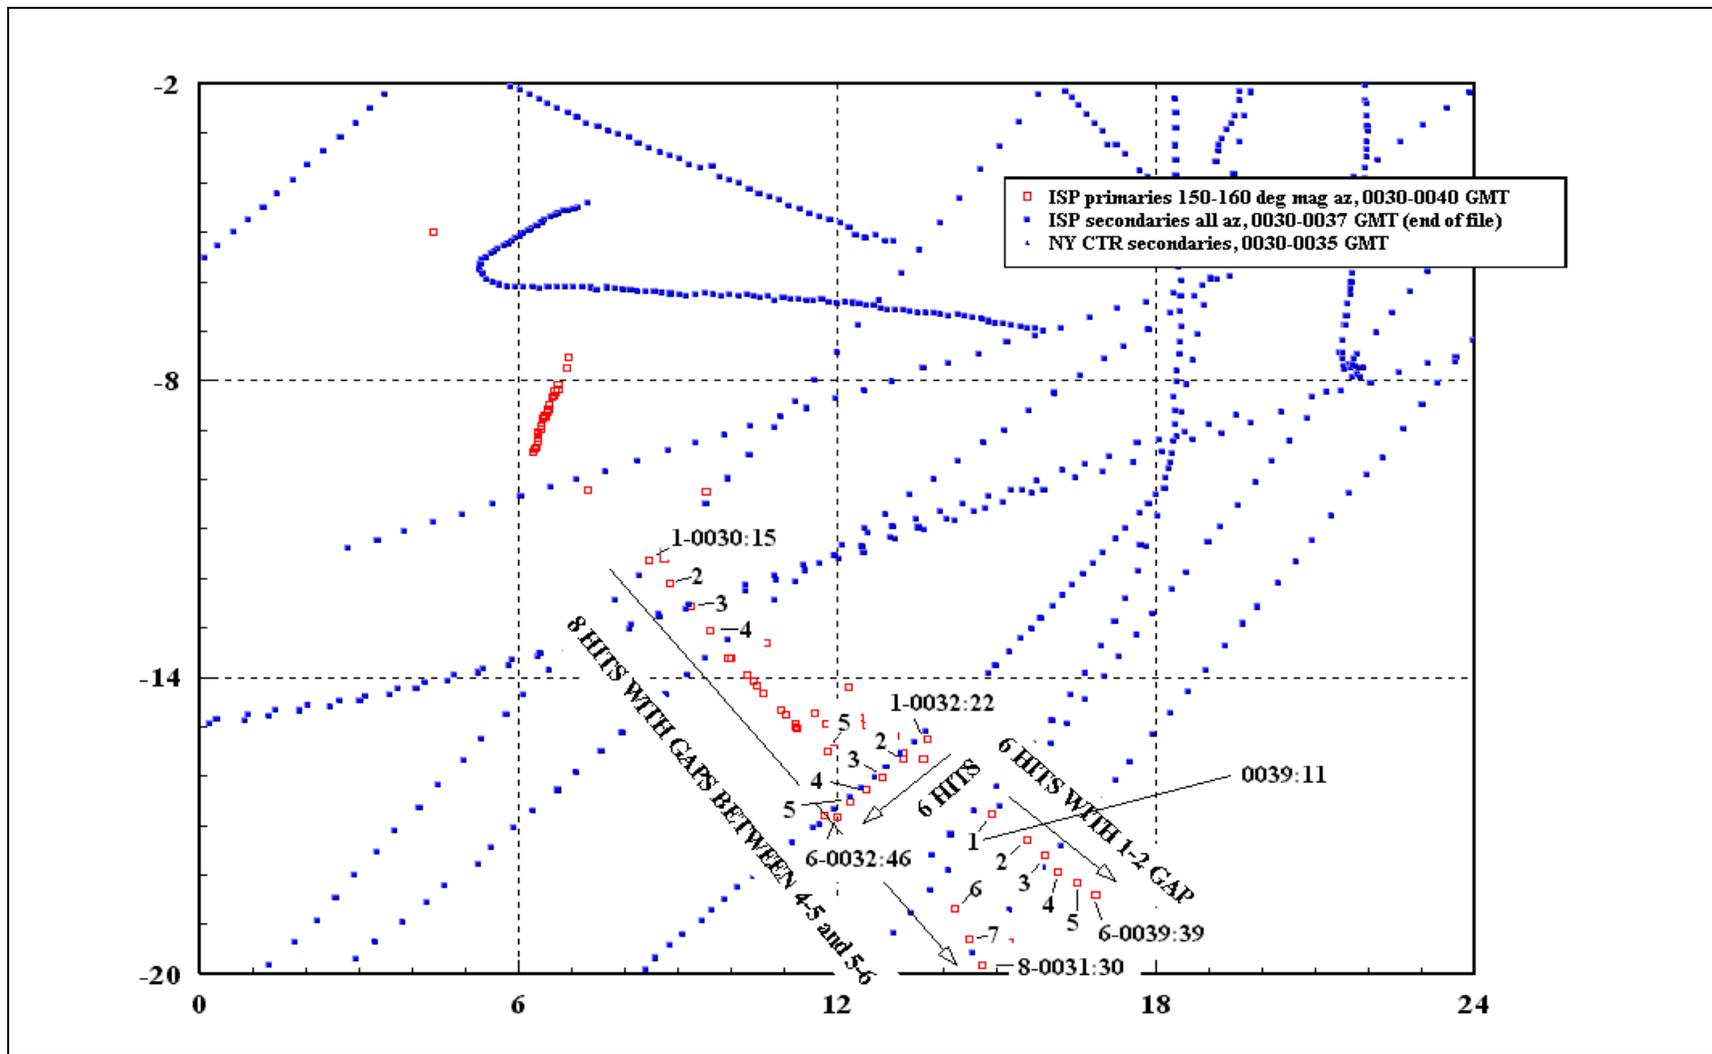
Figure 27. Sequence of eight primary radar returns recorded by the Islip, New York, radar site about the time of the accident.

The Islip, New York, radar data showed one particular sequence of eight primary radar returns about the time of the accident (see figure 27) that warranted further review. On the basis of the times of and distances between these primary radar returns, the target appeared to be moving away from TWA flight 800's position at a ground speed of more than 400 knots. The first of the eight radar returns was recorded at 2030:15, more than 6 nm southeast of the accident airplane. The last of these returns was recorded at 2031:30 (18 seconds after TWA flight 800's last secondary return), about 15 miles southeast of TWA flight 800.

Although most of the radar systems from which the Safety Board obtained data were capable of recording radar targets in the geographic area in which these primary radar returns were recorded, this sequence of eight primary radar returns was only observed in the data from the Islip radar site. Further examination of the returns recorded in that geographic area by the Islip site between about 2030 and 2040 revealed two additional sequences of primary radar tracks with apparent ground speeds greater than 300 knots. One of these sequences indicated a radar target movement away from TWA flight 800 to the southeast, whereas the other sequence indicated a target movement away from TWA flight 800 to the southwest.

Investigators learned from air traffic controllers and radar technicians that ground or building reflections of primary radar returns from airplanes flying in one geographic area can cause "false primary" targets to be recorded as though the airplanes were flying in another geographic area. FAA documentation and review of the area around the Islip radar site showed numerous buildings and structures that could create such reflections. Investigators identified commercial airplanes traveling through other areas within the coverage of the Islip radar at the same time that the three sequences of primary radar returns were recorded; these airplanes had similar ground speeds to those indicated by and flightpaths that were not inconsistent with the three sequences of primary radar returns.

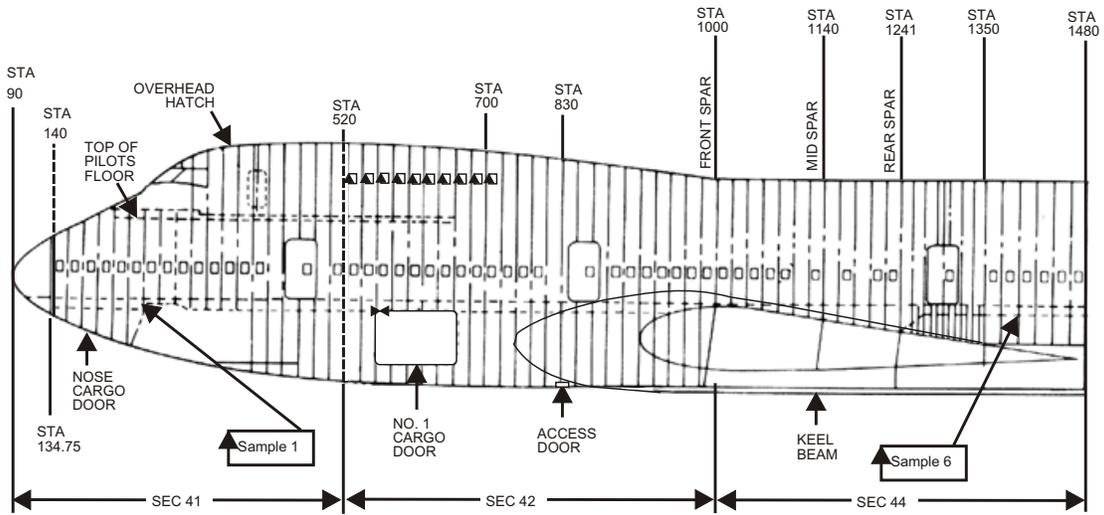
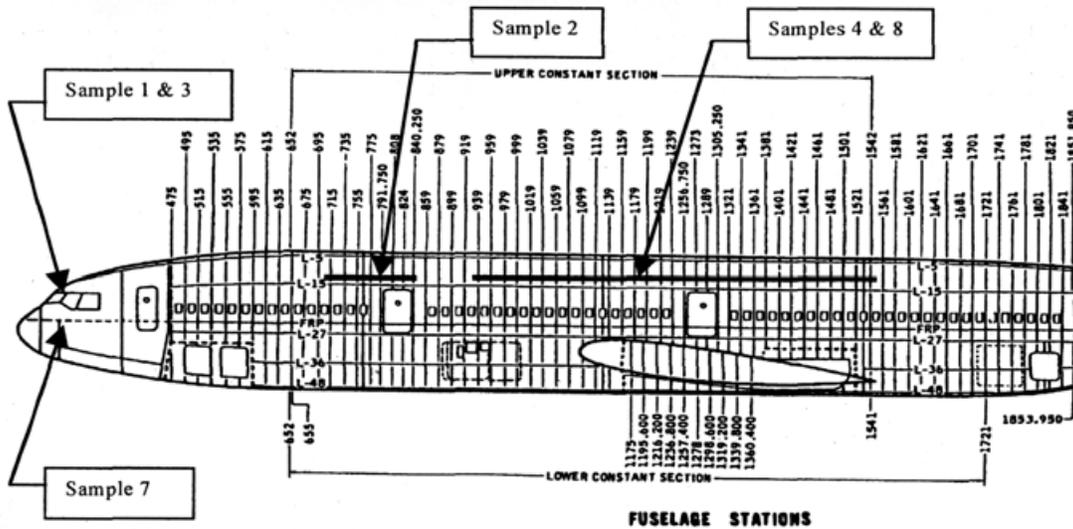
4. The weak point in this wire type appears to be the lack of ability to maintain physical and electrical integrity during extended elevated thermal exposure with mechanical stress. As the wire ages, there is an increased risk of dielectric problems [breakdown of wire insulation integrity], mechanical damage and loss of electrical integrity.
5. No wire was submitted that was exposed to high levels of environmental exposure (such as wires from wheel wells, wing leading edges, etc.). Wire from these areas, would be expected to perform worse than the wire submitted. [See figures 35a, 35b, and 35c for sample locations.]

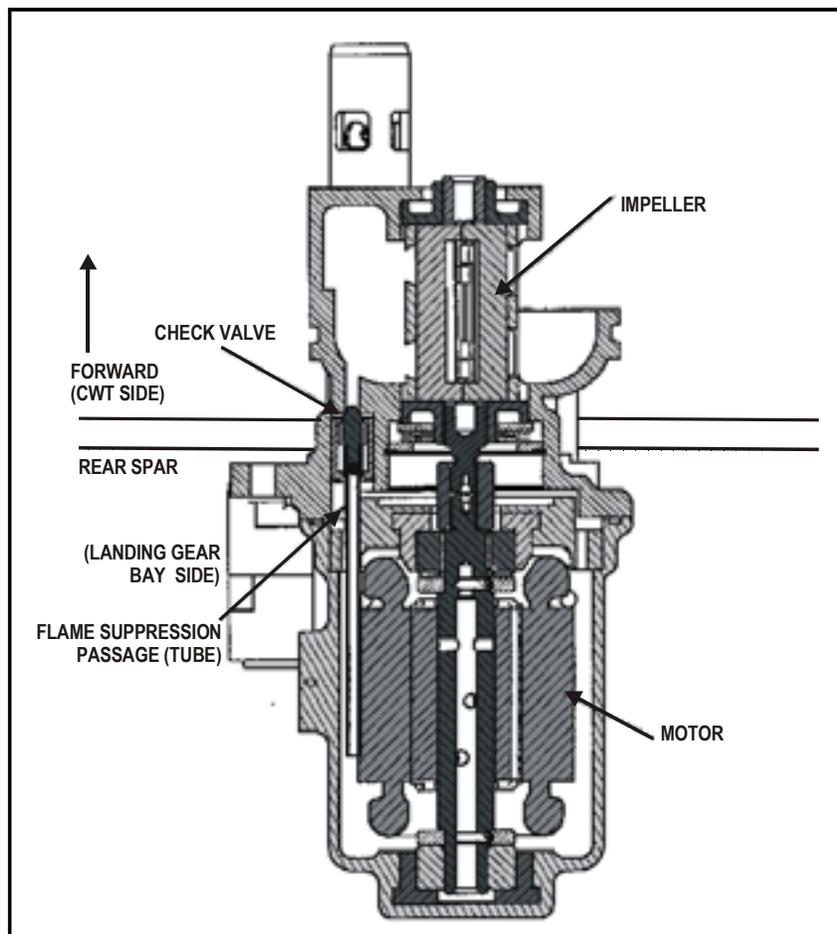
**Figure 37.** A diagram of a scavenge pump.

contained multiple explosions that were intentionally ignited within the pump motor cavity, preventing the ignition from transferring to the fuel tank. (Figure 37 is a diagram of a scavenge pump.) Because the Board became aware of instances in which the flame arrestor tube was broken or missing, investigators also conducted a series of tests to determine whether the scavenge pump motor housing would contain explosions with only one of the flame suppression system components (either the flame arrestor tube or the check valve) functioning. In all tests, the scavenge pump housing contained the explosions, and the explosive atmosphere surrounding the test pump did not ignite.

During its postaccident examination of other transport-category airplanes, the Safety Board observed that components in the electrical connector on a scavenge pump in a retired 747 were deteriorated. (Boeing ASBs 747-28A2194 and 747-28A0043, both dated January 18, 1996, “encouraged” operators to inspect for degradation in connectors.) Investigators observed that several scavenge pump electrical connectors had been manufactured of a material that degraded with long-term exposure to fuel. Boeing provided the Board with a service history for the 747 scavenge pump for the 10 years preceding the accident. When queried about the brevity of this history, Boeing indicated that most operators did not return the scavenge pumps to the manufacturer for overhaul.

As a result of these findings, Boeing issued ASB 747-28A2206, dated September 25, 1997, and AD 97-25-06, effective December 16, 1997. AD 97-25-06 contained the following summary:

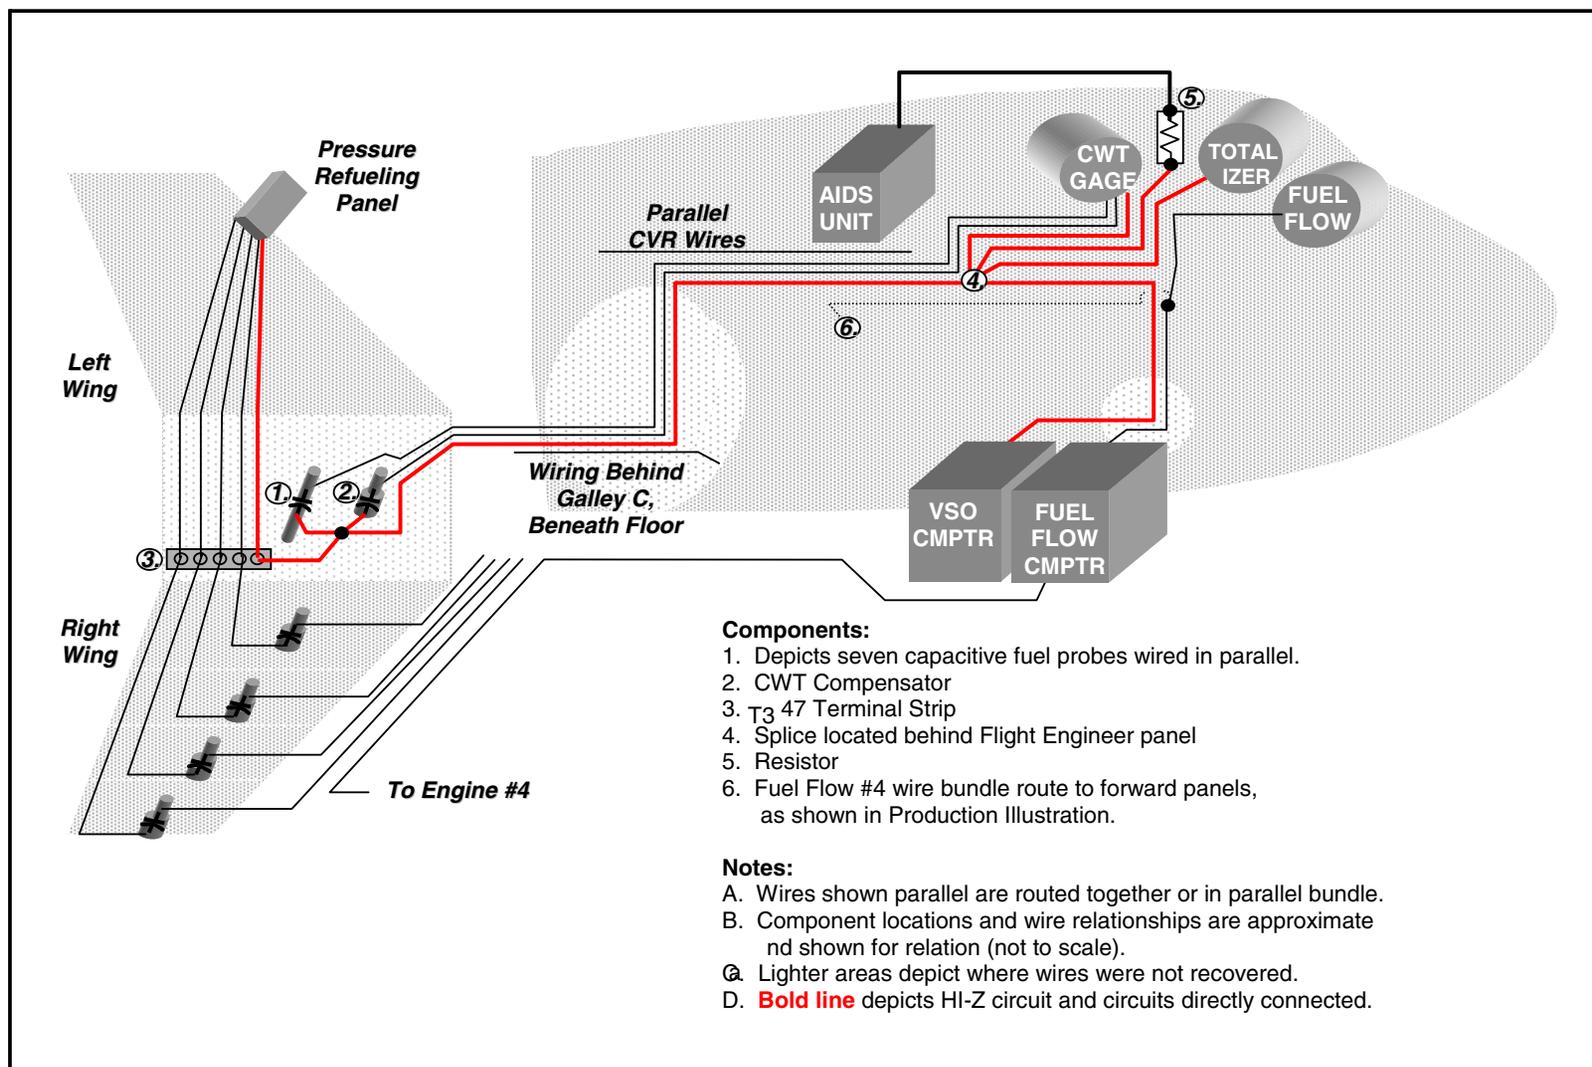
The CWT FQIS wiring in the 747 terminates at common connectors with the fuel quantity indicator, the totalizer gauge, the airborne integrated data system (AIDS), the volumetric shutoff (VSO), and the left wing refueling station; each of these connectors also includes terminating wires from circuits that carry 115 volts.<sup>605</sup> (See figure 46.) Short circuits in connectors have caused incidents in the past. For example, an October 22, 1995, incident involving roll/yaw oscillations on a 737 near Manchester, England, was attributed to a short circuit in the rudder circuitry of the incident airplane that resulted from lavatory fluid bridging the pins within an electrical conductor.

<sup>605</sup> Although the Safety Board is not aware of FQIS wires sharing connectors with wires carrying more than 115 volts, Boeing specifications also permit FQIS wiring to be mixed in common connectors with airplane system wires carrying up to 350 volts.

<sup>606</sup> Testing conducted for the Safety Board by Lectromec demonstrated that current peaks of more than 100 amperes (amp), which released 2 to 4 J of energy (of which about 400 mJ could be transferred to a victim wire), could be produced on wires protected by 10-amp circuit breakers when short circuits were created by dripping either water or lavatory fluid onto damaged wires. (For more information about this testing, see section 1.16.6.2.)

**Figure 46.** Diagram of the center wing tank fuel quantity indication system wiring on the 747 and its common connectors.
