PB91-910409
NTSB/AAR-91/08

AIRCRAFT ACCIDENT REPORT

**RUNWAY COLLISION
OF USAIR FLIGHT 1493, BOEING 737
AND SKYWEST FLIGHT 5569 FAIRCHILD METROLINER
LOS ANGELES INTERNATIONAL AIRPORT
LOS ANGELES, CALIFORNIA
FEBRUARY 1, 1991**

**Adopted: October 22, 1991
Notation 5461A**

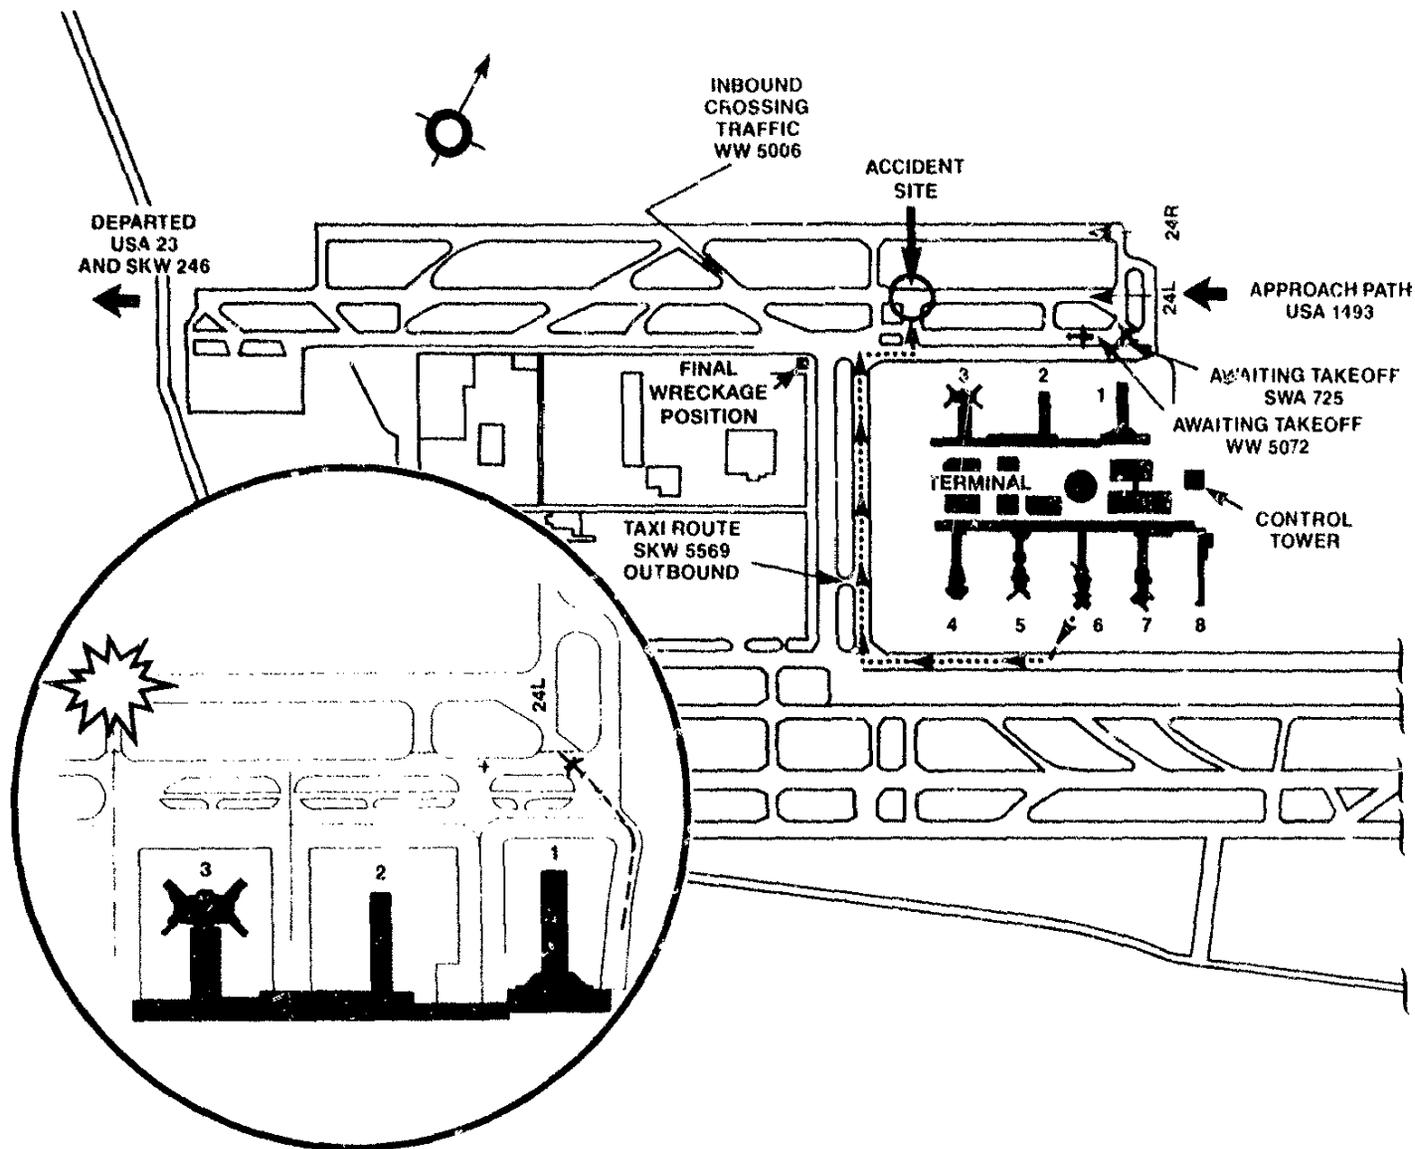
Figure 3.--Airport layout with traffic movements.

About 5 minutes earlier, around 1758, SKW5569 had begun to taxi via the north route from Terminal 6, Gate 32 to runway 24 left for departure (See figure 3). At 1801:43, SKW5569 advised the ATC tower's north ground controller (GC2) "...number two at [taxiway] Tango behind an Aero Mexico airplane." At 1801:49, the GC2 advised SKW5569, "...roger, hold short Tango for right now, Aero Mexico will be moving in just a minute."

The first mark on the runway associated with the accident was a scrape on the concrete with metal deposits located 254 feet from the threshold of runway 24 left, a point adjacent to taxiway 45 Uniform. A wreckage distribution diagram is provided as figure 3. Red and blue scrubbing marks consistent with the paint colors on the Metroliner were intermixed with other concrete marks.

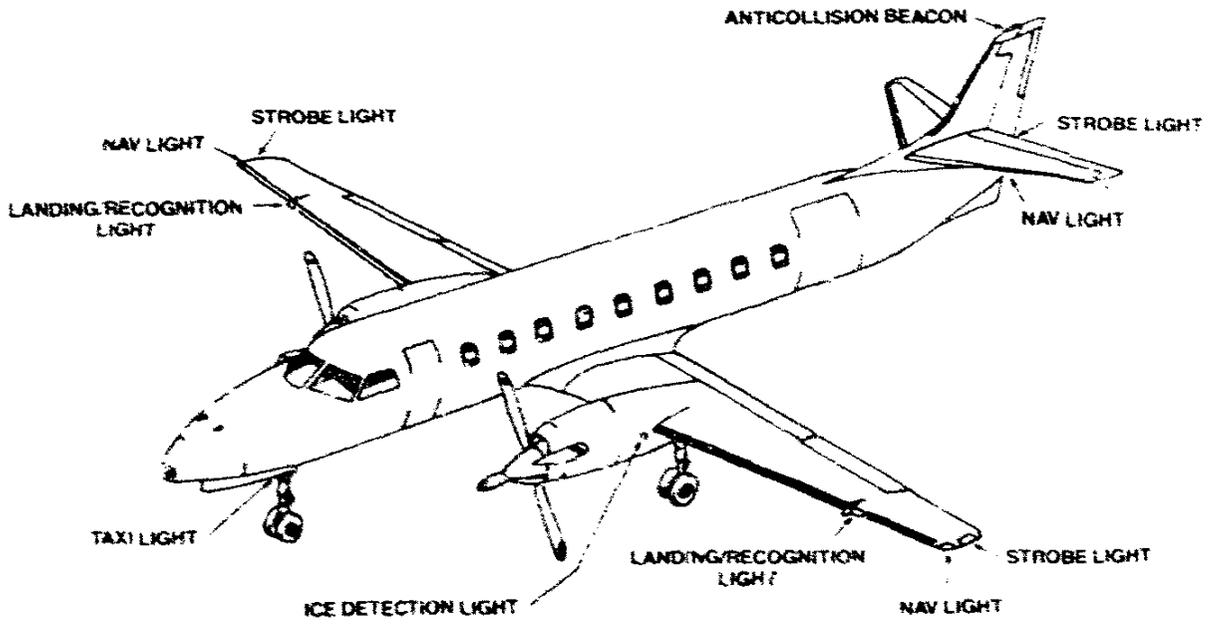
Figure 4.--Metroliner external lighting.

External lighting on N683AV consisted of navigation lights, landing/recognition lights, a taxi light, ice detection lights, strobe lights, and a red anticollision beacon (See figure 4). The beacon light assembly is located on top of the vertical stabilizer forward and below the rudder cap and rudder trailing edge (See figure 5). The location of the beacon light relative to the rudder cap results in some light obstruction; 14 CFR Part 23 permits such obstruction. The rudder cap blocks visibility of the light to an angle of 5.4 degrees above the horizontal and 2.6 degrees left and right of the centerline directly to the rear of the airplane. The beacon light luminance for certification was a candle power of 100 candles; actual luminance was 110 candles.

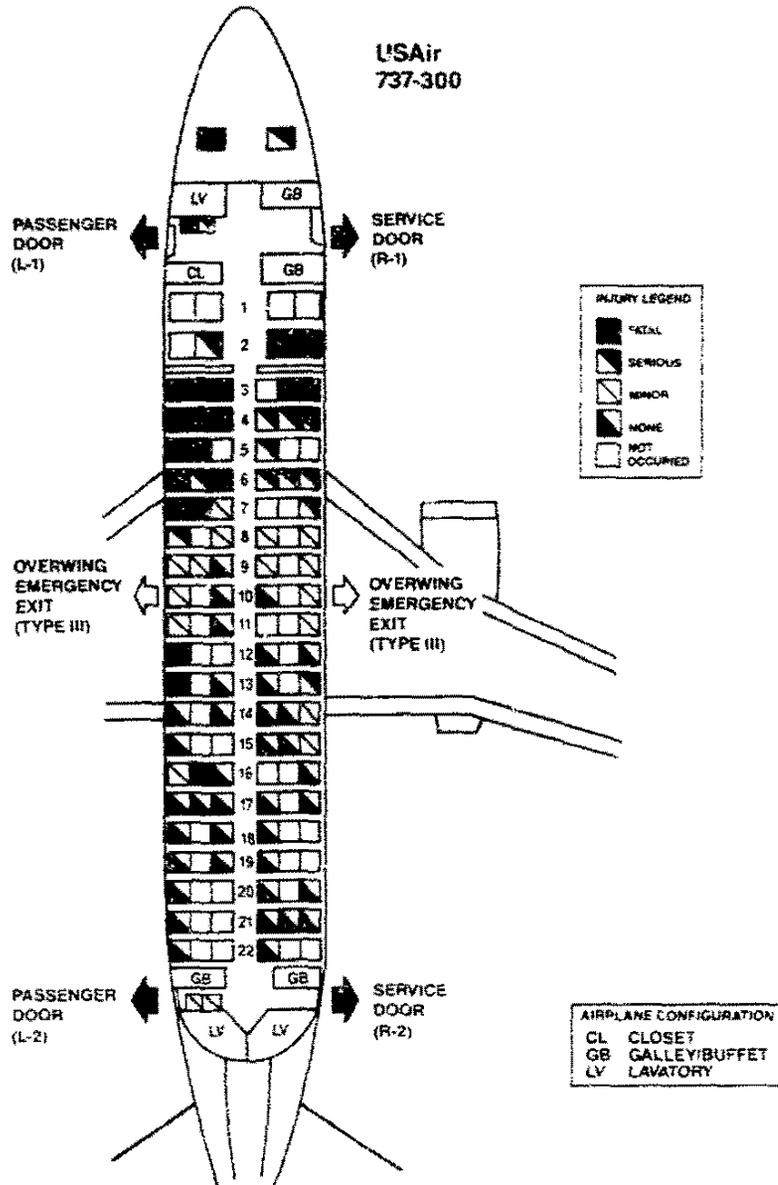
Figure 10.--Seating and injury chart.

Three cabin crewmembers and 63 passengers aboard the B-737 survived (See figure 10), of which 48 persons were interviewed during the on-scene investigation. The following summarizes their interviews:
