## Transportation Safety Board of Canada

### Aviation Investigation Report A13C0150

#### Loss of engine power – Collision with terrain

Bearskin Lake Air Service LP (Bearskin Airlines)  
Fairchild SA227-AC Metro III, C-FFZN  
Red Lake, Ontario  
10 November 2013

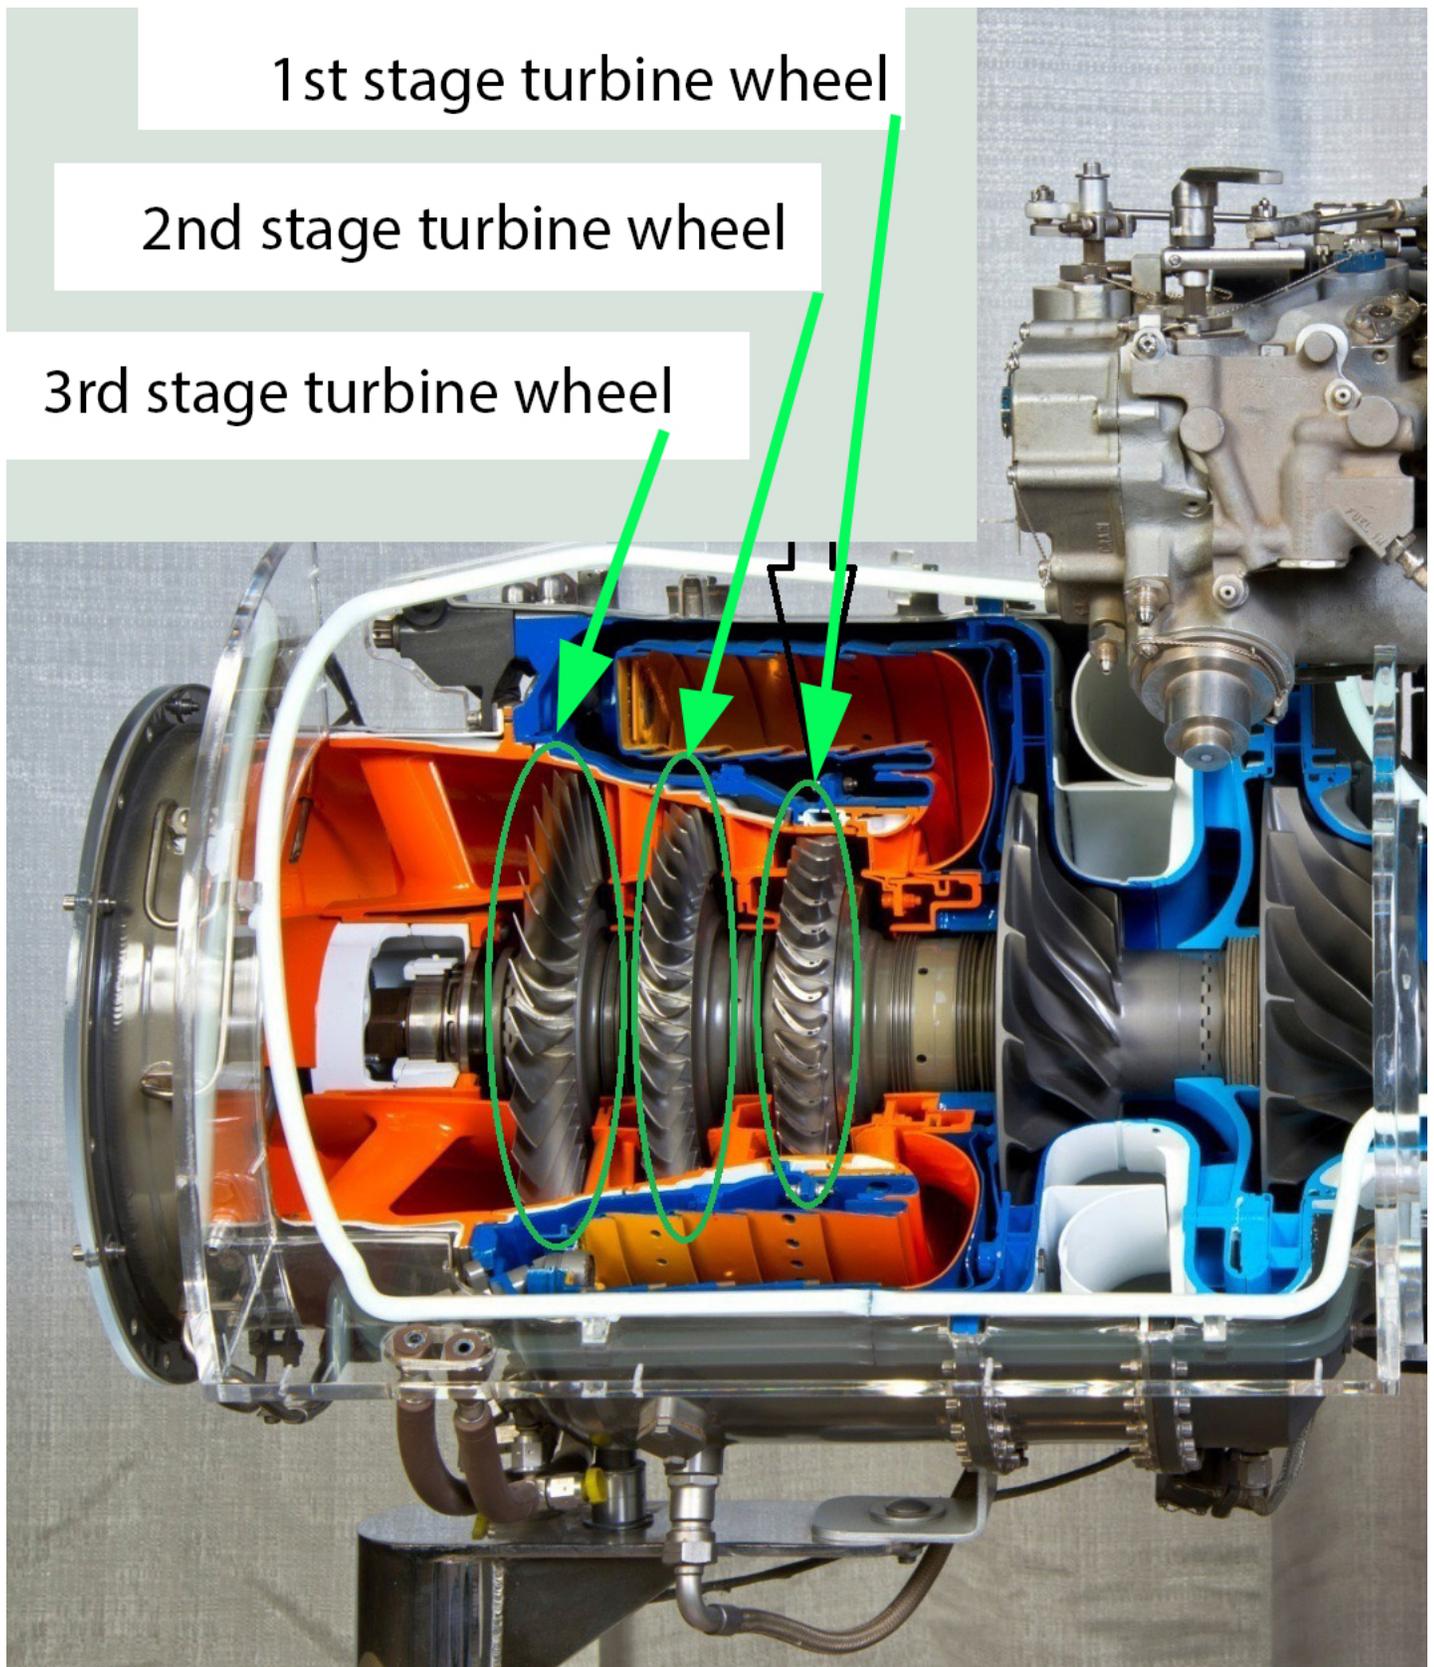
**Photo 6. Engine cut-away view (Source: Honeywell, with TSB annotations)**

The first-stage wheel (Photo 4, Photo 5 and Photo 6) was stripped of all blades down to the blade roots with 1 blade failing at the fir tree<sup>11</sup> blade root area. The area of failure exhibited a distinct fatigue zone near the trailing edge of the blade and was sent to the TSB Laboratory for metallurgical examination. The examination concluded that the blade failure occurred as a result of high-cycle fatigue in an area of high porosity.
