# Aircraft Accident Report

**Crash Into The Sea After An In-Flight Fire**

**Boeing 747-400F, HL7604**

**28 July 2011**

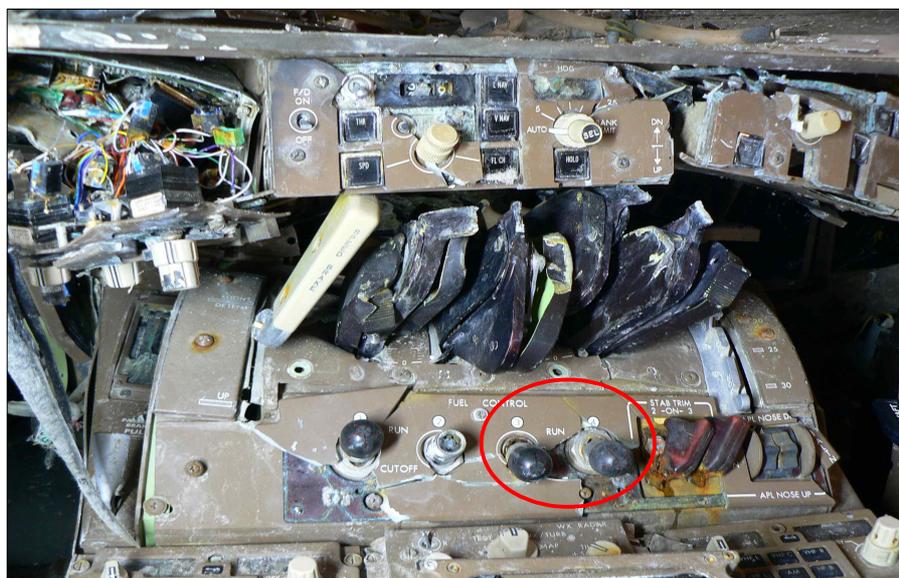
[Figure 18] Cockpit (Throttle Quadrant, Fuel Cutoff Switches, & Others)

The upper section of the cockpit was extensively pressure formed by direct impact of water, which caused the throttle quadrant, switches, and many levers to sustain mechanical damage.

As shown in [Figure 18], fuel cutoff switches No. 1 and 2 were in the ON position, whereas No. 3 and 4 in the OFF position, but under magnification, it was confirmed that No. 3 and 4 moved to the OFF position due to impact forces.

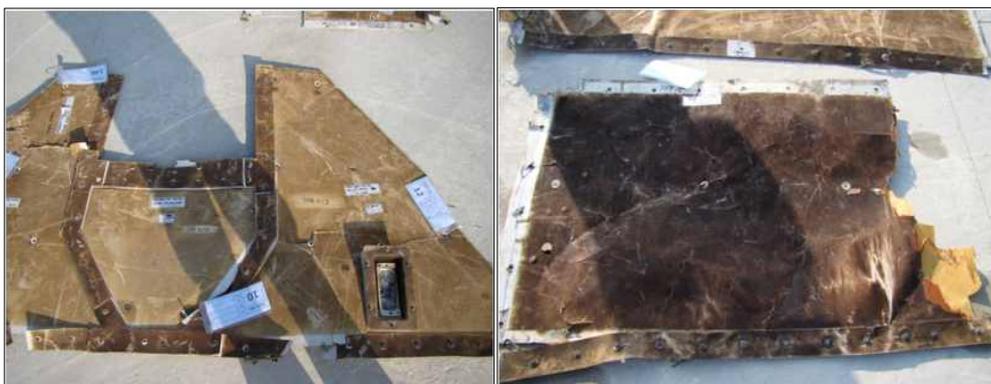
[Figure 36] Panels Near (Left) & Aft (Right) of FS360

As shown in [Figure 36], portions of the ceiling panels belonging to the area under the flight deck had a layer of soot adhering to the surface. Ceiling panels aft of FS360 were also sooted and had a darker appearance.

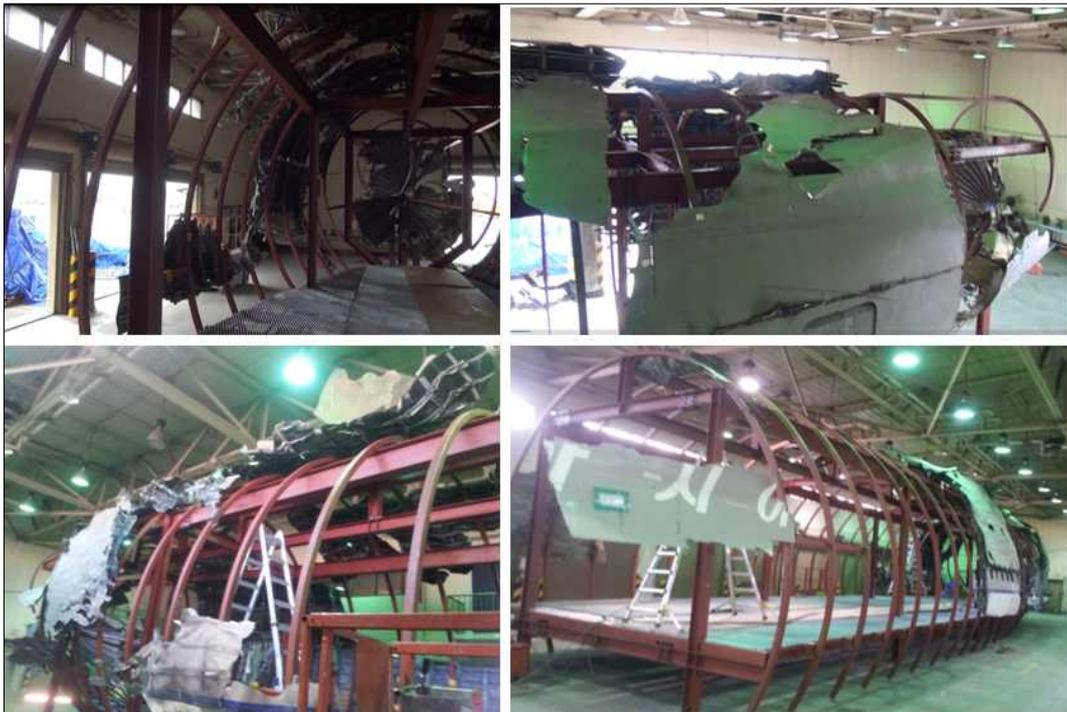
[Figure 45] Wreckage Reconstruction

As shown in [Figure 45], the reconstruction focused mainly on Section 46<sup>57)</sup> with traces of fire damage, including the APB. In other words, 35 pieces of the recovered wreckage from FS1480 to FS2484, about 1/3 the length of the fuselage, were selected and reconstructed.

The reconstructed wreckage was analyzed for physical damage, thermal damage, etc.

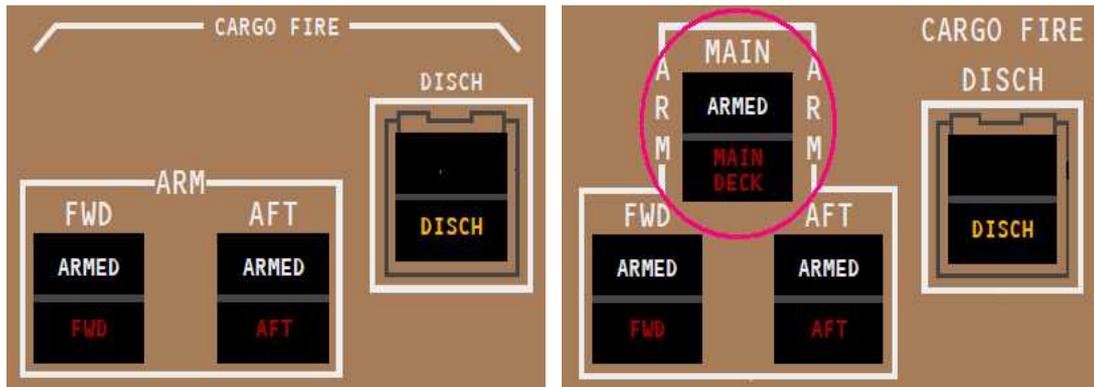
[Figure 48] Fire Suppression Panel of Passenger (Left) & Cargo (Right) Plane

As the simulator is configured as a passenger version of the B747-400, there is no main deck cargo ARM button as shown in [Figure 48], and accordingly, simulator instructors are unable to give a full Fire Main Deck training for B747 freighters. As a result, during briefing before the simulator training, they refer to a cargo plane's panel diagram and the flight crew operations manual.

During the simulator training, the instructors simulate a main deck cargo fire by giving trainees verbal instructions associated with the fire and using the passenger plane's lower cargo deck fire message instead.

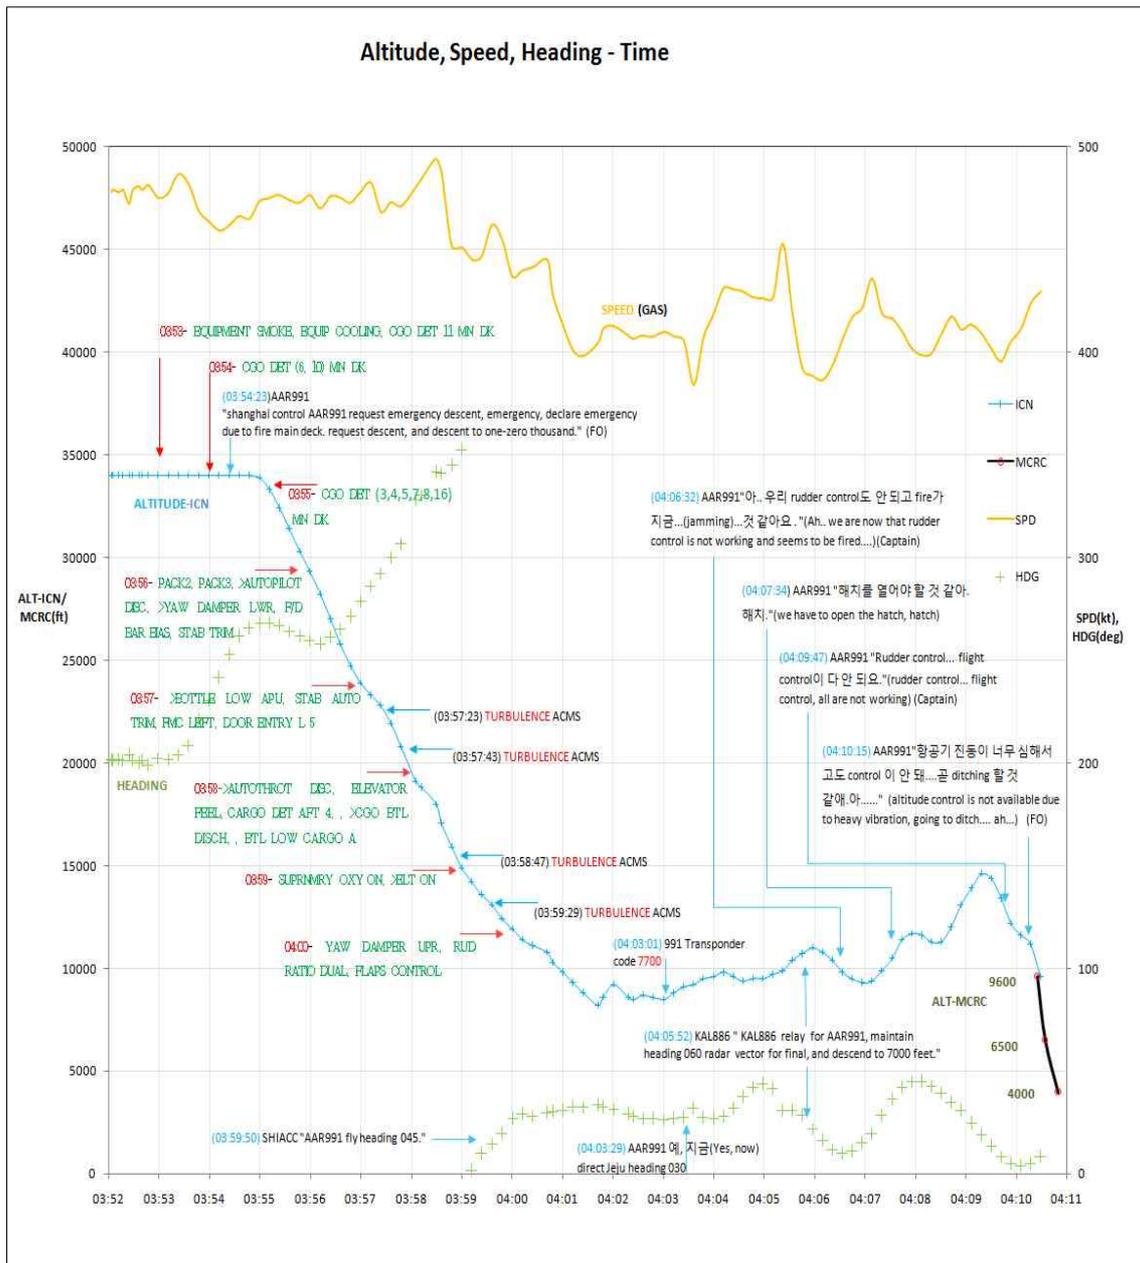
[Figure 62] Vertical Flight Track Including Altitude, Speed & Heading

[Figure 62] shows AAR991's vertical flight track, altitude, speed, heading, and major ATC/pilot communications. The FDE message CGO DET 11 MN DK, which indicates that smoke was detected in zone 11 of the main deck cargo compartment, is transmitted when it is correlated to the CMC fault message.

At 04:00:XX,<sup>111)</sup> AAR991 was descending from 11,900 ft to 9,800 ft. ACARS messages generated at this time indicate a fault with flaps control and rudder control such as upper yaw damper and rudder ratio dual. The messages were not transmitted any more after 04:00:XX.

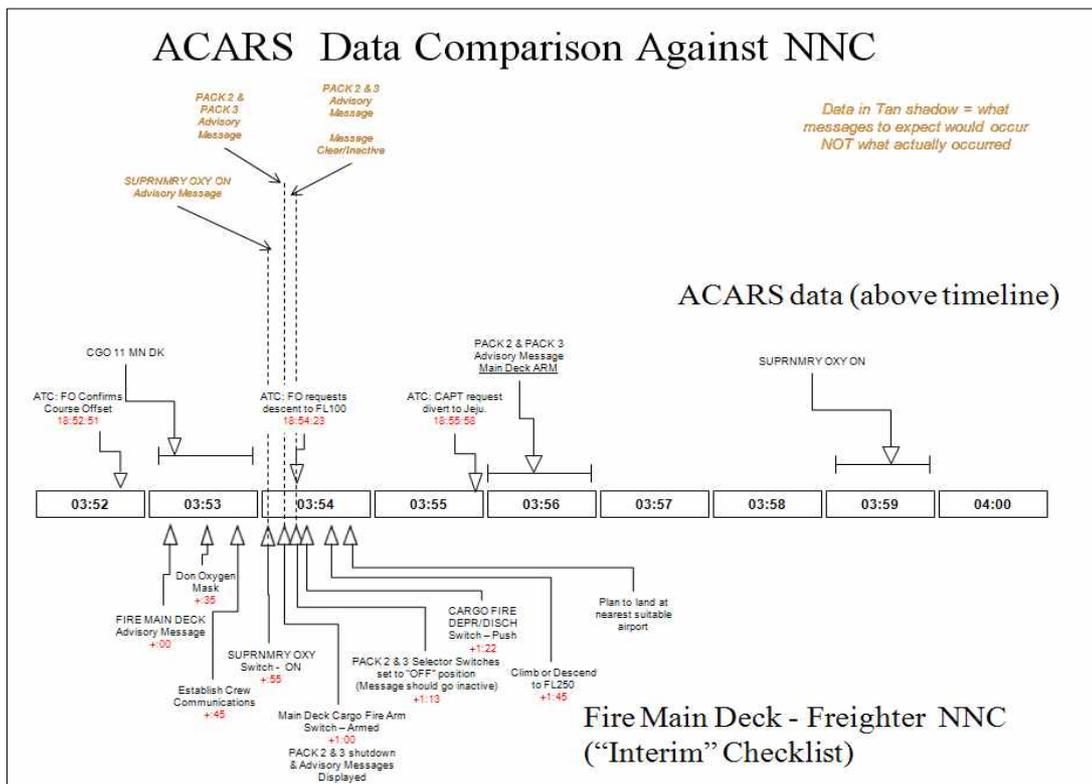
[Figure 65] ACARS Data Comparison Against NNC

Second, a freighter's Fire Main Deck depressurization procedure was delayed. When a main deck cargo fire arm switch is armed, PACK 2 and 3 ACARS messages are generated. At 03:53:XX, CGO DET 11 MN DK ACARS message was generated, followed by PACK 2 and 3 ACARS messages at 03:56:XX.<sup>122)</sup> [Figure 65]<sup>123)</sup> shows that AAR991's PACK 2 and 3 messages were generated

about 2 minutes<sup>124)</sup> later in comparison to Boeing pilots' implementation of the non-normal procedures, which indicates that AAR991's Fire Main Deck depressurization procedure was delayed for about 2 minutes. Step No. 1 of a combi plane's Fire Main Deck non-normal procedures is to "instruct the designated crewmember<sup>125)</sup> to verify the presence of smoke or fire." If the captain<sup>126)</sup> personally verified the presence of fire and continued to implement a combi plane's Fire Main Deck non-normal procedures, the generation of PACK 2 & 3 ACARS messages would be delayed for the time required for fire verification, which explains the time difference of PACK 2 & 3 messages between timeline above and below as shown in [Figure 65].

Meanwhile, AAR991's implementation of depressurization procedures for suppressing a main deck cargo fire was delayed for about 2 (1 - 3) minutes, judging from ACARS messages, PACK 2 & 3 at 03:56:XX and SUPRNMRV OXY ON at 03:59, as shown in [Figure 65].

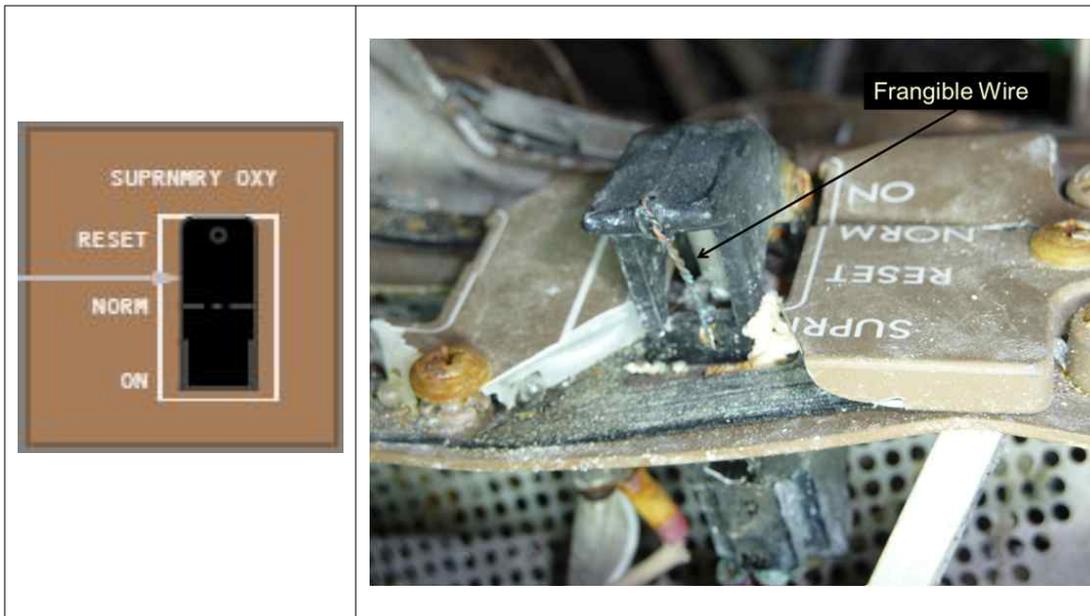
[Figure 66] Supernumerary Oxygen Switch & the Cockpit Wreckage (Right)

Third, as shown in [Figure 66], AAR991's flight crew failed to turn on the supernumerary oxygen switch,<sup>127)</sup> which is specified in non-normal procedures in a freighter's Fire Main Deck checklist, but not in a combi plane's.<sup>128)</sup> Detailed examination<sup>129)</sup> of AAR991's cockpit wreckage revealed that a frangible wire<sup>130)</sup> of the switch guard did not fracture as shown in [Figure 66], and that the supernumerary oxygen switch was in the NORM<sup>131)</sup> position.

130) The supernumerary oxygen switch in the NORM position was covered with the guard connected to a frangible wire that provides protection against careless movement. Therefore, the guard should be open to move the supernumerary oxygen switch to the ON position, which fractures a frangible wire.

Also, if the flight crew had implemented a freighter's Fire Main Deck non-normal procedures in a specified order,<sup>132)</sup> SUPRNMRY OXY ON ACARS message<sup>133)</sup> should have been generated earlier than PACK 2 & 3 messages, but it was generated 3 minutes after them, at 03:59:XX<sup>134)</sup>. The supernumerary oxygen system is automatically operated<sup>135)</sup> when cabin pressure decreases to an equivalent of 14,000 ft altitude even without the cockpit's supernumerary oxygen switch in the ON position. According to Boeing's data, SUPRNMRY OXY ON ACARS message is generated about 2 to 3 minutes<sup>136)</sup> after the initiation of depressurization<sup>137)</sup> (push of CARGO FIRE DEPRES/DISCH switch for 1 sec.).

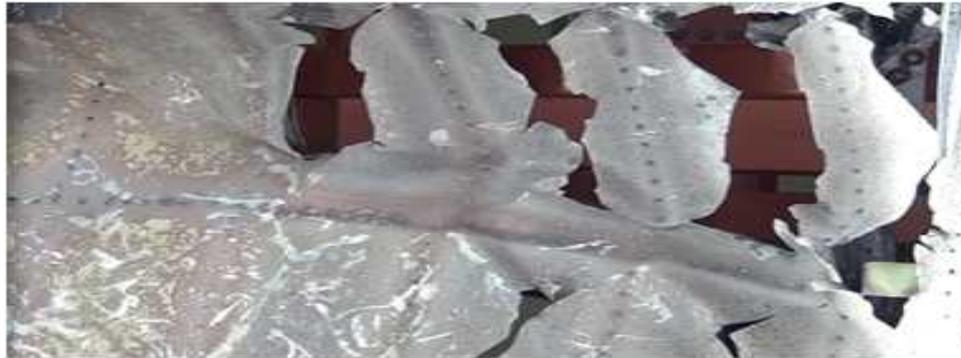
<Fig.165> Melted by heat of fire plane right outside

- 3D H/W reconstructed wreckages analysis : Some of the wreckage #511 of STA 2205 melt a hole in the vicinity of the melting of the heat received and appears to down a cup shape, corresponding to RR area that 250 inches rearward from the main cargo compartment appeared PR area .

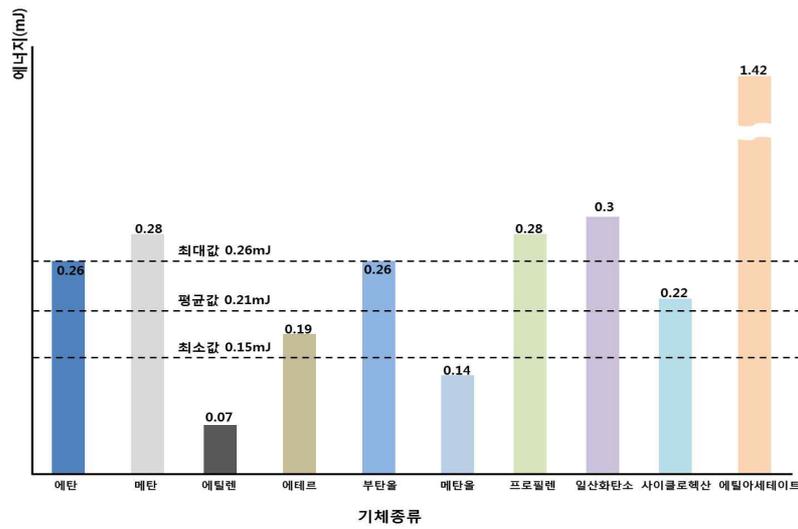
<Fig.171 > Type-B with MIE

● The minimum of the measured Type-B, which can be determined that the average, have at least 2 or more high electrostatic energy than the MIE of vaporized components from the maximum energy is dangerous goods.

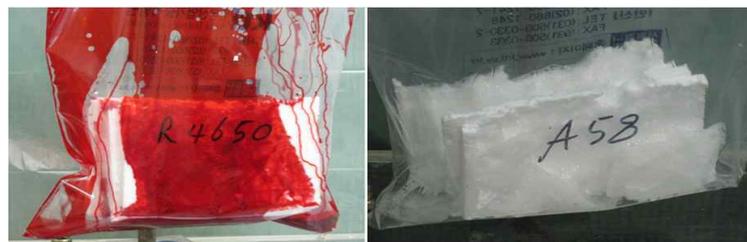
- Performing a test administered by the polystyrene form was used as packaging for liquid dangerous goods loaded on the airplane dangerous goods. Polystyrene form  $990\text{cm}^3$  ( $1.1\text{cm}\times 15\text{cm}\times 10\text{cm}\times 6\text{pieces}$ ), addition liquid Dangerous Goods 40cc. Test Result : Paint, Photo-resist/IC, Photo-resist/LCD are chemical respond rapidly.

<Fig.181> give dangerous goods to a Packaging Materials Left) Photo-resist/LCD, Right) Photo-resist/IC
