Bureau Enquêtes-Accidents

REPORT

*on the accident
to the Air France Boeing 747-428 B
registered F-GITA
on September 13 1993
at Tahiti Faaa*

F-TA930913

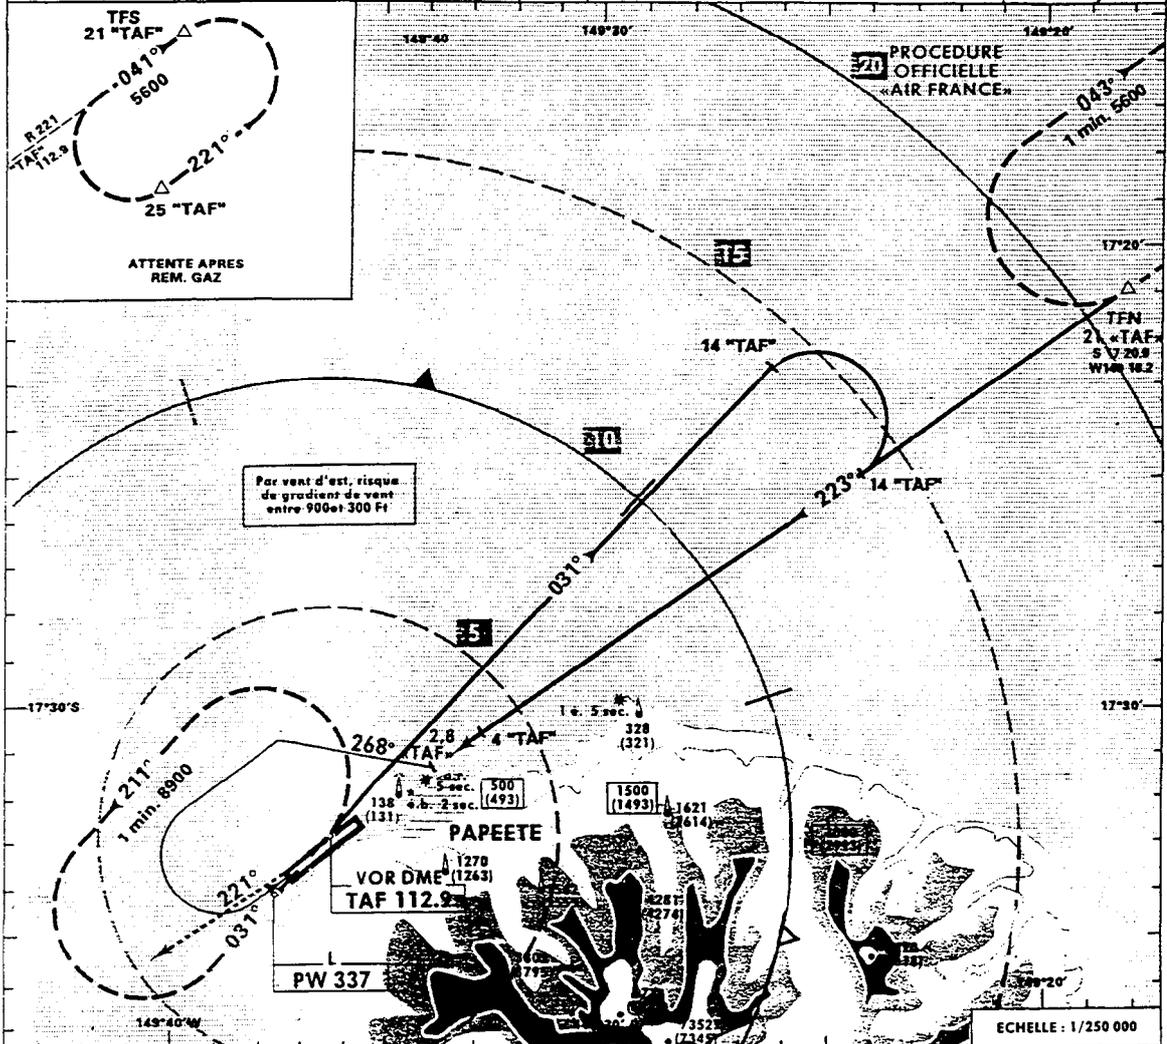
AIR FRANCE DD/MI Alt. Aérod. 7 ft Réf QFE d° Déclin. 12°E APPROCHE INDIRECTE 04 VOR ou VOR DME 22 PAPEETE-Faaa

APP Arr.: 121.3-118.1 TWR 118.1 Clearance Départ Ground Control 121.9 ATIS 128.8 (1600-0700)

HMEA 7900 Piste 22: PAPI 5.2% (FAF) 10 'TAF' 14 'TAF' 18.6 'TAF' NIV. TRANS.: 8900 ALT. TRANS.: 8900

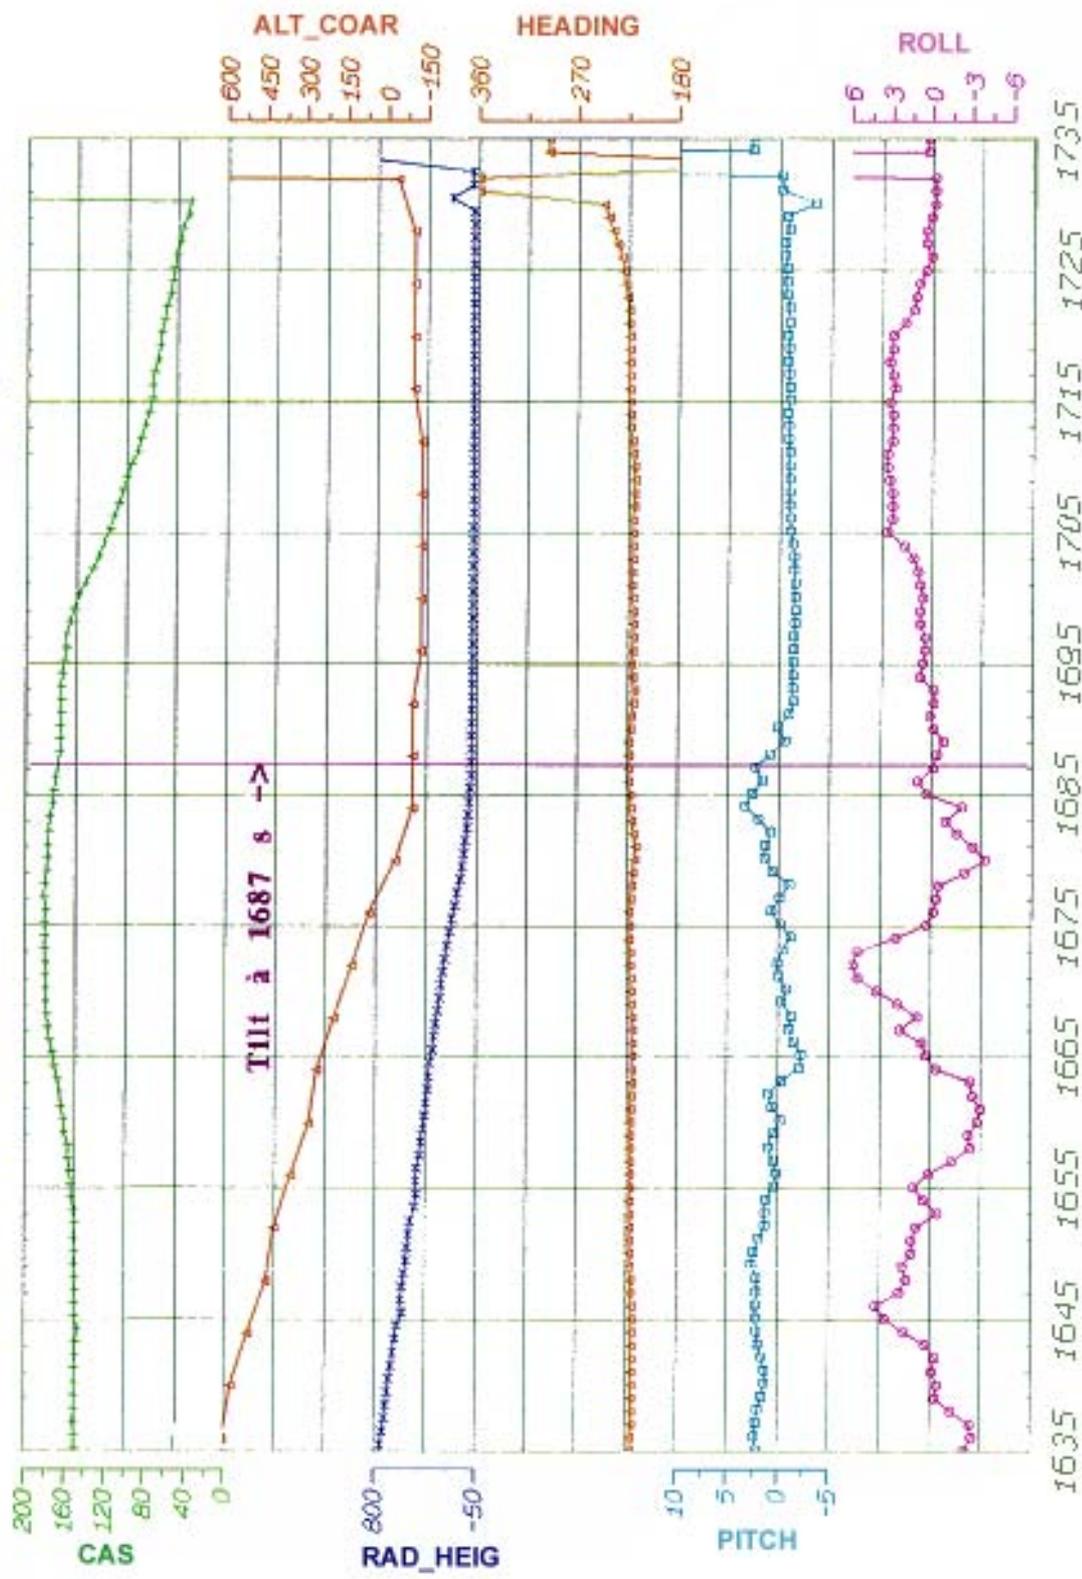
Air France B747-400 F-GITA 12 septembre 1993

DFDR time (sec)

Laboratoire B.E.A. 18 septembre 1993

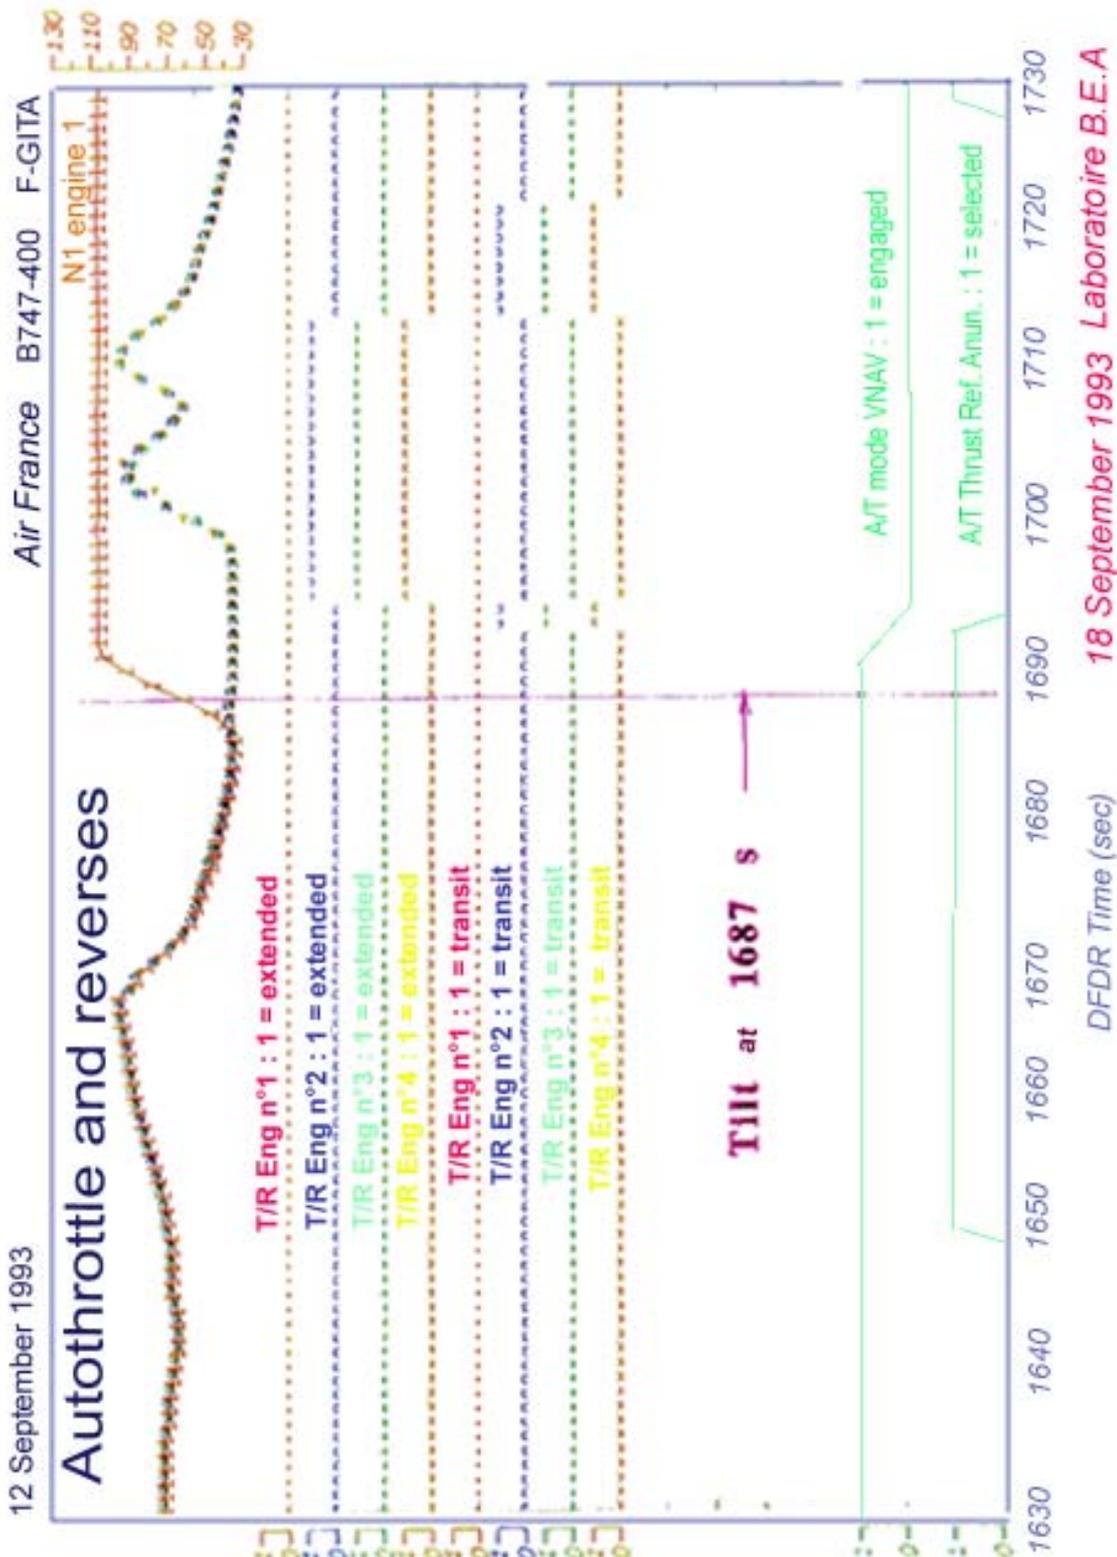
12 September 1993 Air France B747-400 F-GITA

18 September 1993 Laboratoire B.E.A

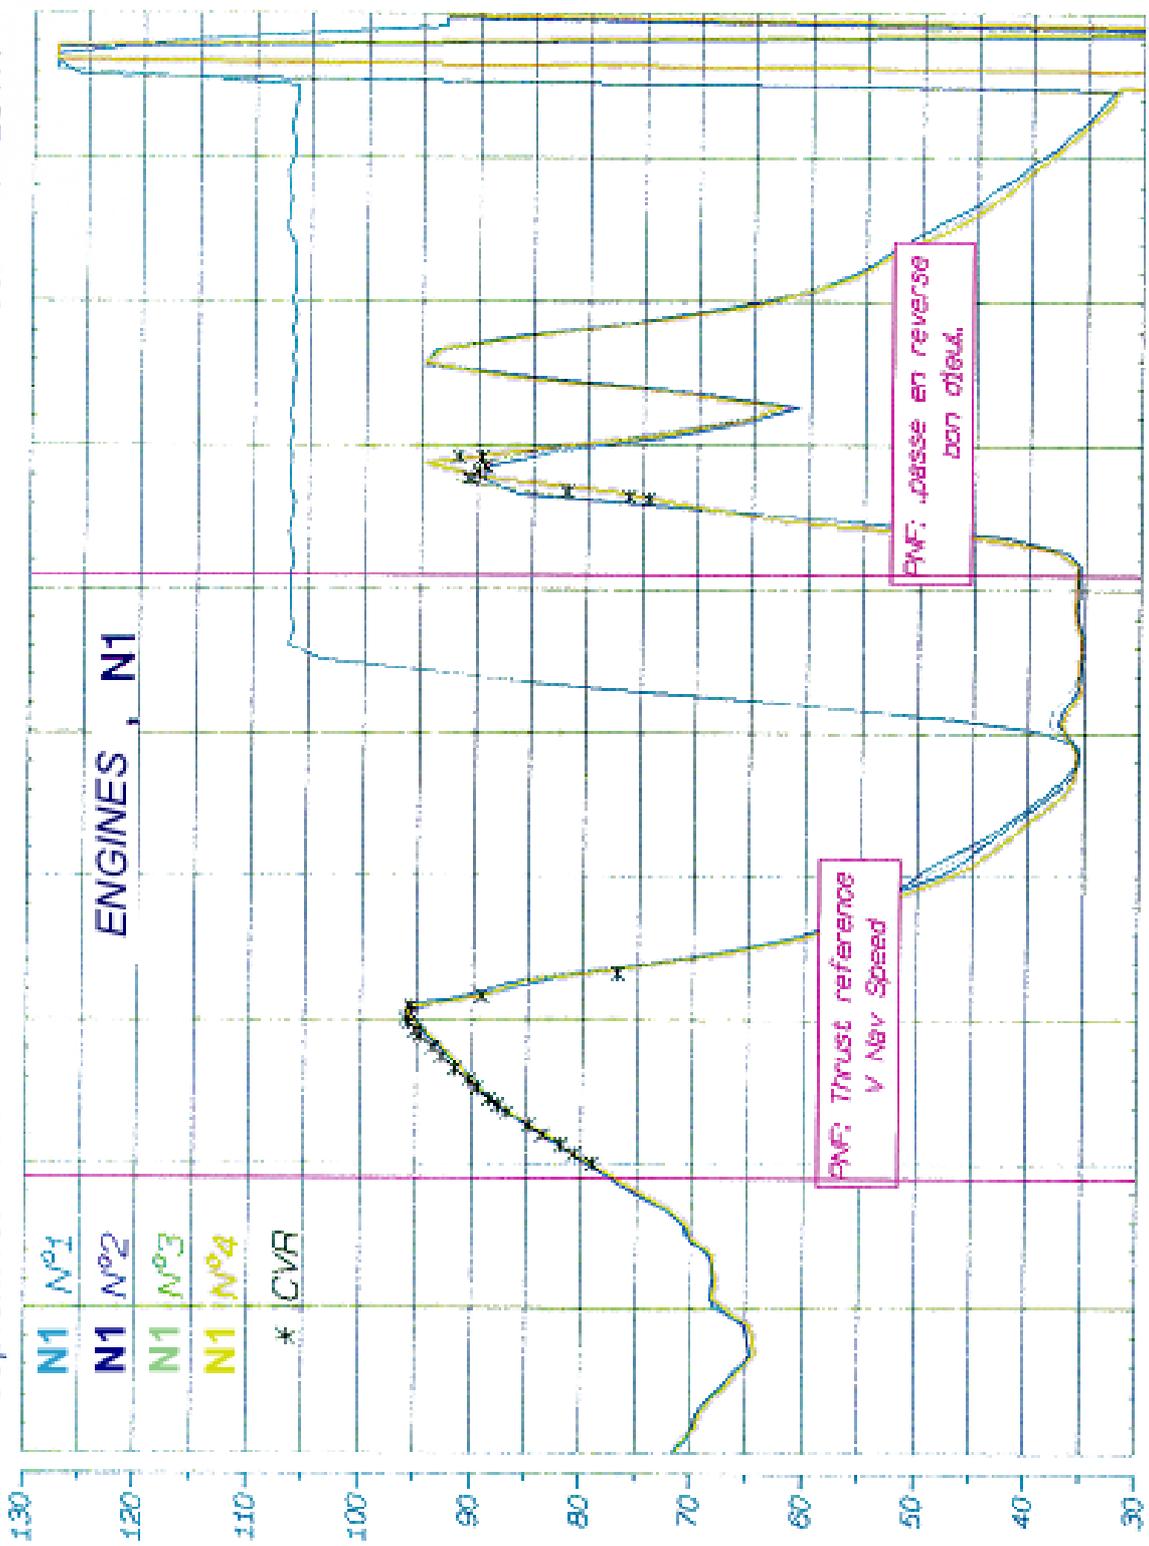
12 September 1993 Air France B747-400 F-GITA

DFDR TIME (Sec)

Laboratoire B.E.A. 22 novembre 1993
