AIRCRAFT ACCIDENT REPORT

IN-FLIGHT ICING ENCOUNTER AND
UNCONTROLLED COLLISION WITH TERRAIN
COMAIR FLIGHT 3272
EMBRAER EMB-120RT, N265CA
MONROE, MICHIGAN
JANUARY 9, 1997

**Adopted: November 4, 1998
Notation 6997A/B/C**

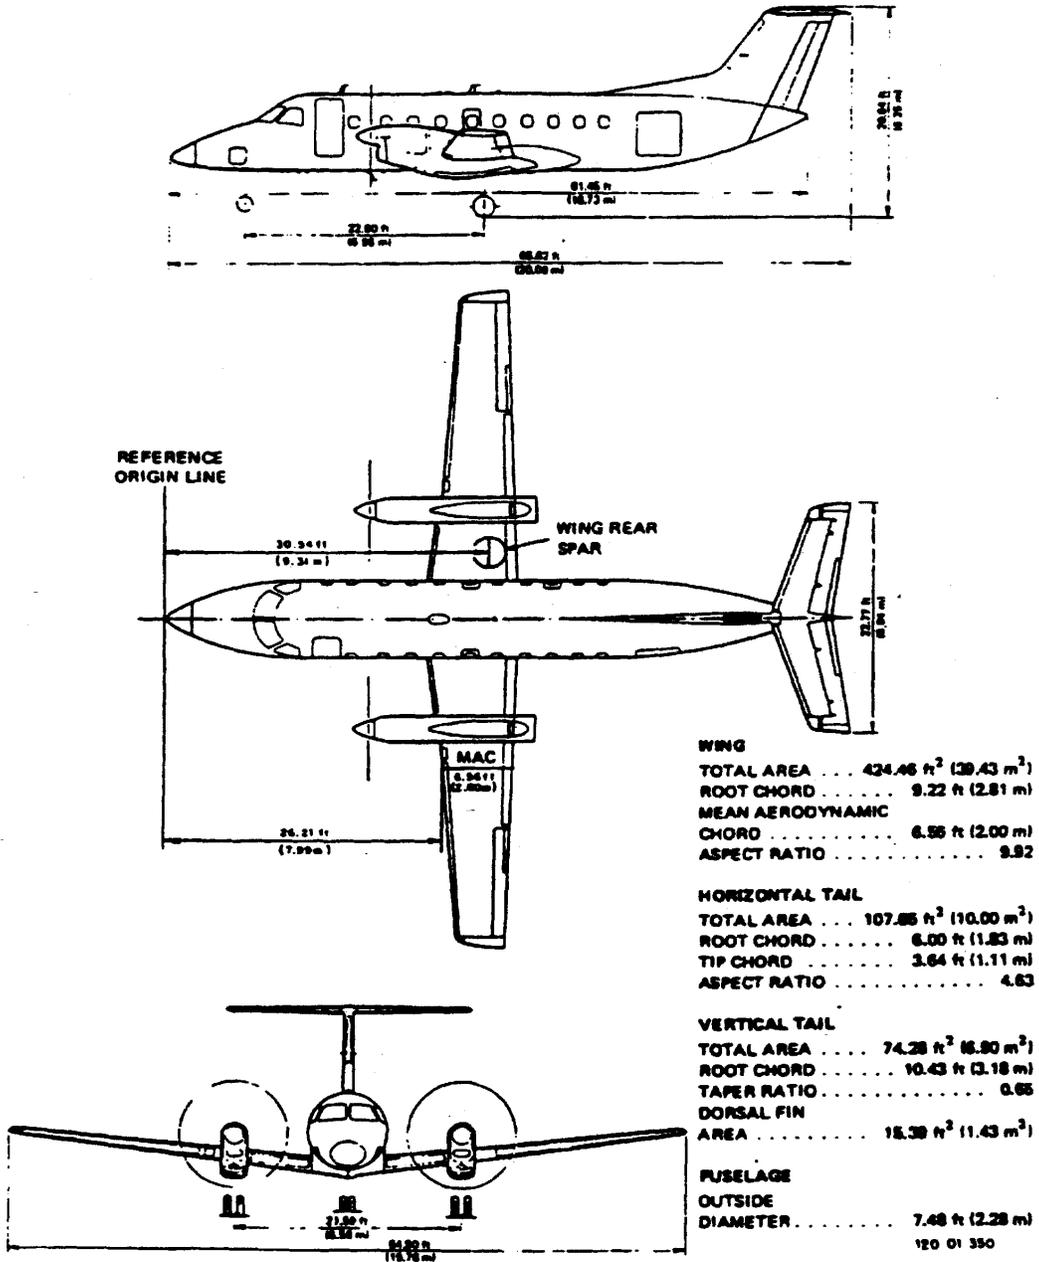
Figure 1.--EMB-120.

THREE-VIEW DRAWING

The EMB-120 is a low wing, T-tail airplane (see figure 1), equipped with two Pratt & Whitney Canada (PWC) PW118 turboprop engines and Hamilton Standard 14RF-9 4-bladed propellers. Aircraft registration records indicated that at the time of the accident, 282 EMB-120 airplanes were operating worldwide, including 220 registered in the United States. According to Comair records, the accident airplane had been operated 12,751.8 hours (12,734 cycles) at the time of the accident. Company maintenance records indicated that at the time of the accident, the left (No. 1) engine, SN 115483, had operated about 12,621 hours, including 1,496 hours since the most recent overhaul; the right (No. 2) engine, SN 115576, had operated about 11,776 hours, including 30.5 hours since the most recent overhaul.¹⁷

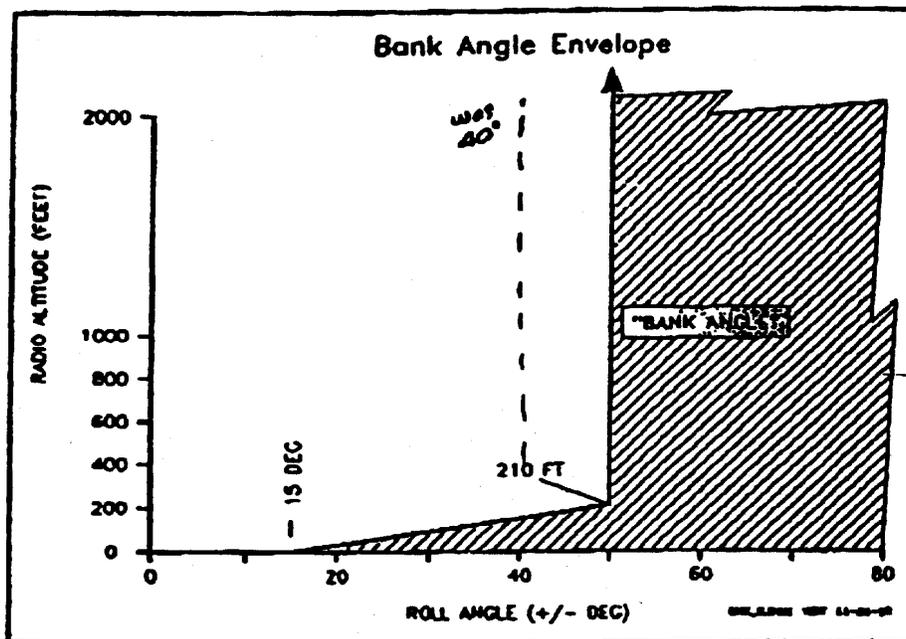
Figure 5.--Bank angle alert envelope.

When the alert envelope of Figure 6.6.2-1 is penetrated, the message "BANK ANGLE" is repeated every three seconds.

Figure 6.6.2-1: Excessive Bank Angle Alert Envelope

This callout is optional, and requires the availability of a 400Hz synchro Roll Attitude signal in the aircraft per section 7.2.5.

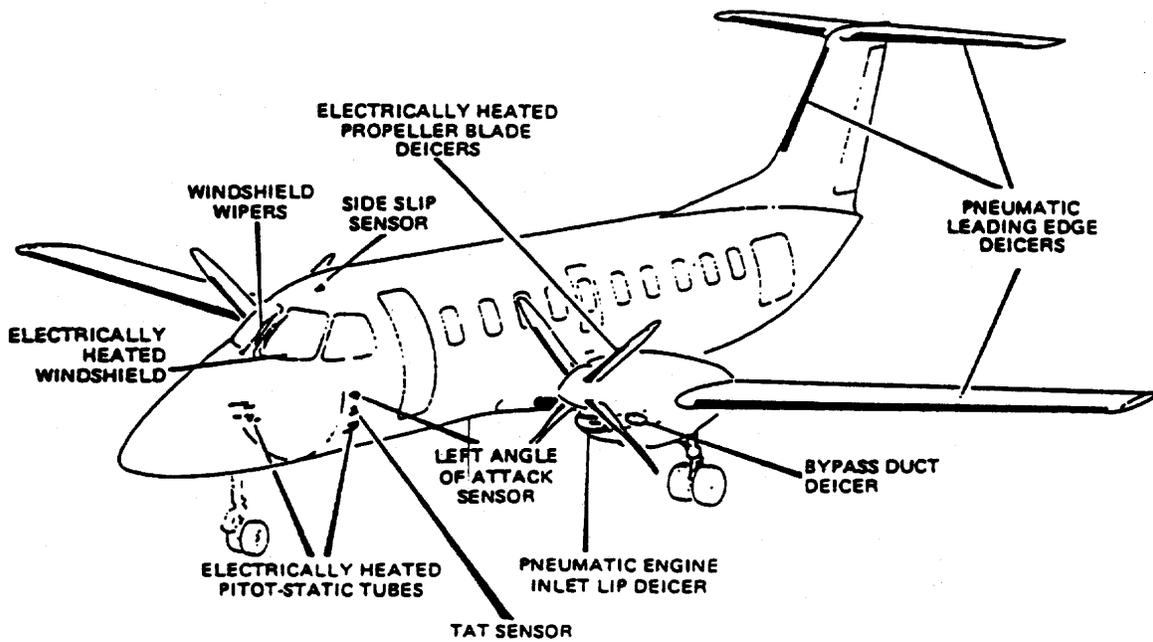
Figure 6.--Ice-protected components of the airplane.

Comair
EMB-120 STUDY GUIDE

(The locations of ice-protected components are shown in figure 6.)

The wing deice boots are divided into three segments (outboard, middle, and inboard), the horizontal stabilizer boots are divided into two segments (inboard and outboard), and the vertical stabilizer boots are a single segment. The tubes in each deicing boot segment are oriented spanwise along the leading edges. The leading edge deicing system is controlled by two toggle switches located on the ice/rain protection panel: the timer select switch and the cycle switch. The cycle switch has two positions: heavy and light. During a heavy cycle, each deicer is inflated for 6 seconds and deflated for 54 seconds; during a light cycle, each deicer is inflated for 6 seconds and deflated for 174 seconds. When activated, the inflation sequence of the deice boots is performed symmetrically, beginning with the outboard wing segments, then middle wing segments, inboard wing segments and inboard horizontal stabilizer segments, and finally outboard stabilizer segments and the vertical stabilizer deicer.

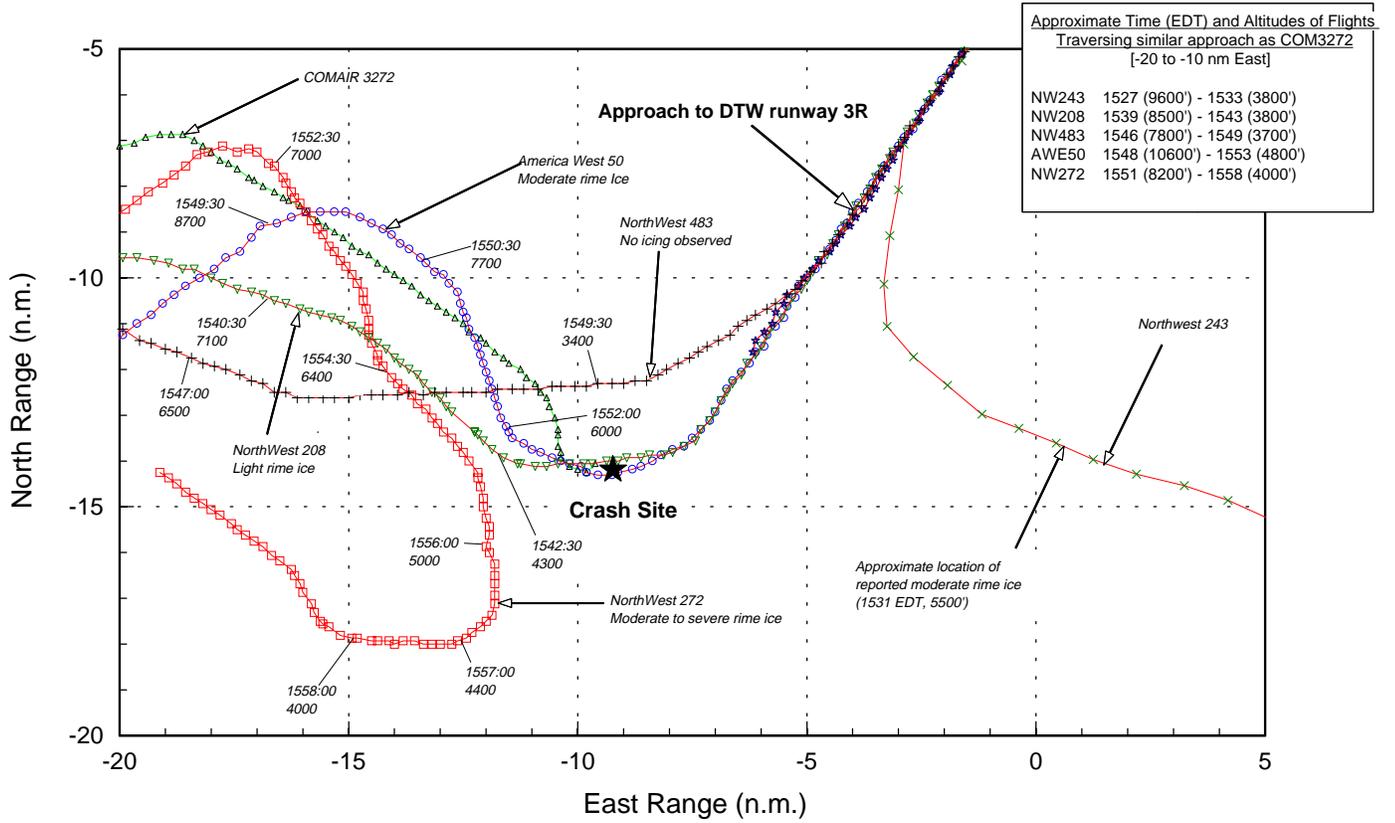
Figure 7.--Ground tracks of aircraft.

**Relative Positions of COMAIR 3272
and several other flights using a similar approach
1/9/97, Monroe, MI**

Because a wide variety of conditions were reported by pilots operating in the Detroit area (see figure 7), the Safety Board tried to narrow the focus to those airplanes that were closest to the accident time and location. Radar data⁶⁰ and pilot statements indicated that the ground tracks of NW flight 208, NW flight 483, Cactus 50, and NW flight 272 passed near the accident site within minutes of the accident and reported the following icing conditions:
