# MANHIRP

Integrating Process Controls with Manufacturing to  
Produce High Integrity Rotating Parts for Modern  
Gas Turbines

Presentation to RISC/RoMan

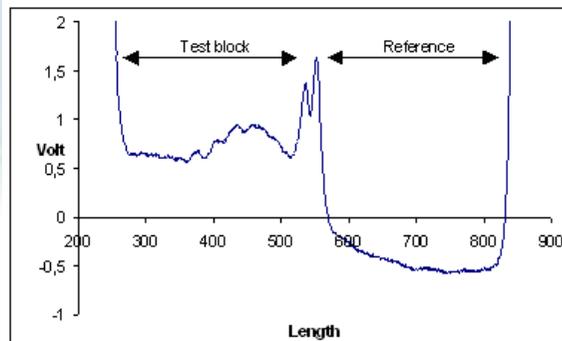
Y component of eddy current signal

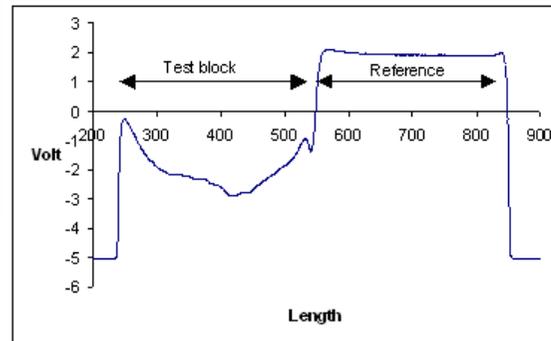
X component of eddy current signal

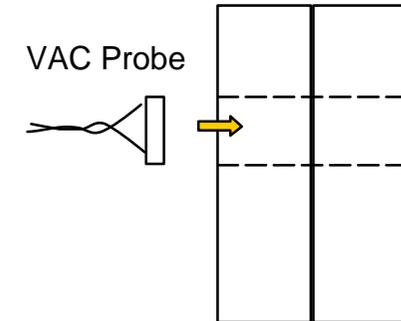
Test block Reference

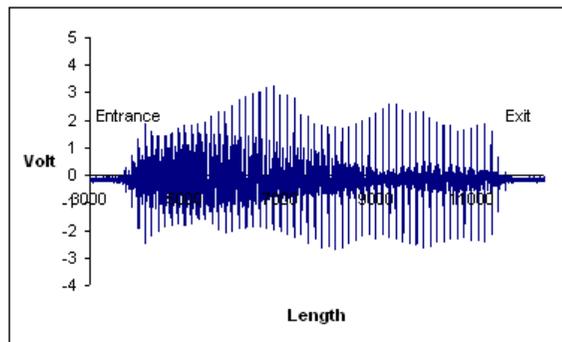
Specimen with scratches

Scratched specimens  
examined by rotating  
eddy current

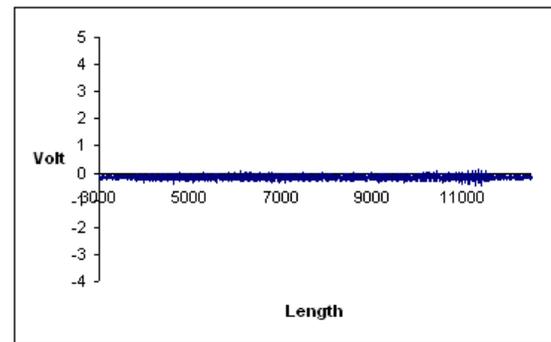
Reference specimen

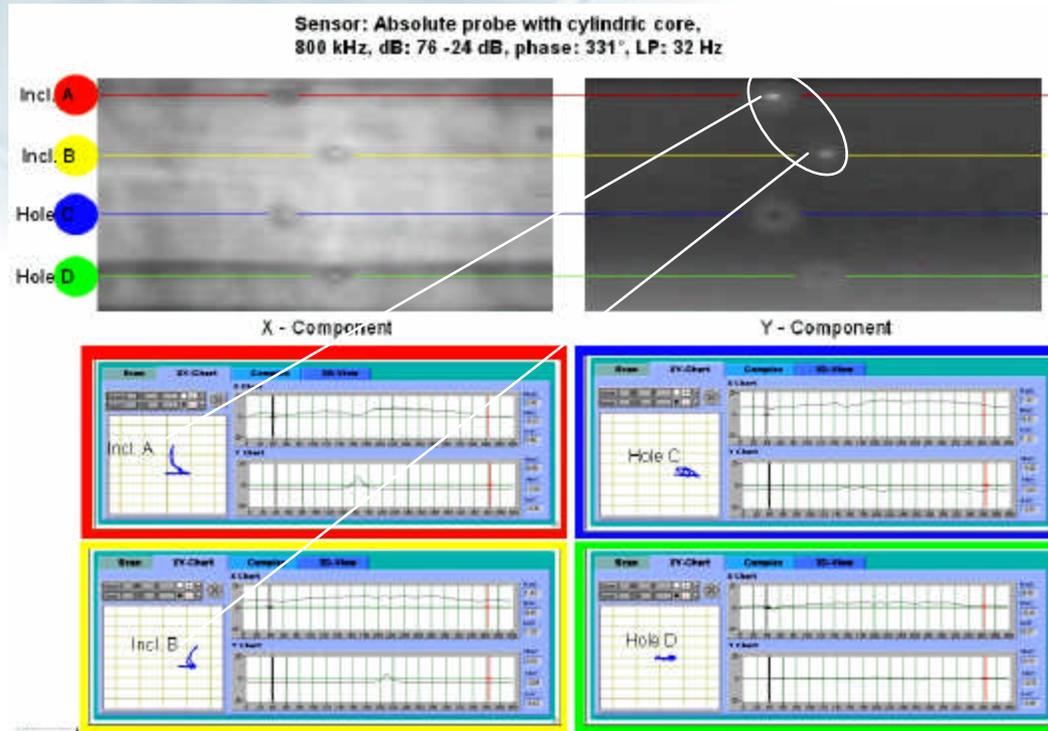
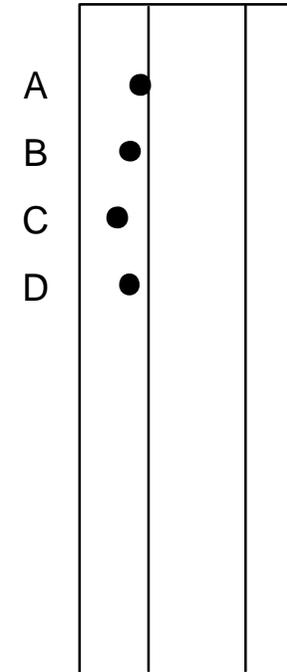
- Eddy current detection of WC inclusions in a hole in titanium.
  - Inclusions A and B are shown in the Y-component c-scan
  - Holes C and D without inclusion are only displayed in the left c-scan of the x-component.

WC particle	Dia., mm.	Depth, mm.	WC incl.
A	0.075	0	Y
B	0.150	0.05	Y
C	0.075	0.10	N
D	0.150	0.05	N

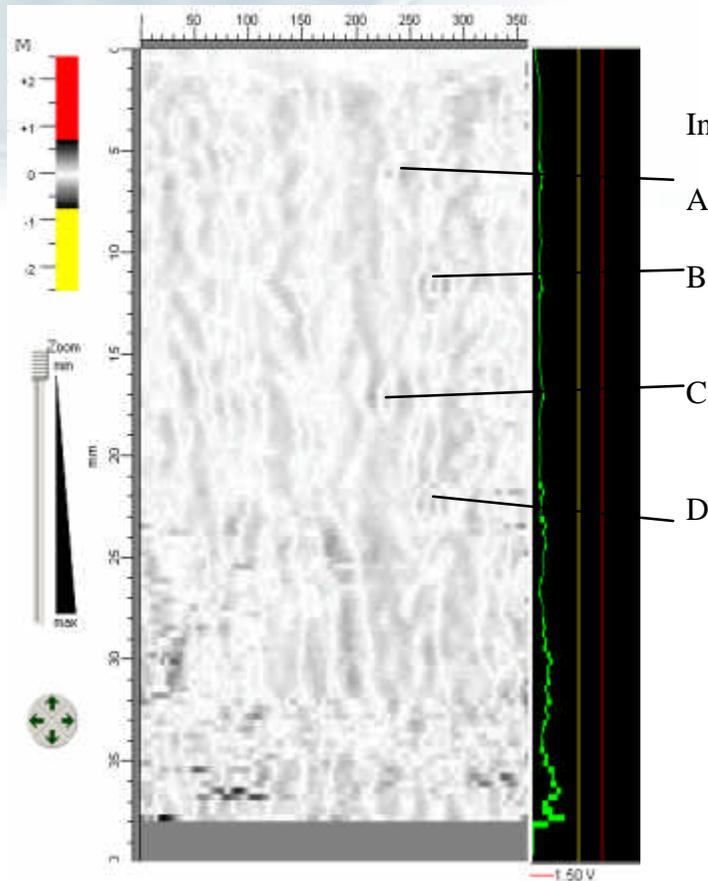
- Eddy current c-scan image performed by SNECMA Lab on the titanium test tube with a standard ET rotating test with c-scan presentation.
- The indications are hardly detected.
- No possibility to separate filled and empty holes due to poor S/N-ratio.

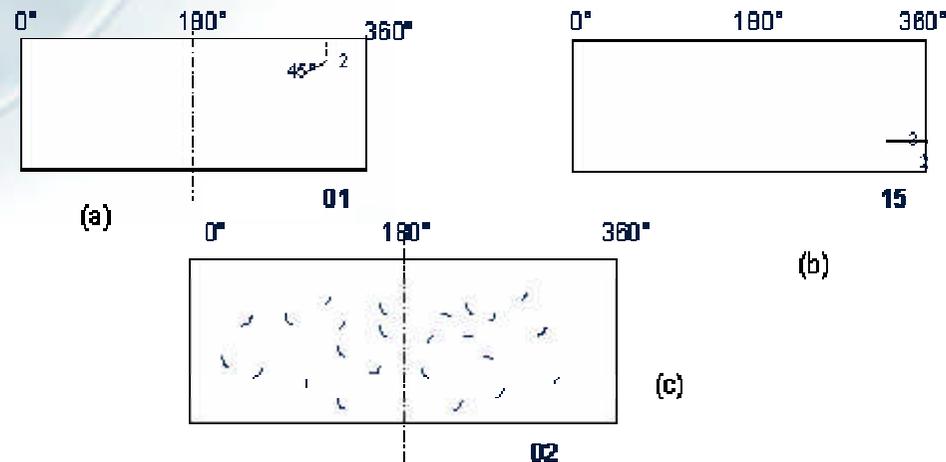
- **FPI typical indications (a) & (b): scores and scratches?, (c) smearing?**
  - The multitude indications as (c) can be related to smearing but the detection is not reproducible and need to be performed by a technically experienced operator.
- Eddy Current was used with a high-speed differential rotating probe at frequency 2 MHz: no significant indications were revealed by this technique.
- This NDI overview shows that the defects are too small and/or too non geometrical to be detected by the available NDI.
- For the next LCF sample inspections, FPI will be the only control performed to increase the potential NDI database.

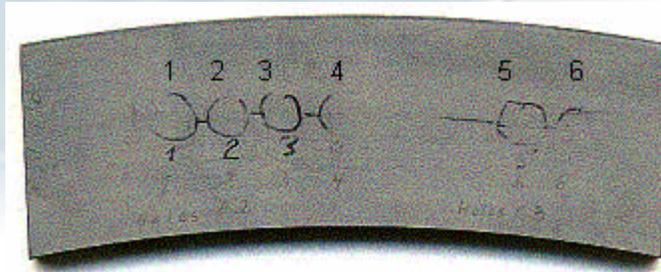
- A test block prepared for the verification of tungsten carbide inclusions by eddy current and/or magnetometric measurement.
- Each number refers to the position of drilled hole (within circle) with or without a WC inclusion

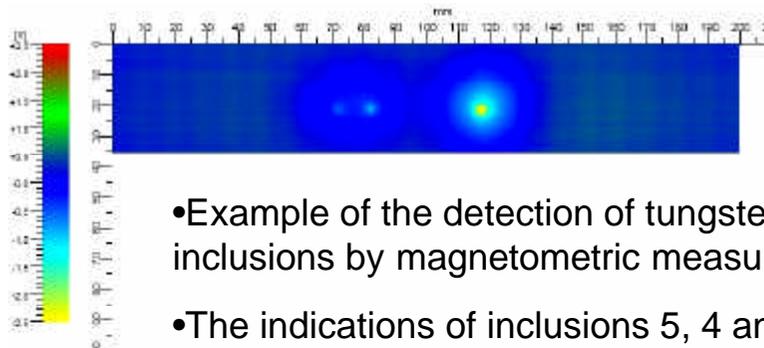
- Example of the detection of tungsten carbide inclusions by magnetometric measurement
- The indications of inclusions 5, 4 and 3 are clearly to be seen, while inclusion 2 is too small to shine up due to its brighter neighbourhood.
- Empty holes are not indicated.

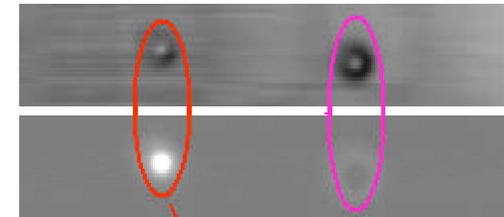
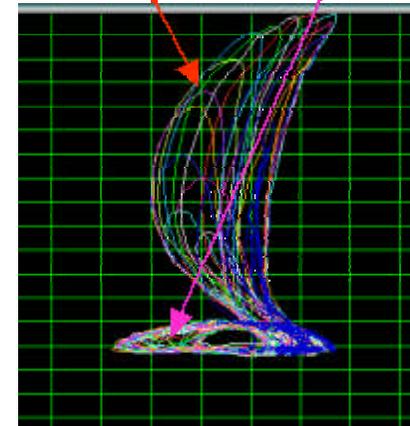
- Example for the detection of a tungsten carbide (WC) inclusion.
- A phase shift of about 90° shows the presence of WC.
- In the c-scan Y-image (upper part of image) the difference is clearly shown between a hole with a WC inclusion (left signal, circled in red) and empty hole (right signal).

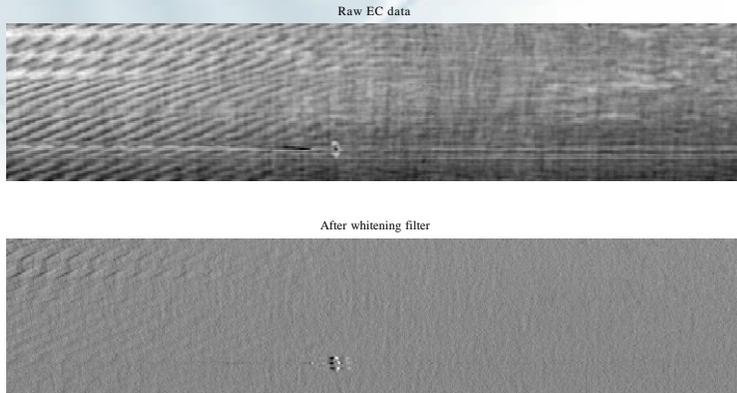
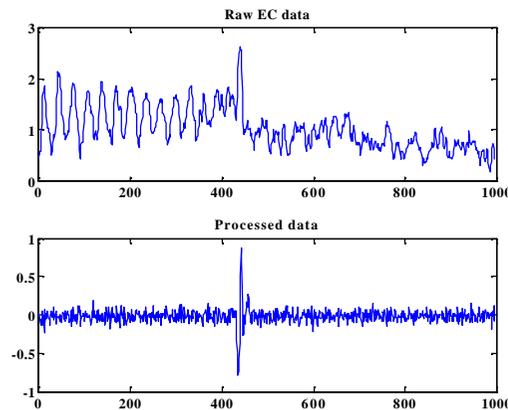
- EC C-Scan of anomaly in Ti ring
  - Raw data (upper)
  - After processing (lower)
- Single EC scan of an anomaly in Ti-ring
  - Raw data (upper)
  - After processing (lower).
- Special process technique of “whitening” filter which performs spectrum equalisation of a stochastic signal
  - Suppresses distinct frequency peaks
  - Enhances frequency intervals where signal has low energy

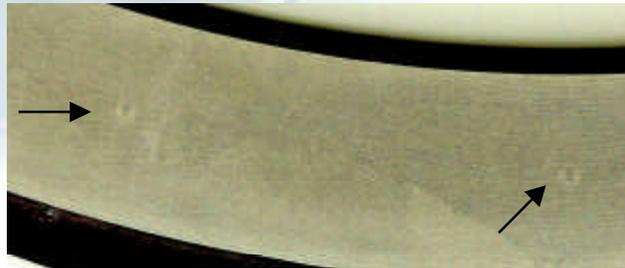
Adiabatic shear bands (arrowed)  
highlighted by BEA

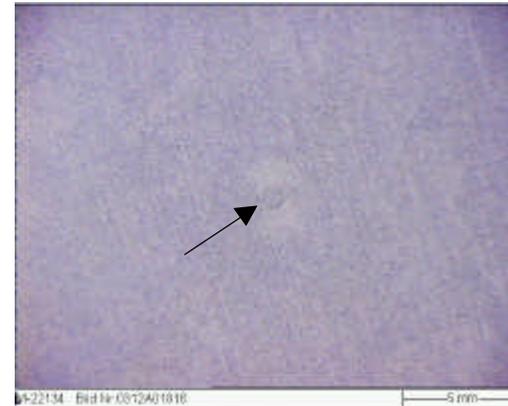
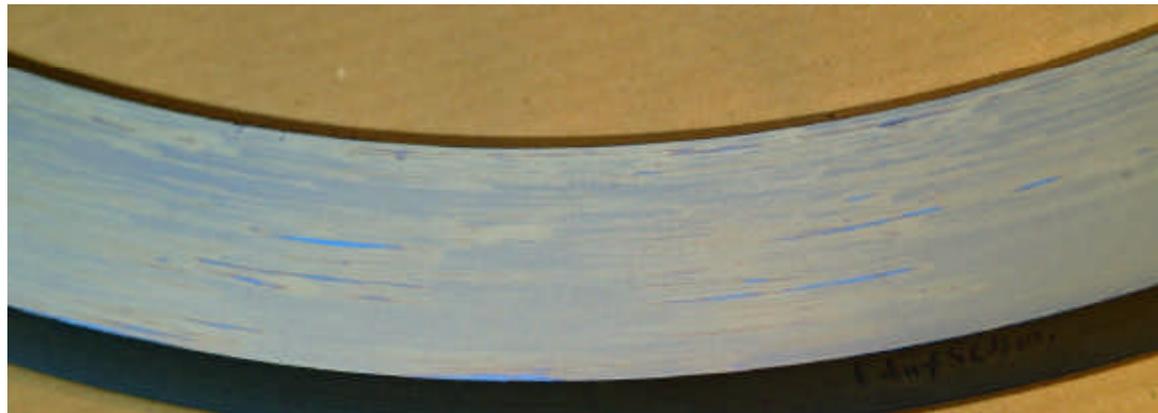
BEA of a turned surface,  
which was deliberately  
contacted by the tool  
fixture during turning. The  
metal distortion produced  
is clearly indicated

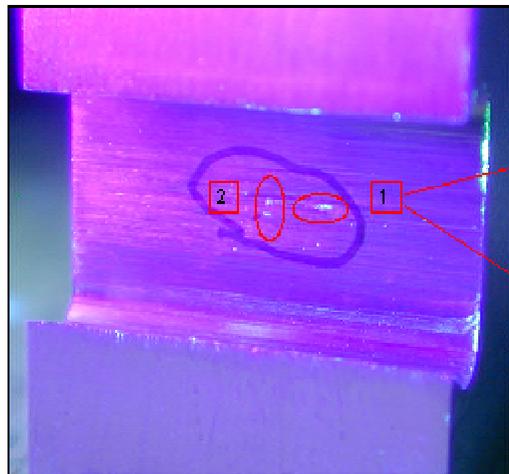
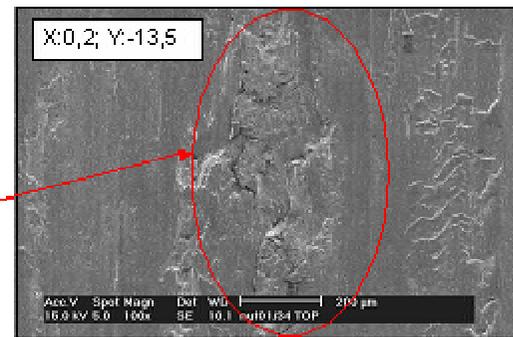
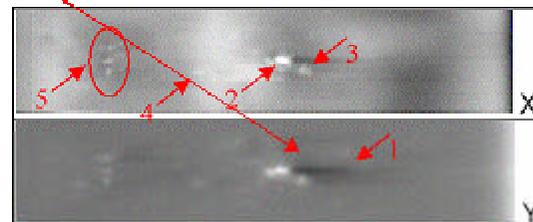
- Typical NDI inspection images showing
  - FPI (left hand side)
  - SEM confirmation (top right)
  - Eddy current results (bottom right)

Sample identification	Cutting conditions	Indication number	Defect locations X-Y, mm	Type of damage	Evaluation method		
					SEM	FLP	MFEC
nUT01x34	Coolant OFF Toolwear	1	X=0,2; Y=-13,5	Pluck and laps	Yes	Yes	Yes
		2	X=0,2; Y=-11,5	Smearing and laps	Yes	Yes	Yes
		3	X=0; Y=-12,5	Small plucks	Yes	No	Yes
		4	X=-1,2; Y=-8	Small plucks	Yes	No	Yes
		5	X=0; Y=-3,95	Small pluckings	Yes	No	Yes
		6	X=2,35; Y=-11,5	plucks	Yes	No	Yes
