# NATIONAL TRANSPORTATION SAFETY BOARD

## AIRCRAFT ACCIDENT REPORT

UNCONTROLLED IMPACT WITH TERRAIN  
FINE AIRLINES FLIGHT 101  
DOUGLAS DC-8-61, N27UA  
MIAMI, FLORIDA  
AUGUST 7, 1997

**Abstract:** This report explains the accident involving Fine Airlines flight 101, a Douglas DC-8-61, which crashed after takeoff from runway 27R at Miami International Airport, Miami, Florida, on August 7, 1997. Safety issues in the report include the effects of improper cargo loading on airplane performance and handling, operator oversight of cargo loading and training of cargo loading personnel, the loss of critical flight data recorder information, and FAA surveillance of cargo carrier operations.

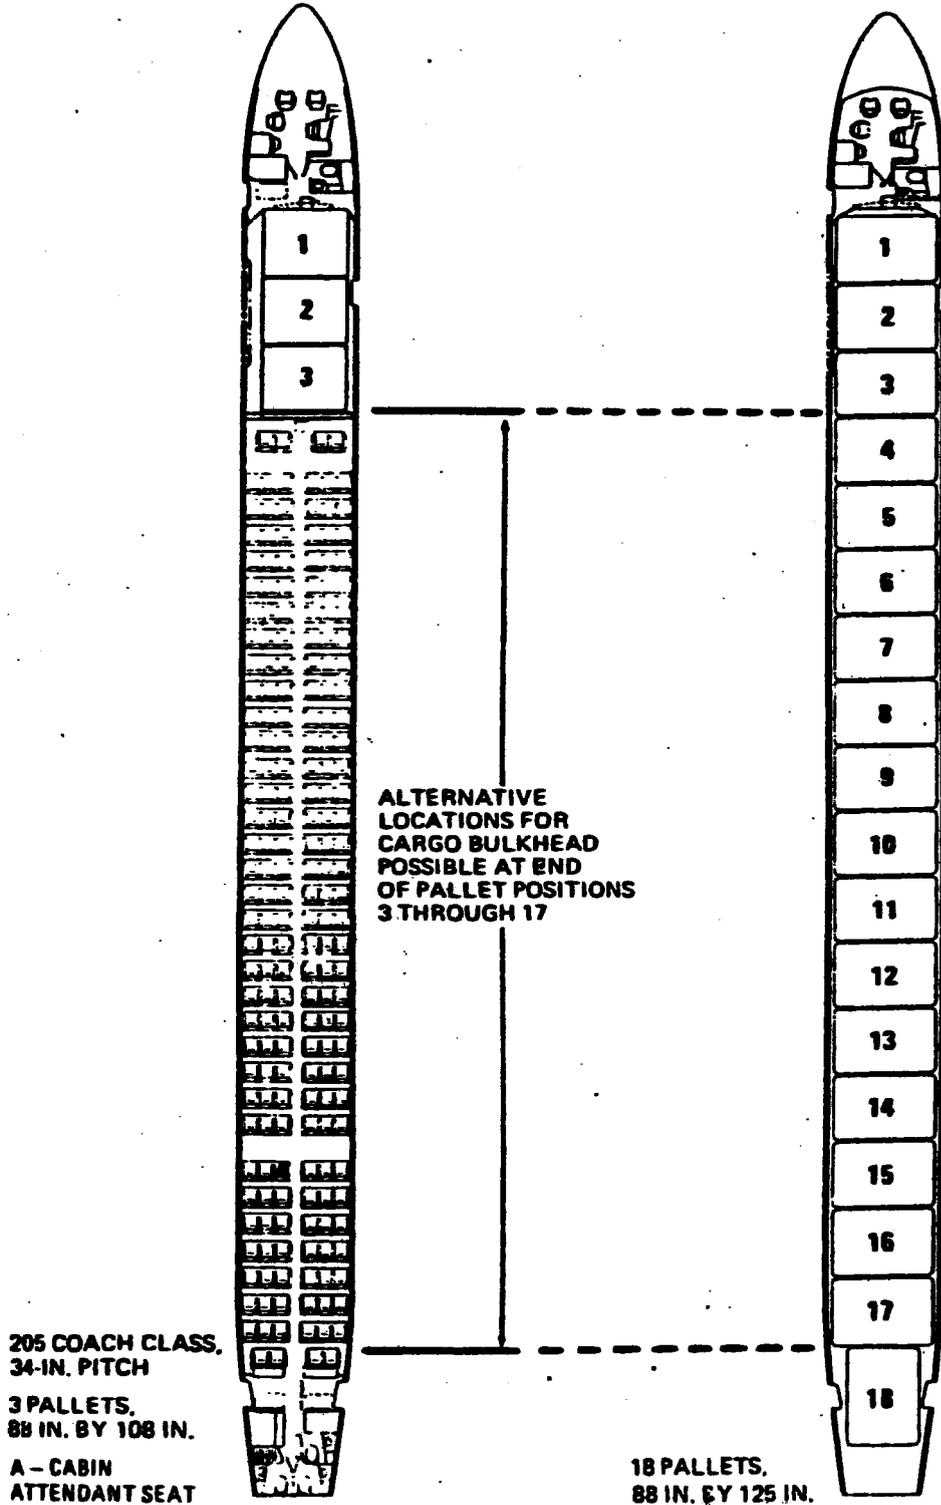
Figure 1.—DC-8-61 18-pallet cargo configuration diagram.

The airplane was equipped with a cargo handling system designed to accommodate and restrain 18, 88-inch x 125-inch pallets. Five guide floor tracks with encased ball rollers were installed in the cabin floor to move cargo pallets forward or aft of the main cargo door. Retractable pallet locks (Pemco 50044-1 pallet lock assemblies), or "bear traps," were installed in the cabin floor along the five guide tracks (aligned in a row) at 89-inch intervals (see figure 2). Each of the 85 pallet locks included a folding lock mechanism (to allow pallets to move over them during loading) comprising a forward and aft facing pawl. When raised, the pawls engage the edges of adjoining cargo pallets and prevent forward, aft, or vertical pallet movement (see section 1.16.3 on load testing). Rails were attached along the cabin walls to prevent cargo from striking the fuselage. According to the loading system design, pallet positions 1 through 17 are loaded in the 125-inch (lateral) x 88-inch (longitudinal) position. Pallet position 18, located in the tapering end of the aft fuselage was reversed, loaded in the 125-inch (longitudinal) x 88-inch (lateral) position.

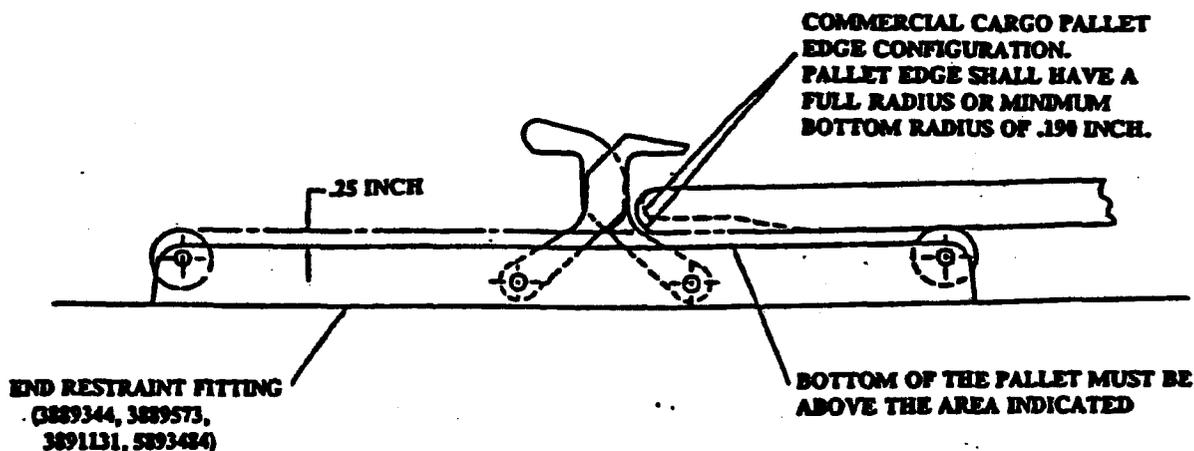
All commercial pallets used in cargo operations must conform to the restrictions shown in Figure 3, below. Specifically, the edges of pallets engaging the pawls of the end restraint fittings must have a full radius or a minimum bottom radius of .190 inch. In no case may the edge of a pallet be so configured that it extends into the shaded area shown in Figure 3.

Figure 2.—Pallet edge configuration requirements.

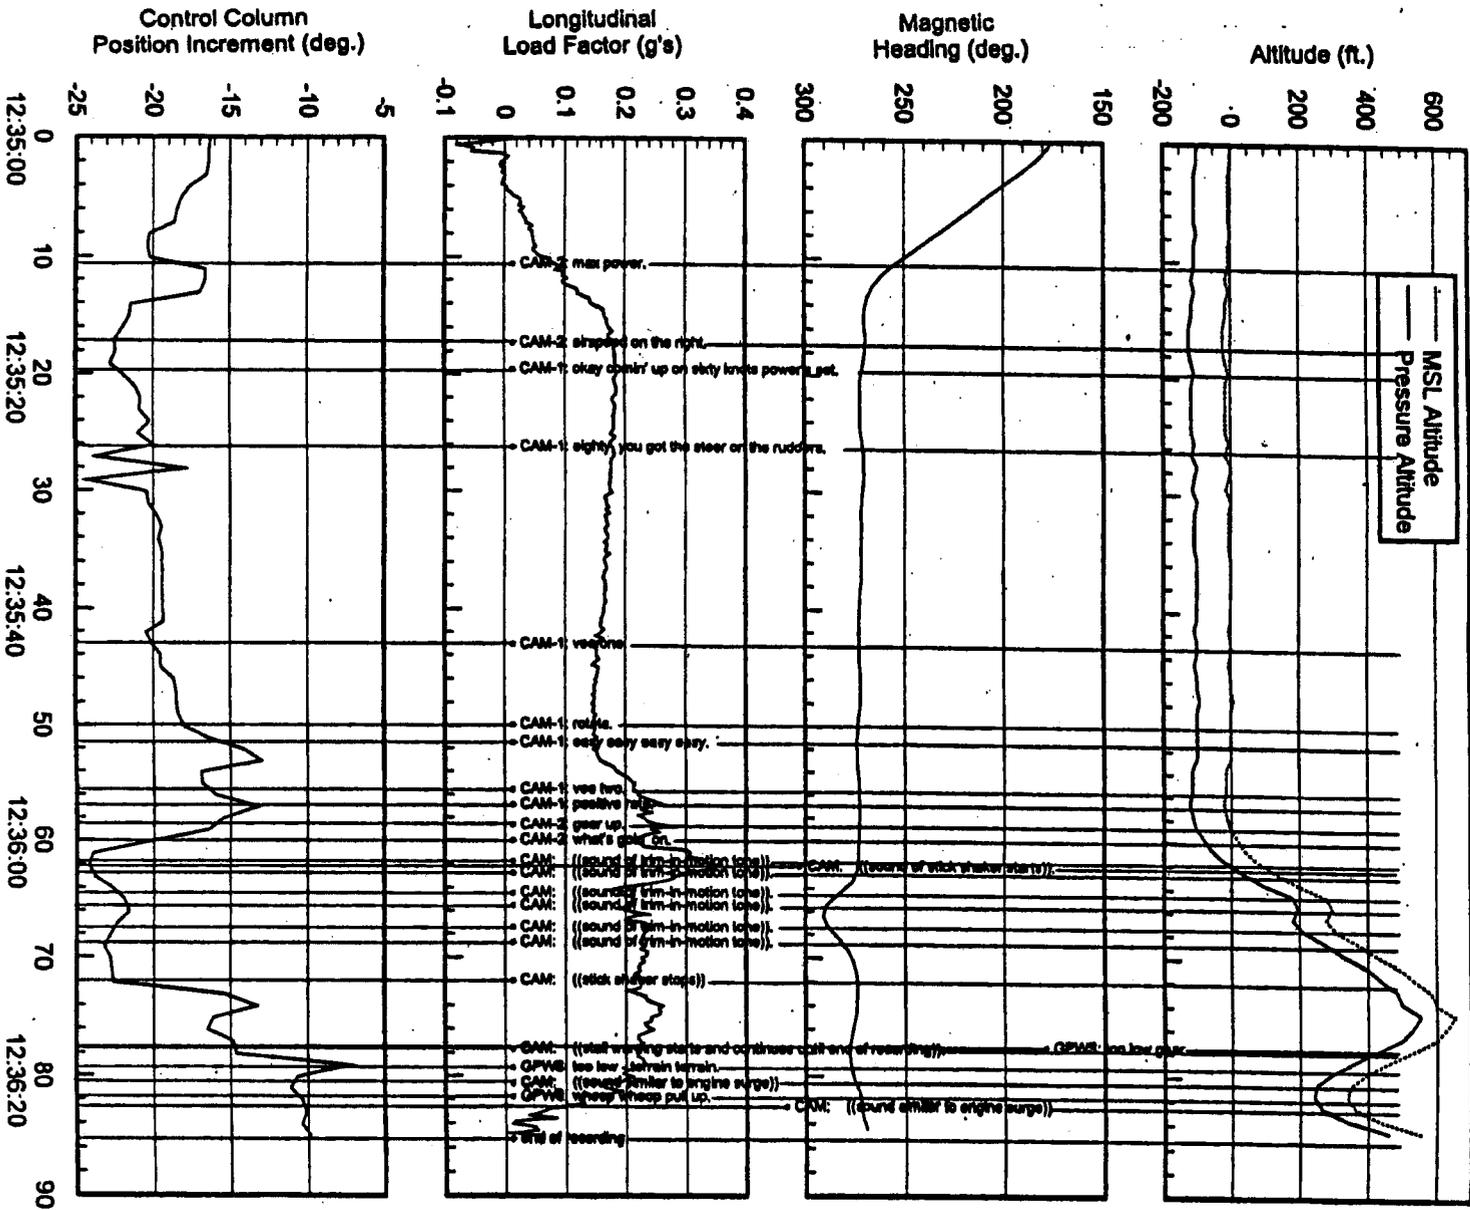
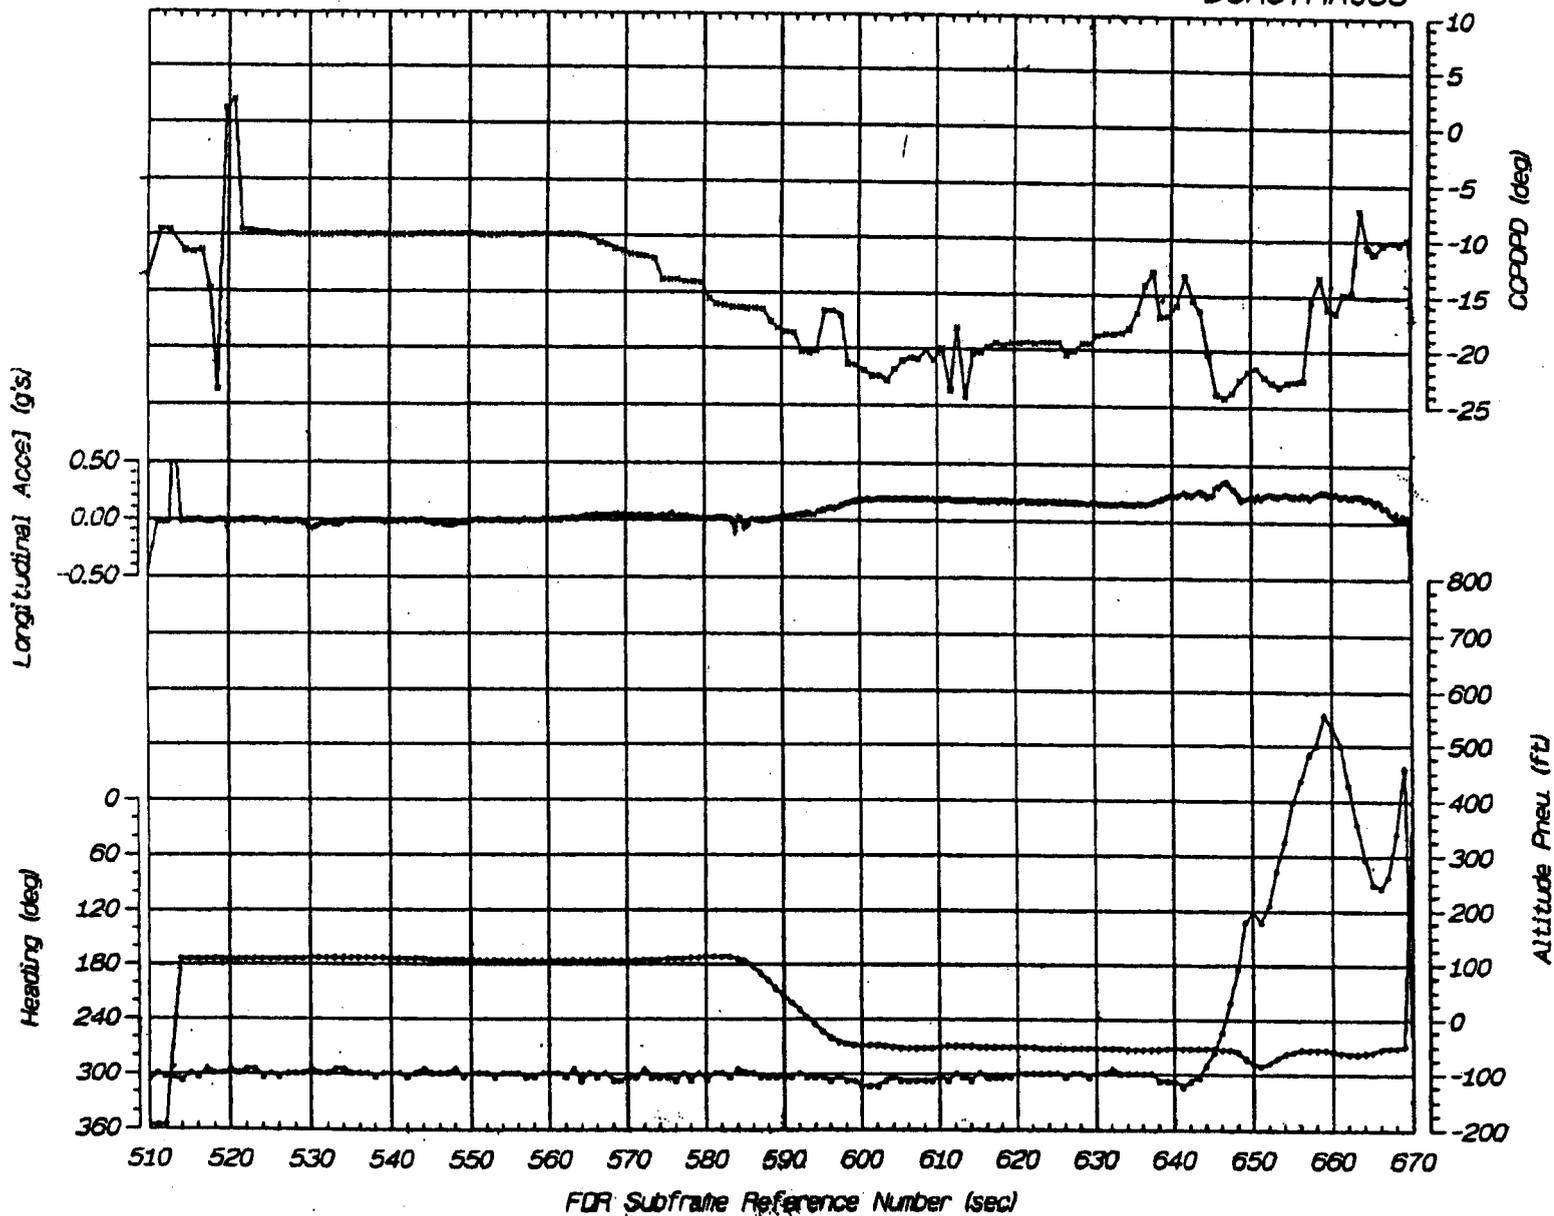
Fine Air Flight 101 - DFDR Data with Cockpit Voice Recorder Events

Elapsed Time = DFDR Time - 584.6 (sec.)

Miami ATC Time (HH:MM:SS)
