Airworthiness Directive

Docket No. 99-NM-162-AD; Amendment 39-11750; AD **2000-11-02**

Airworthiness Directives; McDonnell Douglas Model DC-10-10F, DC-10-15, DC-10-30, DC-10-30F, and DC-10-40 Series Airplanes, and Model MD-11 and -11F Series Airplanes

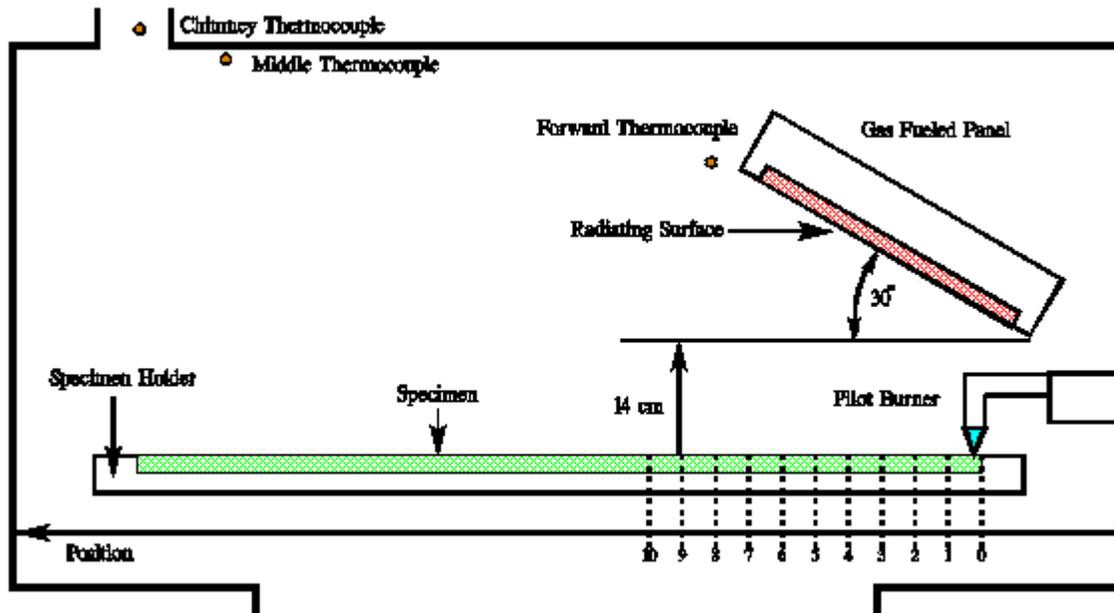
Figure 1.

(b) Test Apparatus (as schematically shown in figure 1).

(2) Radiant Heat Source. The radiant heat energy source will be a panel of porous refractory material mounted in a cast iron frame, with a radiation surface of 12 by 18 inches (305 by 457mm). It shall be capable of operating at temperatures up to 1500°F (816°C) (Figure 1).

(1) During burner application, no flaming is allowed to propagate more than 2 inches (50.8mm) along the sample (to the left in figure 1) of the centerline of the flame.

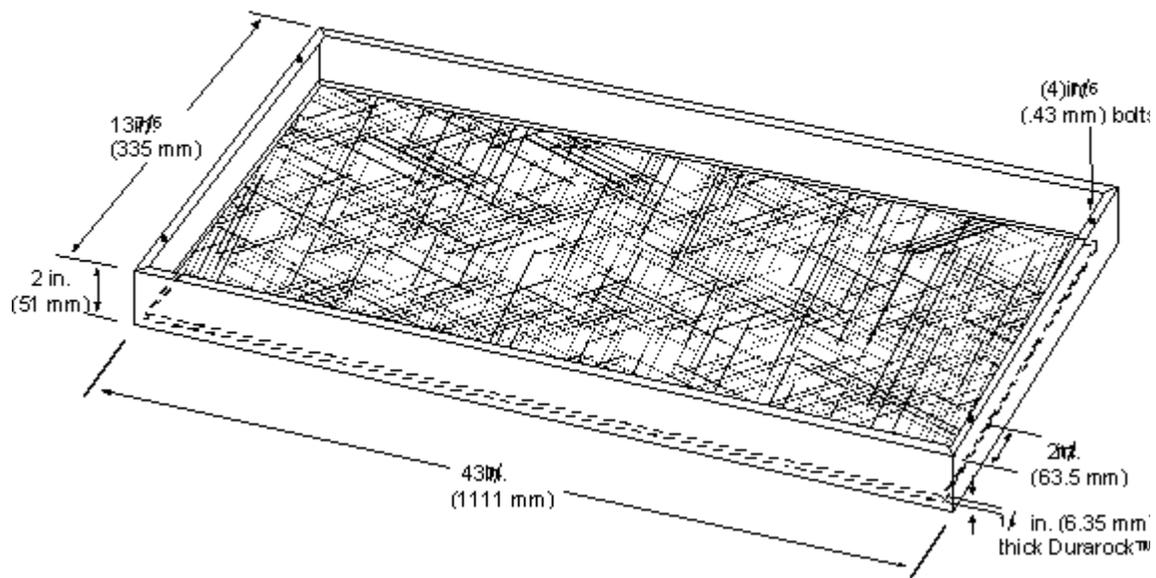
Figure 2: Sliding Platform

(i) The sliding platform serves as the housing for test specimen placement. A $\frac{1}{4}$ inch (6.35mm) sheet of Duraroca, or other non-combustible base, measuring 43 $\frac{1}{4}$ inches by 12 $\frac{1}{2}$ inches (1098 by 317.5mm) will be placed in the open bottom (base) of the sliding platform. It is necessary to cut the non-combustible base into two pieces for placement in the bottom of the platform, since it will be supported by a $\frac{3}{4}$ -inch (19.1mm) lip that extends around the bottom of the platform base. It is suggested that the shortest piece be placed at the end furthest from the radiant panel (figure 2). A $\frac{1}{2}$ inch (13mm) piece of KaowoolTM board or other high temperature material measuring 41 $\frac{1}{2}$ by 8 $\frac{1}{4}$ inches (1054 by 210mm) will be attached to the back side of the platform. This board will serve as a heat retainer and will protect the test specimen from excessive preheating. The height of this board must not be too high such that it will impede the sliding platform movement (in and out) of the test chamber.

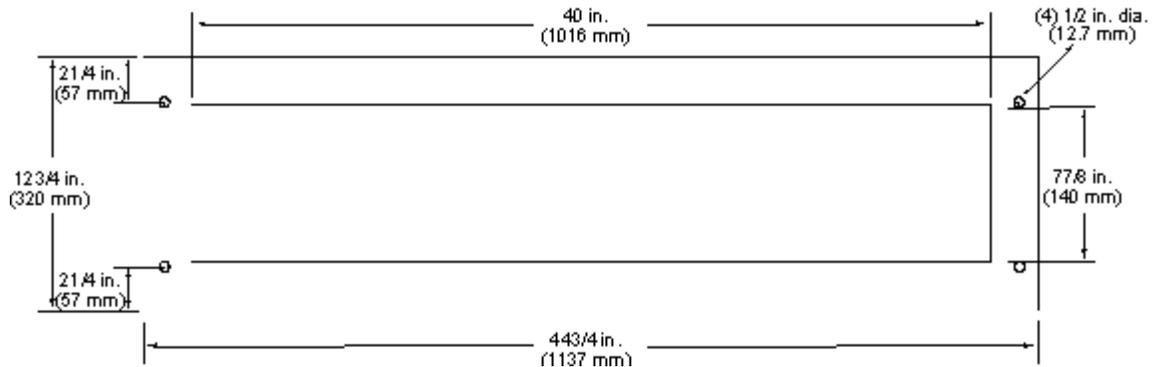
Figure 3: Stainless Steel Retaining Frame

(ii) The test specimen will be placed horizontally on the non-combustible base. A stainless steel retaining frame (AISI Type 300 UNA-NO8330), or equivalent, having a thickness of 0.078 inches (1.98mm) and overall dimensions of 44 $\frac{3}{4}$ by 12 $\frac{3}{4}$ inches (1137 by 320mm) with a specimen opening of 40 by 7 $\frac{7}{8}$ (1016 by 140mm) will be placed on top of the test specimen. The retaining frame will have two $\frac{1}{2}$ inch (12.7mm) holes drilled at each end for positioning the frame to the two stud bolts at each end of the sliding platform (figure 3).

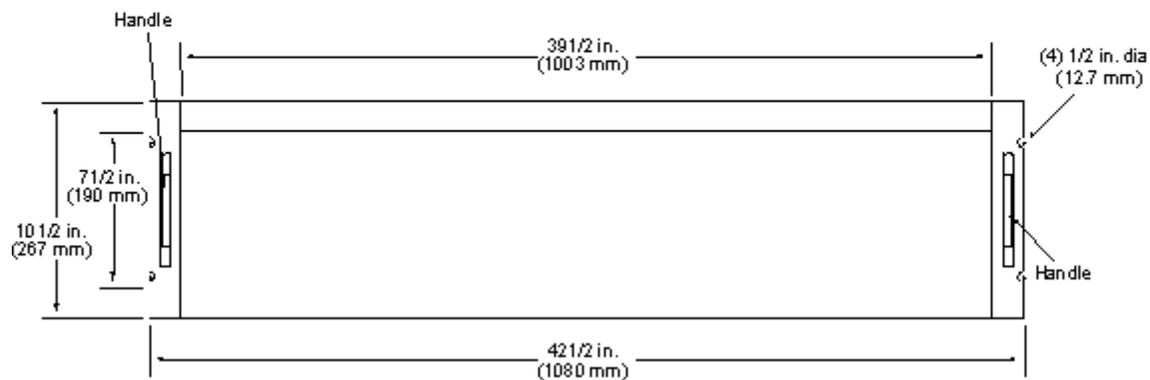
Figure 4: Angle Iron (1.5x1.5) Securing Frame
 *NOTE: All Seams Welded

- (I) The recording device used must record the 2 transducers simultaneously or at least within 1/10 second of each other.
- (8) Calorimeter Fixture. With the sliding platform pulled out of the chamber, install a 2-rail fixture that has a travel range of 40 inches (1022mm) over the sliding platform. The dimension between the 2 rails is 2 11/16 inches (68mm). The rail fixture is screwed into the sliding panel, such that it is always directly under the geometric center of the radiant panel (figure 4). Push the platform into

the chamber and insert the calorimeter. The calorimeter, which is mounted in an insulated housing, fits in the rail opening but has enough clearance such that it may be moved along the rail for heat flux readings. The top surface of the calorimeter must be level with the rails.

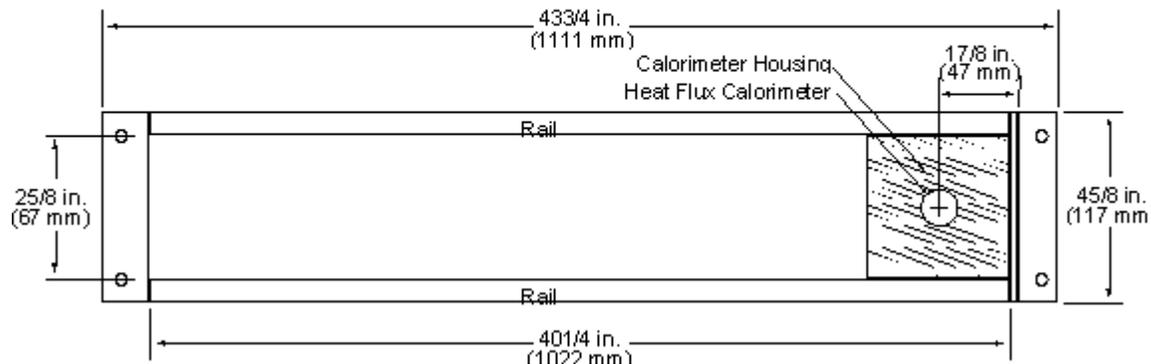
Figure 5: Calorimeter Rail

(1) With the sliding platform out of the chamber, install the rail fixture. Push the platform back into the chamber, install the calorimeter (in its housing), and move the calorimeter to the "zero" position (figure 5). Close the bottom door located below the sliding platform. The centerline of the calorimeter is 1 7/8 inches (46mm) from the end of the sliding platform. This will be the "zero" position. The distance from the center of the calorimeter to the radiant panel surface at this point is 7.5 inches +/- 1/8 (191 mm +/- 3).

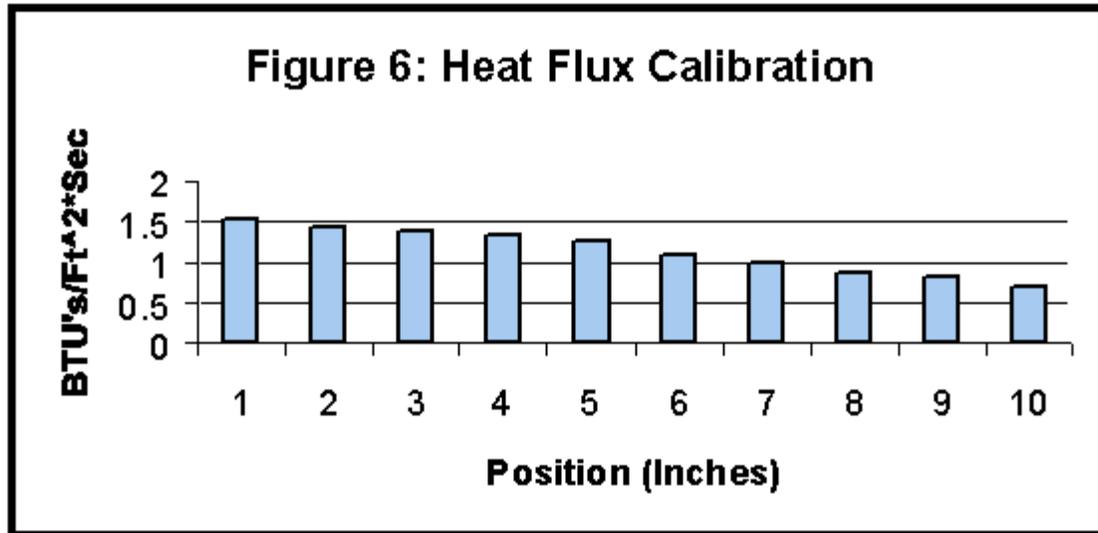
(3) After steady-state conditions have been reached, move the calorimeter 2 inches (51mm) from the "zero" position and record the heat flux. Allow a minimum of 30 seconds at each position for the calorimeter to stabilize. Record at least 10 positions. (Figure 6 depicts a calibration profile.)
