Cargo Compartment Fire Protection in Large commercial Transport Aircraft

July 1998

DOT/FAA/AR-TN98/32

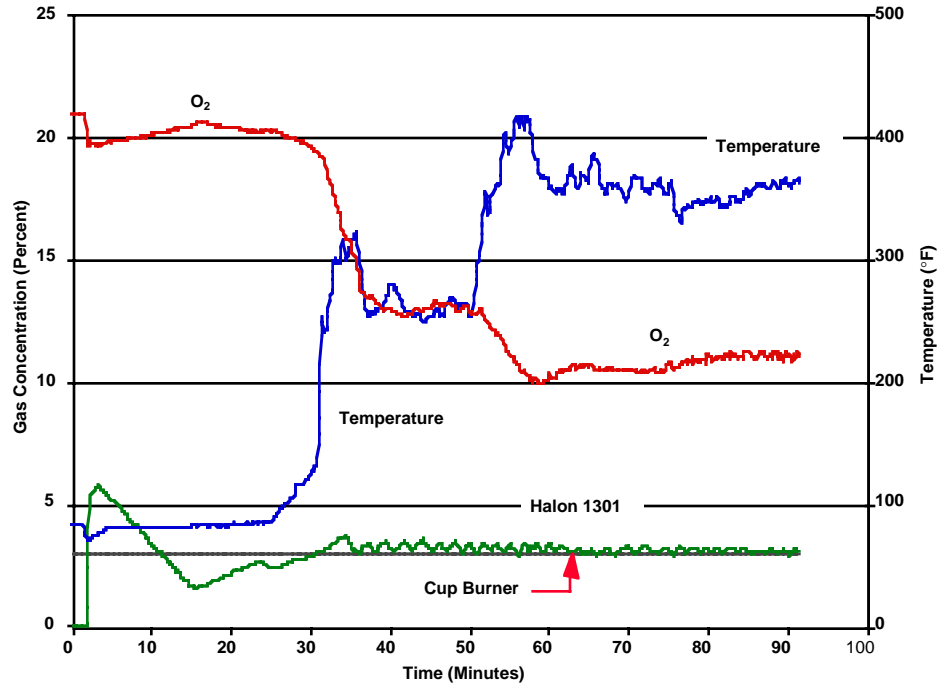
FIGURE 1. GAS AND TEMPERATURE PROFILES IN CARGO COMPARTMENT DURING BULK-LOADED FIRE SUPPRESSION TEST WITH HALON 1301

The results of these 90-minute tests were generally similar to previous shorter duration tests conducted with these agents. [8] The cargo compartment ceiling temperatures ranged from 300 to 450°F while the fires were suppressed and the oxygen concentrations were reduced to 10% to 15%. The depletion of oxygen was caused both by smoldering fires and the displacement of air by suppression agents. Figures 1 and 2 show the ceiling temperatures, oxygen concentrations, and agent concentrations measured in the cargo compartment for the tests with Halon 1301 and HFC-125, respectively. One anomaly was observed during the test with HFC-125. Shortly after the concentration from the initial discharge had decayed down to the cup burner value of 8.8% and the metering system had started, there was an ignition of combustible gases in the smoke layer above the cardboard boxes. The flame front progressed along the entire length of the compartment at the ceiling level. This caused a sharp rise in ceiling temperature and a drop in oxygen concentration. The fire was suppressed for the duration of the test after this event. A similar event had previously been observed in a test using HFC-125 with a containerized fire load. This type of behavior had not been observed with Halon 1301 or other gaseous candidate replacement agents. Further testing is planned in an attempt to understand this anomaly.

Of particular interest for these longer duration tests was the generation and accumulation of agent decomposition products in both the cargo compartment and in the normally occupied passenger cabin area above it. Figure 3 shows the hydrogen fluoride (HF) concentrations in the cargo compartment for the two tests. The values in the graph are the average concentrations of HF over each 10-minute interval. The higher concentrations of HF between 20 and 40 minutes with HFC-125 are due mainly to the open flame that was present when the combustible gases along the ceiling ignited. This open flame produced significantly more decomposition products than the smoldering suppressed fire. Previous testing showed higher concentrations of HF even where there was no ignition of combustible gases when HFC-125 was used as the suppression agent rather than Halon 1301. This result is expected because not only does HFC-125 contain more fluorine per molecule than Halon 1301, but higher concentrations of HFC-125 are also

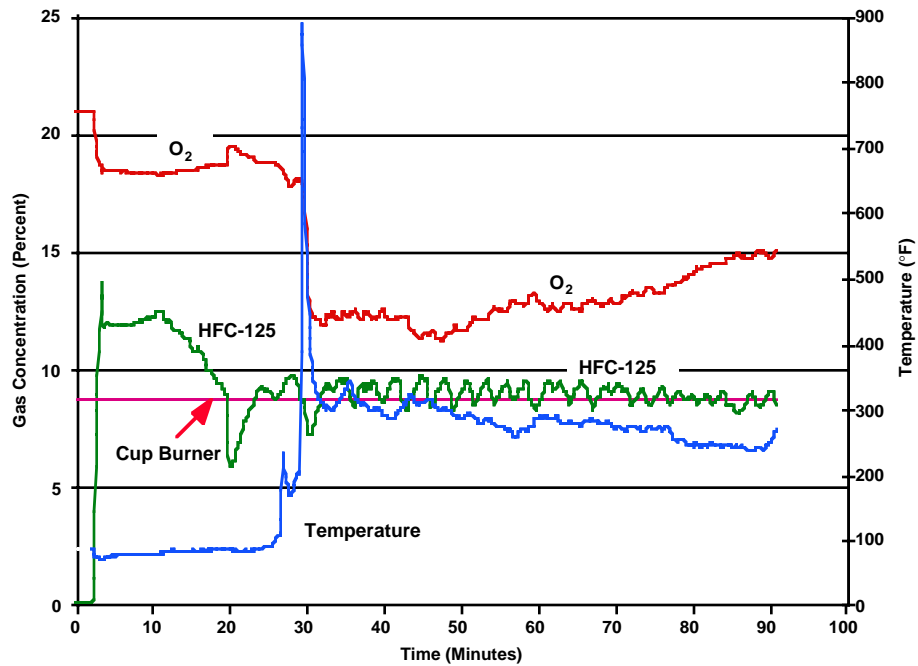
FIGURE 2. GAS AND TEMPERATURE PROFILES IN CARGO COMPARTMENT DURING BULK-LOADED FIRE SUPPRESSION TEST WITH HFC-125

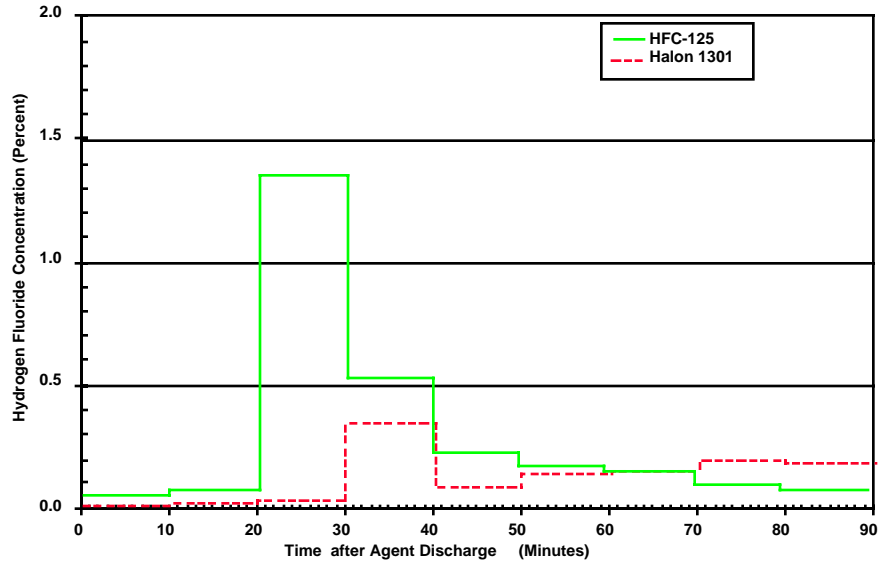
FIGURE 3. HYDROGEN FLUORIDE PROFILES IN CARGO COMPARTMENT DURING BULK-LOADED FIRE SUPPRESSION TESTS WITH HALON 1301 AND HFC-125

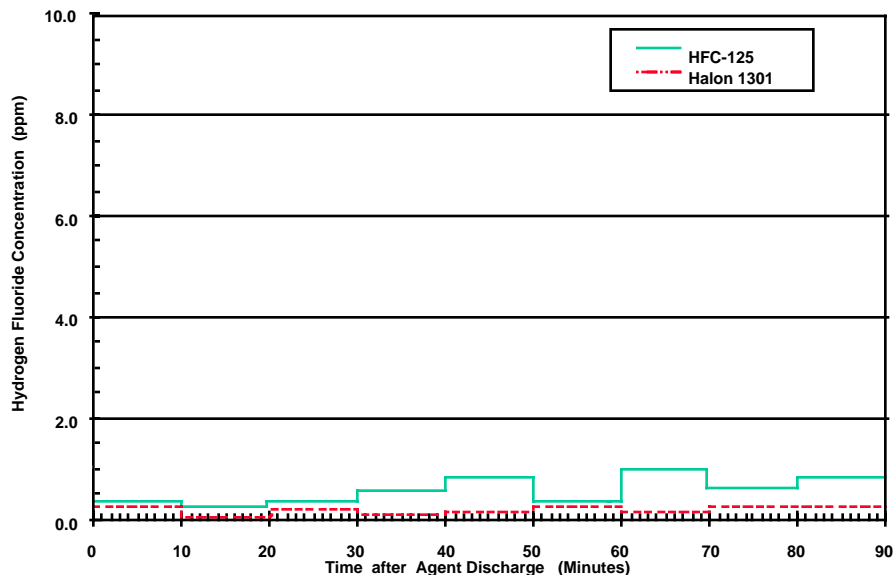
FIGURE 4. HYDROGEN FLUORIDE PROFILES IN PASSENGER CABIN DURING BULK-LOADED FIRE SUPPRESSION TESTS WITH HALON 1301 AND HFC-125

required compared to Halon 1301. Figure 4 shows the HF concentrations in the passenger cabin above the cargo compartment. HF concentrations are again higher in the test with HFC-125 for the same reasons as stated above. However, the data show that there is not a significant accumulation of HF in the cabin area. The fuselage ventilation system exhausts the decomposition products out of the cabin at a rate similar to the inflow rate of these products. The measured levels for both tests were well below the maximum Occupational Safety and Health Administration (OSHA) 15-minute exposure limit of 6 parts per million (ppm) and the Immediately Dangerous to Life and Health (IDLH) limit of 30 ppm.

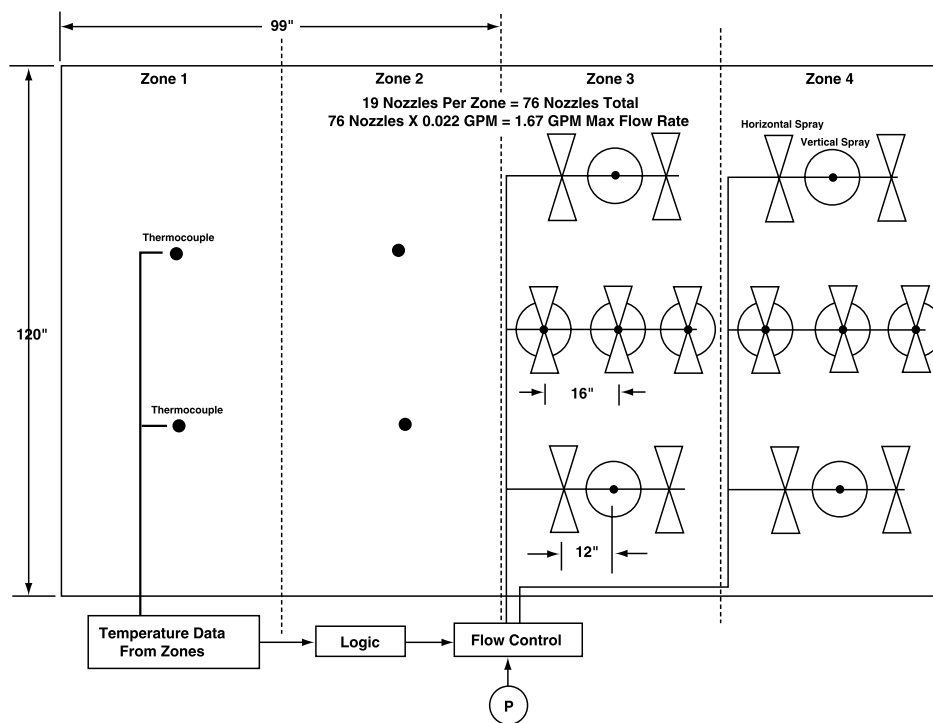
FIGURE 5. WATER MIST SYSTEM SCHEMATIC

A B727 aft cargo compartment test article was used to evaluate a high-pressure water mist system. The test article measured approximately 120 inches wide by 200 inches long at the ceiling (the floor of the compartment covered significantly less area due to the curvature of the fuselage). The compartment volume was approximately 550 cubic feet. The ceiling and sidewall were constructed of the original fiberglass cargo liners; the forward and aft bulkheads were made of aluminum. Two thermocouples trees were installed along the compartment centerline with three probes each located at 1-, 2-, and 3-foot levels. Video and photographic equipment were placed in the aft bulkhead to monitor test progress.

The water mist system was supplied by Environmental Engineering Concepts (EEC). These systems are commercially available under the trade names Microcool® and Enviromist® Fog Systems and are primarily used for environmental cooling and vegetable hothouse humidification. The system used for the cargo compartment testing was co-designed by the FAA and EEC and consisted of a high-pressure pump, four zone control valves, and the basic piping and nozzles. The water mist system, designed to minimize the amount of waste water by applying the mist to the areas of the fire, was divided into four zones that could be individually activated (see figure 5). Each zone contained 19 nozzles and covered an area of approximately 4 by 10 feet. The nozzles were oriented to spray mist both horizontally and vertically (down) to maximize mixing and coverage. The mist was automatically controlled by two thermocouples mounted in the ceiling of each zone. The control of the spray activation could be adjusted prior to each test. During the test, when either of the zone thermocouples exceeded the preset value, a signal was sent to open the zone control valve, discharging the mist in that zone. The water mist pressure was adjustable from 800 to 1200 psi, as supplied by an electrically driven pump.

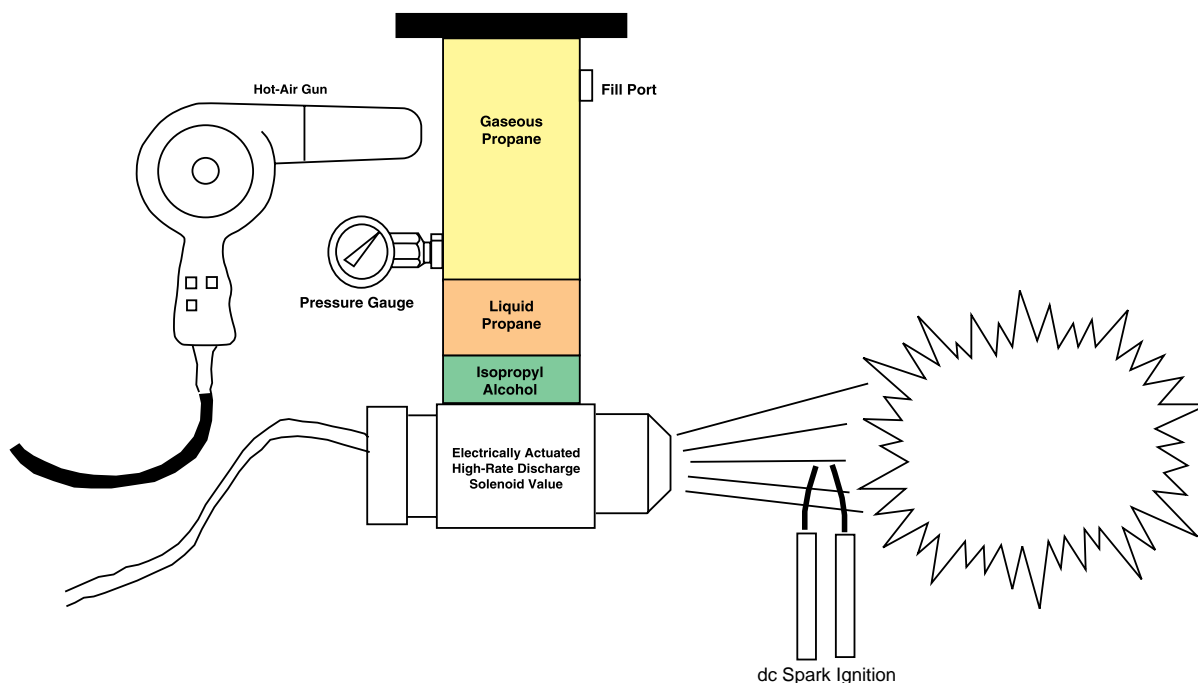
FIGURE 6. EXPLODING AEROSOL CAN SIMULATOR

The initial simulator design was a steel pipe pressure vessel mated to a high-rate discharge (HRD) electrically actuated solenoid valve (see figure 6). The vessel contained ports and valves to transfer the base product (initially isopropyl alcohol) and hydrocarbon propellant (typically propane). The contents are heated by blowing a hot-air gun against the surface of the steel vessel, effectively raising the pressure of the contents. When the pressure was sufficient to burst a standard strength can, approximately 210 psig, the contents were released over a set of direct current (dc) spark igniters. A high-voltage transformer produced the electric spark to bridge the 1.2-cm gap between the pair of electrodes.

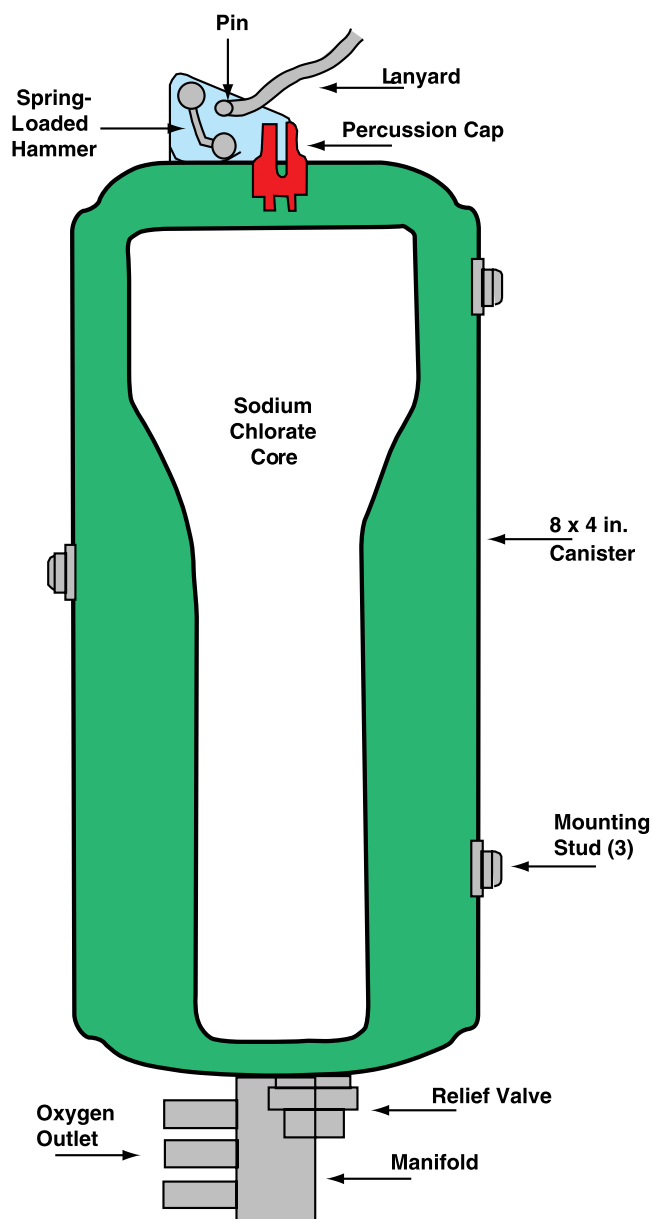
FIGURE 7. CHEMICAL OXYGEN GENERATOR

Most commercial transport aircraft use oxygen canisters to supplement or replace cabin air for passenger breathing in the event of a cabin depressurization. Figure 7 shows the design of a common oxygen canister. The main components are the chemical core composed of sodium chlorate and iron particles, a stainless steel housing, a means of initiating the chemical reaction (such as a spring-loaded hammer striking a percussion cap), and outlets for the gaseous oxygen generated. Because the oxygen-producing reaction is exothermic, the steel housing is insulated from the chemical core to maintain the temperature of the housing below 500°F. As discussed earlier, the activation of improperly packaged and shipped oxygen canisters in the forward cargo compartment was the probable cause of the fatal ValuJet in-flight fire. [5]

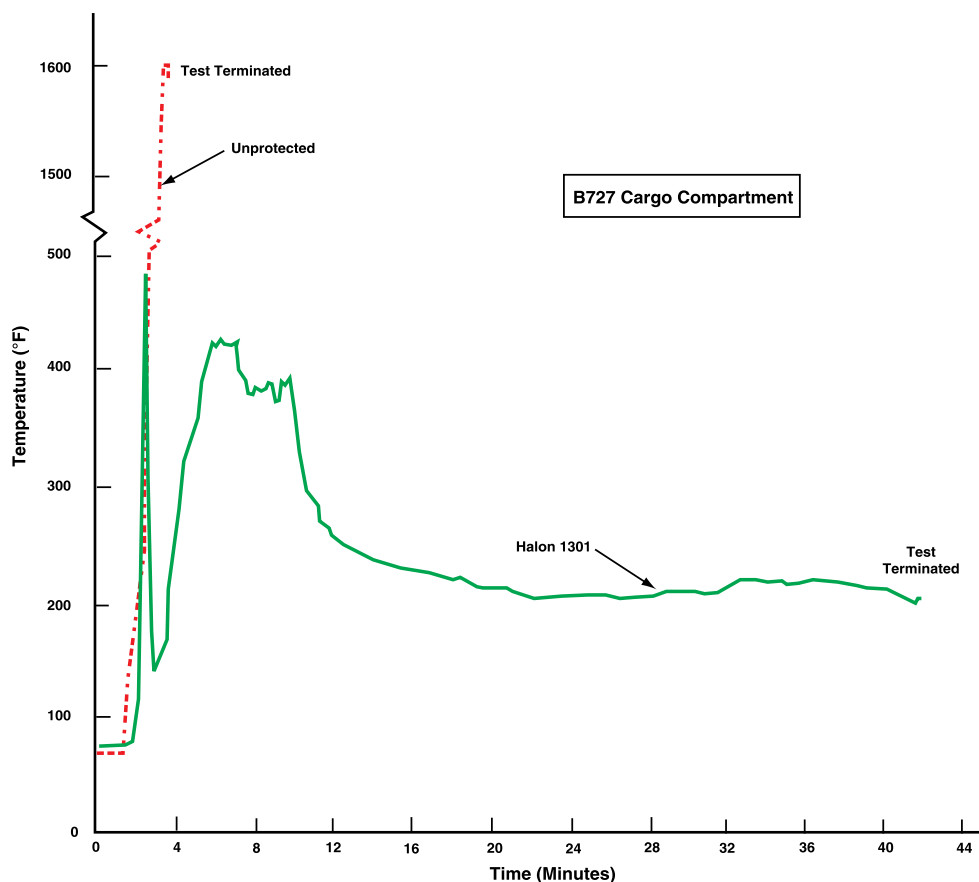
FIGURE 8. COMPARISON OF CEILING TEMPERATURES DURING A CARGO FIRE INVOLVING 12 OXYGEN CANISTERS WITH HALON 1301 SUPPRESSION AND UNPROTECTED

The second test was similar to the first with the following exceptions. Only 12 generators were used; all were stored in one cardboard box. Only a single layer of boxes filled with shredded paper was used. In this test the fire was detected much faster than in the first test (see figure 8). Temperatures at the ceiling never exceeded 500°F. As in the first test, upon discharge of Halon 1301 the visible flaming was immediately extinguished. However, in this test the ceiling temperature was maintained at about 400°F for approximately 10 minutes and decreased to approximately 200°F for the next 30 minutes. After the fire was extinguished, it was discovered that only 2 of the 12 generators had activated.

The third test was a repeat of test two without using any suppression agent. Temperatures at the ceiling rapidly reached the point where the liner would be breached and the test was immediately terminated (see figure 8).

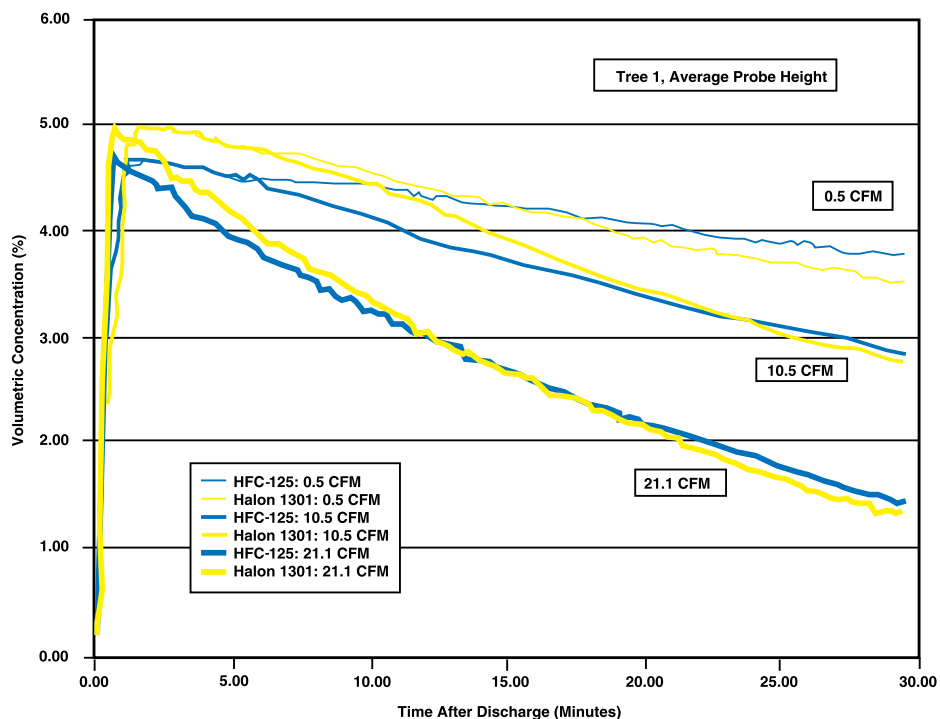
FIGURE 9. AGENT CONCENTRATION HISTORY AT DIFFERENT LEAK RATES

A comparison of the HFC-125 and Halon 1301 concentration histories at the three leakage rates for the sampling tree nearest the leak duct is shown in figure 9. The data represents the average concentration measured at the six sampling heights and from replicate tests at each leakage rate. The higher peak concentrations of Halon 1301 were expected due to the difference in charged weight; 5.8 pounds and 4.45 pounds for Halon 1301 and HFC-125, respectively. Also, the Halon 1301 decays faster than HFC-125 due to its higher vapor density; however, the difference in decay rate lessens as the leakage rate increases. It appears that HFC-125 can be used as a simulant for Halon 1301 provided that suitable conversion equations are used to correlate the concentrations of Halon 1301 and HFC-125.
